AIRCRAFT ACCIDENT FINAL REPORT NUMBER A05/2016

**ACCIDENT INVOLVING EUROCOPTER AS350 B3e REGISTRATION RP-C6828
AT BATANG LUPAR, SARAWAK
05 MAY 2016**

ACCIDENT REPORT NO.: A05/2016

**AIRCRAFT TYPE : EUROCOPTER AS350 B3e
(ECUREUIL)**

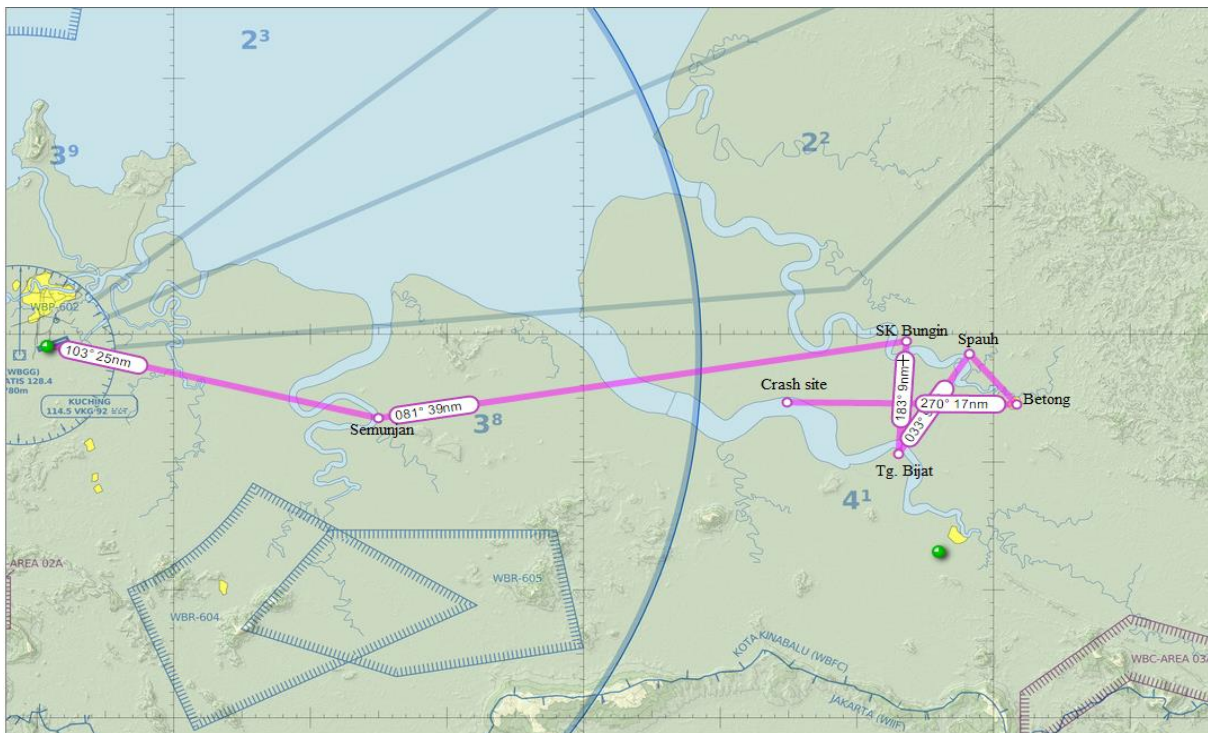
At 1612 LT, RP-C6828 departed Betong for Kuching with fuel endurance of one hour thirty two minutes. (The flight plan is at Appendix A). A radio call was made to Kuching Information (134.75 MHz) shortly after take off Betong at 1615 LT giving an estimate time abeam Triso at 1630 LT and estimate time abeam Simunjan in 20 minutes. Subsequently, there was no more communication with RP-C6828. According to other aircraft flying around the area during that time, the weather en-route from Betong to Kuching was observed to be raining with thunderstorms. The route that was flown is as per Figure 1 below.

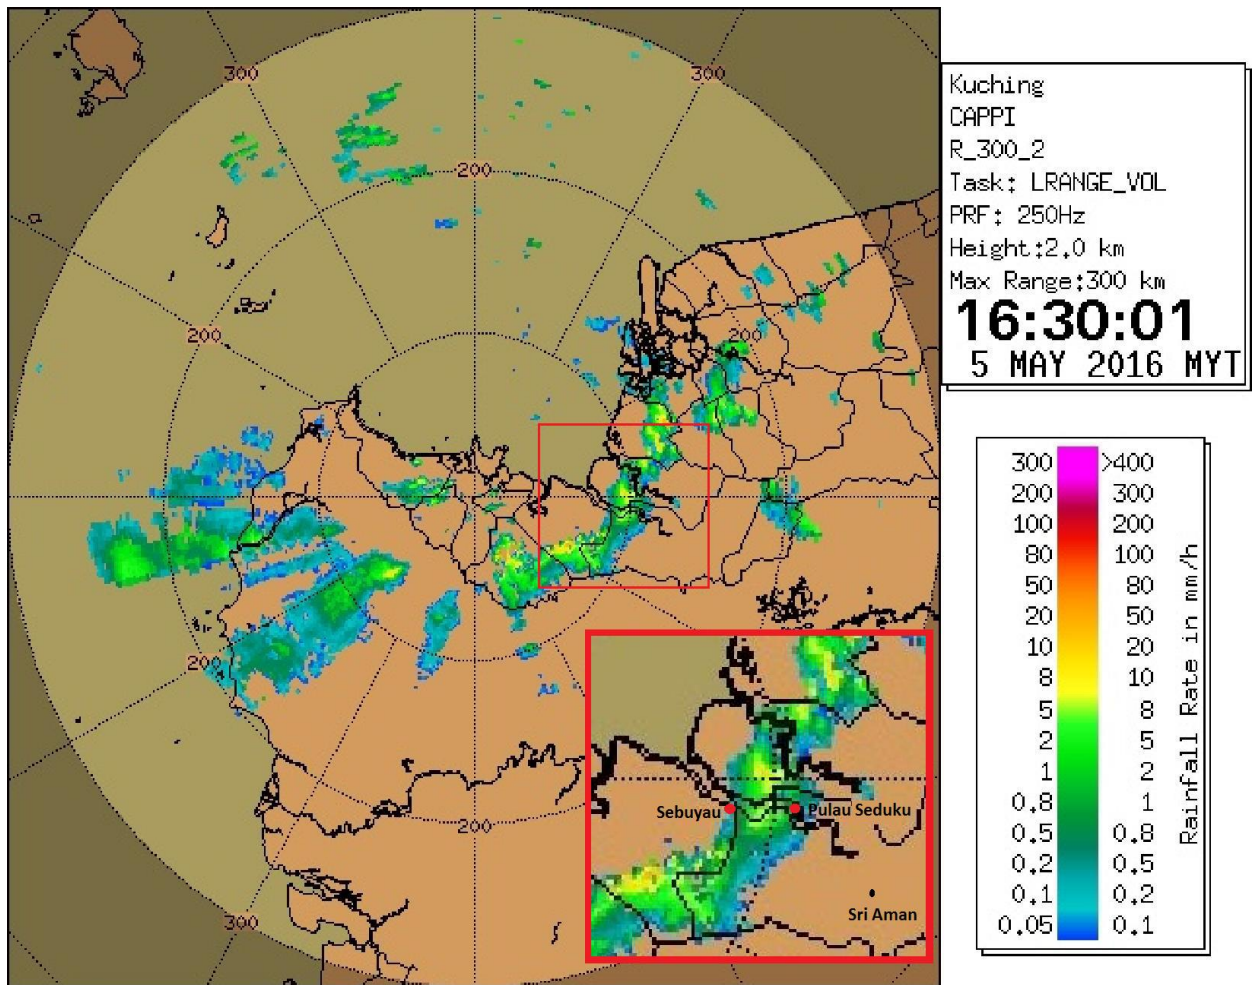
Figure 2 Meteorological radar image at 1630 LT 5 May 2016

1.7.1.2 Meteorological radar image that was taken at 1630 LT on 5 May 2016 (Figure 2) showed that there was moderate rainfall of 5 to 10 millimetres per hour at the point

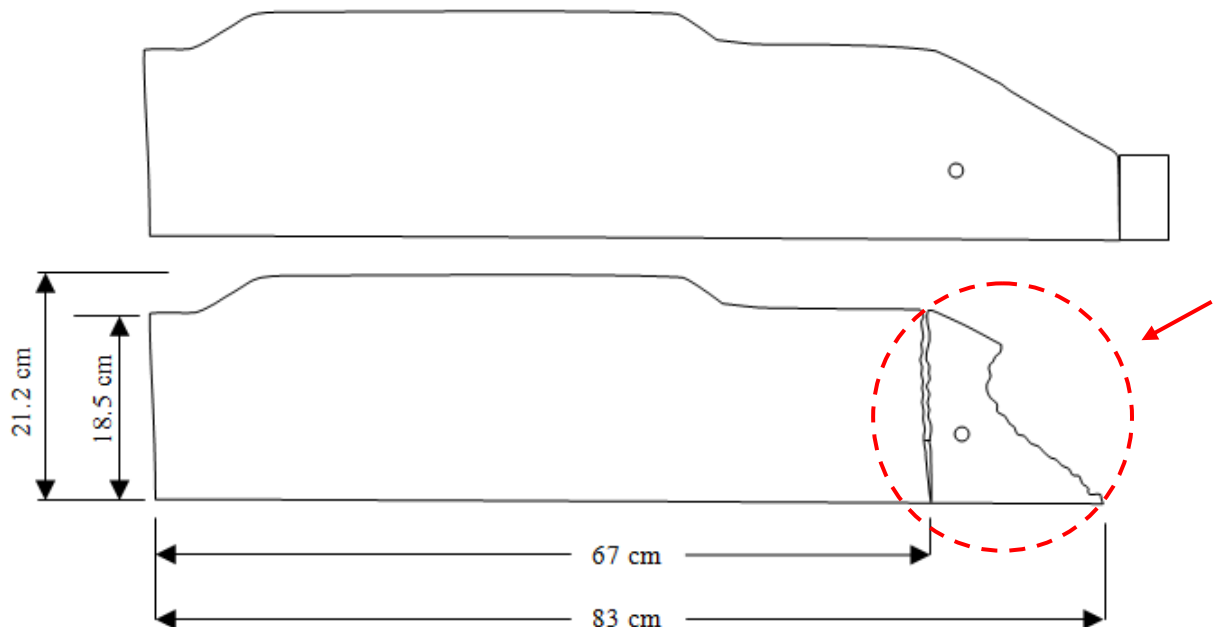
Figure 11 : Illustrated drawing of tail rotor blade

An illustrated drawing of the tail rotor blade in Figure 11 shows the fractured location and the straight crack line found as received. The location of the tail rotor blade unit and detailed type of material in each section of the helicopter are shown in Figure 12.

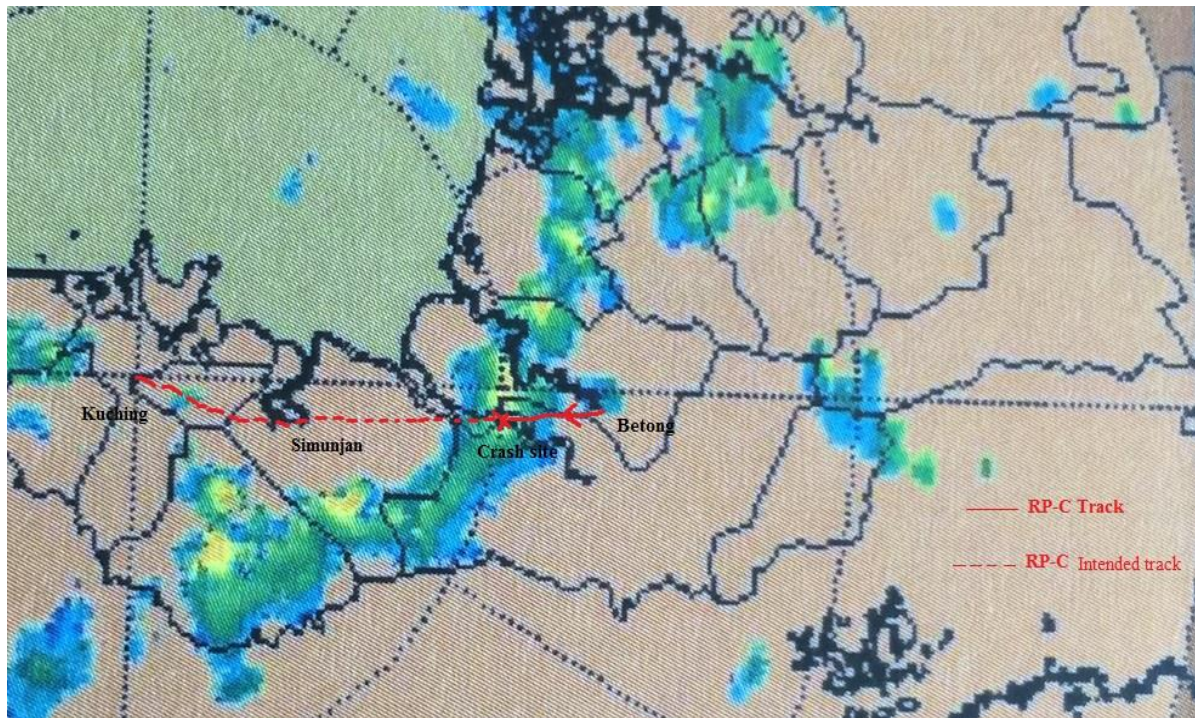
Figure 21 : Satellite weather at 1630 LT on the 5th May 2016

5 helicopters (9M-WSE 9M -WSA, 9M-WSM 9M-AWB and 9M-AZK) that were flying in the same area at about the same time reported heavy rain with strong winds over Lingga area.

Based on the forecast and actual weather investigation believed that the flight has penetrated the rain and flying over the river at Lingga area.

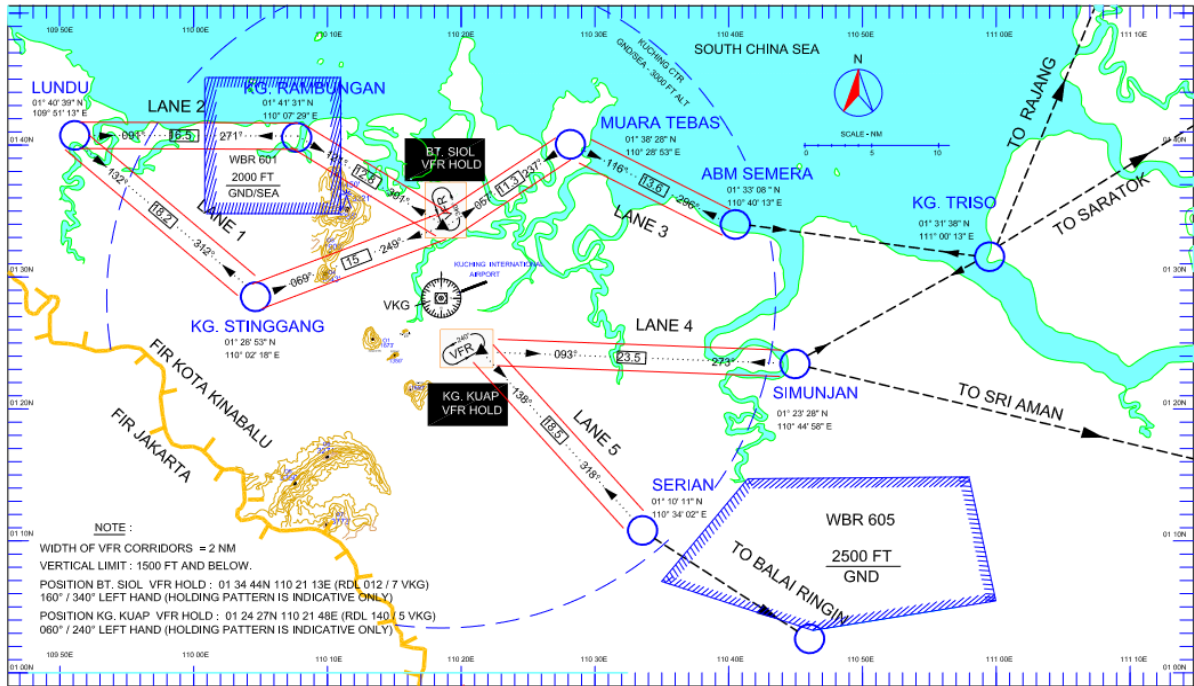
Figure 22a : VFR routes and VFR holding areas

The required route by Air Information Publication on VFR routes from Betong to Kuching is via Simunjan. Since the pilot was not familiar with the terrain and the severity of the weather during the flight, he could have navigated using the GPS information for the direct route to Simunjan which was the reporting point for VFR flight to enter Kuching control through VFR lane 4. However, before he could reach Simunjan at 1620LT, the weather surrounding Lingga, based on the satellite picture was covered with squalls and thunderstorm. He could have flown into the rain directly to Simunjan. See figure 22a and 22 b.
