**AIRCRAFT SERIOUS INCIDENT
FINAL REPORT
SI 04/18**

**Air Accident Investigation Bureau (AAIB)
Ministry of Transport, Malaysia**

**Serious Incident involving Fixed wing aircraft Boeing B737-900
Registration 9M-LNJ
Runway Excursion at Tribhuvan International Airport,
Kathmandu, Nepal
on the 19th April 2018**

SERIOUS INCIDENT REPORT NO. : SI 04/18

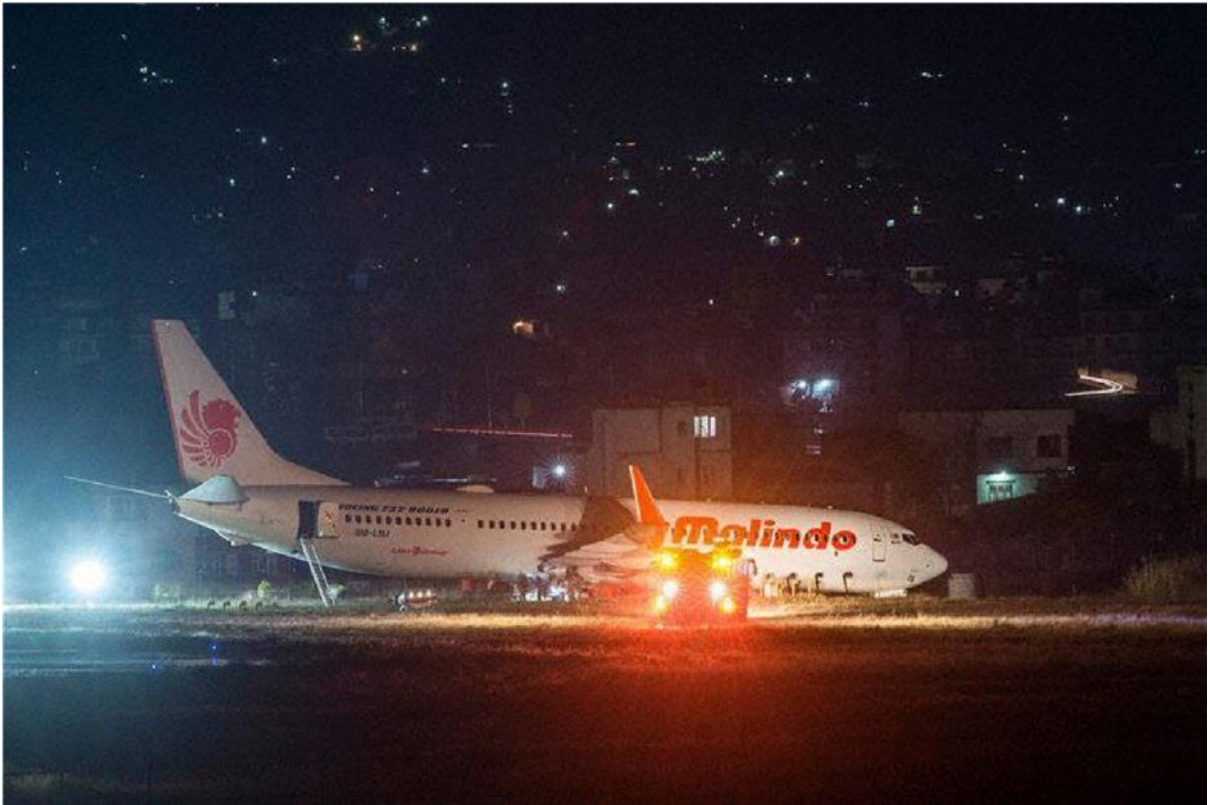
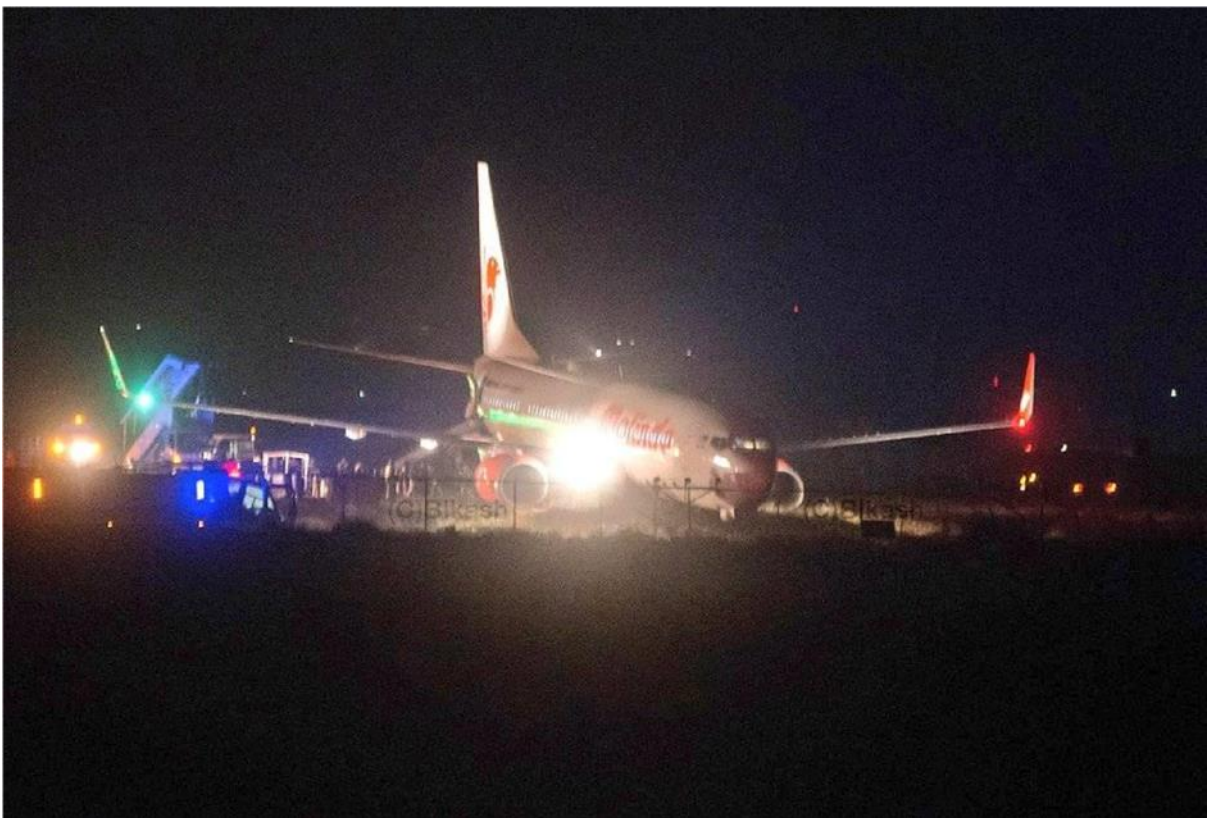
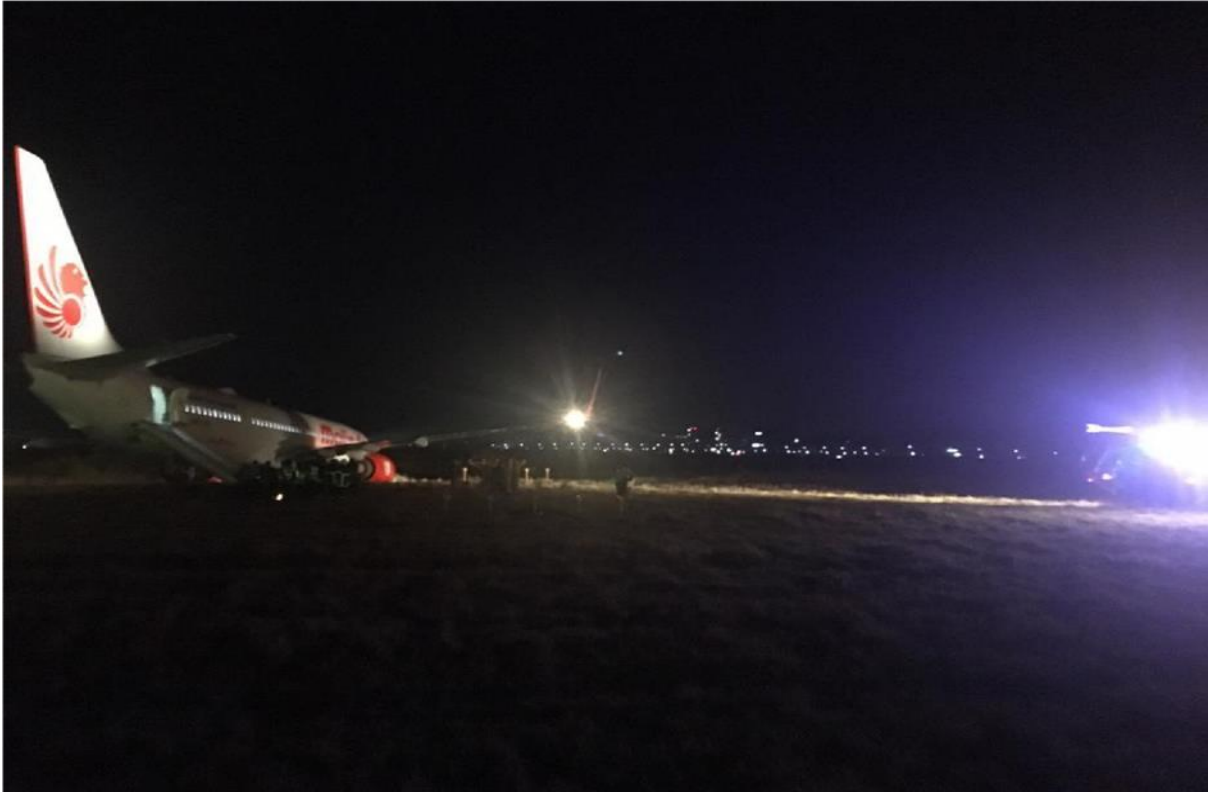
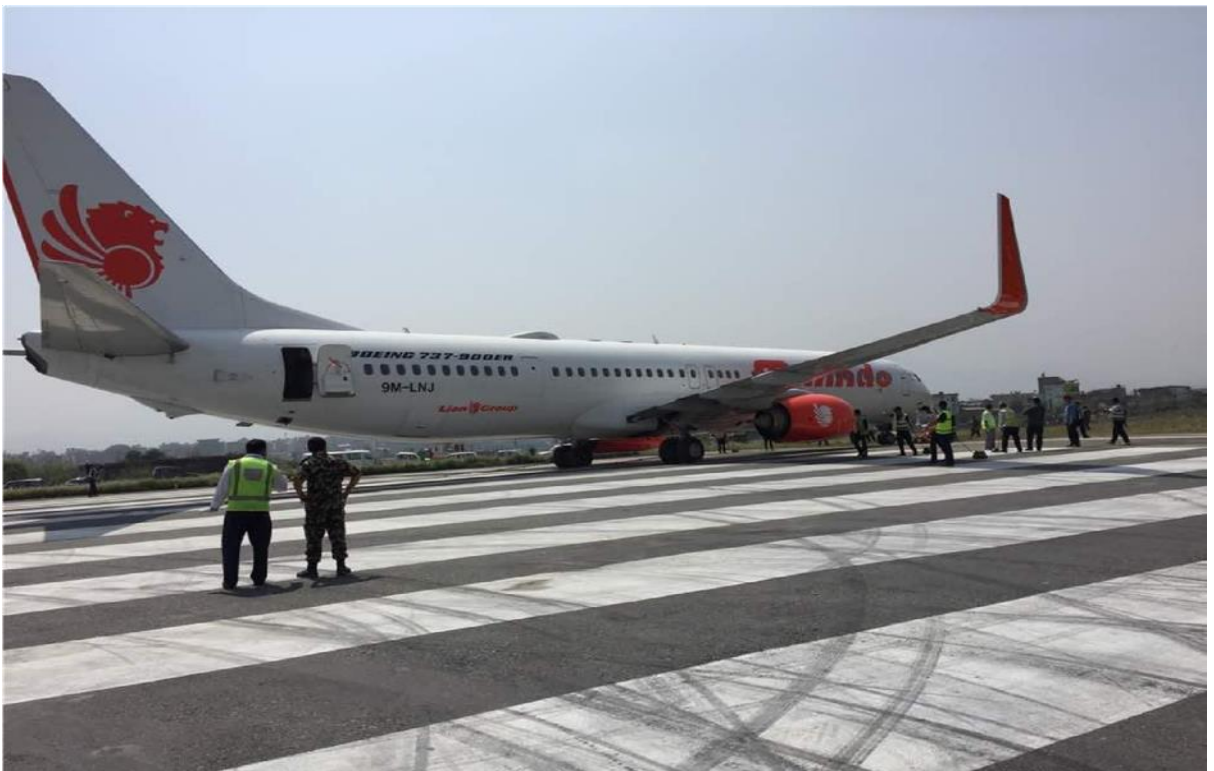
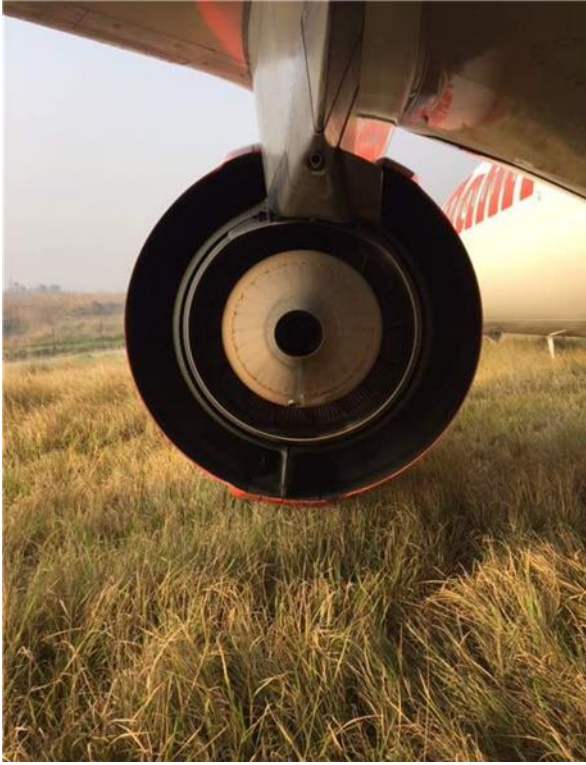
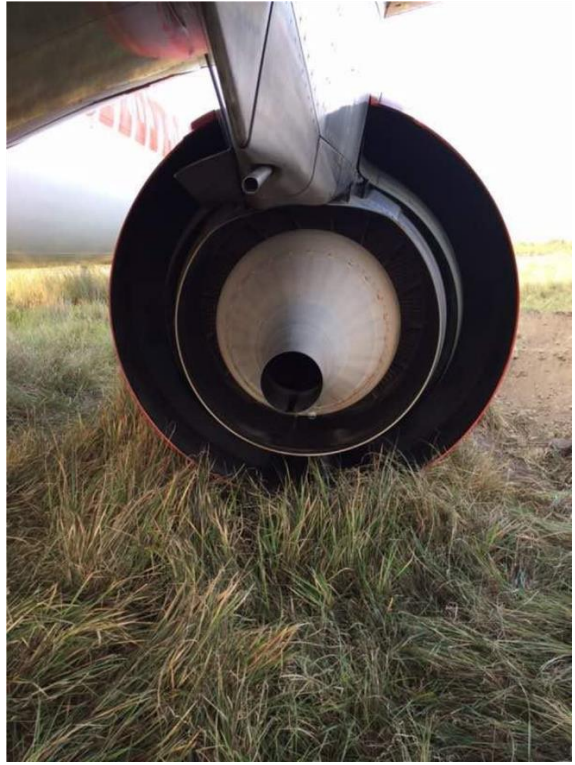
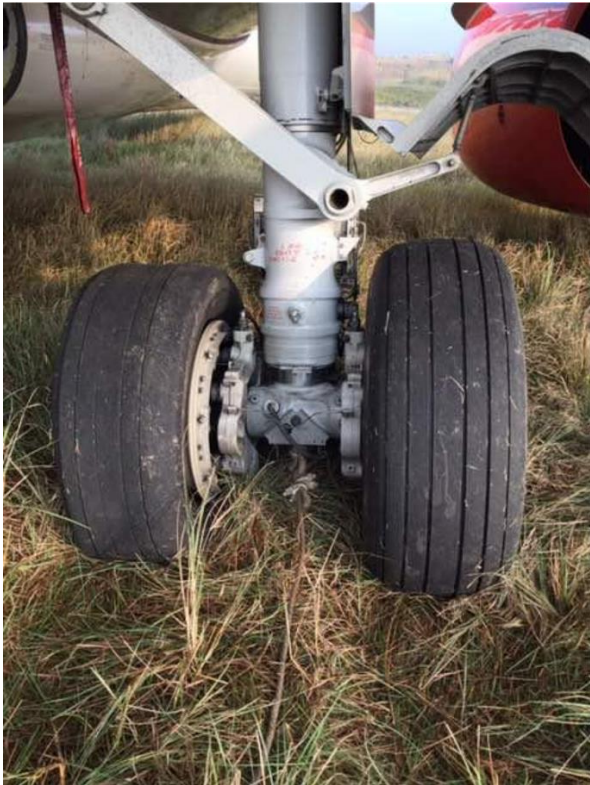
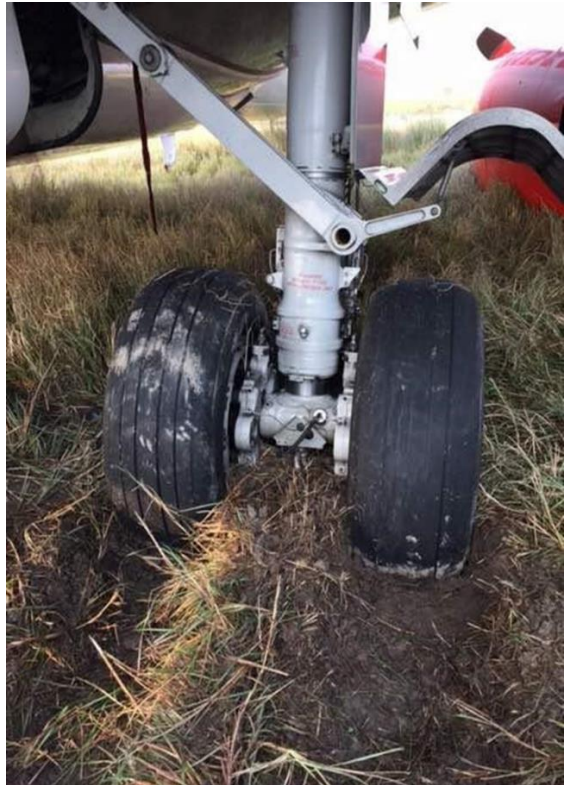
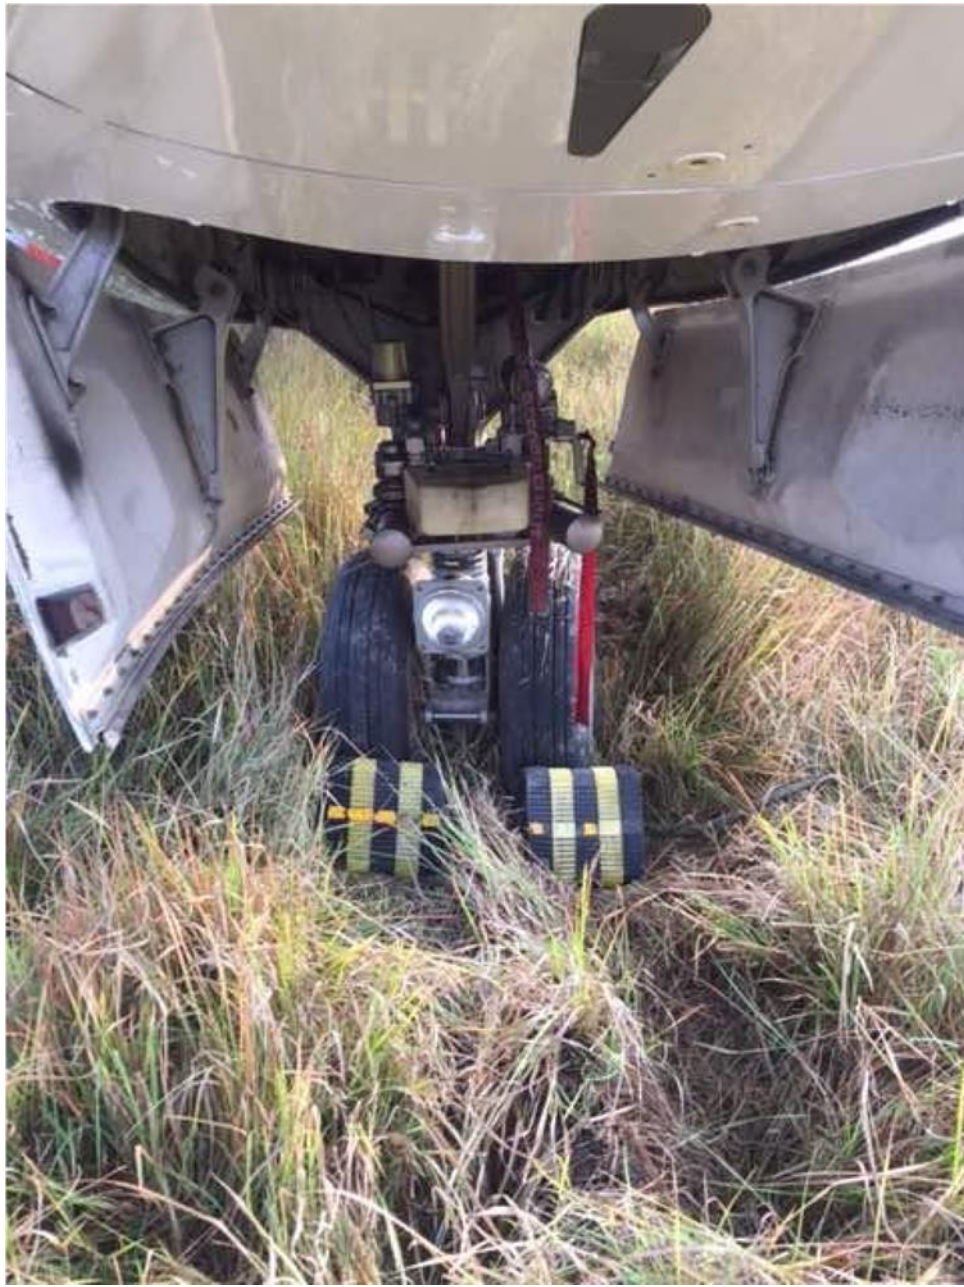
Appendix 4: Pictures taken after the event

No damage on the aircraft structures, flight controls, engines and landing gears. Number 2 main wheel found deflated. All wheels replaced as per AMM requirement.

The aircraft was found on soft ground about 50 meters after the runway threshold.
