### **FINAL REPORT**

**SI 01/20**

**Twin Otter DHC6-400, Registration 9M-SSE**

**at Miri Airport, Sarawak**

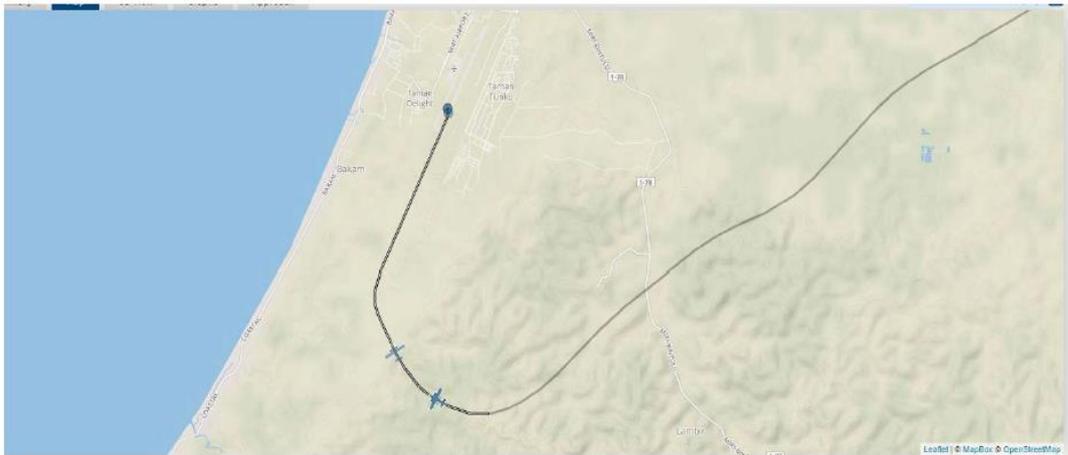
Figure 8: QAR Data Below 1,000ft – Approach Stabilized

QAR data shows that the aircraft had stabilized at 500ft during the approach to land in accordance to the DHC-6 Series 400 SOP. The data also found no significant event during the approach to land phase (Figure 8). The incident occurred after the aircraft touchdown on the runway

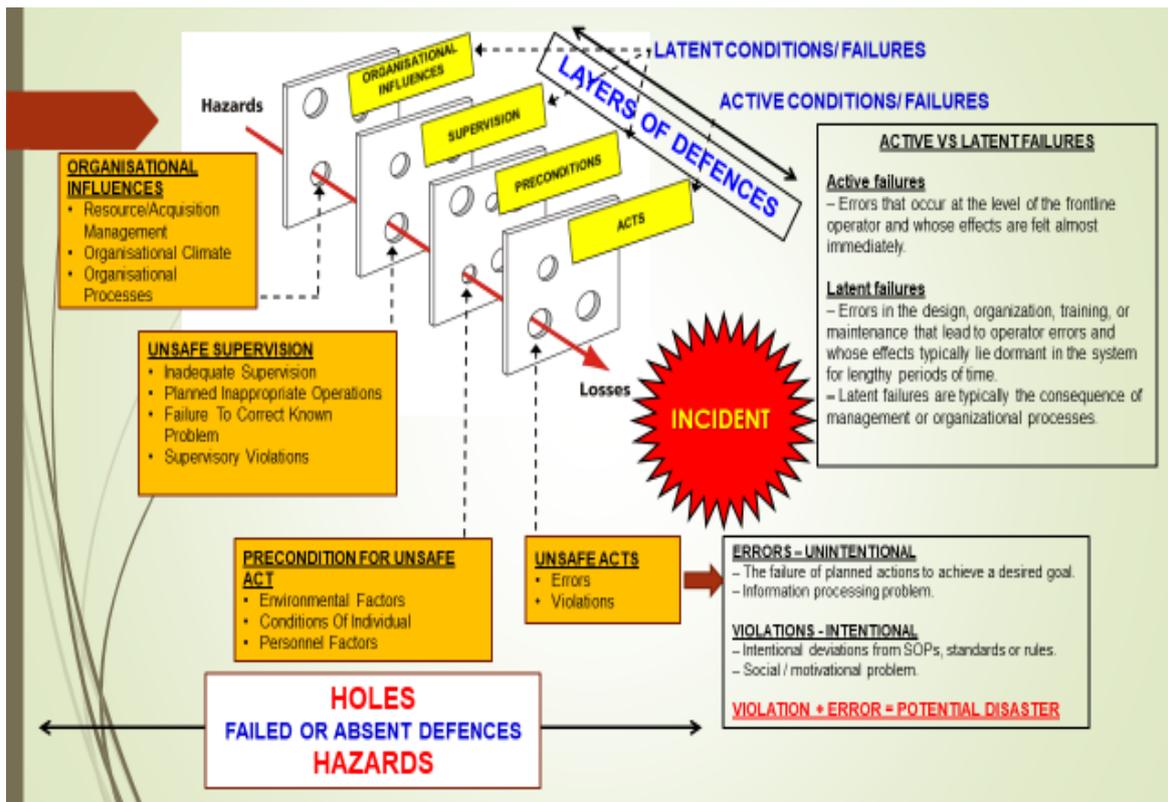
Figure 28: Reason's 'Swiss Cheese' Model

The Reason's Swiss Cheese Model is used to analyse human factor issues related to this incident (Figure 28). The model is used to describe the layers of defences at which active failures/conditions and latent failures/conditions may have occurred in this incident.

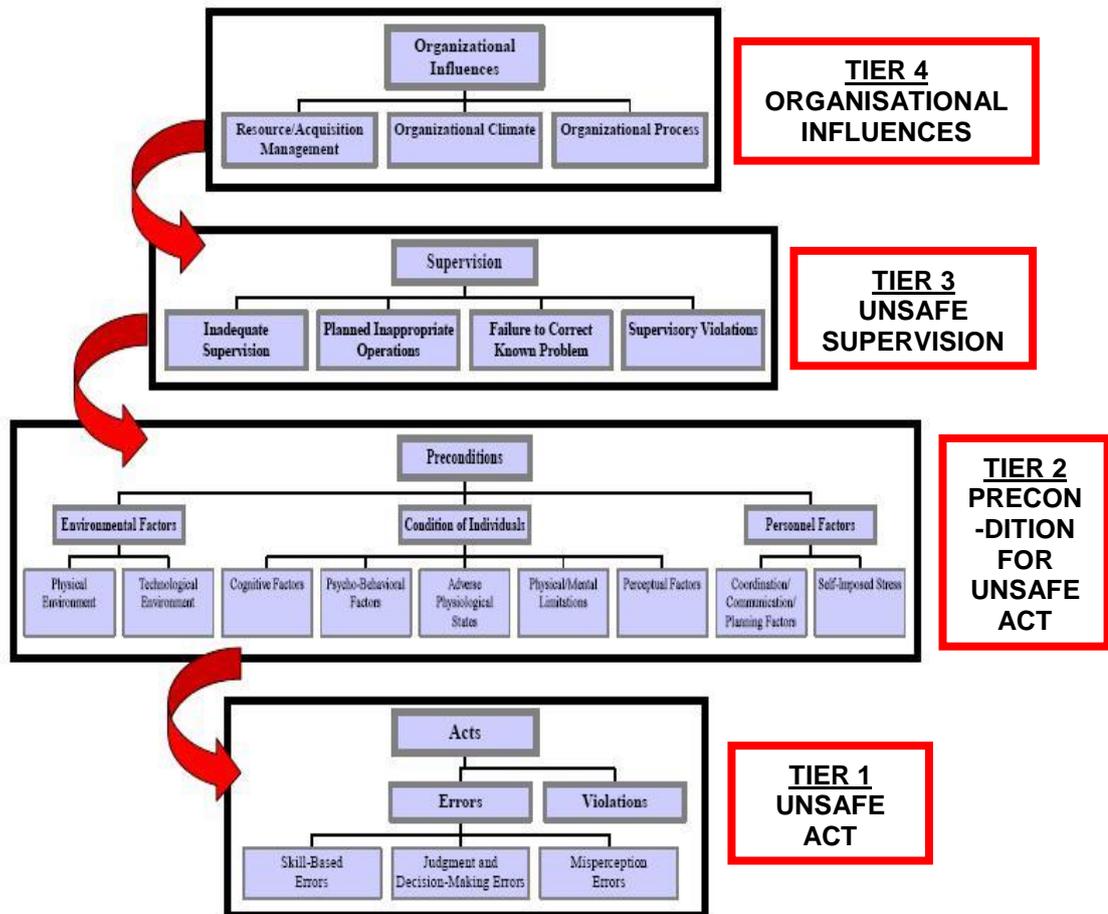
Figure 29: Human Factors Analysis and Classification System (HFACS)

(HFACS) will be used to evaluate and rule in or eliminate the various preconditions that resulted in the unsafe act. It will then evaluate the supervisory and subsequent organizational issues that had contributed to the precondition. Finally, this will provide a detailed human factors picture of all the event that led up to the incident as in Figure 29.

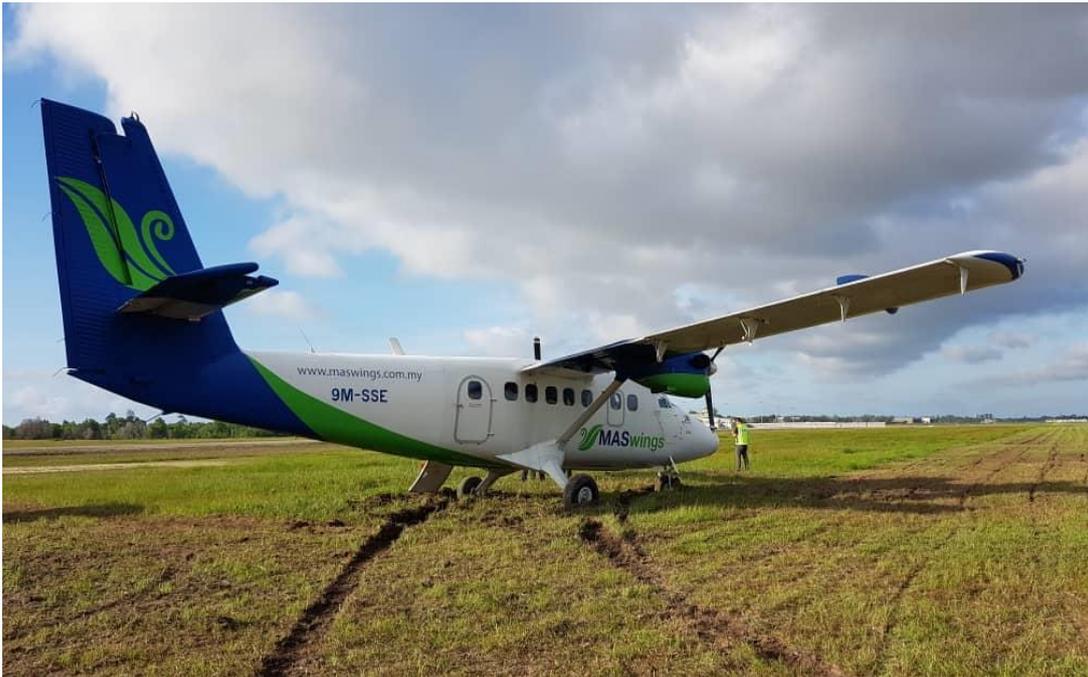
Figure 35: Rear View of Aircraft at Final Stop Position

After exiting the runway, the captain moves the nose wheel steering lever to centre (refer captain's interview statement) and the aircraft started to recovered its direction albeit on the grass area (Figure 33). It continued about straight until it got stuck in soft ground veering slightly to the right in its final stop position (Figure 34, 35 & 36).

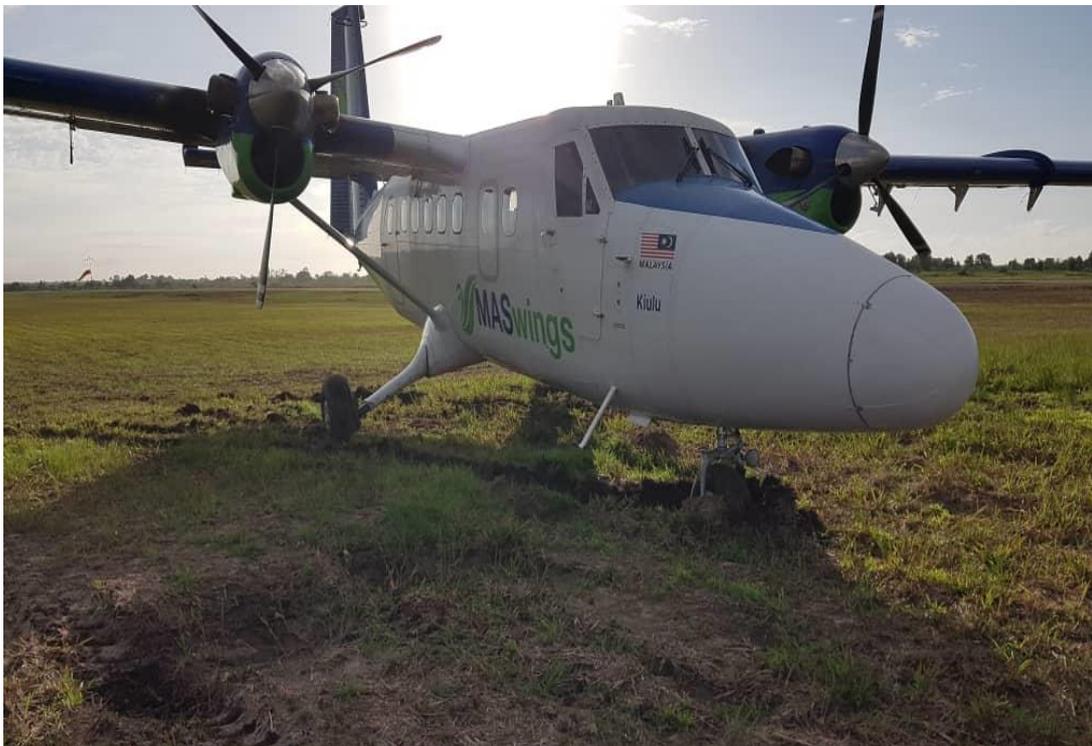
Figure 36: Front View of Aircraft at Final Stop Position
