AIRCRAFT SERIOUS INCIDENT

SI 05/20

Twin Otter DHC6-400, Registration 9M-SSC

at Long Seridan, Sarawak

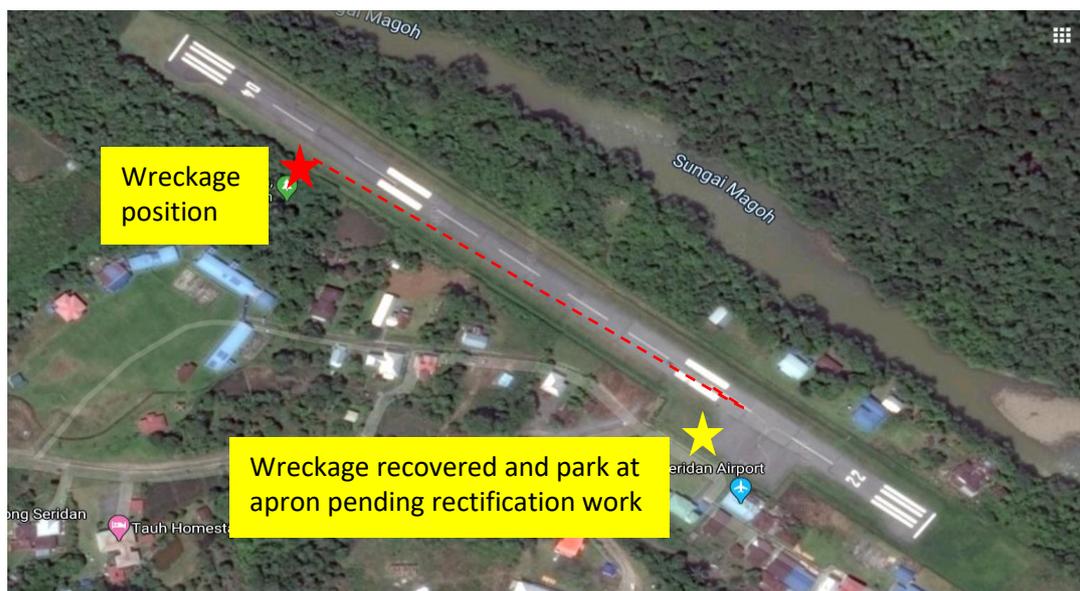
Figure 8: Aerial view of aircraft position at Long Seridan airfield
(Not according to scale)

The aircraft remained intact after the incident, albeit with damage. The aircraft had veered to the left side of the runway while rotating to the starboard, coming to a rest after impacting an embankment tail first. Damage was largely confined to the starboard wing and right side of elevator which impacted the ground and a fence post.

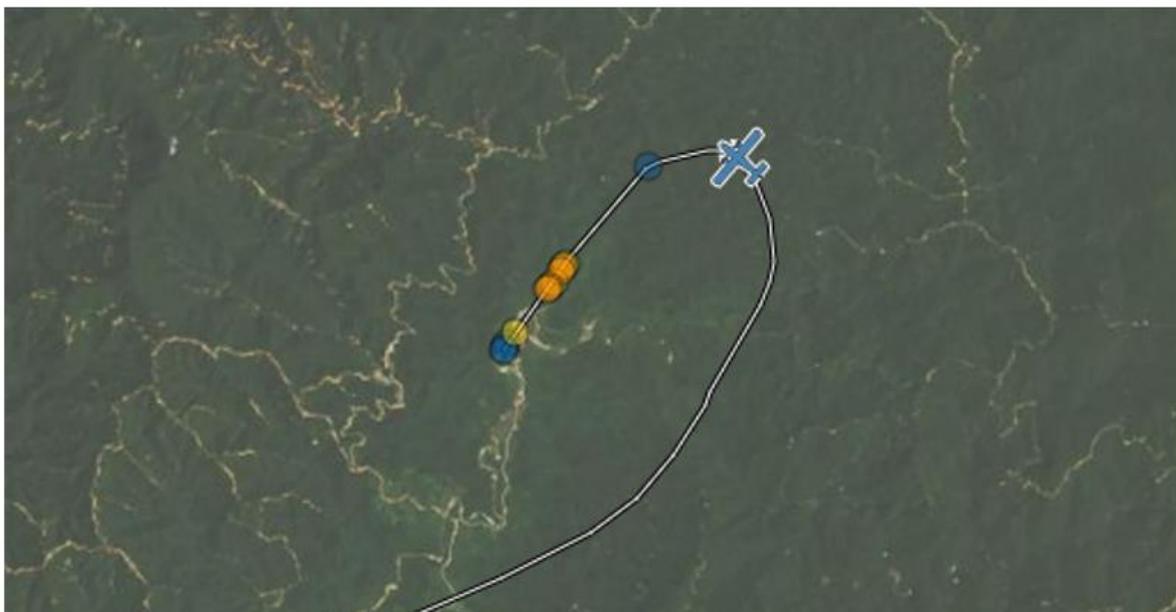
Figure 9: QAR data below 1,000ft – approach stabilized

QAR data shows that the aircraft had stabilized at 500ft during the approach to land in accordance to the SOP DHC-6. The data found no significant event during the approach to land phase (Figure 9). The incident occurred after the aircraft touchdown on the runway before veering to the left at about halfway down the runway and rotated starboard after exiting the runway with a yaw rate of 20° per second (Figure 10).

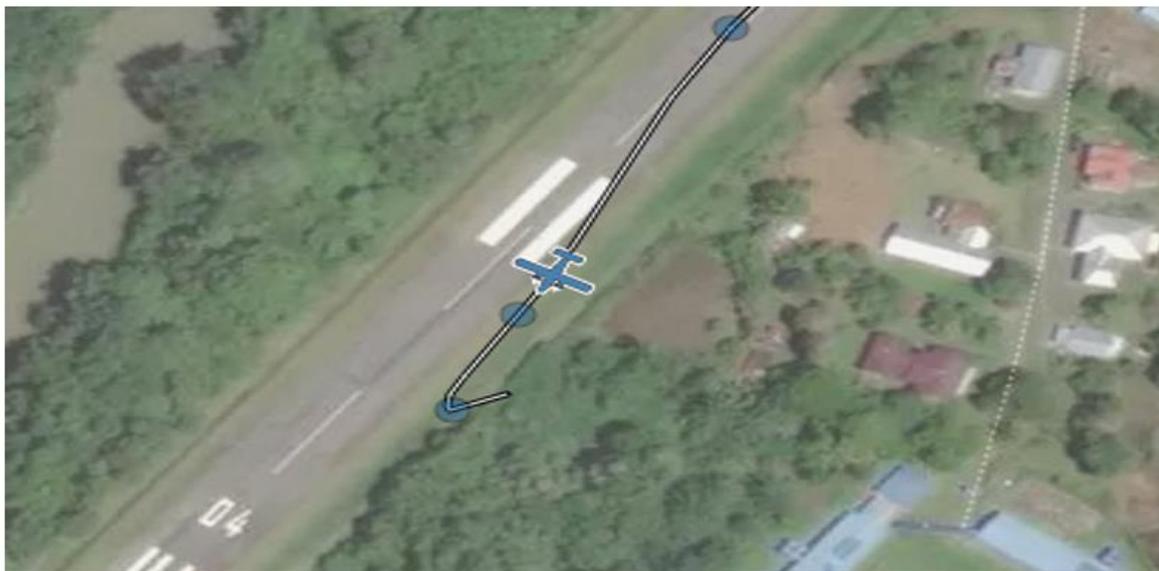
Figure 10: QAR data final approach to aircraft complete stop – aircraft veered left after touch down

It was observed that the QAR and FDR recorded an approximate tail wind of an average of 25kts (Figure 10) below 500ft AGL. Nevertheless, interview statement from the pilot and operations assistant Long Seridan airfield states that the wind was light and variable from visual observation. It would be impossible for the aircraft to land on such strong tailwind and not logical for the pilot and operations assistant not to realised such strong wind at the aerodrome.

From the aircraft tyre track marks as shown in Figure 20 to Figure 24, it was analysed that when the aircraft touch down on the runway, it rolls straight on the runway centreline for about 4 seconds (See Figure 10 QAR Data) before it started to veer to the left. Tyre marks on the runway shows the aircraft started to veer left about the half way distance from threshold Runway 22 (concurred with captain interview statement).

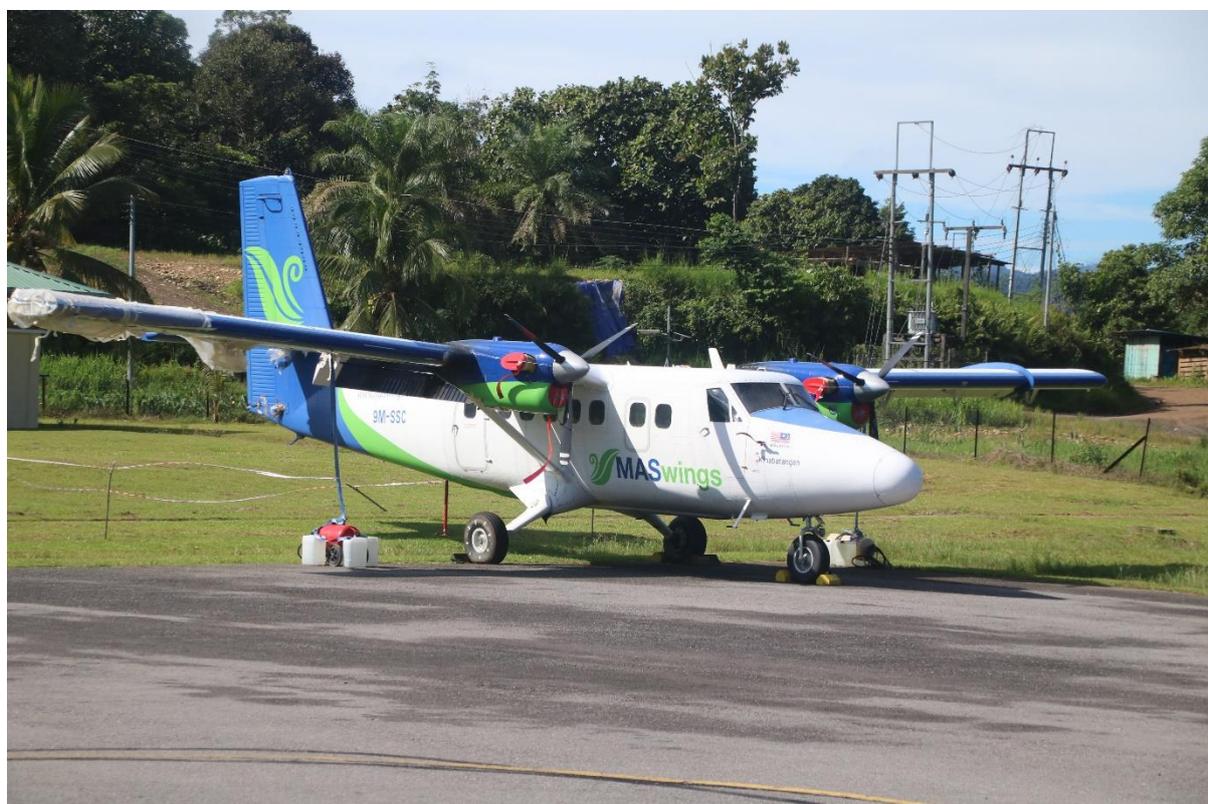
Figure 26: Aircraft was recovered from incident site and secured at airfield terminal parking area pending rectification work.

The Operator's Aircraft Recovery Team recovered and cleared the aircraft from the incident site two days after the incident. Aircraft was towed and secured at the airfield terminal parking area pending rectification work (Figure 26).

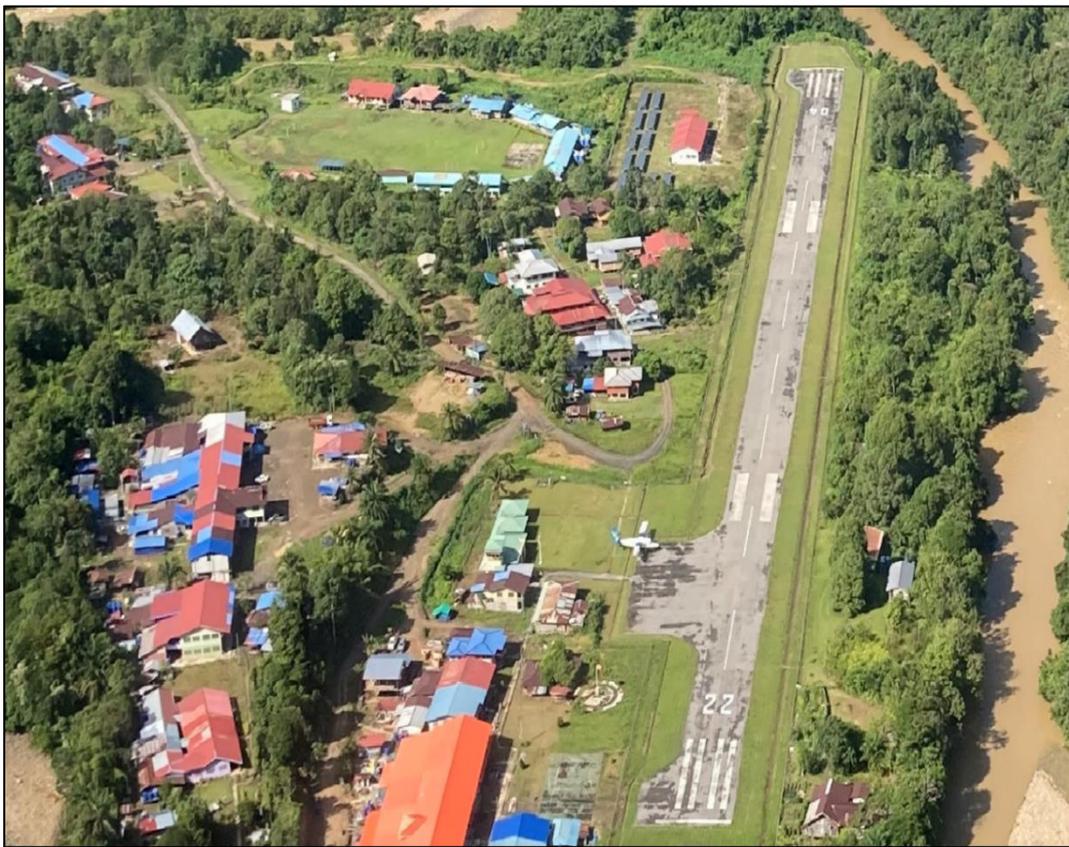
Figure 31: Site reconnaissance and mapping on Long Seridan runway using DJI Phantom 4 Pro Version 2.0 Drone

A site investigation was conducted by researchers from UPNM together with the investigation team at Long Seridan on 21 August 2020. Actual observation of the runway was conducted and mapping of the airfield using DJI Phantom 4 Pro Version 2.0 Drone was also carried out as seen in Figure 31.

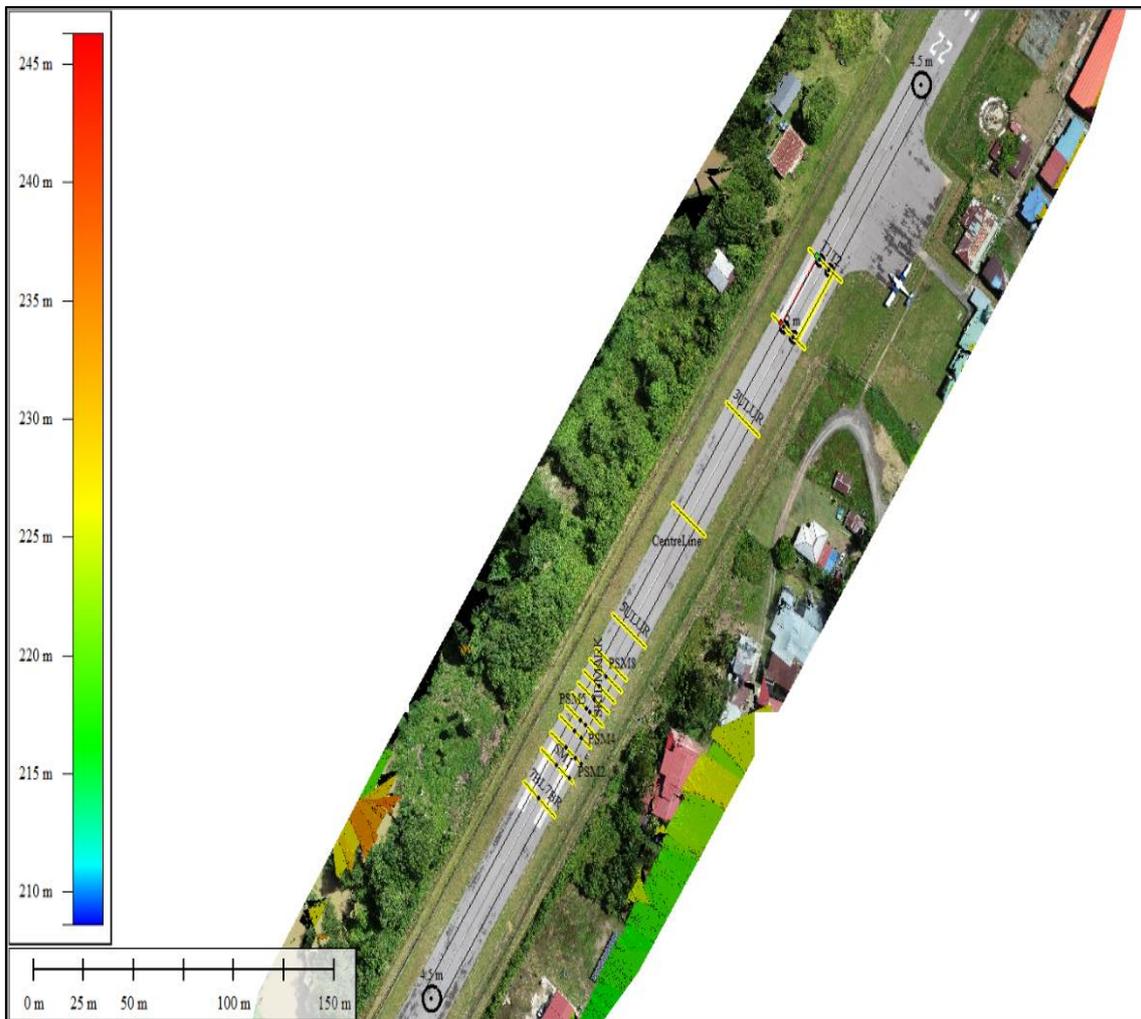
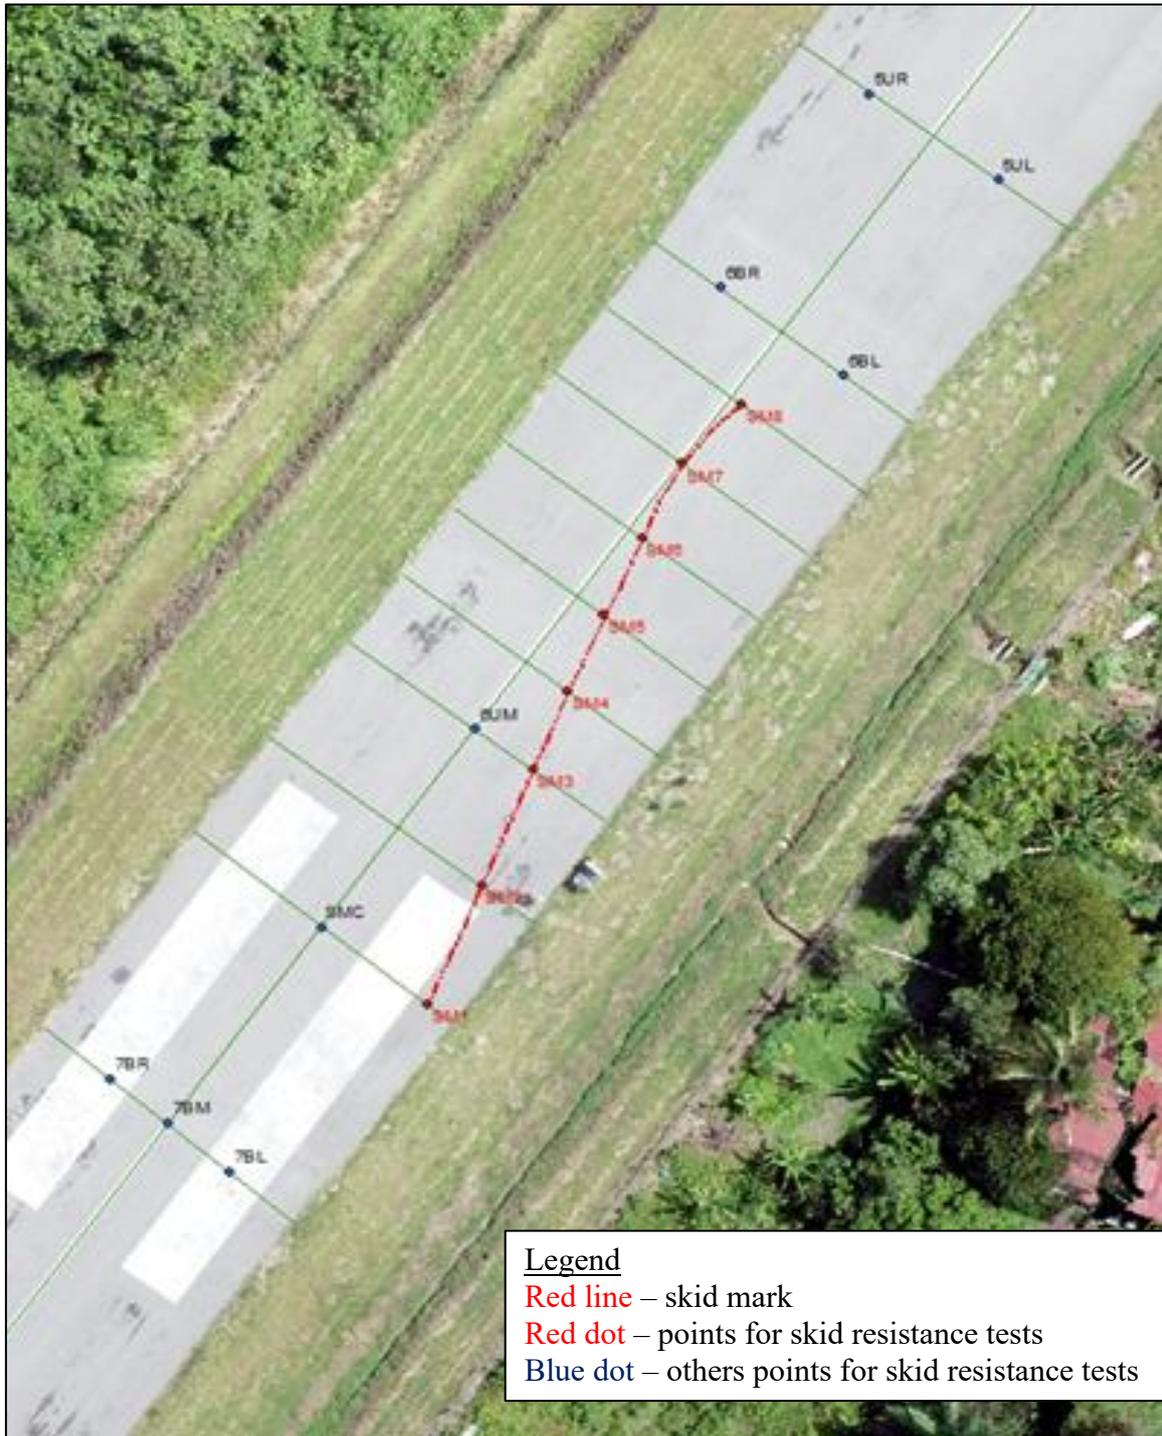
Figure 38: Layout Plan for Skid Resistance Tests at Long Seridan

Figure 38 and 39 shows the dry and wet BPN readings where the skid resistance tests were performed at Long Seridan runway. These readings were separated into different groups, (1) BPN readings at centreline, (2) BPN readings at the left-hand side of the runway, (3) BPN readings at the right-hand side of the runway and (4) BPN readings at the skid marks location.

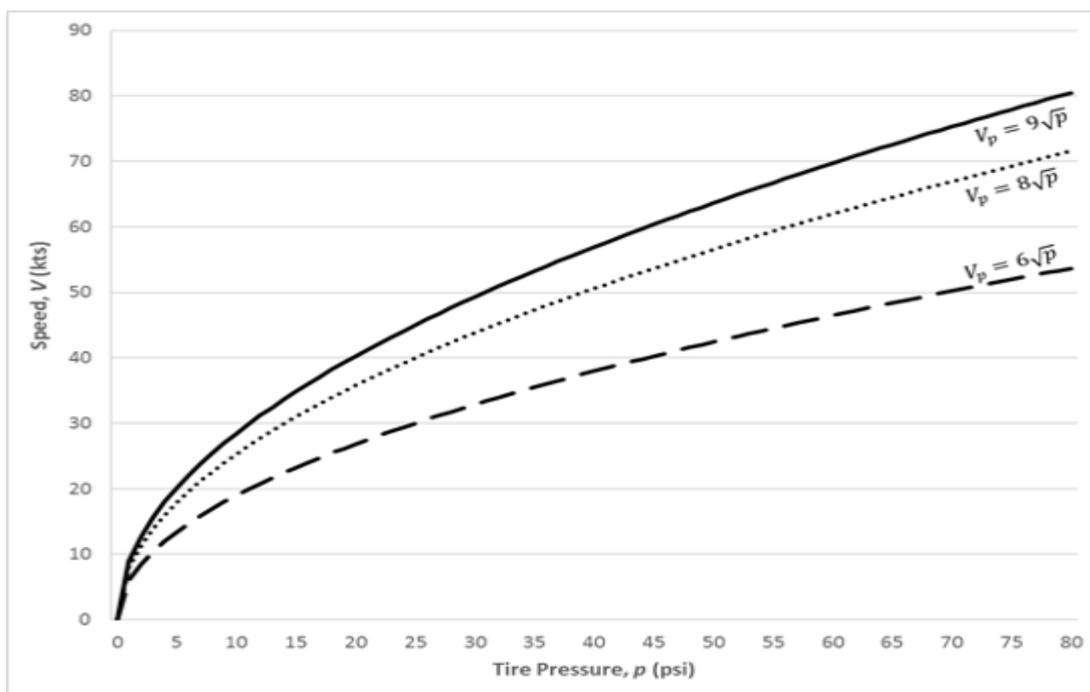
Figure 48: Relation between aircraft tyre pressure with hydroplaning velocity of aircraft

Dynamic hydroplaning generally relates to tyre inflation pressure. Tests have shown that for tyres with significant loads and enough water depth for the amount of tread so that the dynamic head pressure from the speed is applied to the whole contact patch, the minimum speed for dynamic aquaplaning V_p in knots can be established. The equation that relates hydroplaning speed with the tyre inflation pressure are plotted in Figure 48 based on Horne's³⁸ and Cepic's³⁹ empirical equation.

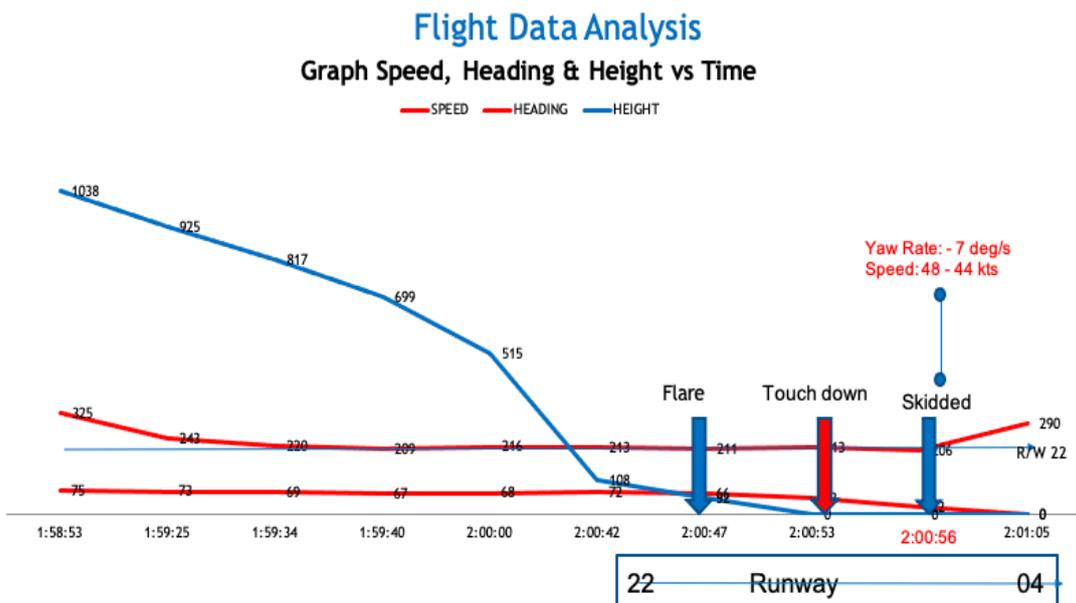
Figure 50: Flight data analysis showing the incident chronology of events

From the analysis of the QAR using **ground airspeed**, it can be seen that at 02:00:42, the aircraft approach was stabilized as it reached 108ft above field elevation at 82kts and flared before touch down at the recorded time 02:00:47 at 75kts. The aircraft touchdown on the runway at 61kts at the recorded time of 02:00:53 and proceeded to decelerate to 44kts and was found to yaw at 7 degrees per second to the left at 2:00:57 and finally came to a complete rest at 2:01:05.

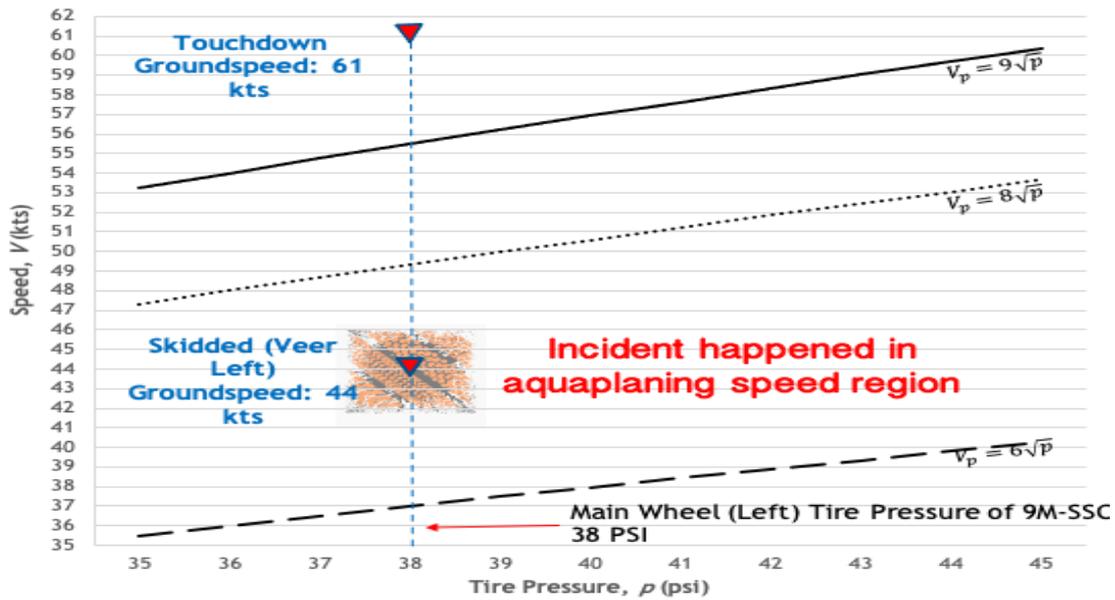
Figure 51: Hydroplaning speed plot with respect to aircraft speed

From Figure 51, using the main tyre pressure of 38psi, the touch down ground speed of the aircraft was 61kts which was above the hydroplaning region on the upper limit equation of the plot, $9\sqrt{p}$. When the aircraft touch down, reverse power and brakes were applied to slow down the aircraft. As the aircraft slows down, it started to encounter hydroplaning and the aircraft started to veer left. When the speed slow to 44kts, the aircraft started to yaw sharply to the starboard. The aircraft was identified to be in the hydroplaning region, below upper limit $9\sqrt{p}$ but above the lower limit of $6\sqrt{p}$.

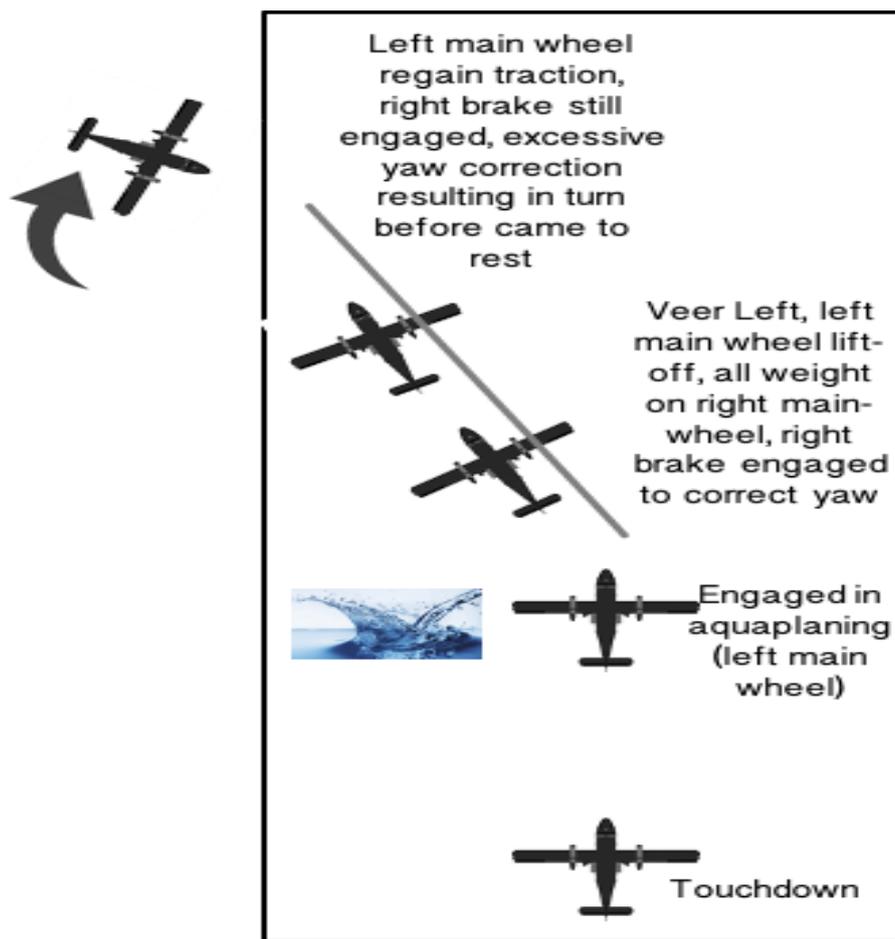
Figure 53: Illustration of series of event experienced by the aircraft starting from touchdown until final stop position

This caused the port main wheel to be lifted off the surface of the runway, putting the whole weight of the aircraft on the starboard main wheel. To counter the left veer due to hydroplaning, right brake was also applied at the same time by the pilot. Immediately after the aircraft entered the grass sideways on the left of the runway, the port main wheel restored grip on the ground. Since the right brake was still being applied, it resulted in a sharp starboard yaw and turned the aircraft facing the runway before it came to complete stop. The summary of the events is illustrated in Figure 53.

When the tyres hydroplane and lift off the runway, its ability to steer and stop the aircraft was practically lost. This is evident in this incident where braking by the pilot to steer the aircraft back to centreline actually aggravated the situation. This is compounded by the poor runway surface friction qualities at Long Seridan which contributed to the hydroplaning incident.

In conclusion, based on the hydroplaning speed analysis in paragraph 2.8, the touchdown speed of the aircraft was found to be within the range of hydroplaning. This shows that the aircraft was exposed to the risk of the skidding incident as early as the touchdown if any thin layer of water existed on the surface of the runway. Based on tyre marks analysis above, the difference in the intensity of the tyre marks found on the runway was also a strong evidence that the port main wheel was slightly lifted off from the runway surface due to hydroplaning. From the evidence adduced above, it can be concluded that dynamic hydroplaning had caused this incident.
