**AIRCRAFT ACCIDENT FINAL REPORT**  
**A 04/20**  
**Air Accidents Investigation Bureau (AAIB)**  
**Ministry of Transport**

**Accident Involving a Leonardo AW139**  
**Registration 9M-PMC**  
**in Tawau, Sabah**  
**on the 27 February 2020**

# AIRCRAFT PRELIMINARY DAMAGE ASSESSMENT REPORT (9M-PMC) ADAR/ PMC/ 20/ 01

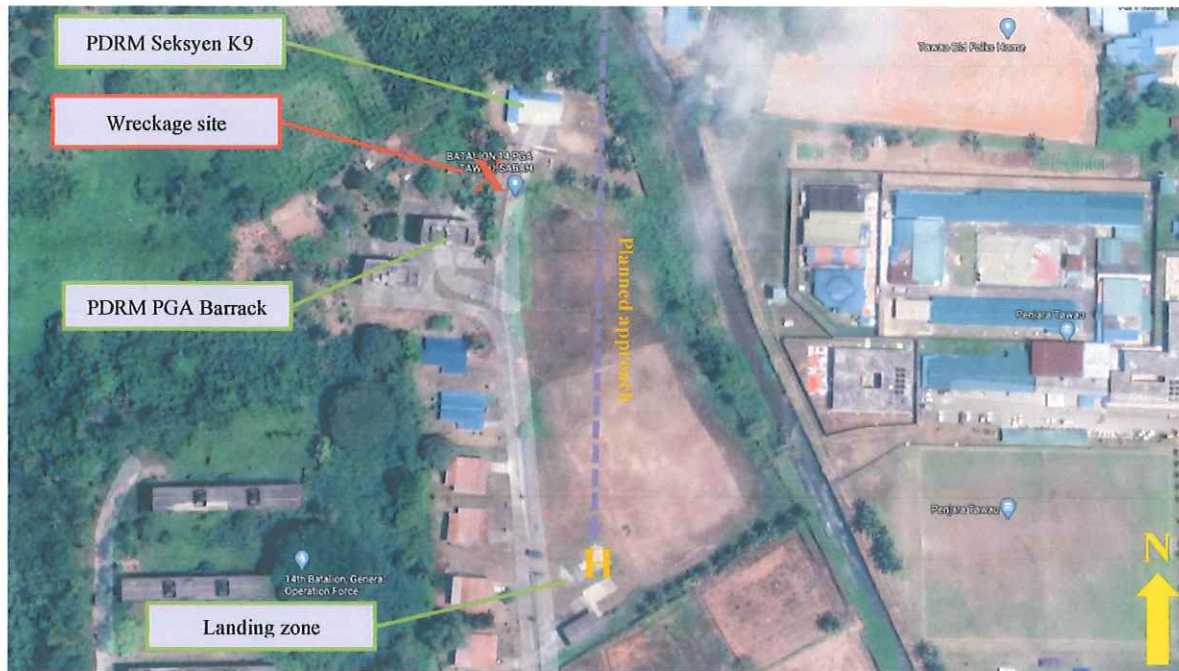
Figure 5: Location of wreckage, the planned approach and landing zone

The impact site is located on the right side of the intended approach path towards designated landing zone 160 m away, across the PDRM Seksyen K9 access road.

The aircraft came to rest on its port side, next to a fallen medium-sized coconut tree (about 4 m tall) presumably struck down by the impact. Substantial physical damage only found on port side of the helicopter with no sign of fuselage roll or tumble when it impacted ground.

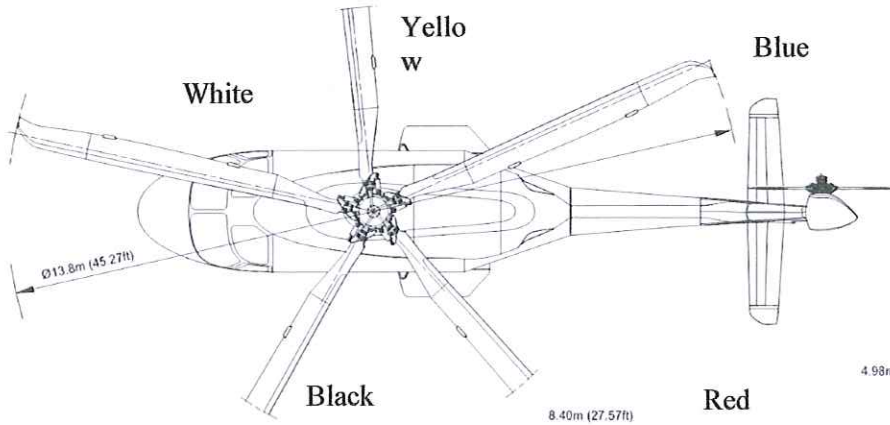
Figure 8 : Main rotor blade color position diagram

All 5 main rotor blade (MRB) found badly damage with 5 distinct marks of impact on the ground approximately 4 m away from the wreckage main rotor hub;

- MRB black found detached, 20 m away from the wreckage, impacted the roof of Seksyen K9 building and a transport.
- MRB red found detached 5 m away near the perimeter fence of the Seksyen K9 area.
- MRB blue, yellow and white found badly damage, partially connected with the wreckage.

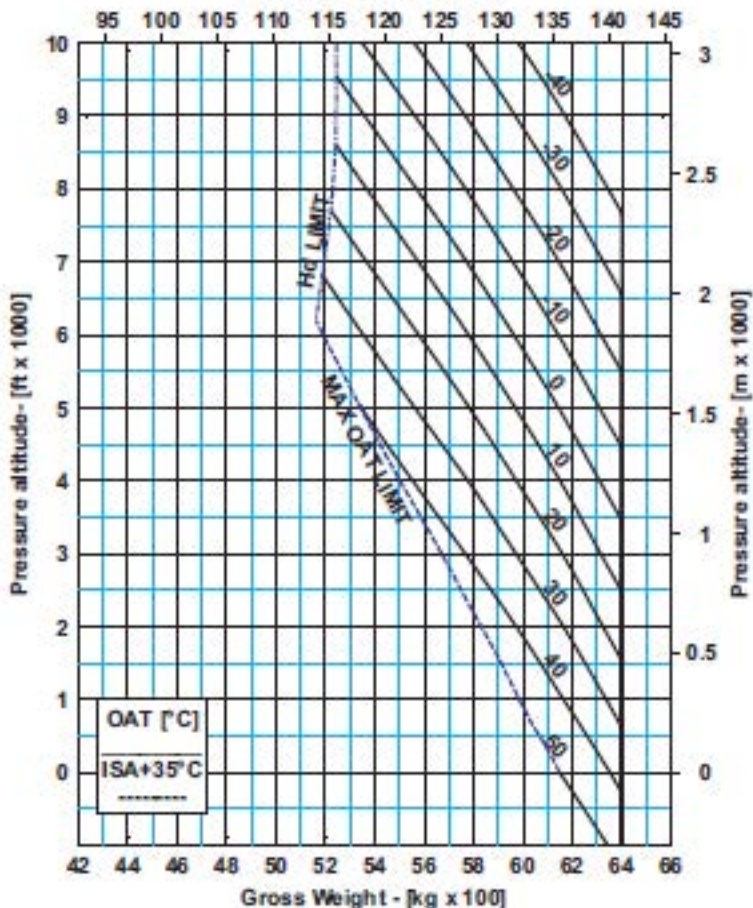
Figure 4D-4 Confined Area Heliport Procedure Weight Limitations

2.1 **AUW:** The AUW calculated by the crew at Tawau Airport was 6,598.39kg (See **APPENDIX B**). According to **APPENDIX C**, a Weight / Altitude / Temperature Chart from the AW139 RFM, the maximum AUW for the intended landing point is 6,400kg. Allowing for 50kg of fuel for start-up, taxi and hover this meant that the crew had to burn off 148.39kg of fuel during the flight in order to safely land at 14 Bn GOF.
