## **AIRCRAFT ACCIDENT**

**I 04/21**

**Incident Involving Fixed Wing Aircraft**

**Airbus 320-216, Registration 9M-AJN**

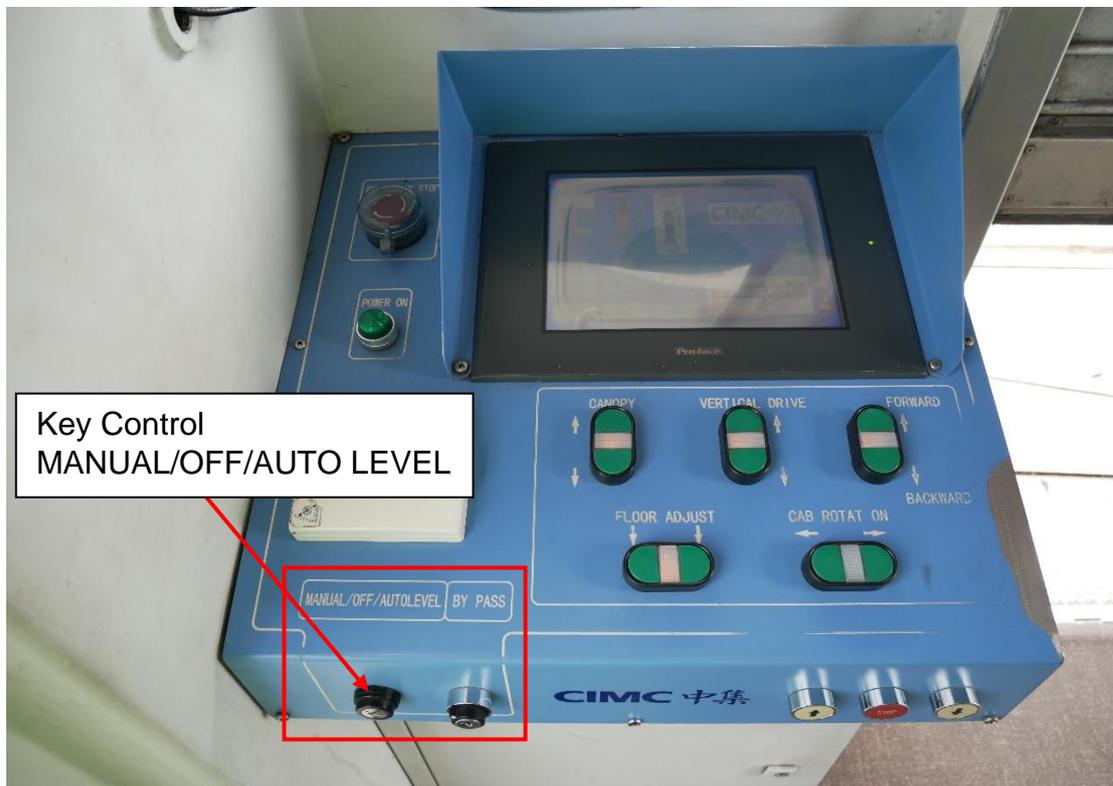
Figure 25: MANUAL / OFF / AUTO LEVEL Key Switch

The PBB Operator will switch the key switch to AUTO LEVEL to extend the levelling wheel to be flush to the aircraft fuselage after safely engaging the PBB to the aircraft (Figure 25). The function of the AUTO LEVEL is to track the height difference of the aircraft fuselage when passengers embark or disembark and cargoes are loaded or unloaded. It allows the PBB to make height adjustment automatically if the aircraft fuselage height difference reaches 2cm between the advancing edge of the PBB and the aircraft door step. It functions to assist passengers embarking or disembarking conveniently by ensuring a safe height difference between the PBB advancing edge and aircraft door step (Figure 26).

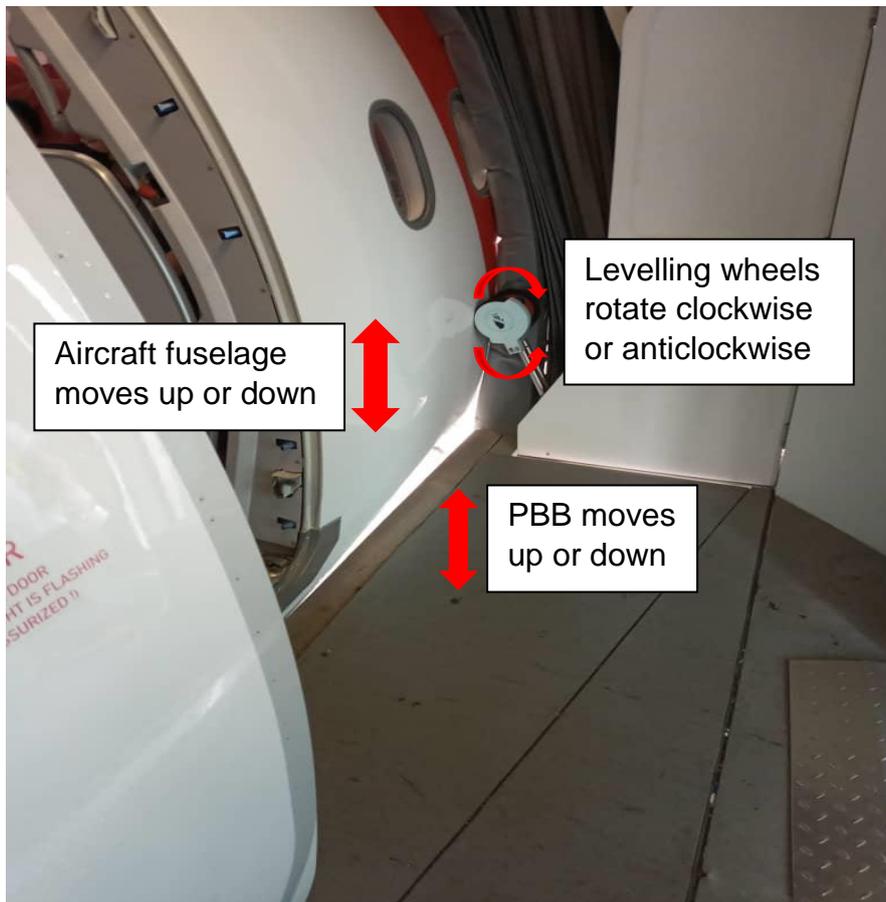
Figure 27: Operating principle of the Levelling System

The operating principle of the levelling system is that it will function when the aircraft fuselage moves up or down, a relative movement between the fuselage and the levelling wheels will caused the levelling wheels to rotate clockwise or anticlockwise. When the angle of rotation reaches 15 degrees (relevant height difference of about 2cm), a limit switch will send electrical signal to drive the PBB up or down. When the original height difference had recovered, the limit switch is reset, eliminating signal for up or down causing the PBB to stop motion which completes the levelling cycle. If the aircraft fuselage moves again, another levelling cycle starts again until the original height difference recovers (Figure 27).

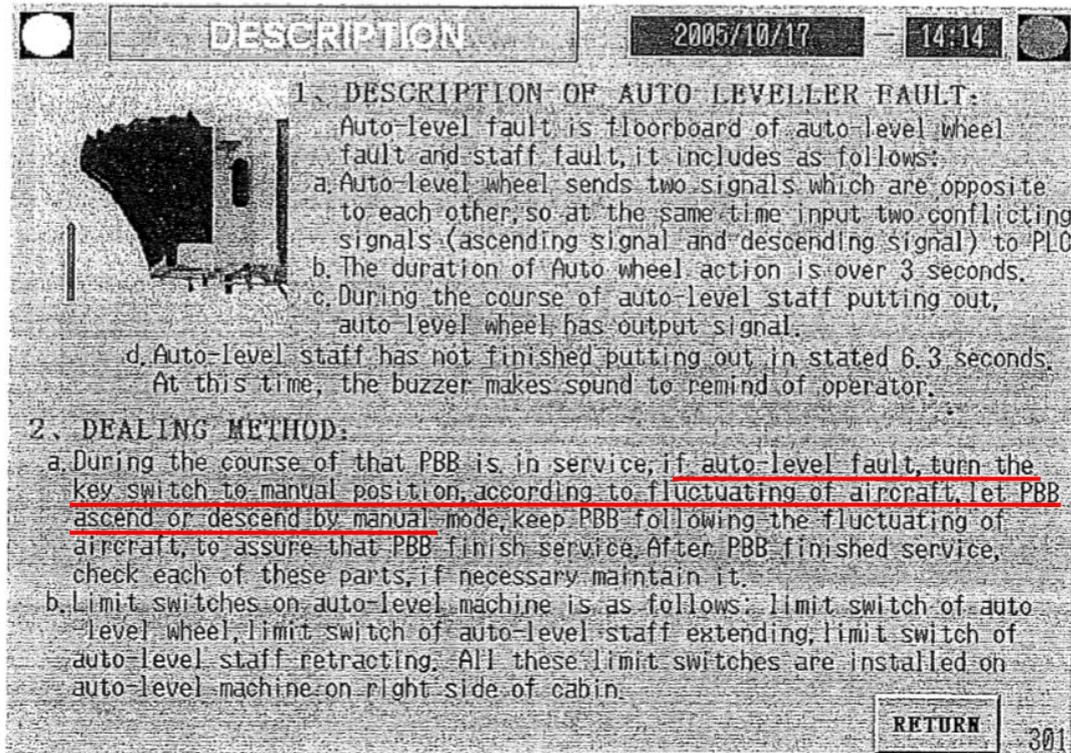
Figure 28: Manufacturer's PBB Operations Instruction – Auto leveller fault description

If the PBB does not make height adjustment when the aircraft fuselage height variation reaches 5cm, the AUTO LEVEL system will indicate AUTO LEVEL FAULT at the PBB Operating Console LCD screen and a buzzer will sound to alert the PBB Operator. The PBB Operator is required to put the key switch to MANUAL to adjust the height of the PBB based on the aircraft fuselage height variation and inform the maintenance department (Figure 28).

In this incident, the PBB Operator was not at the PBB Console, therefore there was no immediate actions taken which subsequently led to the safety shoe being pressed as the aircraft fuselage continue to move downwards.

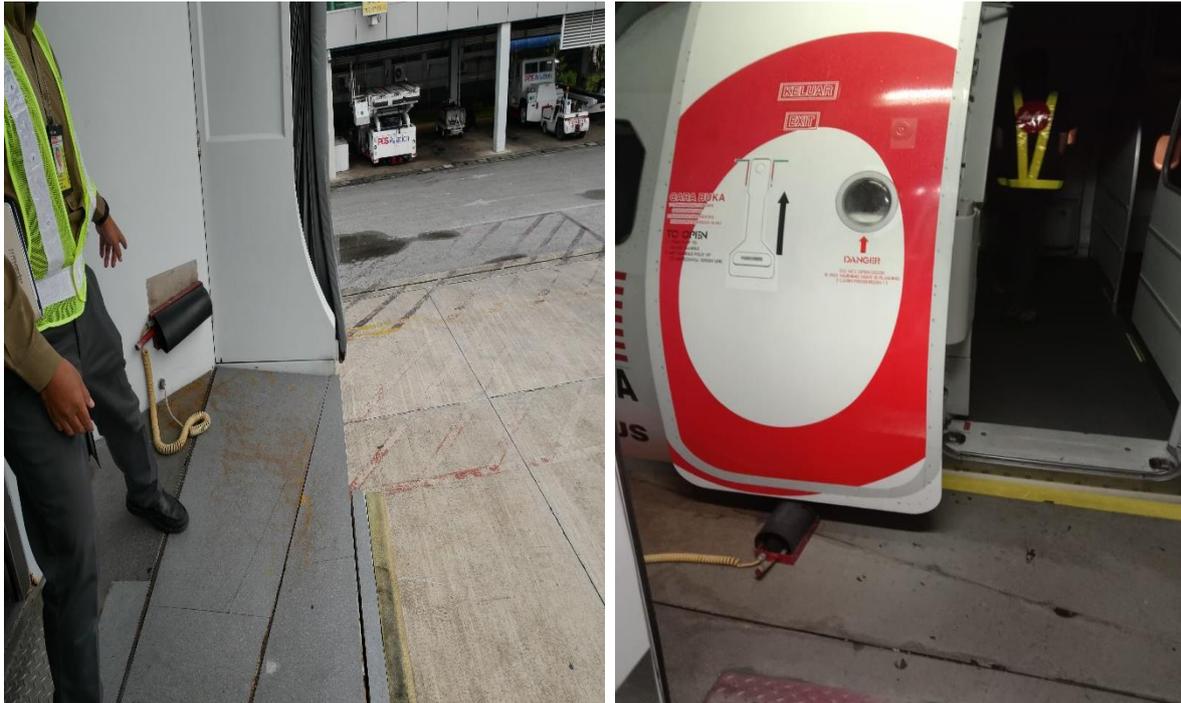
Figure 29: Safety shoe at stowed position (Left) and safety shoe placed below aircraft open door

After the aircraft passenger door had been fully open, the PPB Operator will take the safety shoe from its stowed position on the left side of the cab and place the it below the aircraft door (Figure 29). The PBB Operator is required to press the 'Safety Shoe On' button at the LCD screen within 2 minutes after under AUTO LEVEL status, otherwise a prompt message will be display on the LCD screen and a buzzer will sound to alert the PBB Operator to activate the 'Safety Shoe On' button.

The function of the safety shoe is to protect the aircraft open door in the event the auto leveller fault or malfunction when the aircraft fuselage moves down during passengers' embarkation or disembarkation and cargoes loading or unloading.

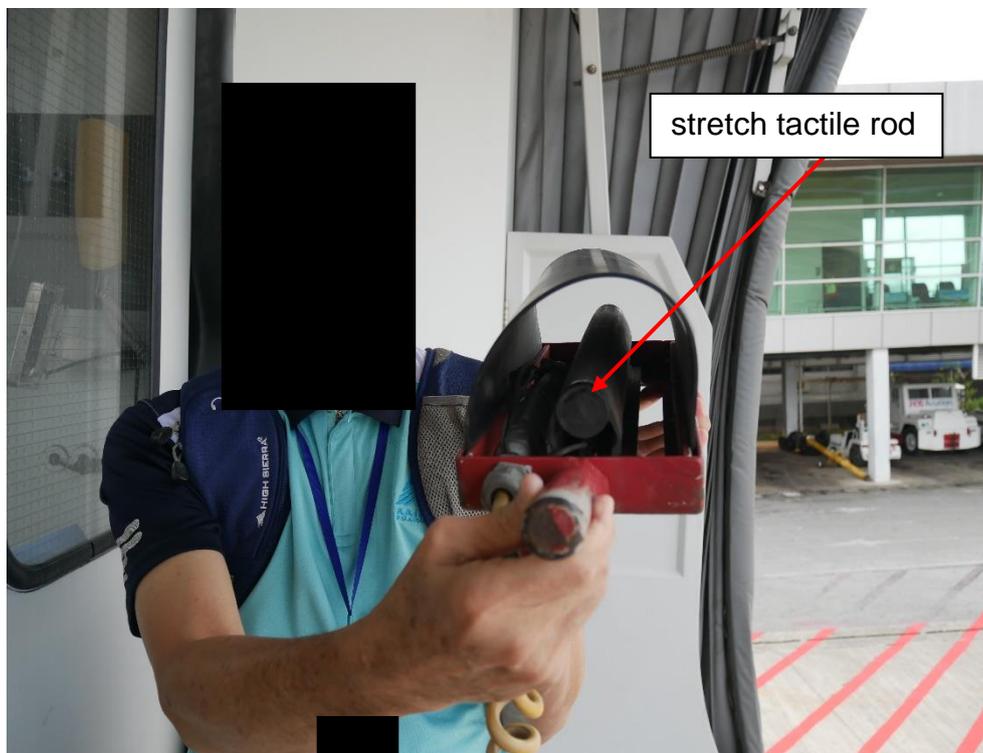
Figure 30: PBB Safety Shoe stretch tactile rod

The operating principle of the safety shoe is that it will function when the stretch tactile rod of the limit switch had been pressed by the open door as a result of the aircraft fuselage moving down (Figure 30). When the limit switch is activated, it will cause the PBB to move down by 2cm follow by the canopy and auto leveller retracting to its original position to prevent damage to the aircraft. When the PBB moves down 2cm it will release the limit switch and the canopy and auto leveller will extend out again. The cycle repeats itself for three times if the limit switch had been activated again by the open door.

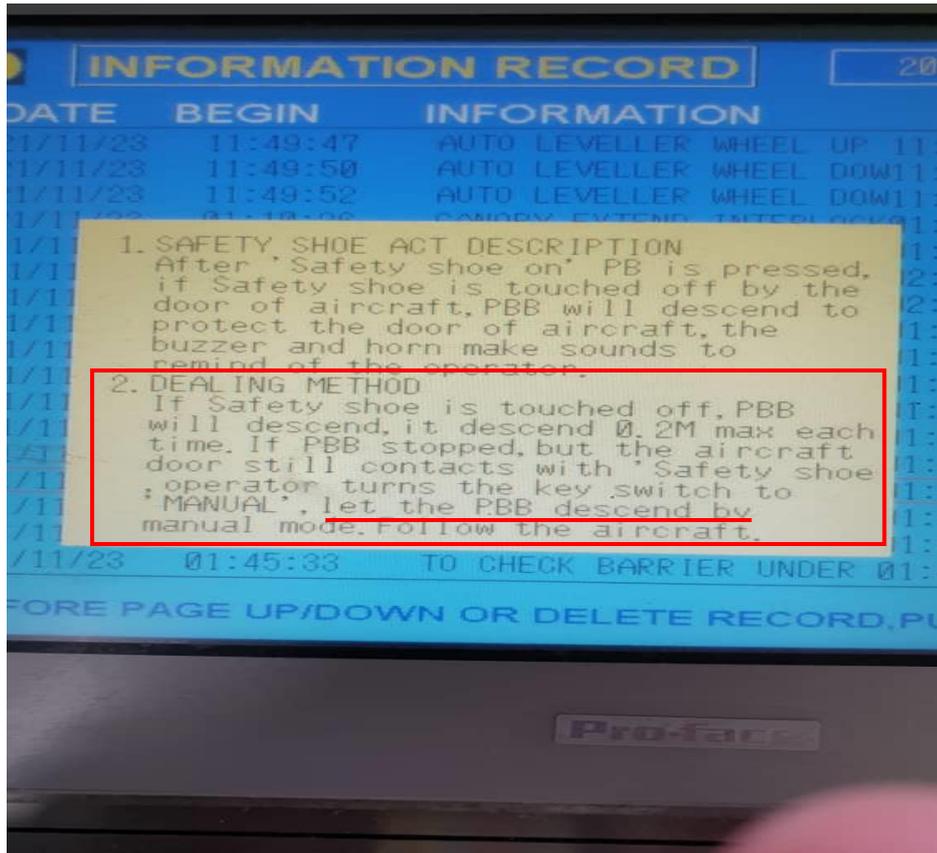
Figure 31: Manufacturer's PBB Operations Instruction – Safety shoe act description

passenger door remains in contact with the safety shoe after the PBB stop movement (Figure 31).

In this incident, the PBB Operator tried to unstuck the door by retracting the PBB first instead of descending the PBB which causes a loud clicking sound. It further aggravated the situation when the aircraft passenger door was still stuck with the safety shoe metal structure frame. The door was unstuck only after the Aircraft Captain had instructed the PBB Operator to descend the PBB first before retracting to reposition it.

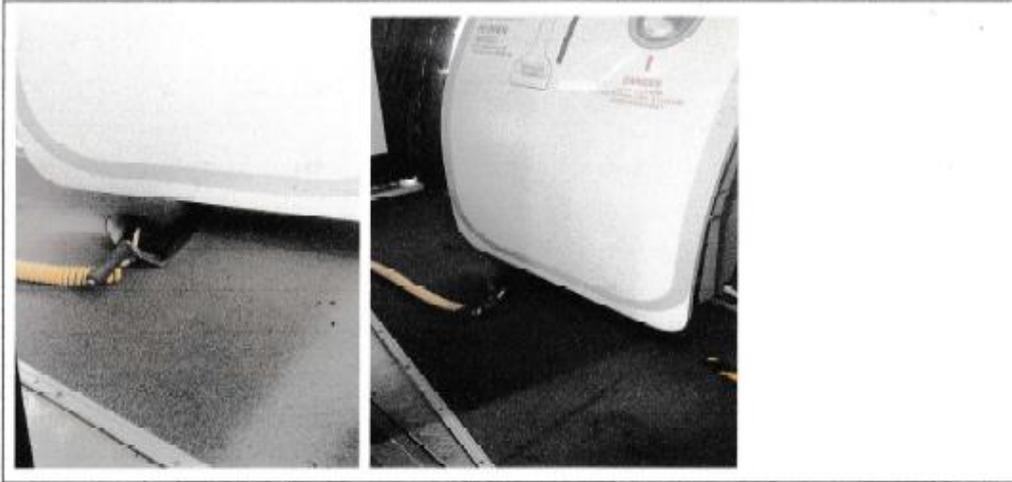
**The CORRECT Location**

The purpose of Safety Shoe is protecting the Aircraft Door from contact with the Passenger Boarding Bridge (PBB) in a proper position (Refer the photo as Attached).
