## AIRCRAFT SERIOUS INCIDENT

### FINAL REPORT

SI 02/21

**Serious Incident Involving Microlight**

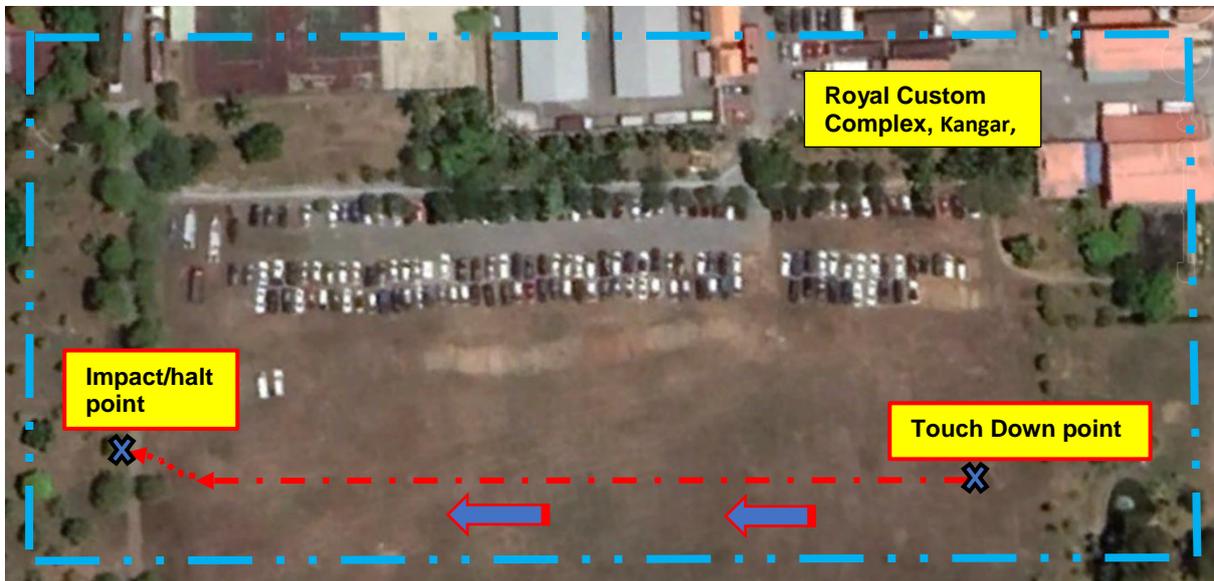
Figure 15: Microlight actual landing and impact point

Due to the unsafe conditions (public parking and heavy crowd) to land the Microlight at Kangar Sports Complex, PIC landed the Microlight at an open field at Custom Complex. However, the Microlight throttle got stuck after landing (during

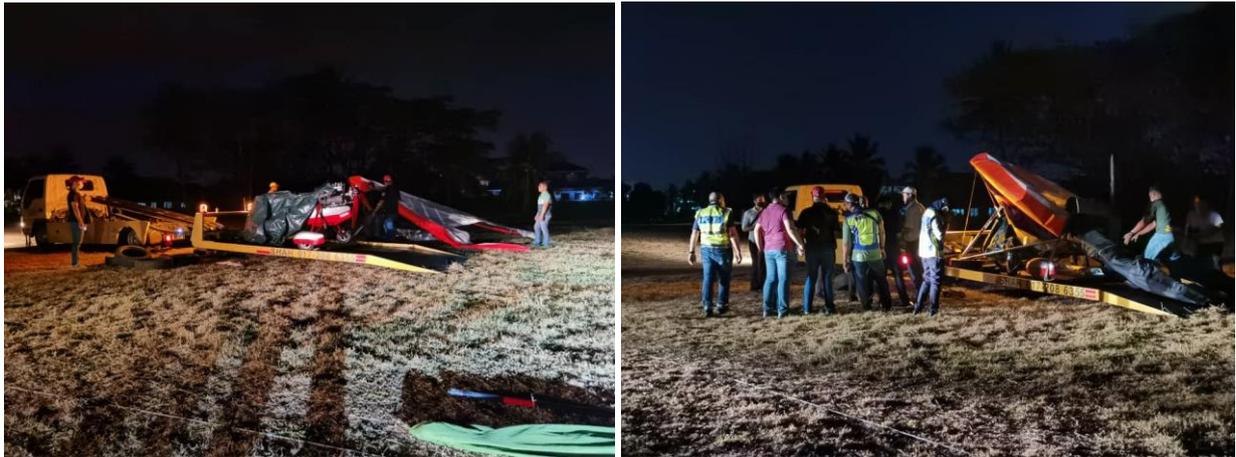
Figure 17: Salvage and recovery by the Microlight team immediately after the accident

The recovery was performed on the same day at approximately 1900H and was successfully removed from the crash site and transported back to Kuala Lumpur for further action by the owner.

Pending rectification work, the Microlight had been secured and put under storage condition at the owner premise in Banting, Selangor.

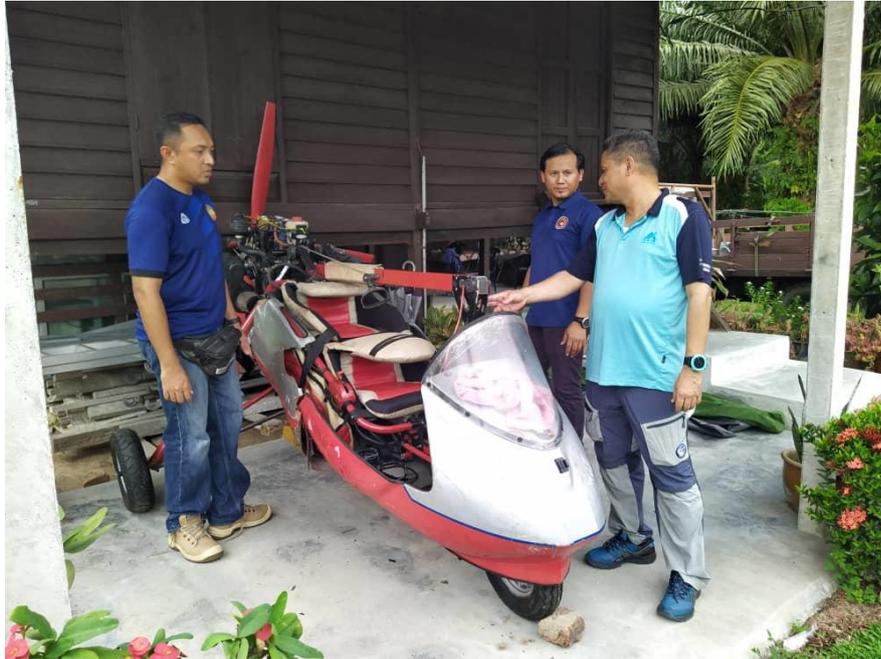
Figure 18: Post incident inspection

Throttle cable was secured and assessment was carried out on the cable condition at University Kuala Lumpur Malaysian Institute of Aviation Technology (UniKL - MIAT). Assessment Report as per Appendix F.

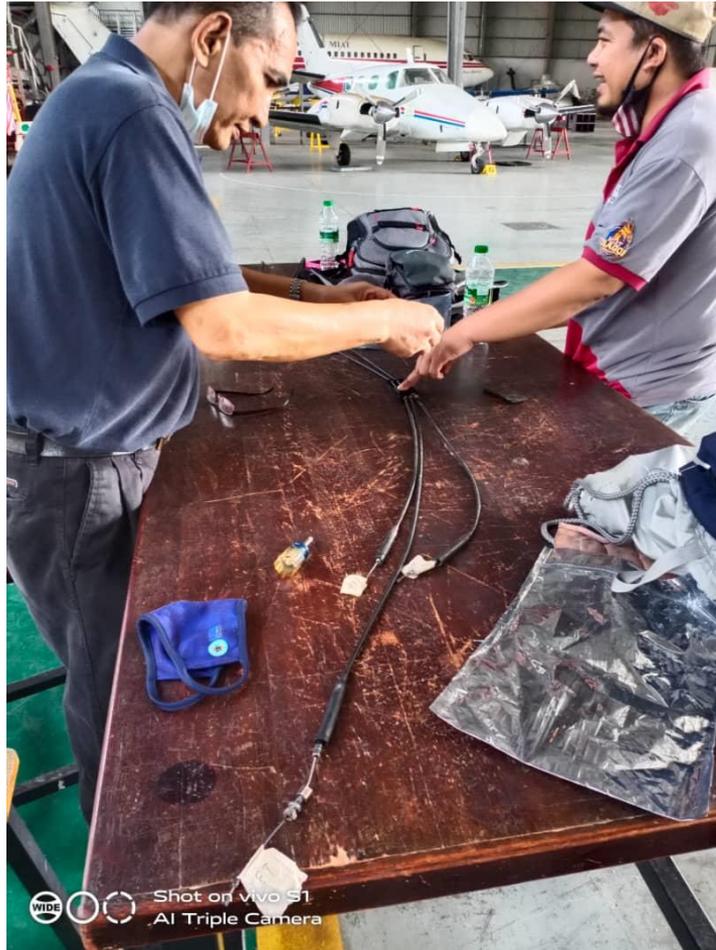
Figure 26: Throttle Cable assessment

The probable cause of the accident was due to Throttle Cable being dented after Microlight came in contact with outreached rope during the landing roll, which led to the failure of the throttle paddle to reduce the speed.

- DAMAGE PART : Throttle Cable**  
QUANTITY: One (1) unit  
STATUS: ~~Serviceable~~/Unserviceable  
ACTION: Replace new part

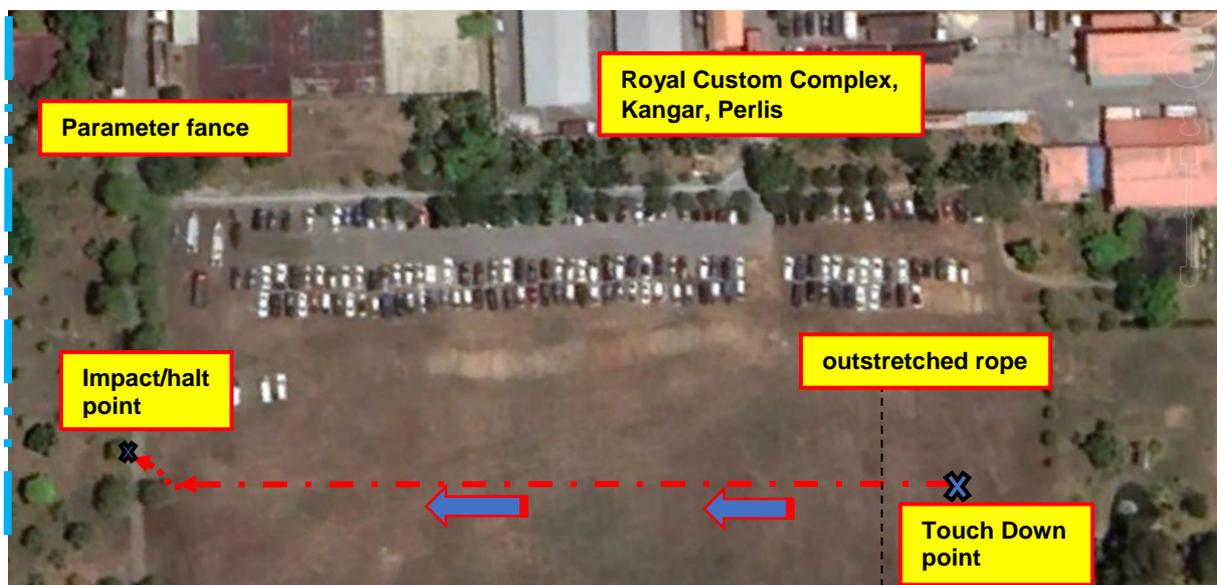
Figure 29: Microlight actual landing and impact point

with vehicles parking at the area. Due to the unsafe conditions, PIC has decided to change the landing plan to the adjacent area and he has landed the Microlight at an open field at Custom Complex.

Prior to the landing process the Microlight hit the outstretched rope laying on the grass during landing roll and resulted the throttle cable got stuck and increased the Microlight power.

PIC was unable to control the Microlight, and as Microlight moving to the end of the field, Microlight wing hit twice the adjacent tree before Microlight came to a halt after hitting the third tree at the end of the landing area.

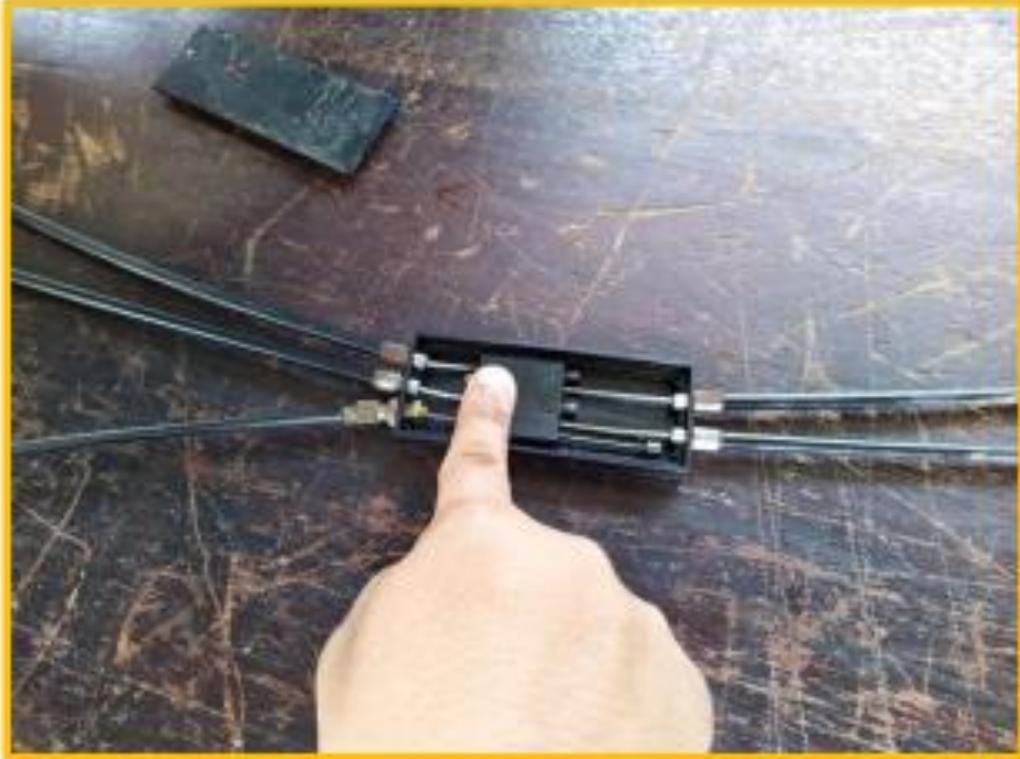
**FUEL CONTROL CABLE BOX**

For this fuel control cable, we found that these two cables were frayed and broken. This causes restriction of movement to this cable and eventually stuck.

Any cable assembly that has even a single broken wire strand located in a critical fatigue area must be replaced. Per the FAA guidance, a critical fatigue area is defined as the working length of a cable where the cable runs over, under, or around a pulley, sleeve or through a fair-lead; or any section where the cable is flexed, rubbed, or worked in any manner; or any point within one foot of a swaged-on fitting.
