AIRCRAFT ACCIDENT FINAL REPORT
A 05/22P
Air Accidents Investigation Bureau (AAIB)
Ministry of Transport Malaysia

Eurocopter EC120B Registration N409HH
in Hutan Simpan Chikus, Bidor, Perak, Malaysia
on the 11 September 2022

ACCIDENT REPORT NO.: A 05/22

OPERATOR : FLYSTAR GLOBAL SDN BHD
AIRCRAFT TYPE : EUROCOPTER EC120B
NATIONALITY OF AIRCRAFT : UNITED STATES OF AMERICA
REGISTRATION : N409HH
**PLACE OF OCCURRENCE : HUTAN SIMPAN CHIKUS, BIDOR,
PERAK, MALAYSIA
(4° 06' 13.8'' N, 101° 12' 45.1'' E)**
DATE AND TIME : 11 SEPTEMBER 2022 AT 1217 LT

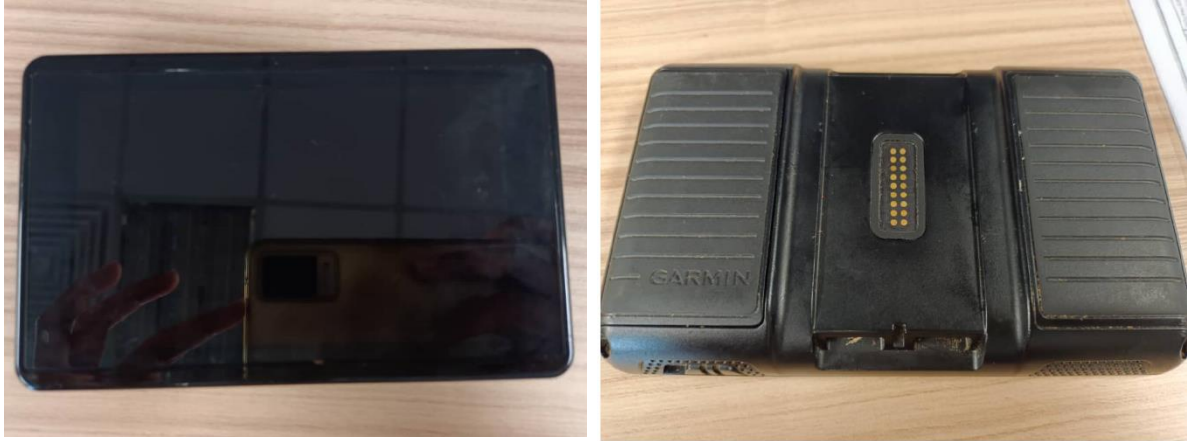
Figure 6: Garmin Aera 660 Recovered from the Wreckage

The PIC had his personal hand-held navigation device mounted on the helicopter's instrument panel. The device (a Garmin Aera 660) was recovered from the crash site. However, it did not yield any important information to assist the investigation.

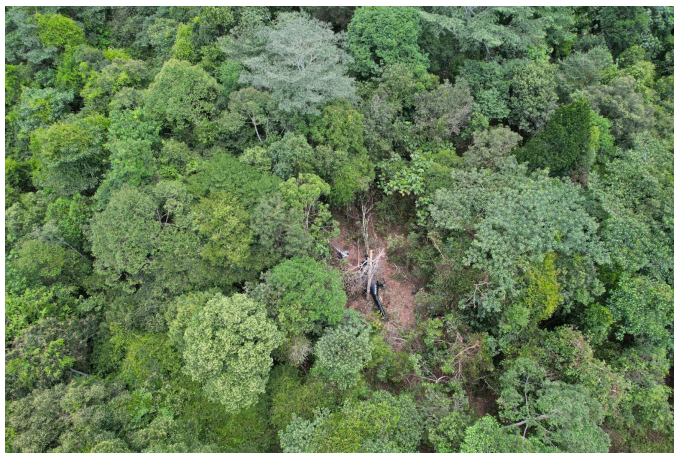
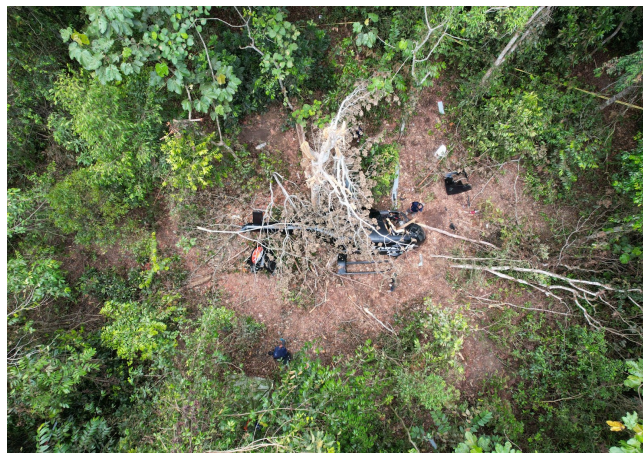
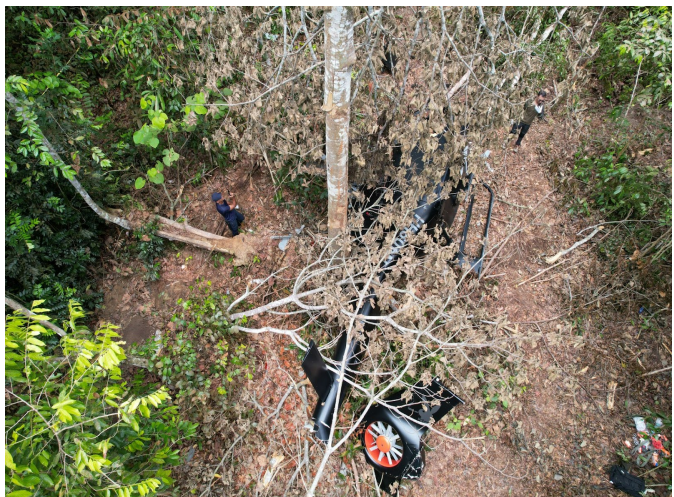
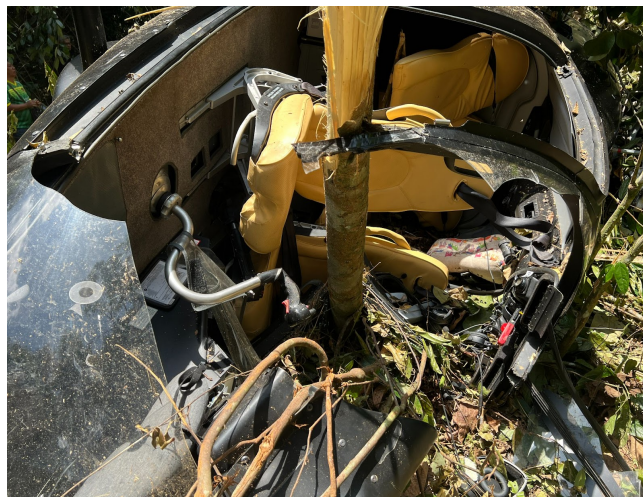
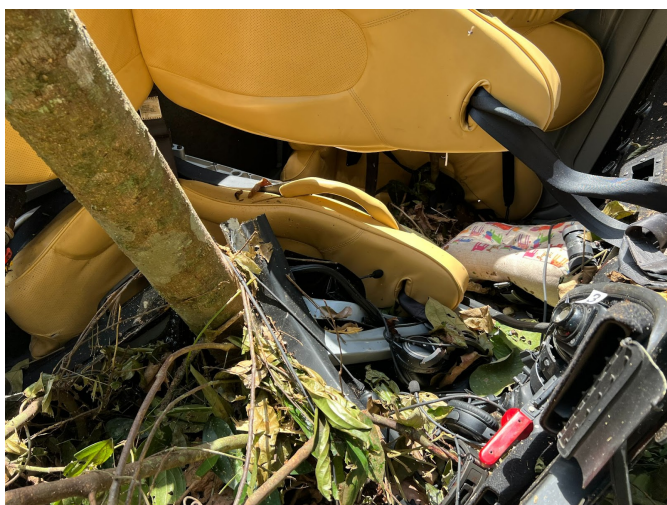
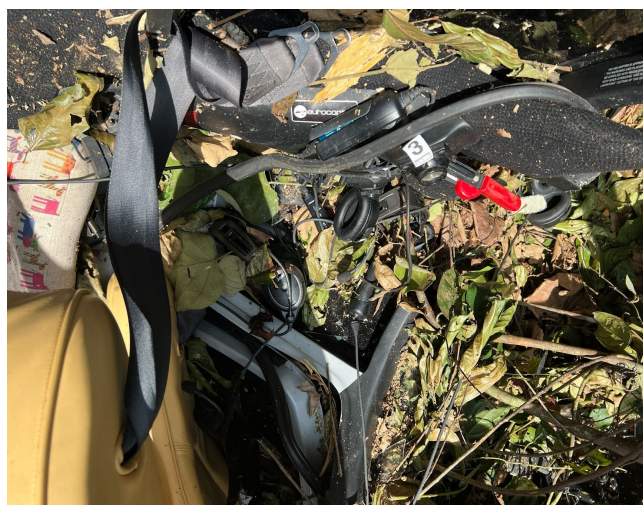
05.00 The aircraft was found lying on the left fuselage with the exhaust area resting against a tree. The fenestron (Tail) had broken off and was found beside the tailboom. The broken LH horizontal stabiliser was found under the aircraft buried in the ground.

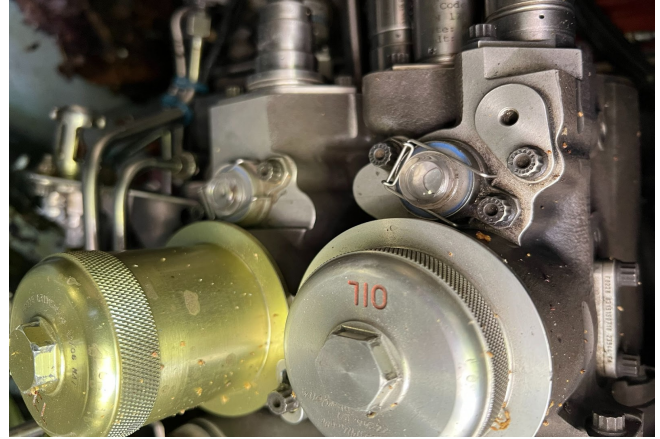
No Pop-up on engine fuel and oil filter

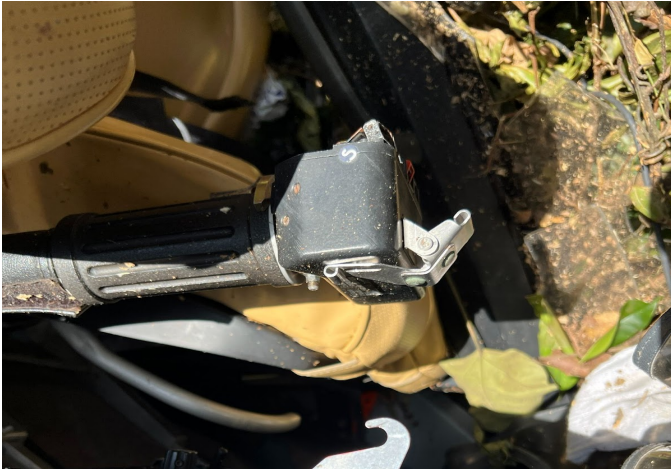
Twist grip at flight position. Collective control unlocked and up midway.

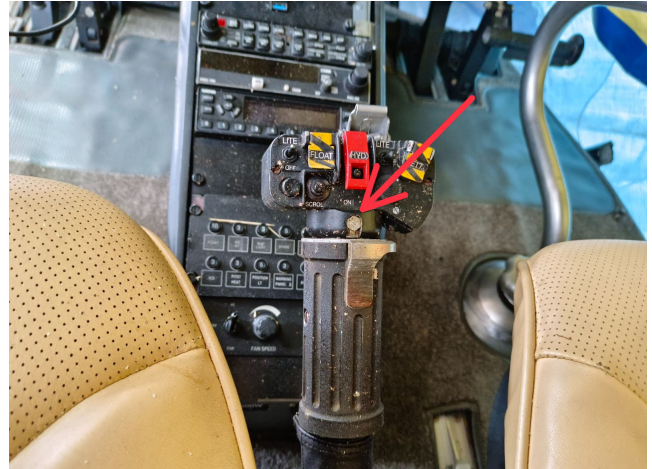
Twist grip at flight position

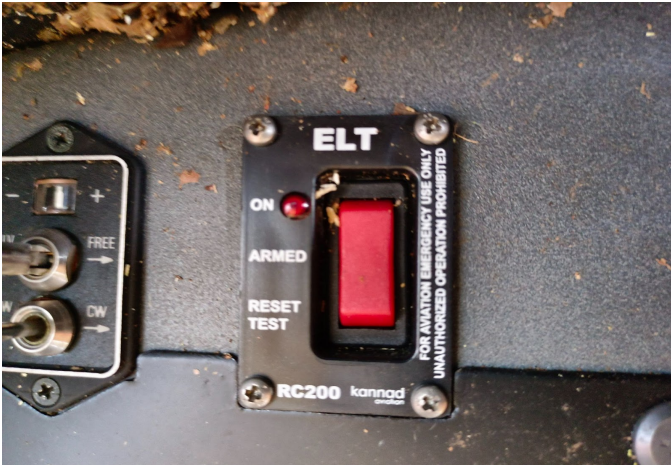
ELT in armed position

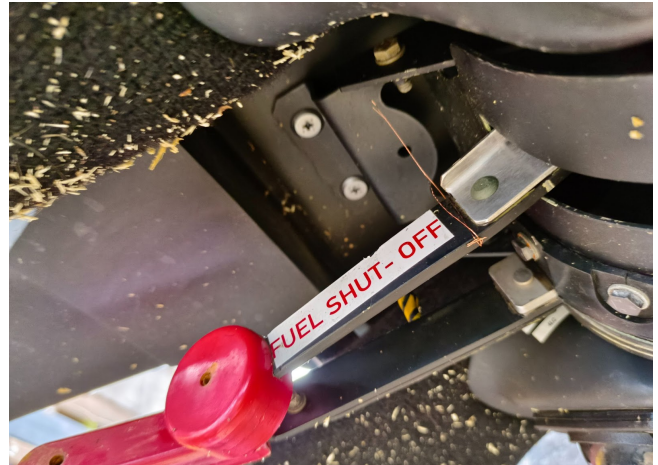
Fuel Shut Off Lever secured with wire and rotor brake off

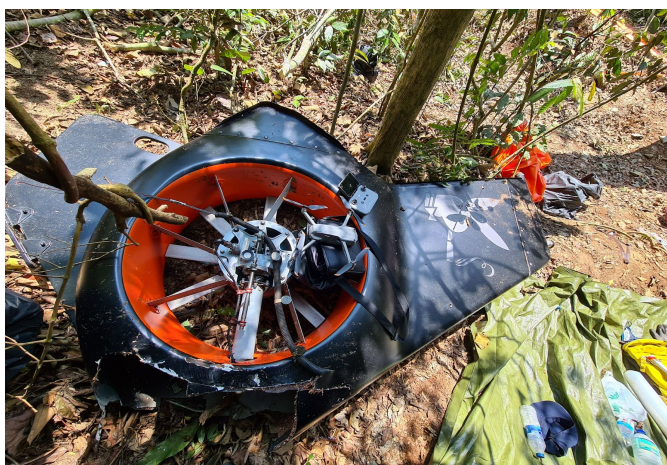
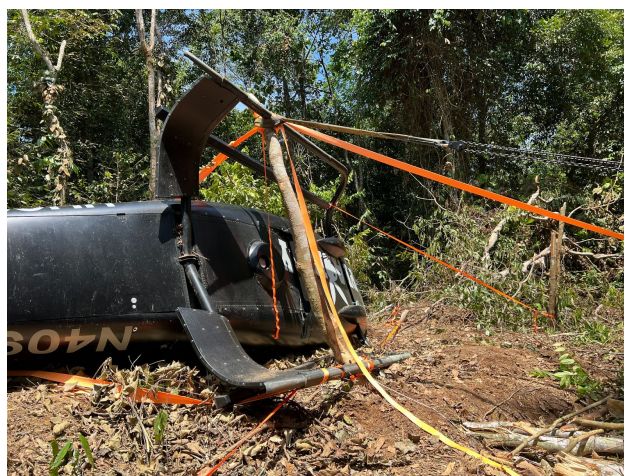
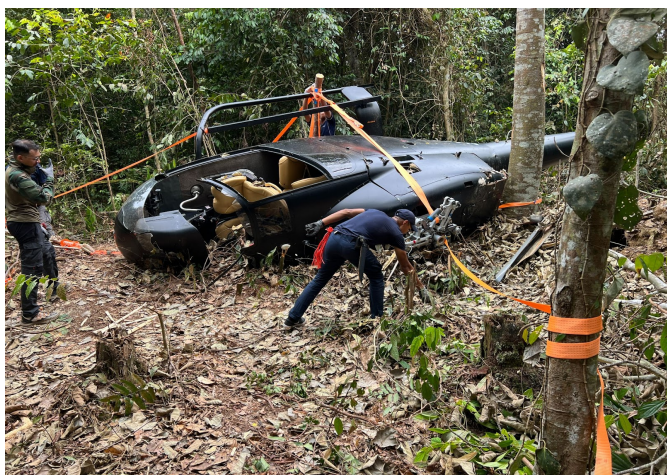
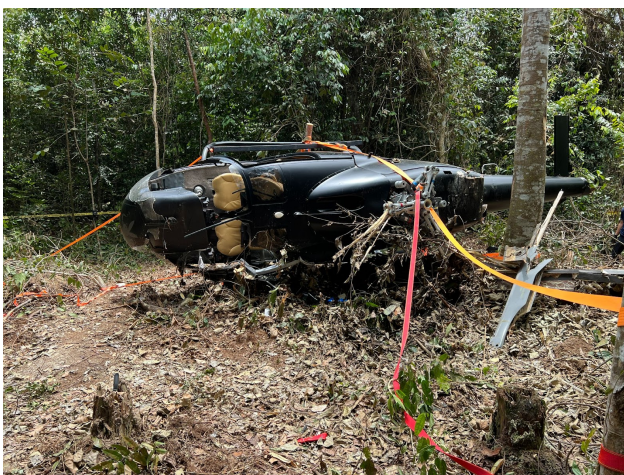
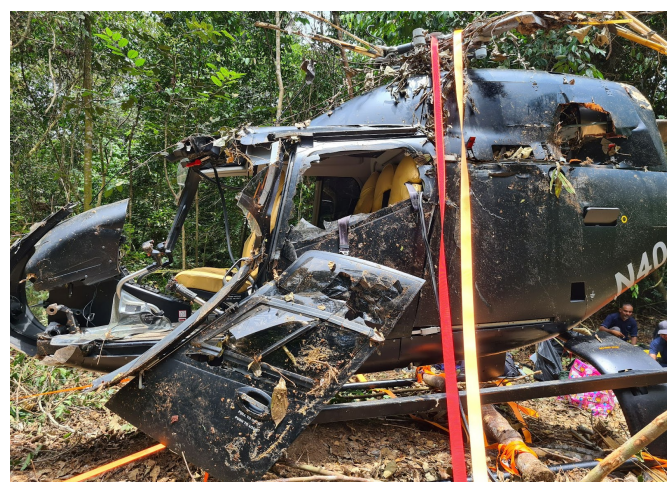
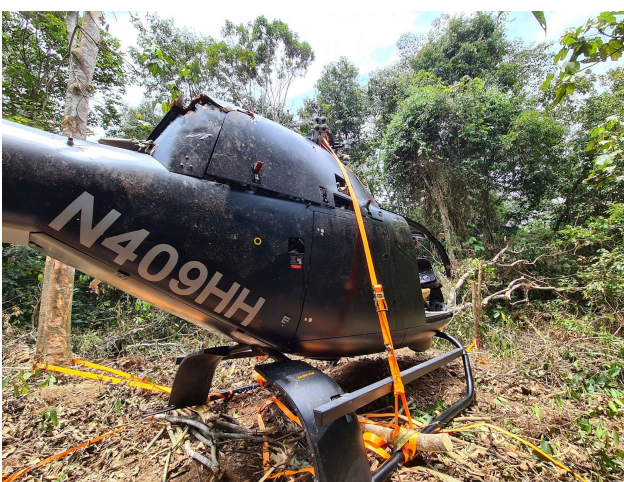
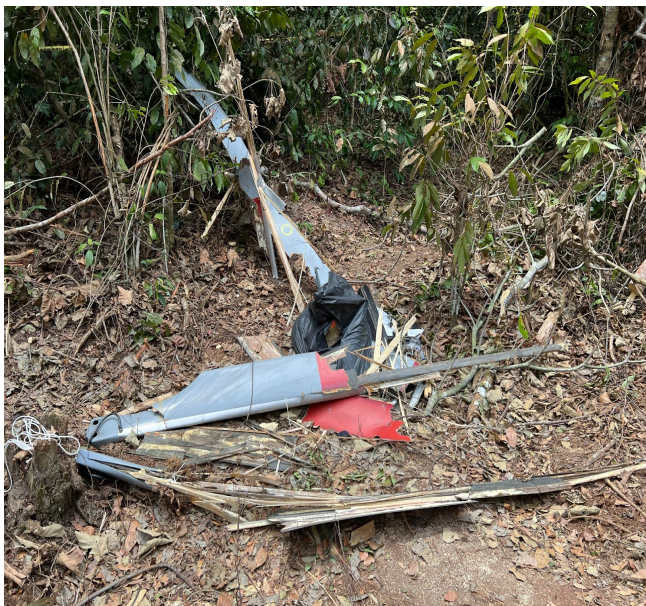
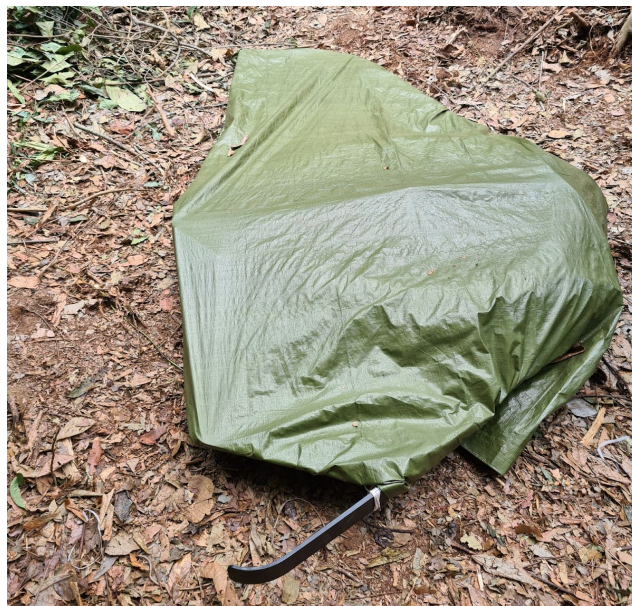
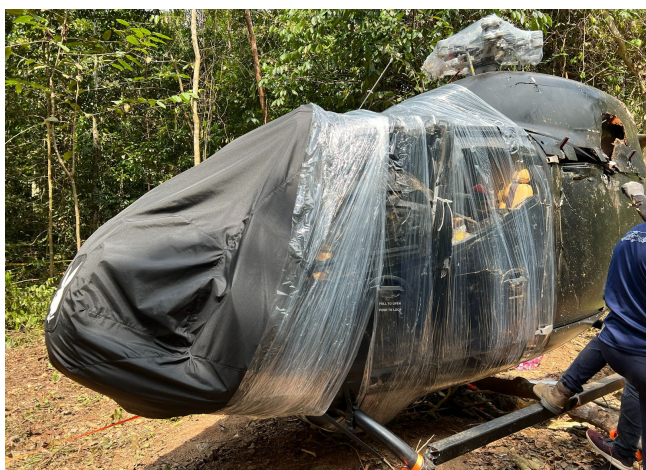
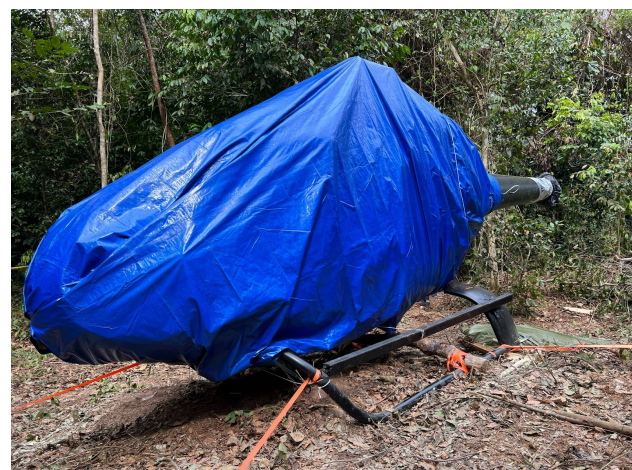
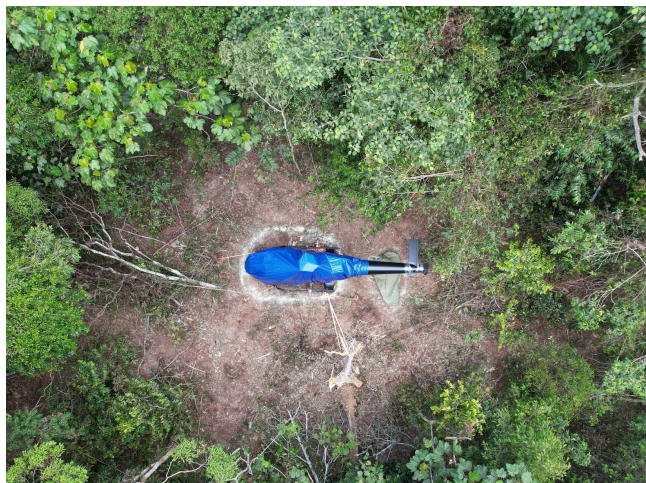
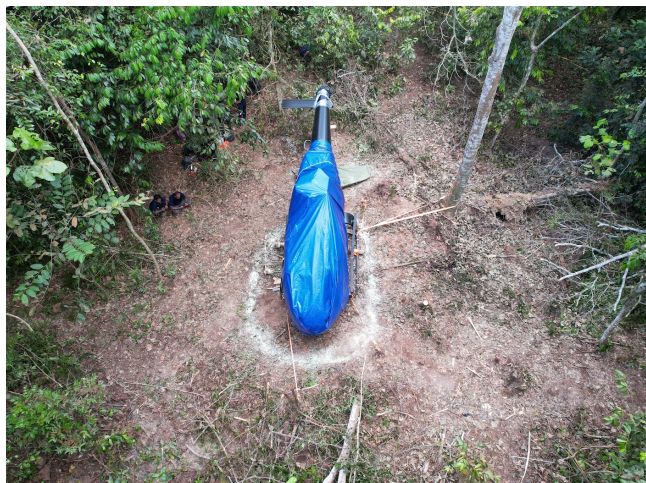
05.01 During the recovery of the aircraft, the surrounding foliage was cleared and the aircraft was winched upright for ease of removal from site. The main rotor blade roots were removed for ease of transport. The aircraft was also covered to protect from further damage in the elements during the recovery process.

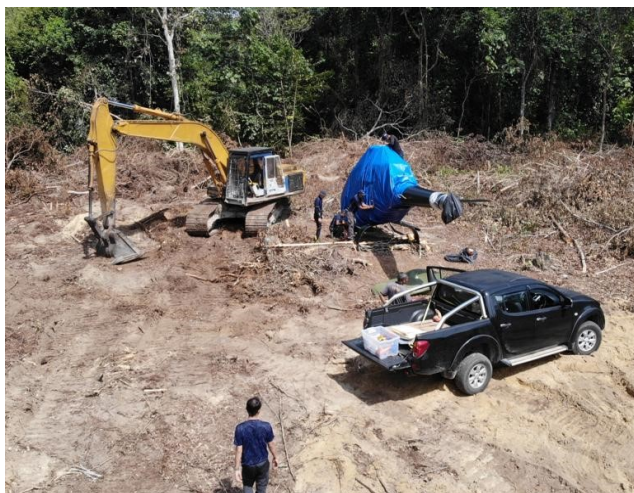
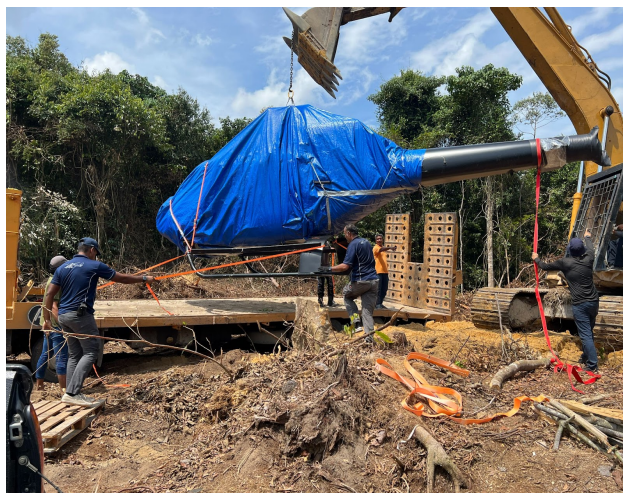
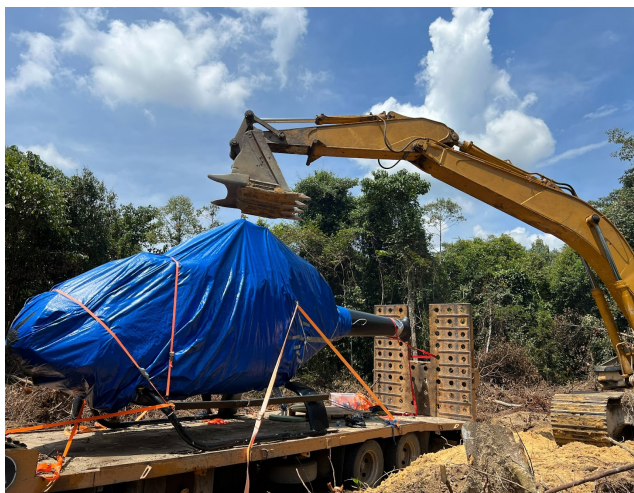
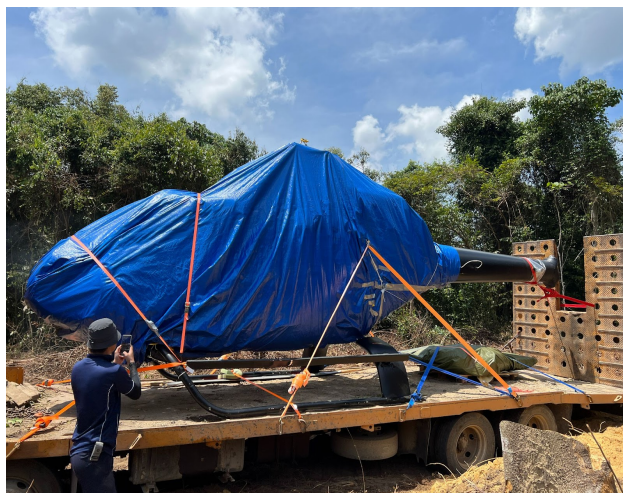
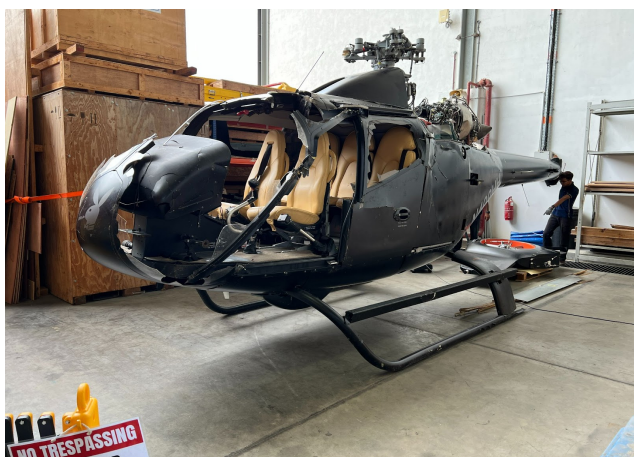
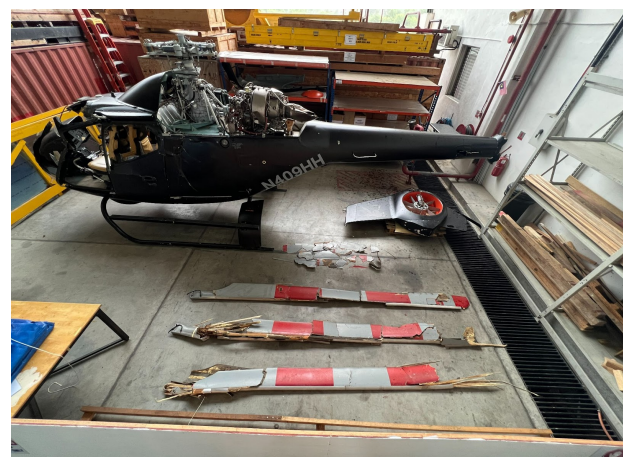
07.00 The aircraft was lifted by backhoe onto a low loader and transported back to the Hammock Helicopter facilities on the 19th of October 2022

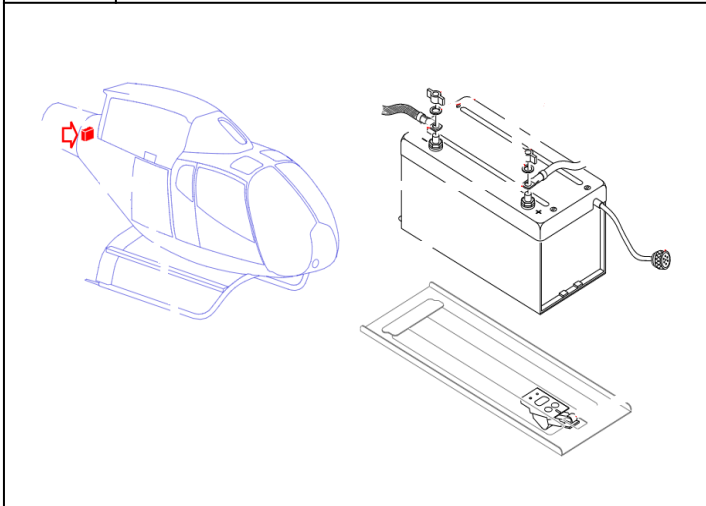
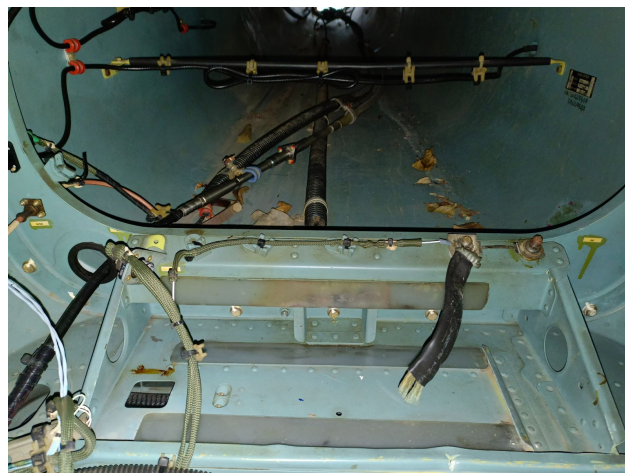
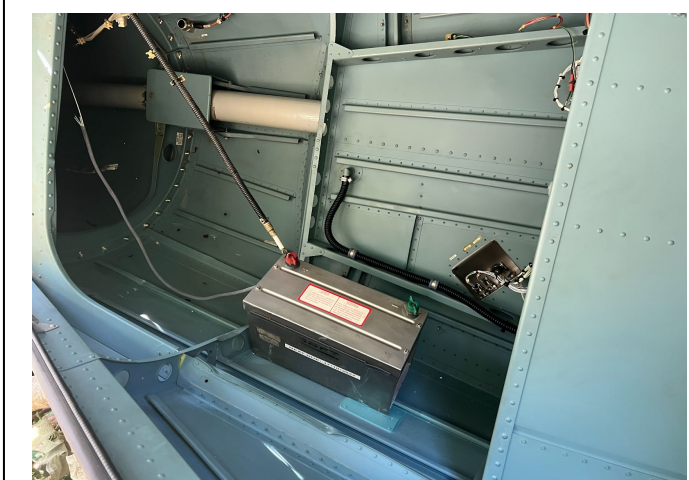
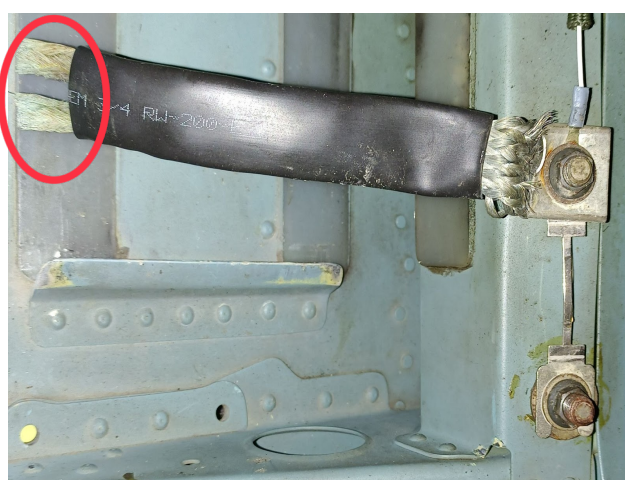
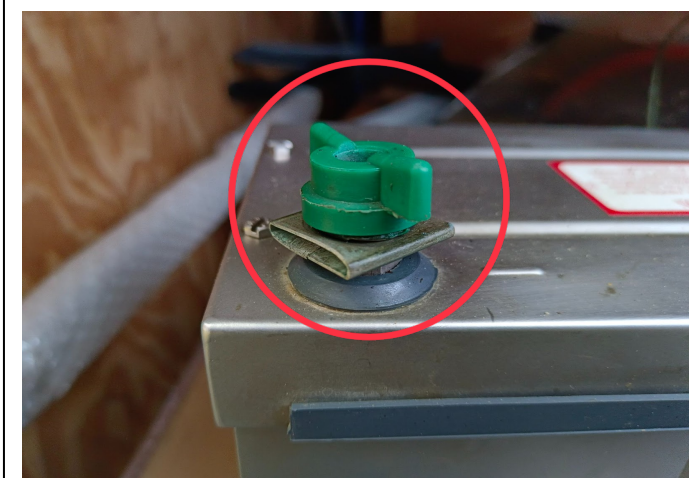
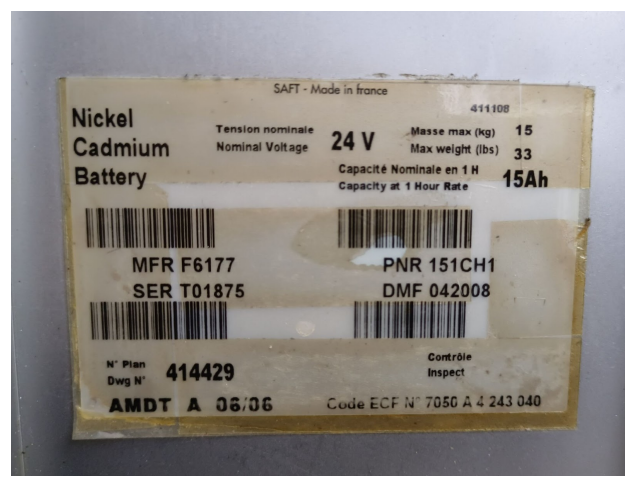
24.00 Battery found detached from the battery bay. Positive Battery connector terminal found broken.

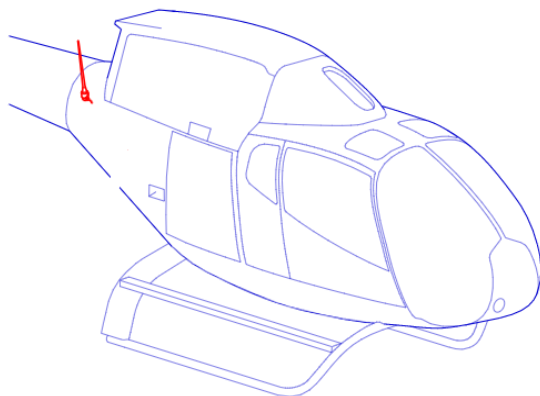
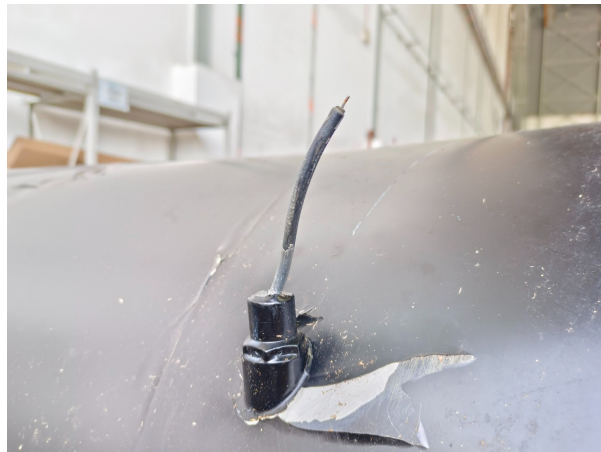
25.00 ELT External Antenna broken off from contact with tree (tree aircraft rested on)

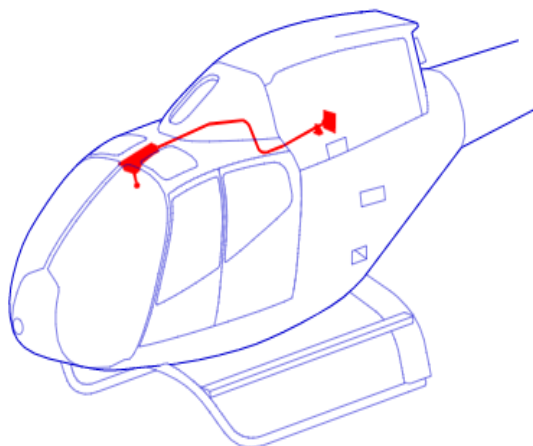
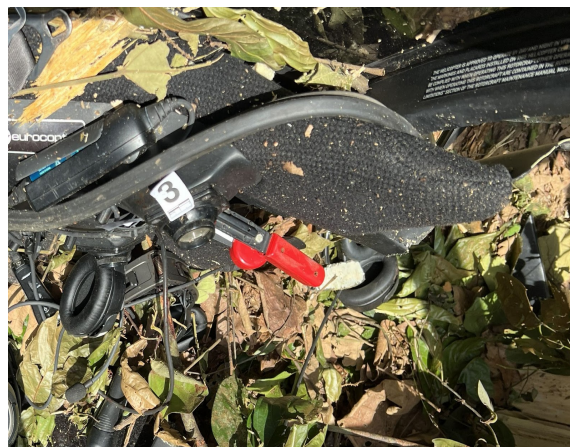
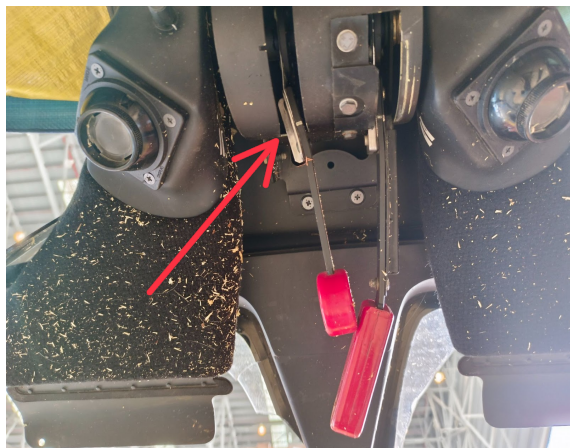
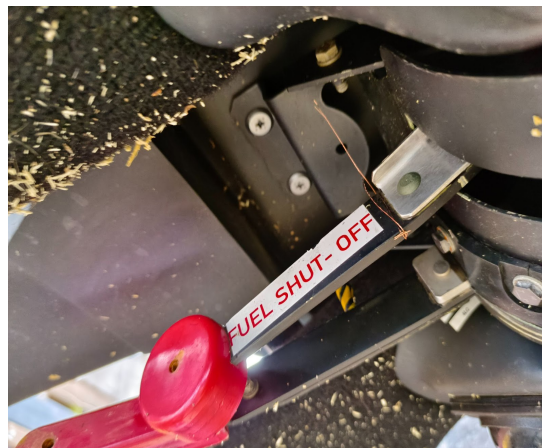
28.00 Emergency Fuel Shut Off Lever bent to the right from LH impact

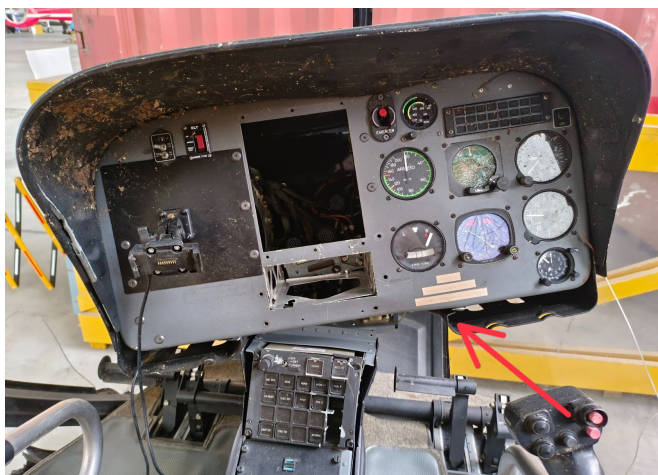
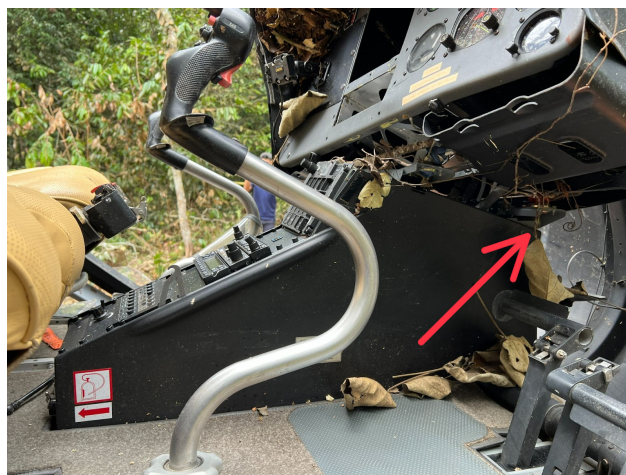
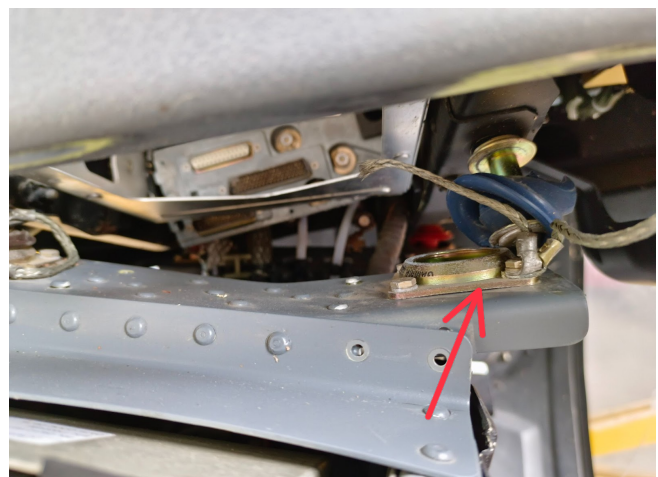
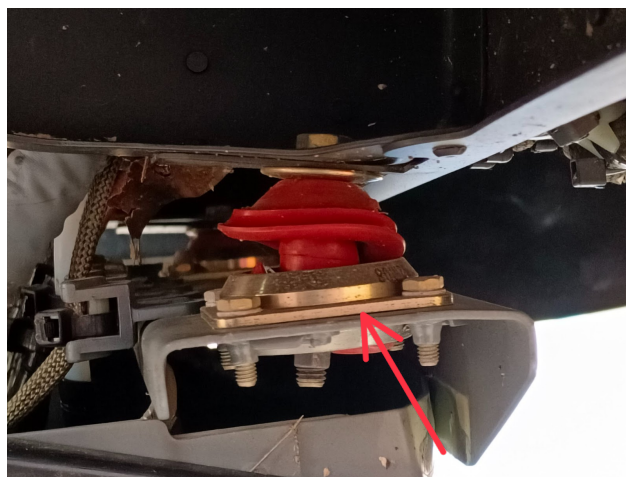
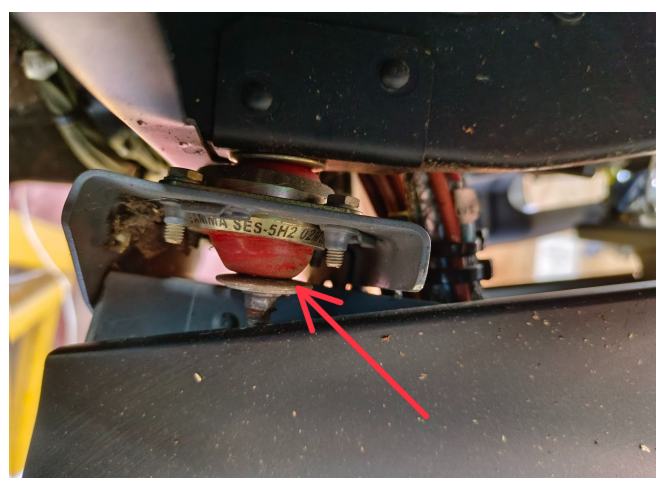
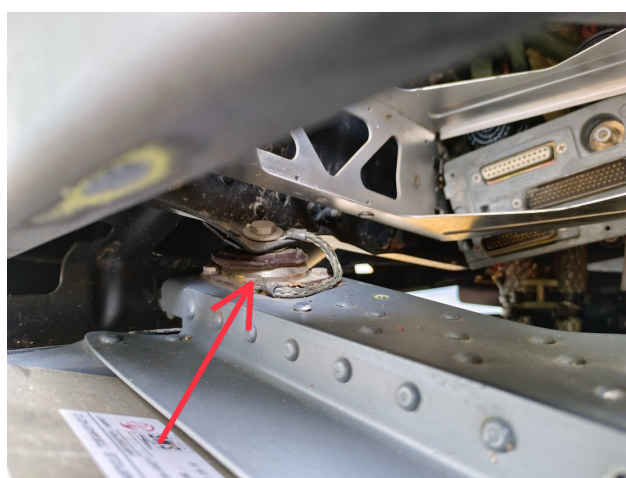
31.00 Instrument panel shock absorbers detached (VEMD & GNS430 removed for analysis)

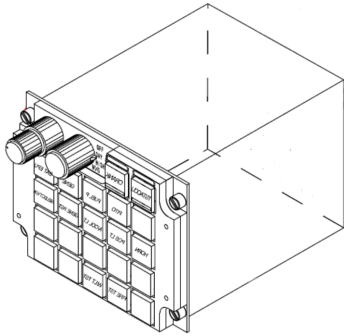
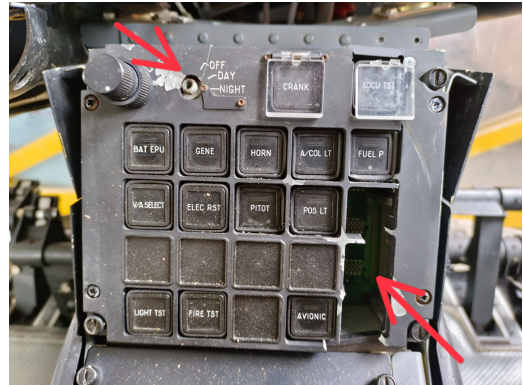
31.01 LACU panel missing 3 switch blanks and 1 light knob

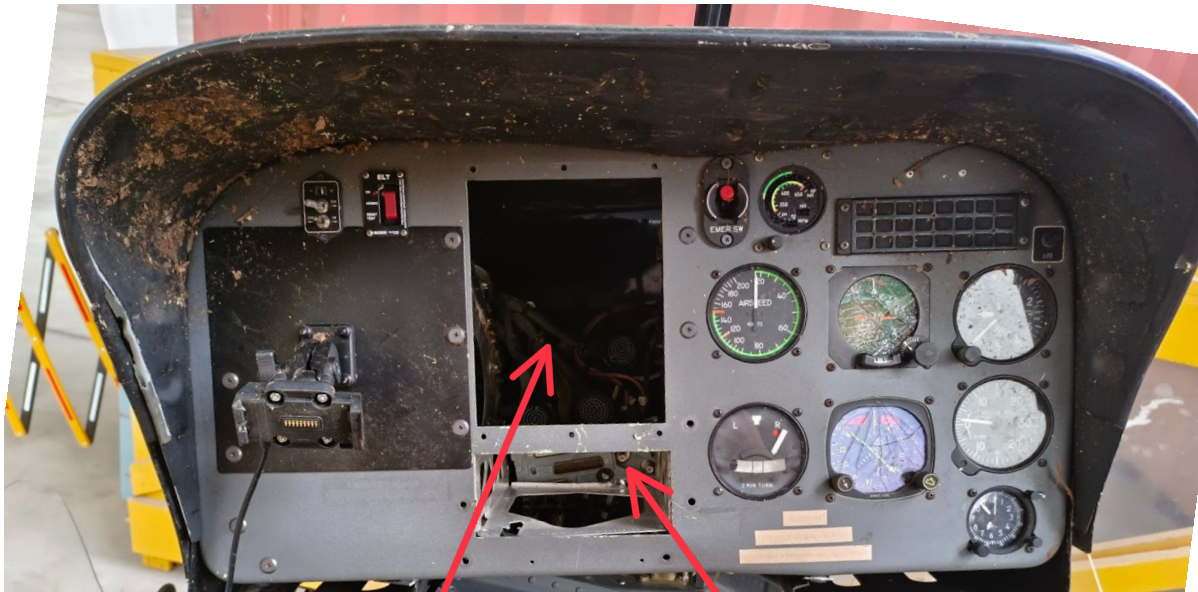
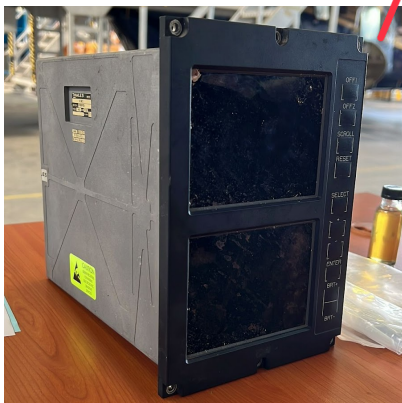
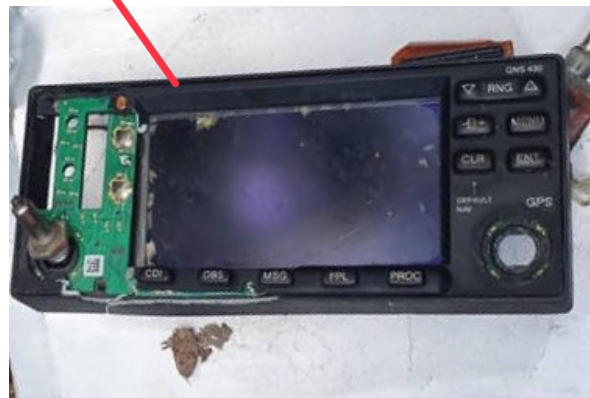
31.02 VEMD and Garmin GNS 430 removed from aircraft for analysis

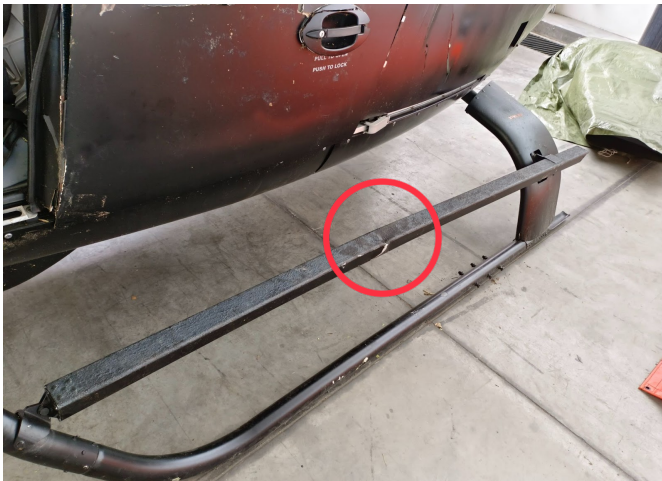
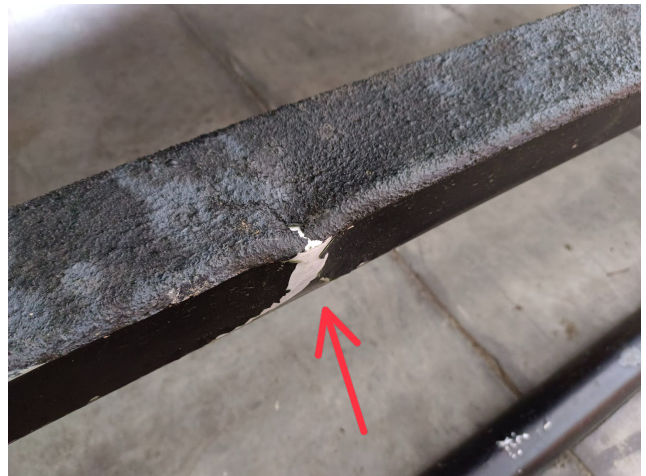
32.00 LH Skid Landing Gear step bent from LH impact

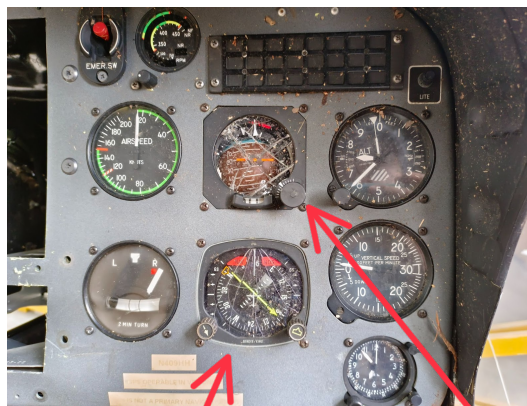
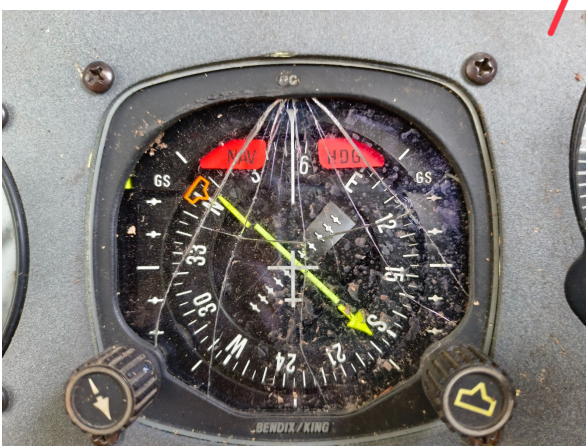
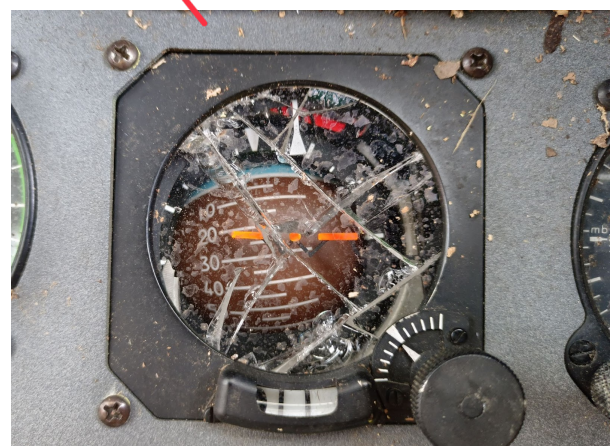
34.00 Attitude Direction Indicator(ADI) and Horizontal Situation Indicator(HSI) glasses cracked

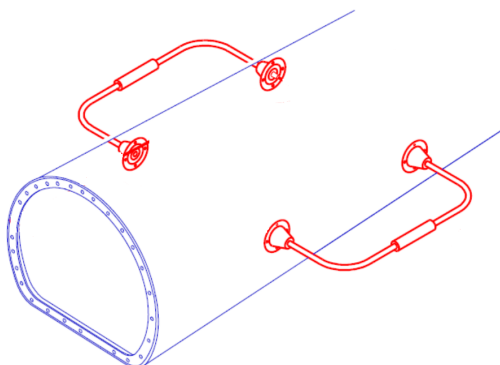
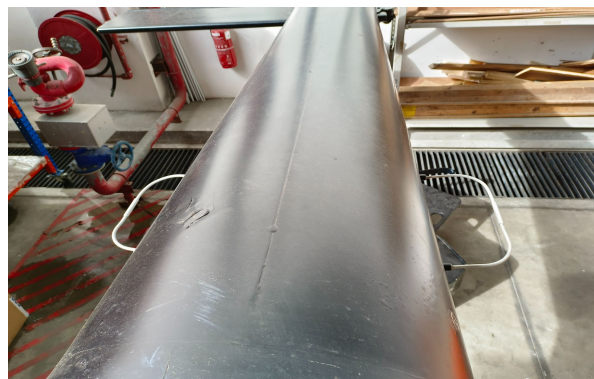
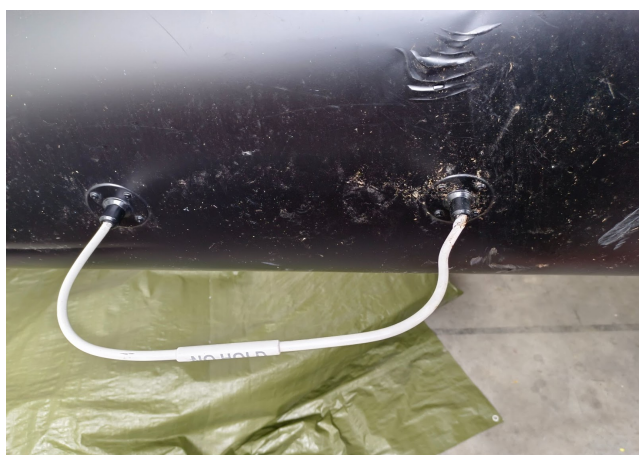
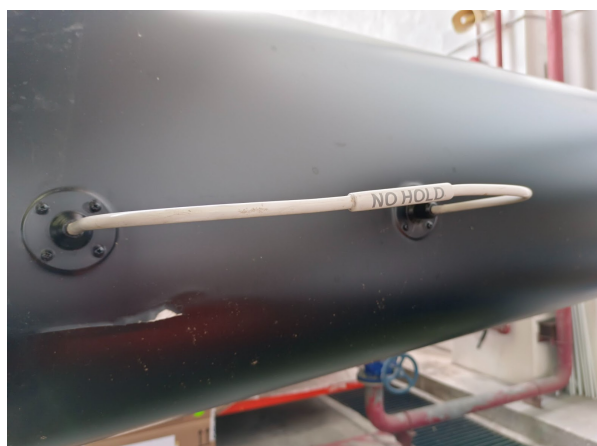
34.01 VOR Antenna deformed on both sides

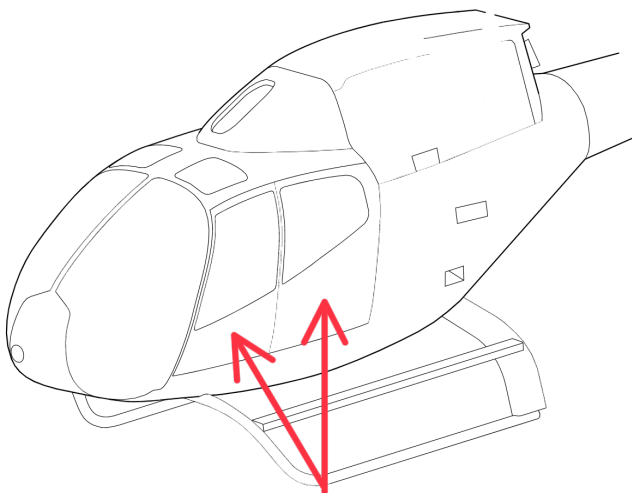
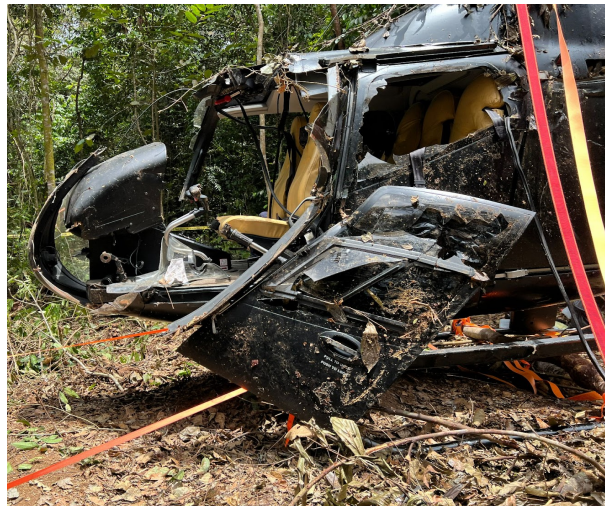
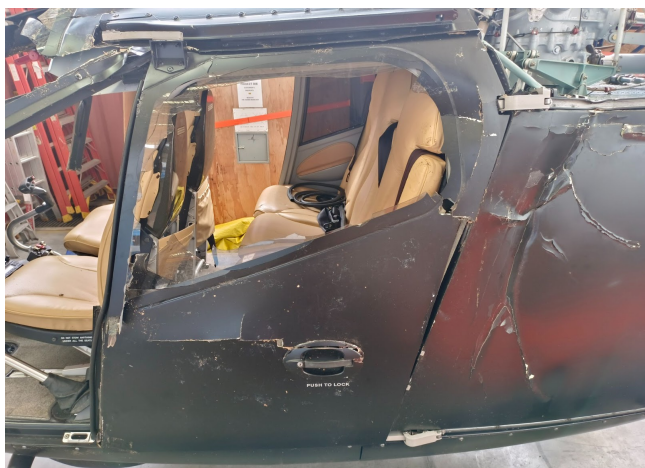
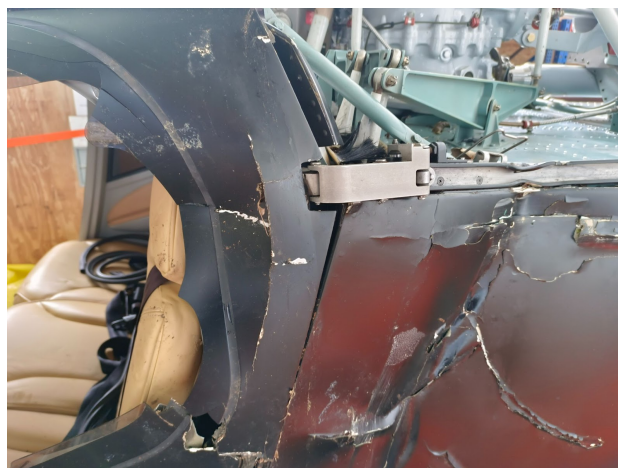
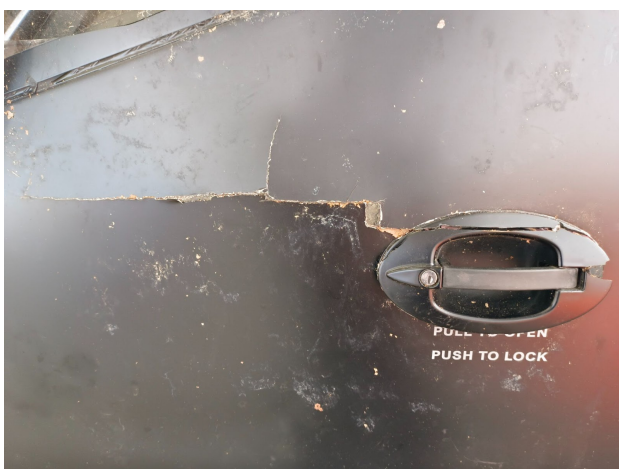
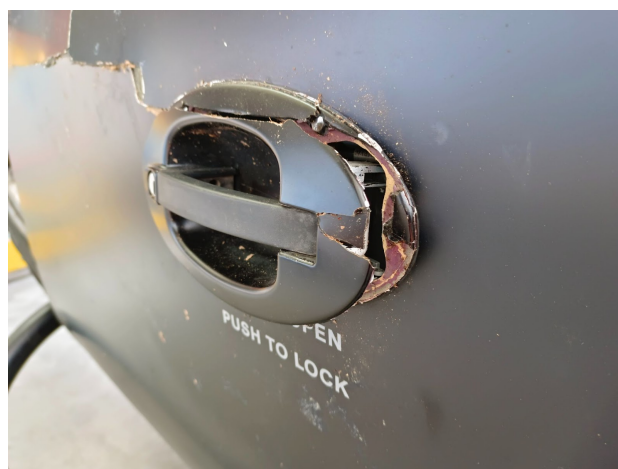
52.00 LH sliding door and co-pilot door with impact damage from LH impact

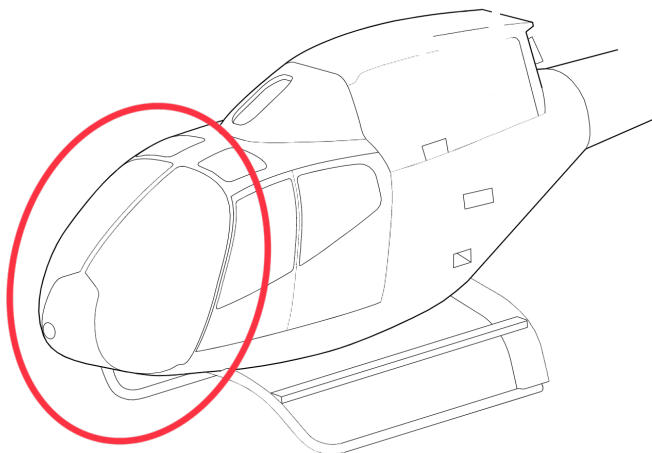
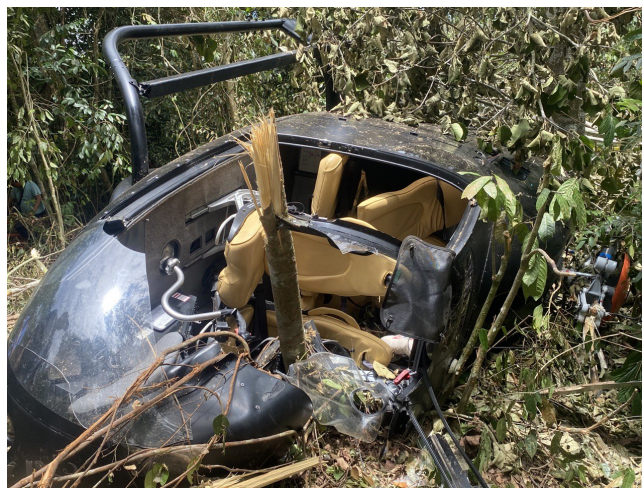
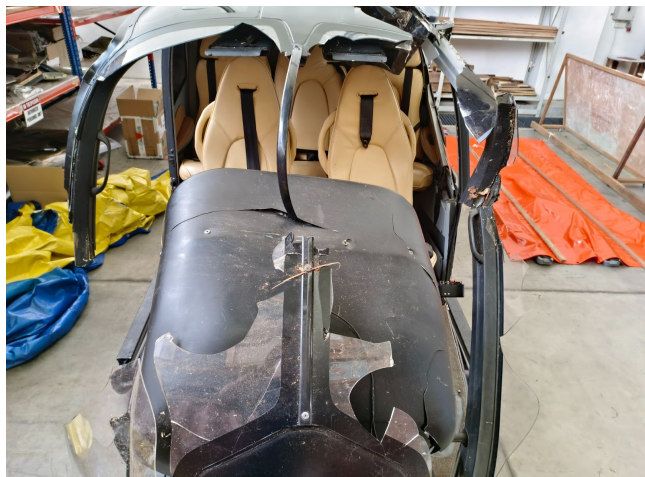
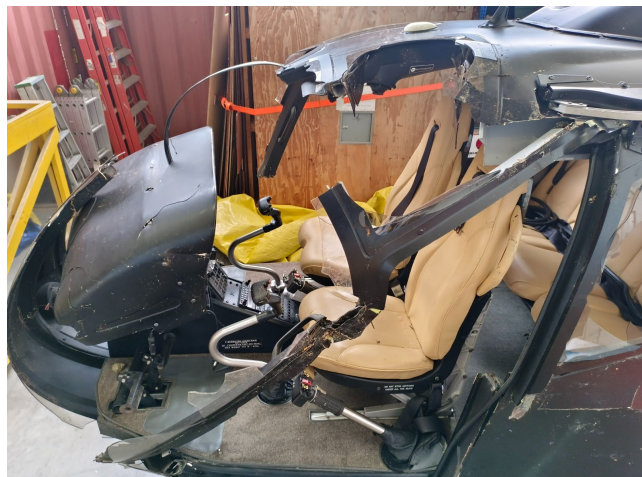
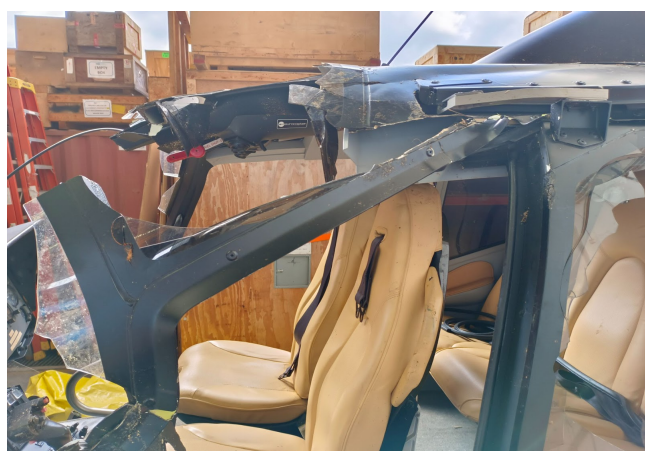
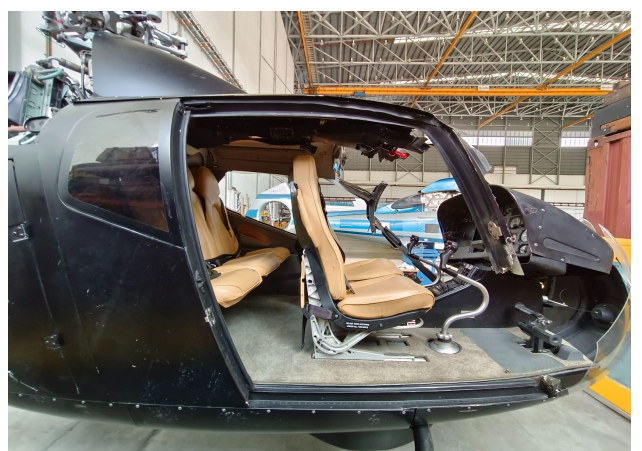
53.00 Windshield Canopy Posts found broken from STA X2196 to X1000 from impact with ground and tree.
