AIRCRAFT ACCIDENT FINAL REPORT
A 05/22P
Air Accidents Investigation Bureau (AAIB)
Ministry of Transport Malaysia

Eurocopter EC120B Registration N409HH
in Hutan Simpan Chikus, Bidor, Perak, Malaysia
on the 11 September 2022

ACCIDENT REPORT NO.: A 05/22

OPERATOR : FLYSTAR GLOBAL SDN BHD
AIRCRAFT TYPE : EUROCOPTER EC120B
NATIONALITY OF AIRCRAFT : UNITED STATES OF AMERICA
REGISTRATION : N409HH
**PLACE OF OCCURRENCE : HUTAN SIMPAN CHIKUS, BIDOR,
PERAK, MALAYSIA
(4° 06' 13.8'' N, 101° 12' 45.1'' E)**
DATE AND TIME : 11 SEPTEMBER 2022 AT 1217 LT

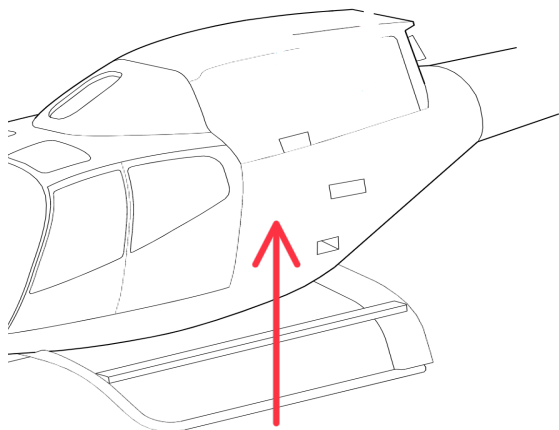
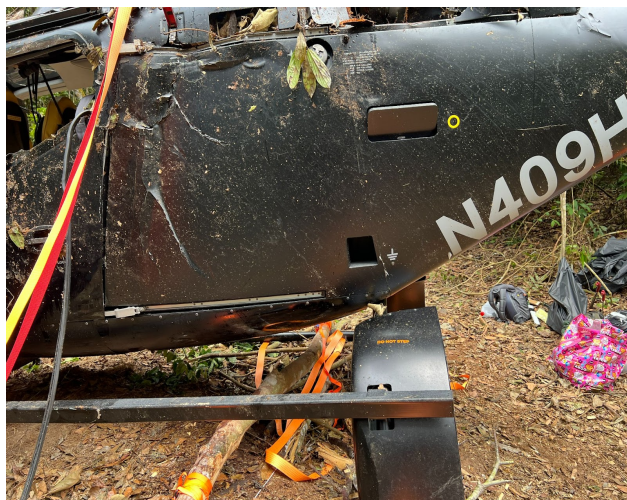
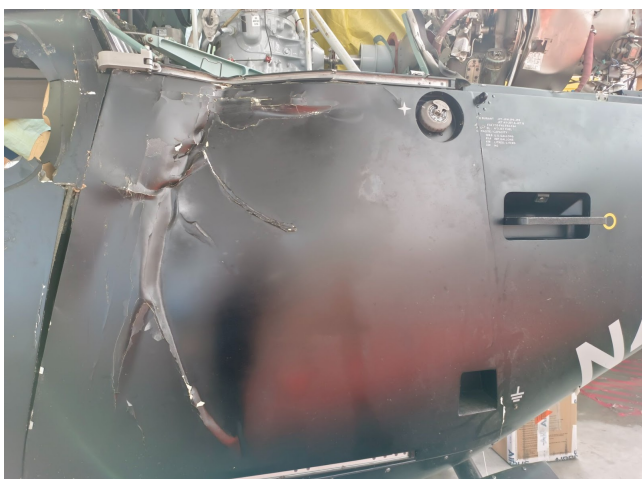
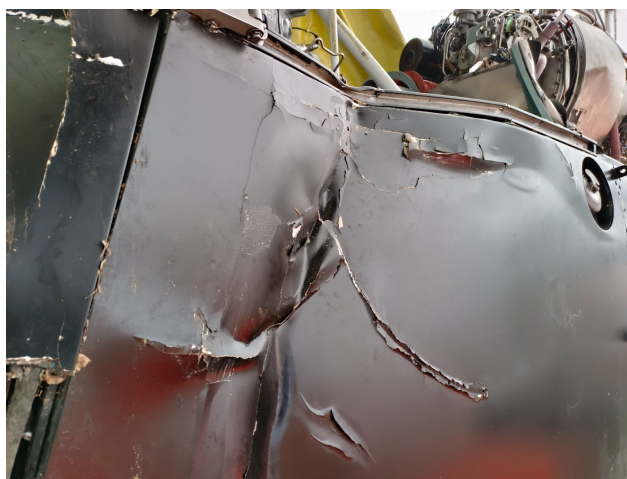
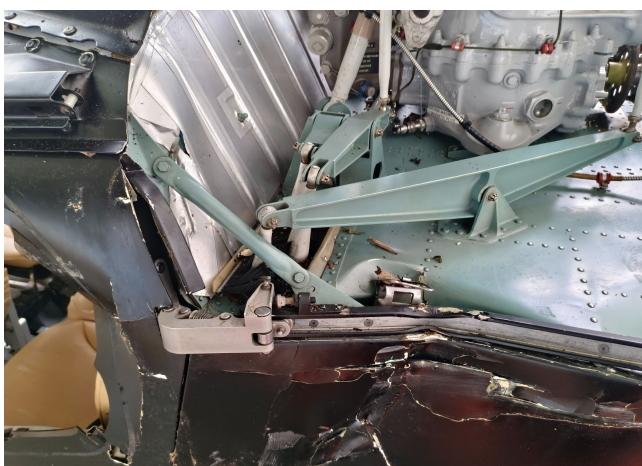
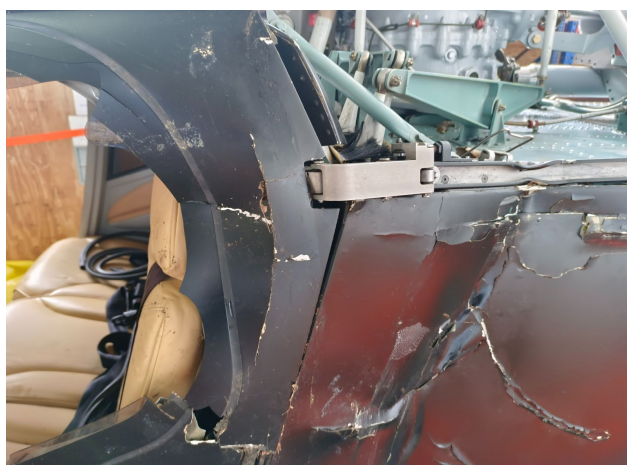
53.01 Left main fuselage dented from LH impact with ground (resting side)

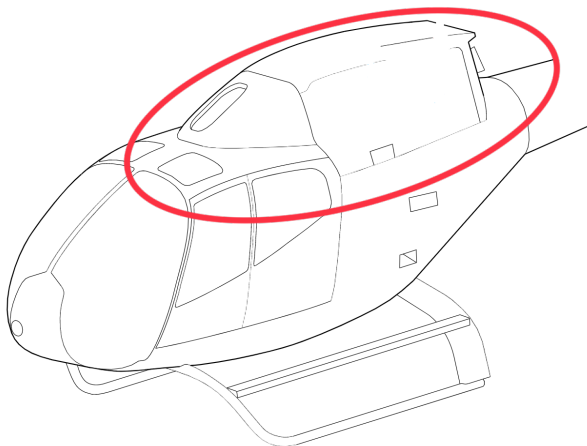
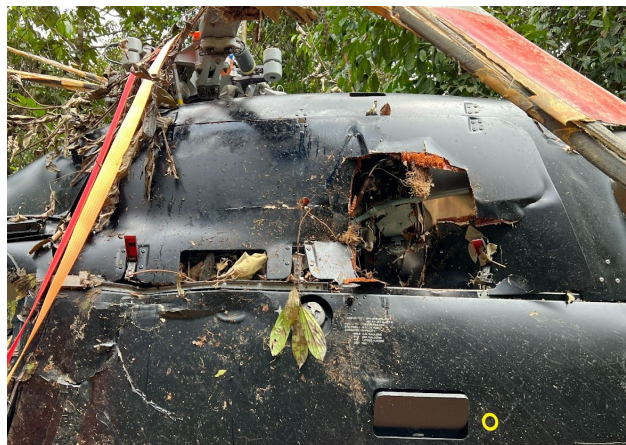
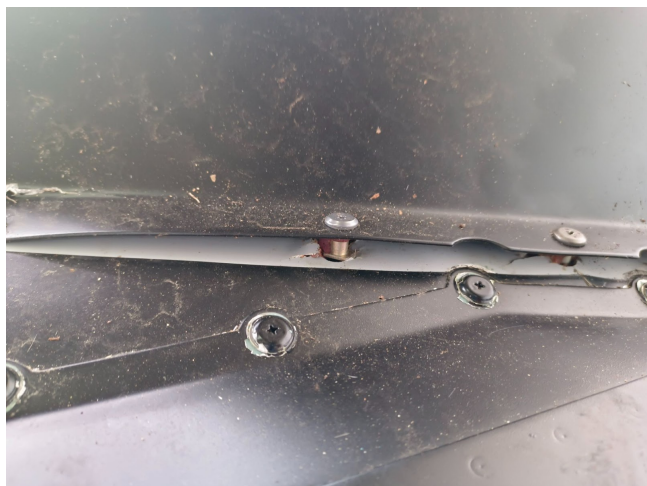
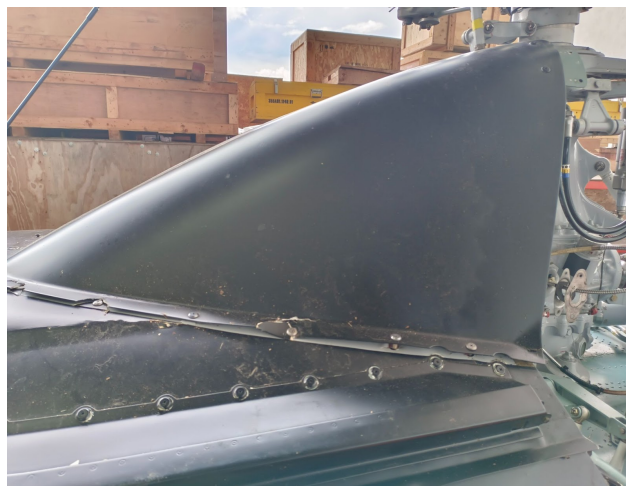
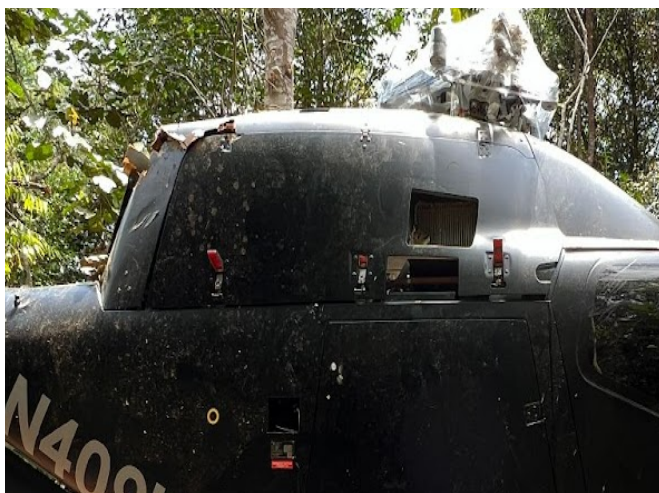
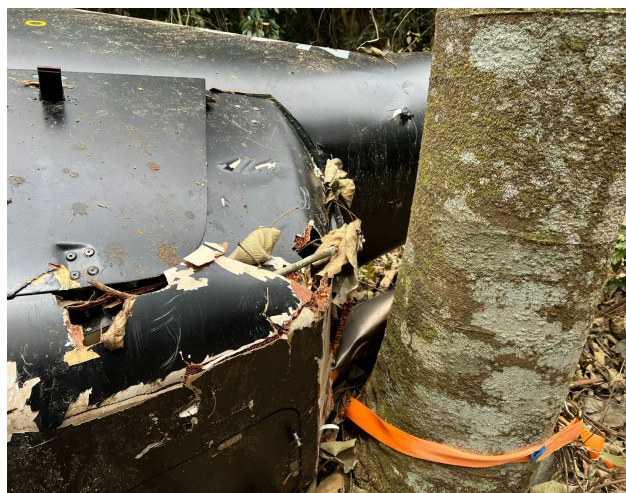
53.02 LH of MGB main cowling damaged from impact with large panels broken on the aft portion towards the engine. The FWD Cowling is also damaged with inserts debonded. The exhaust and the aft portion of main cowling were crushed by the tree the aircraft was resting on.

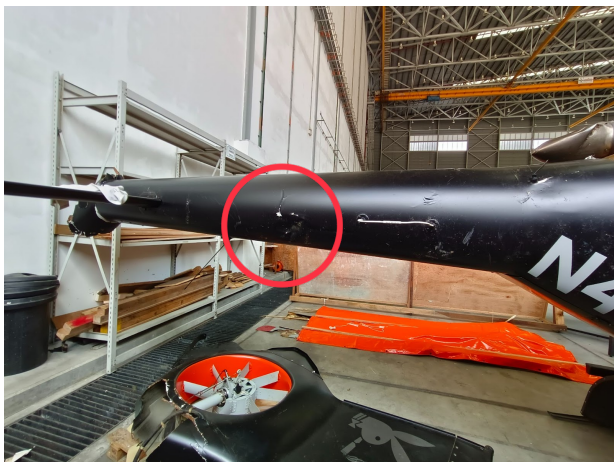
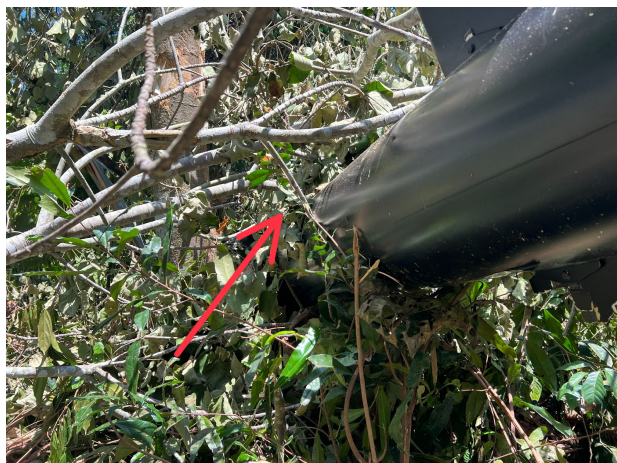
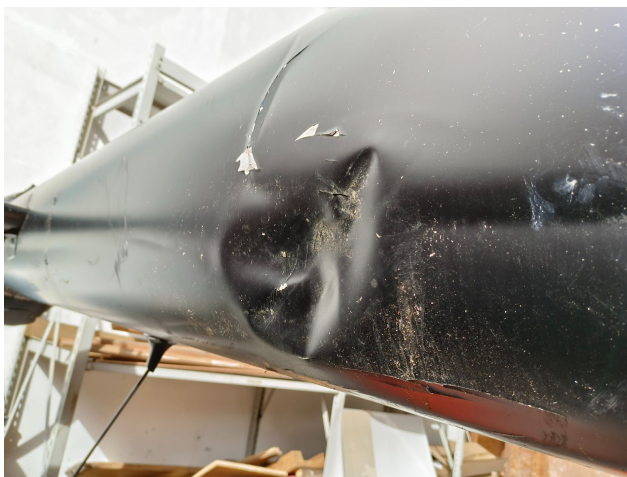
53.03 Tail boom skin found dented/cracked from impact with fallen tree

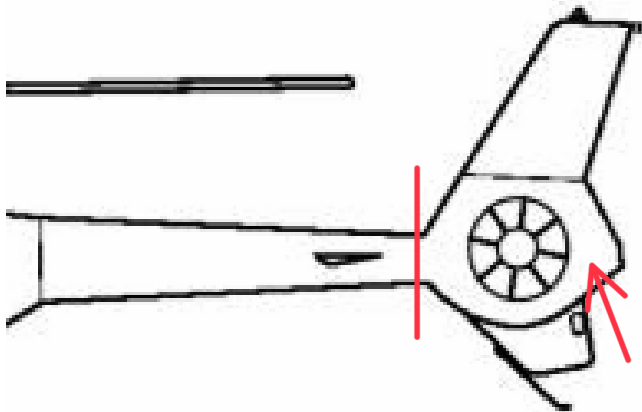
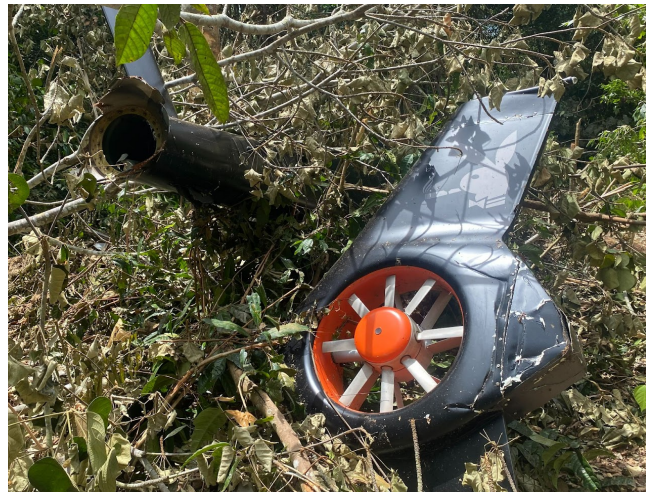
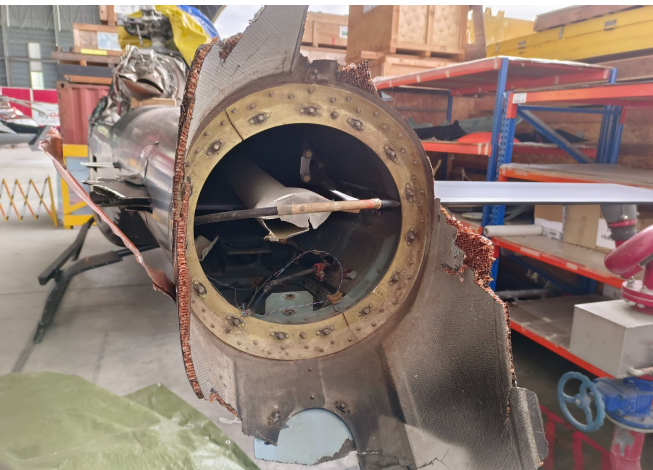
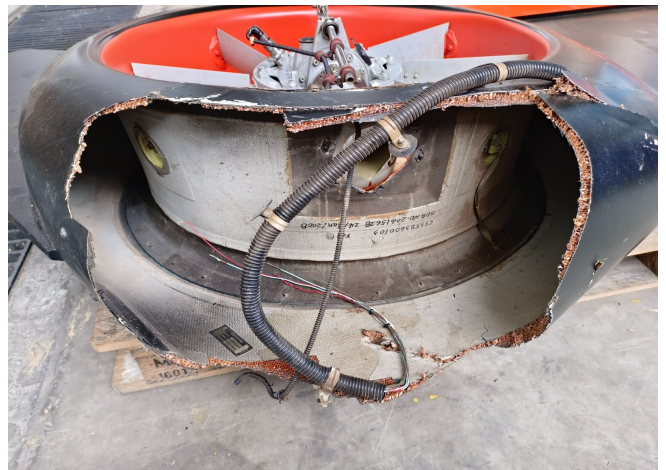
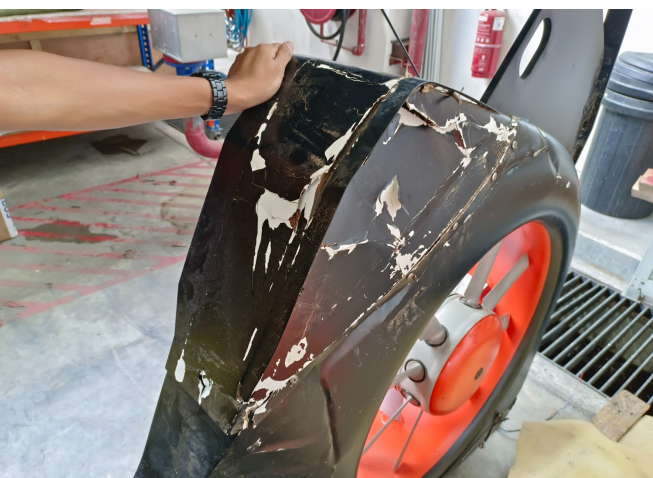
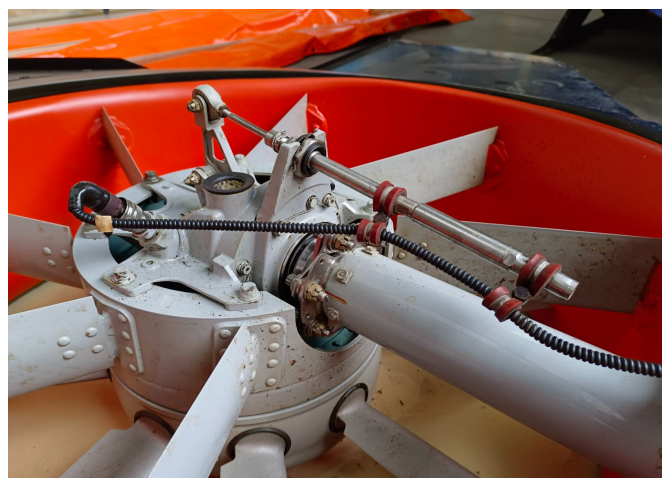
53.05 Tail Rotor Drive Shaft broken at TGB input (evidence of sudden stoppage/twisting). Forward and aft flexible couplings found twisted/bulging

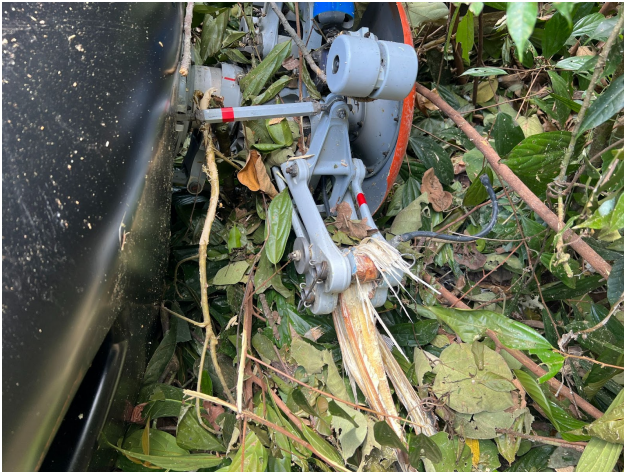
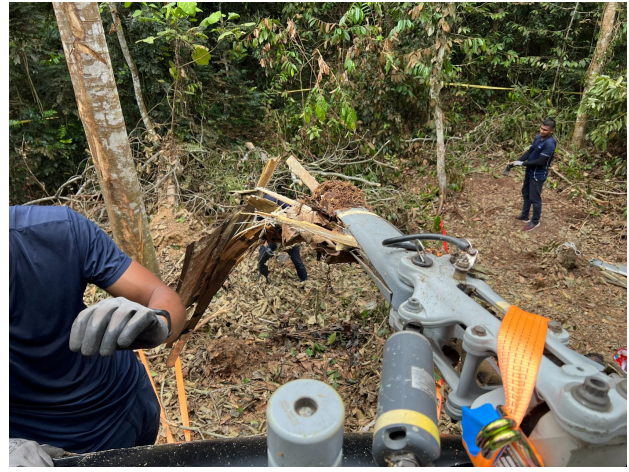
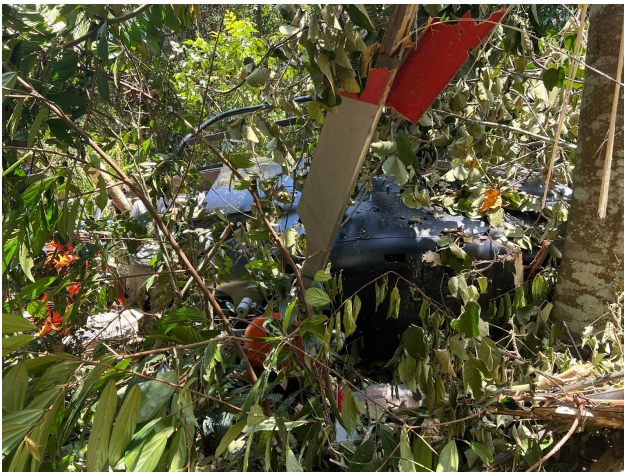
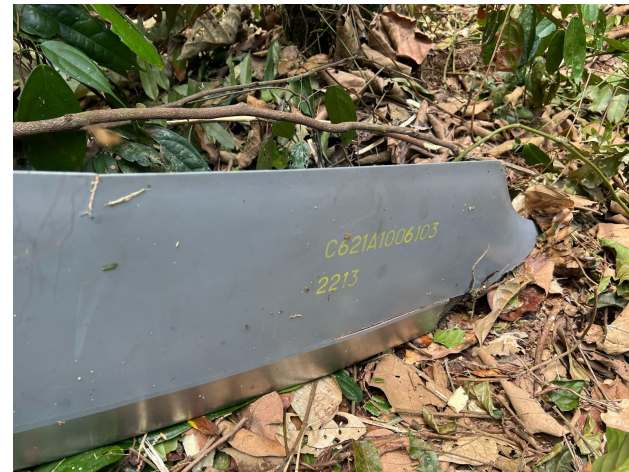
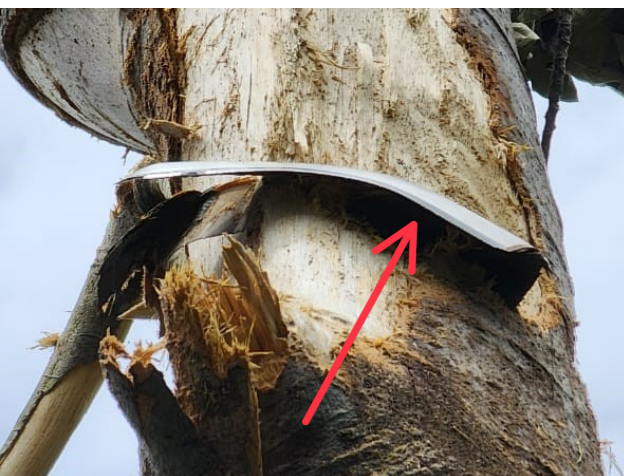
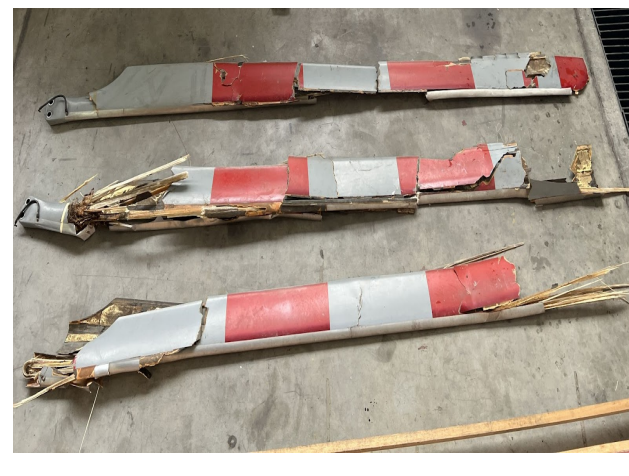
63.00 Rotating Scissor Drive Adaptor detached from sudden stop of rotating motion. Pitch links eye ends slightly bent.

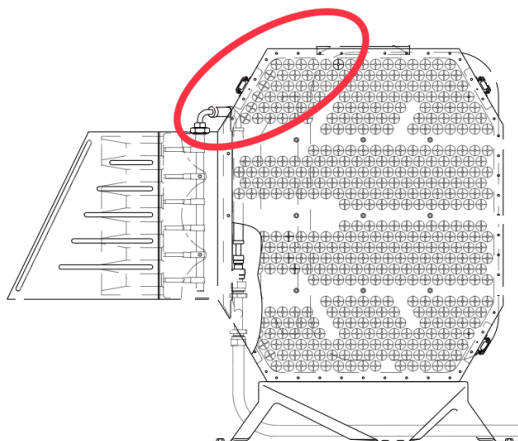
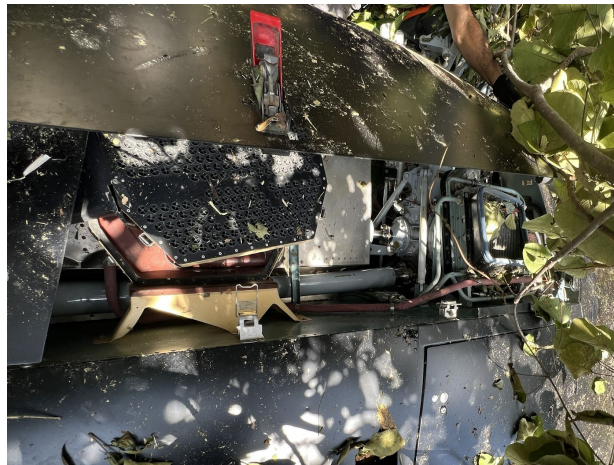
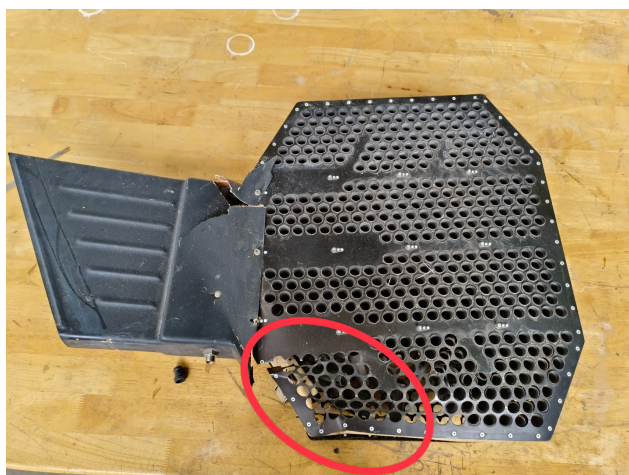
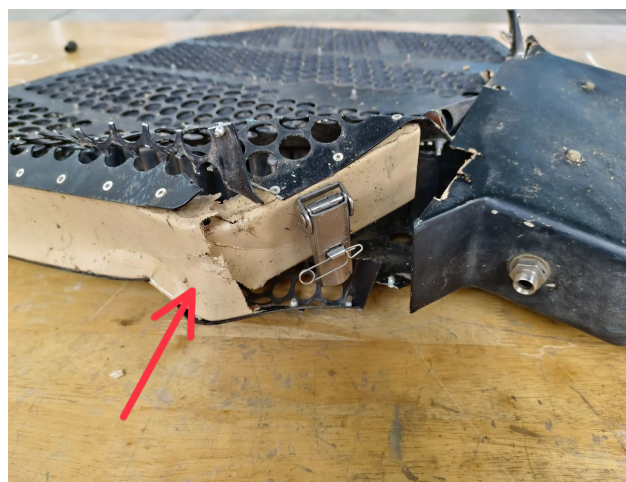
71.02 Sand filter damaged on top left corner from Top side impact with tree (tree aircraft rested on)

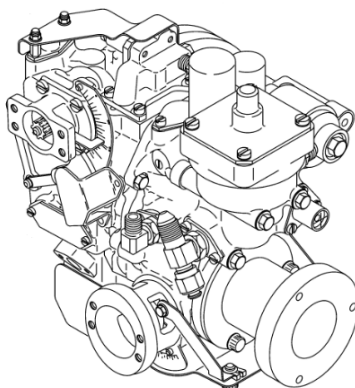
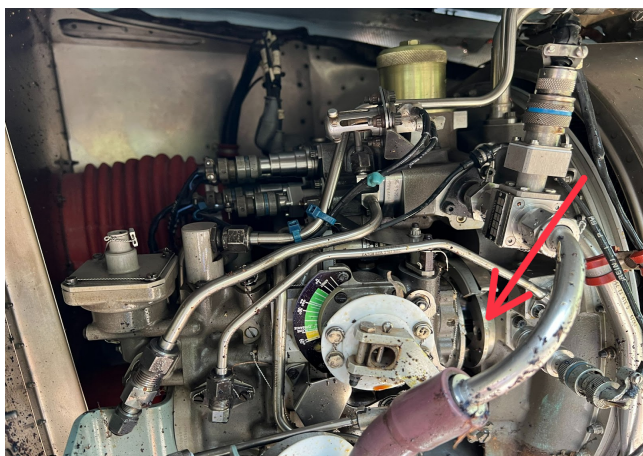
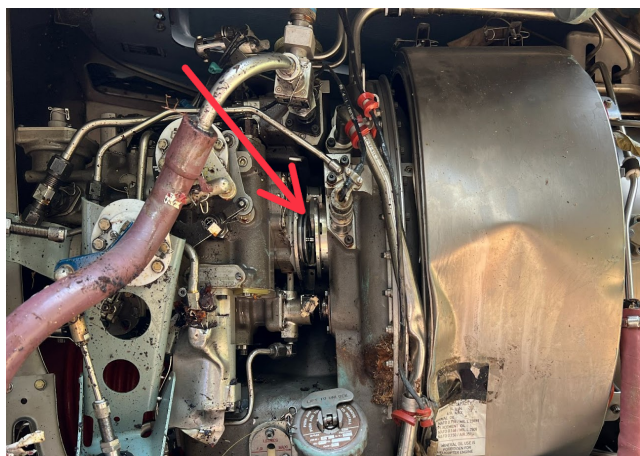
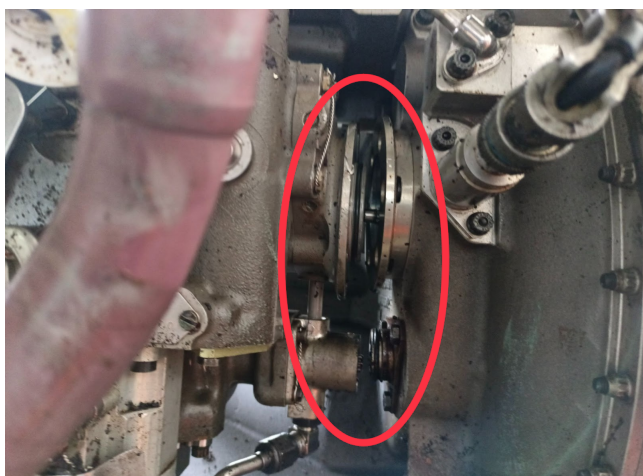
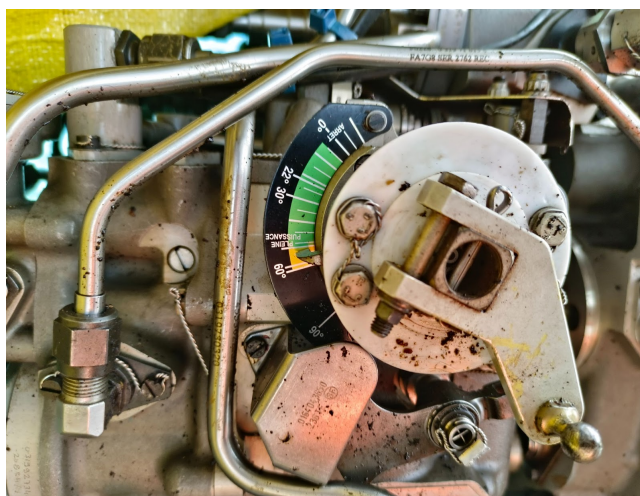
73.00 Fuel Control Unit clamps detached from LH impact

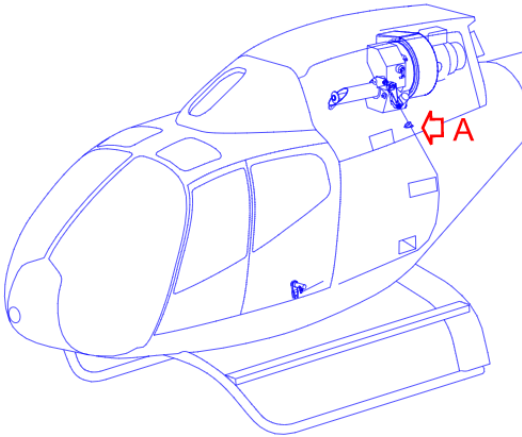
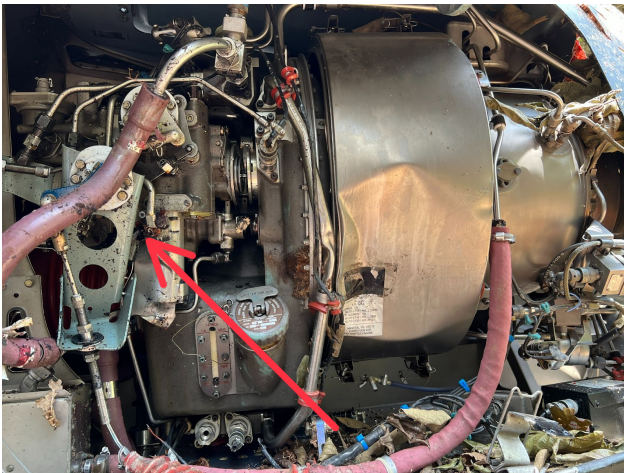
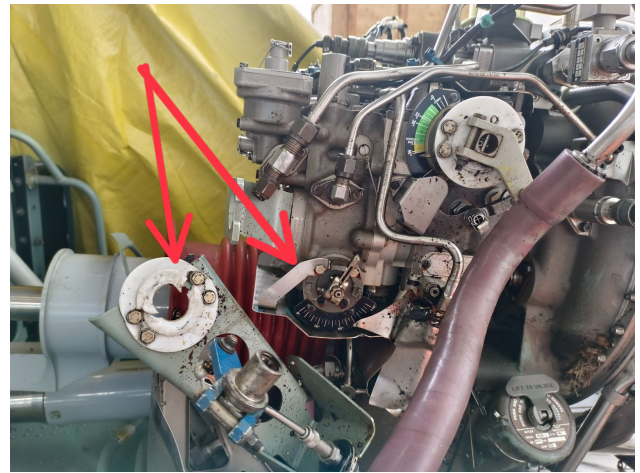
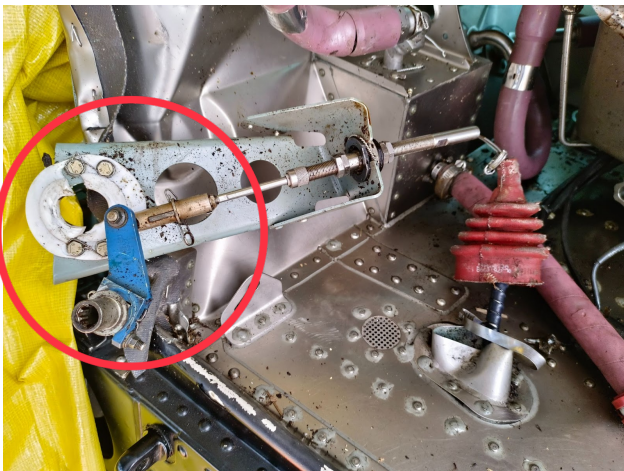
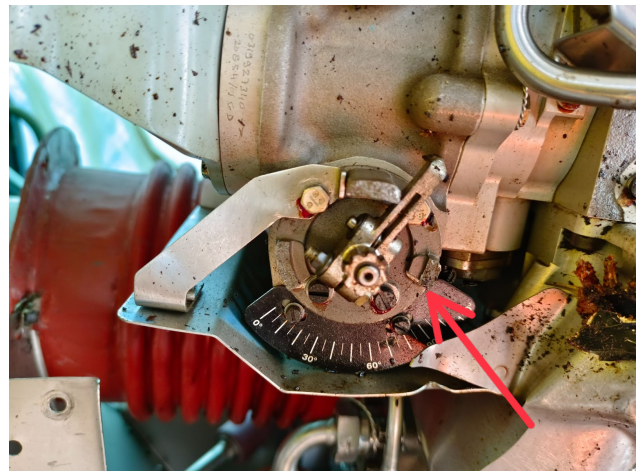
76.00 Engine Anticipator Control Cable Mount found broken from LH impact

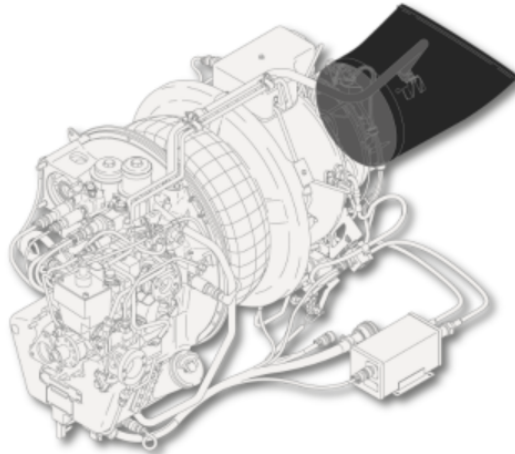
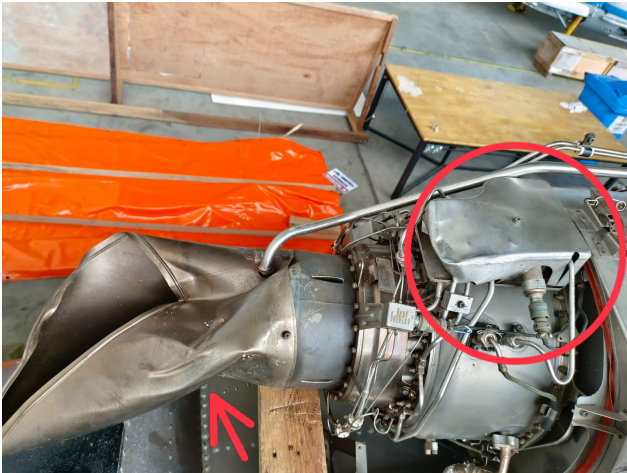
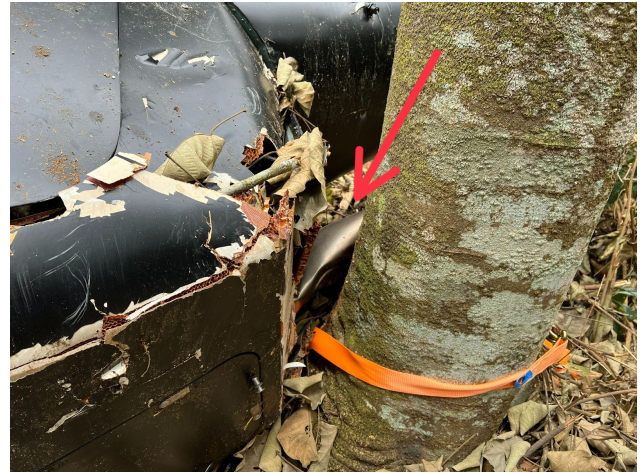
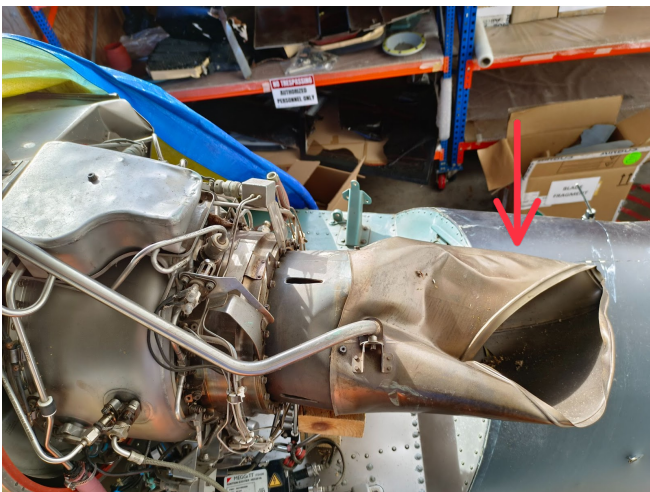
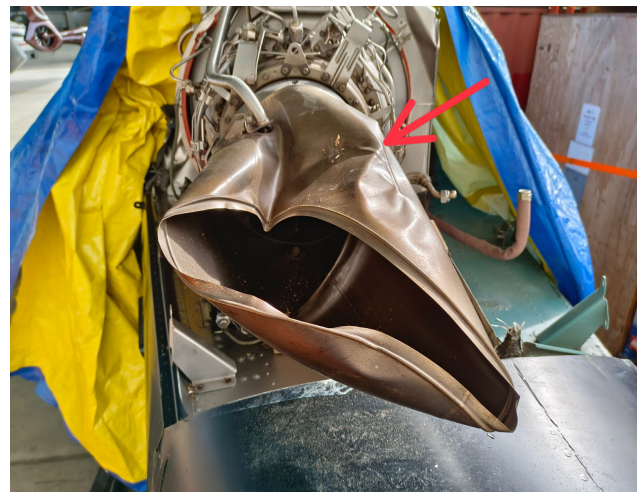
78.0 Engine exhaust and Fuel Valve Assy Cover flattened from top side impact with tree (tree aircraft rested on)

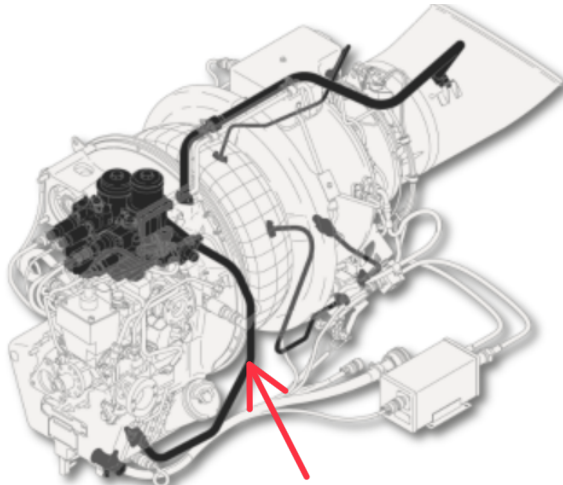
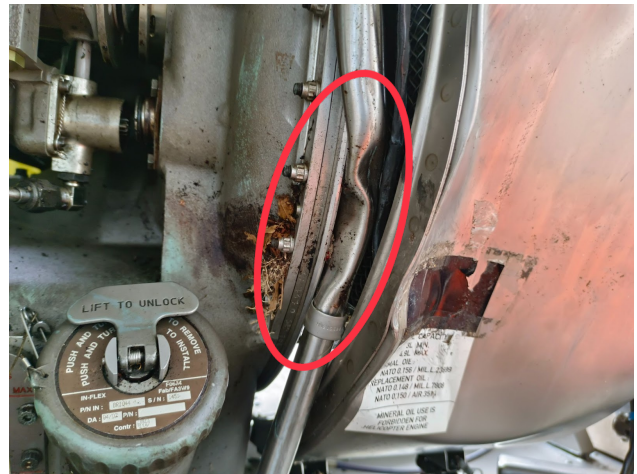
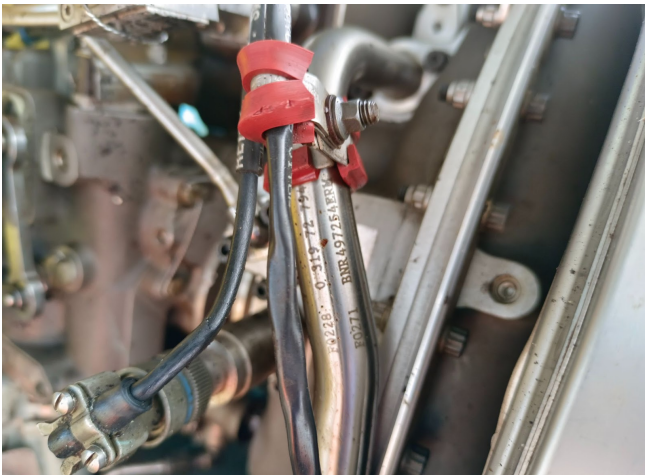
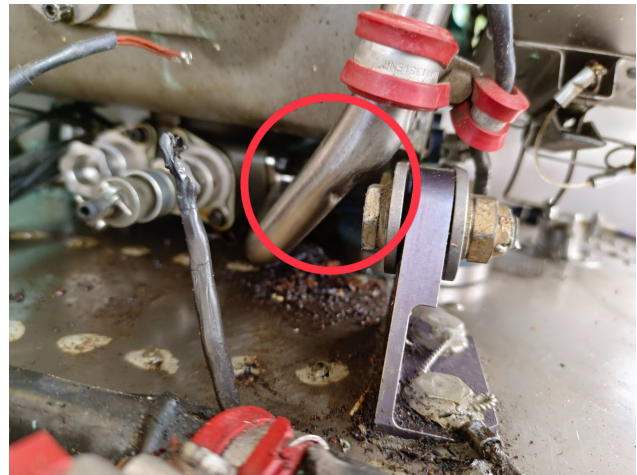
79.00 Engine Oil Return line flattened from LH impact

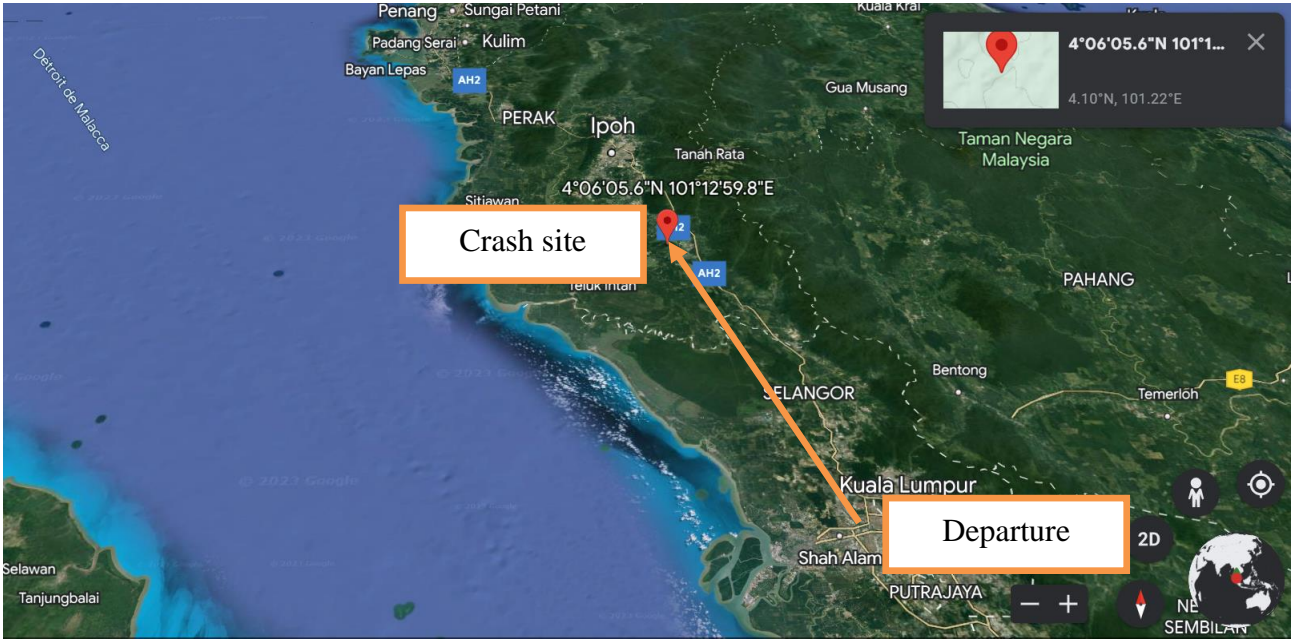
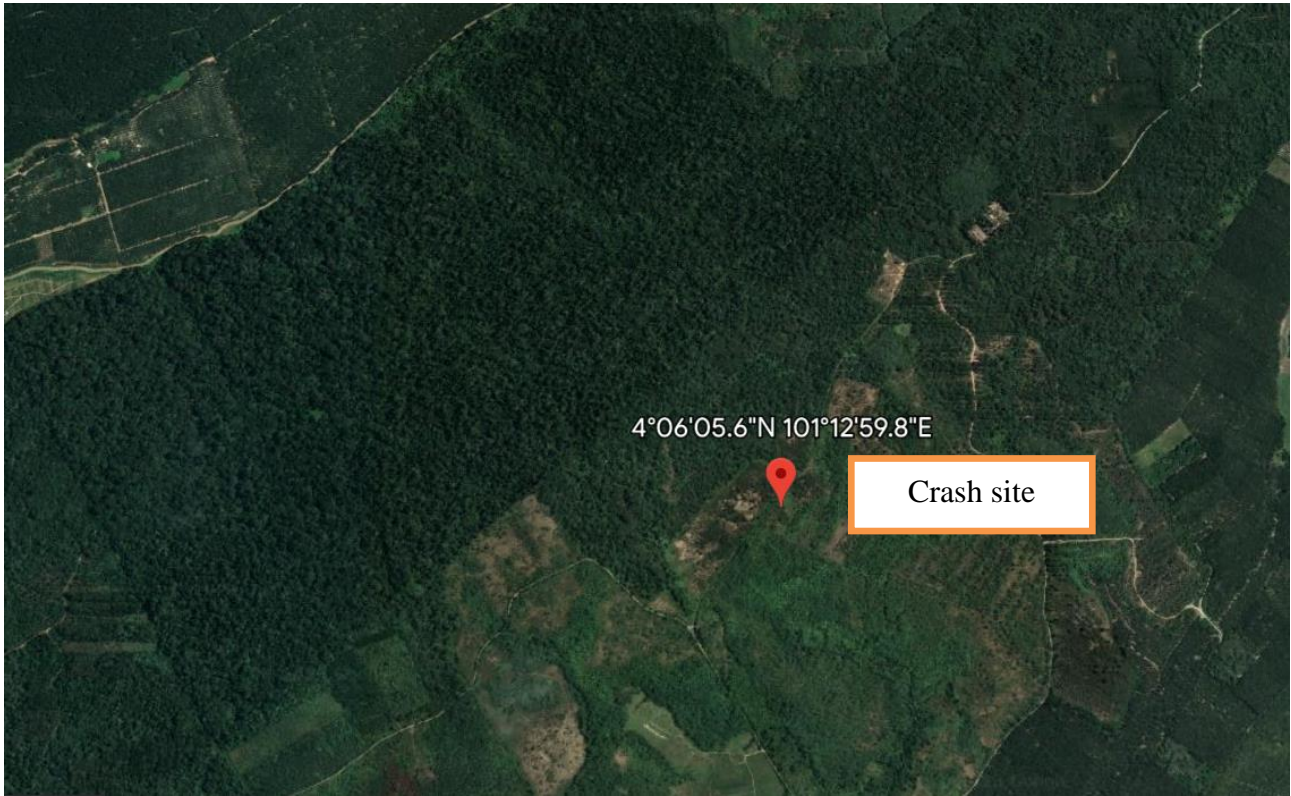
2. CRASH SITE MAPS:

The aircraft was found in the canopy (forest) lying on its left hand side.

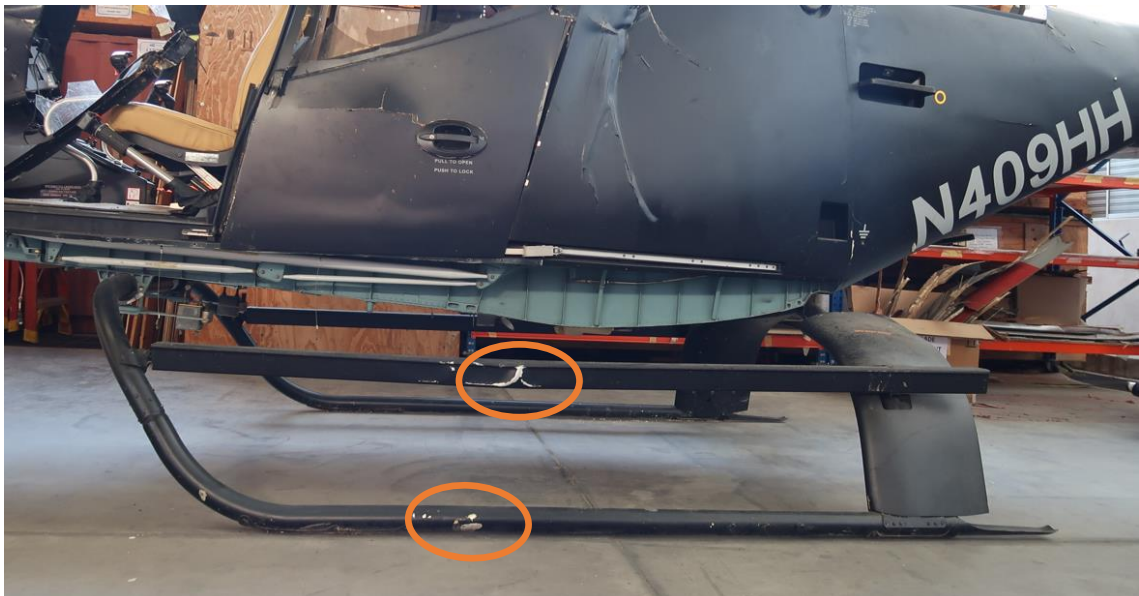
The landing skids were in good condition, with no visual deformation observed.

Two contact marks were observed: one on the left hand skid and one on the left hand footstep (see explanation in the next chapter).

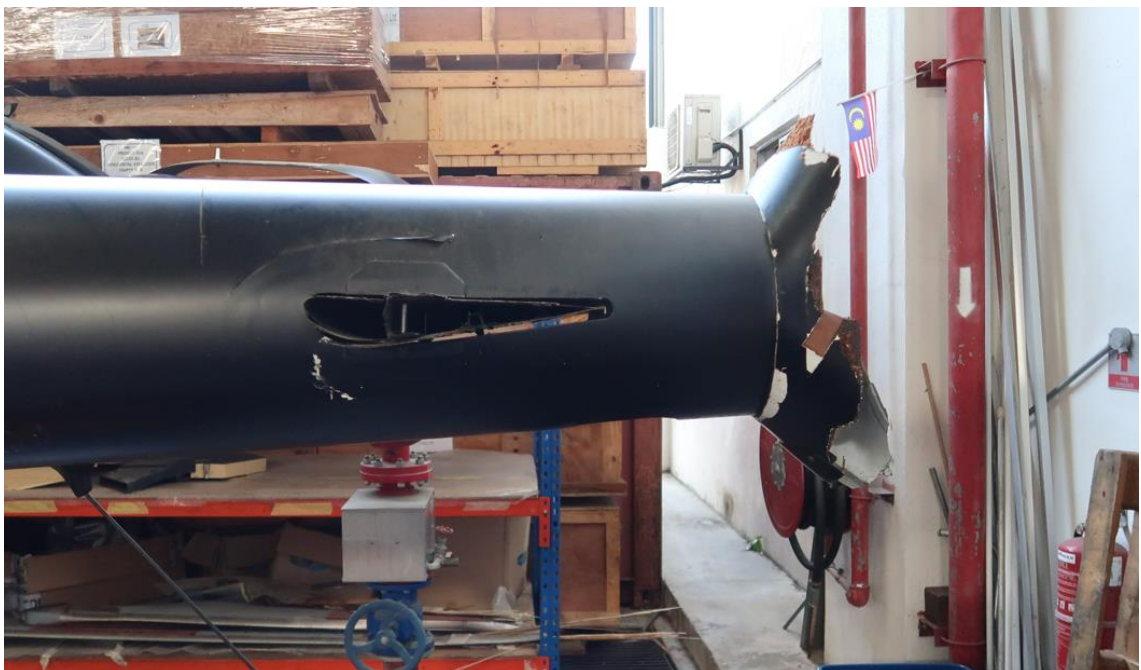
The tail boom was still connected to the intermediate structure, but the Fenestron was separated from the tail boom.

The horizontal stabilizer was broken on the left hand side at its junction with the tail boom.

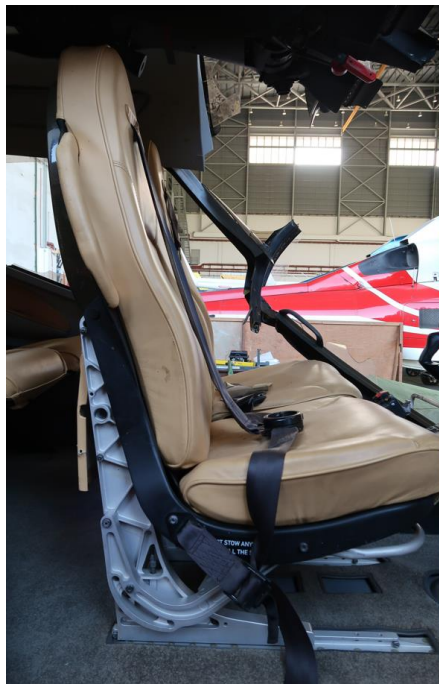
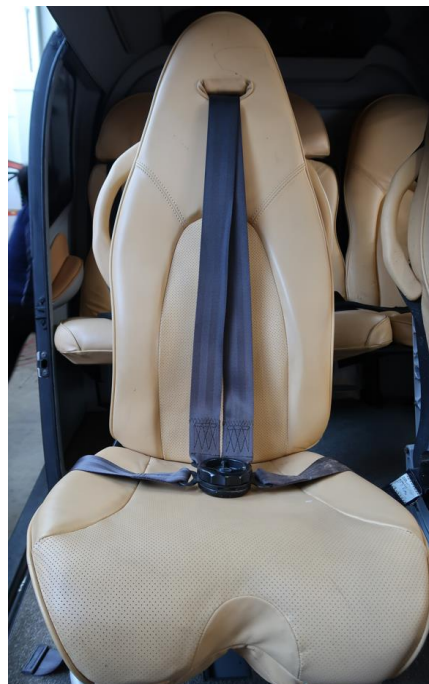
3.4. Seat:

The pilot was the sole occupant of the aircraft and was sat on the front right seat. The helicopter was equipped with high energy absorption seats.

The pilot seat didn't exhibit deformation.

The safety belt was found open, but the harness locking turnbuckle was tested and operate as expected.

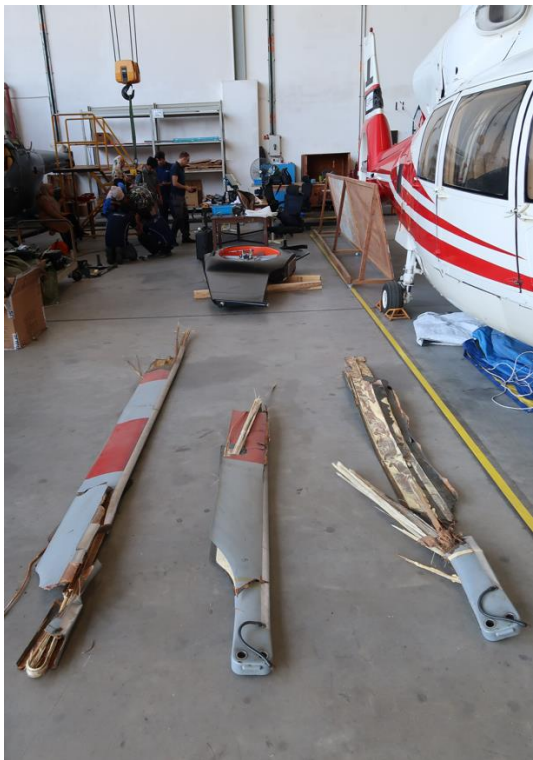
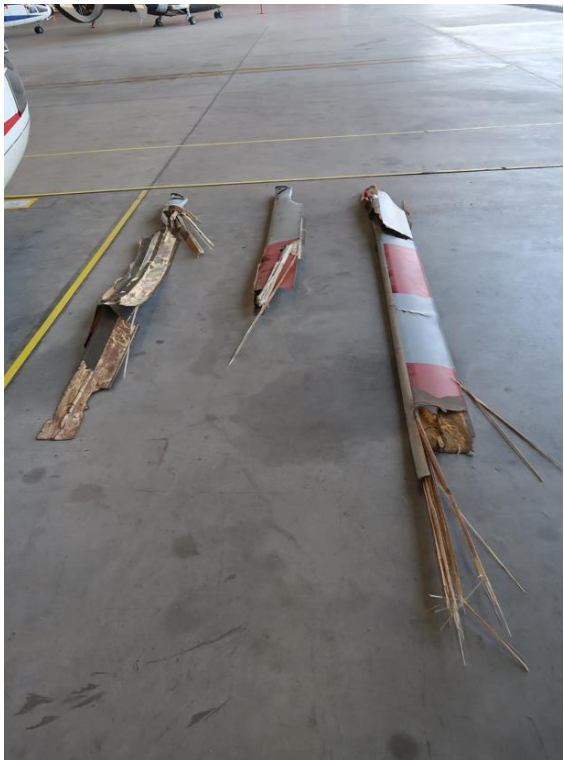
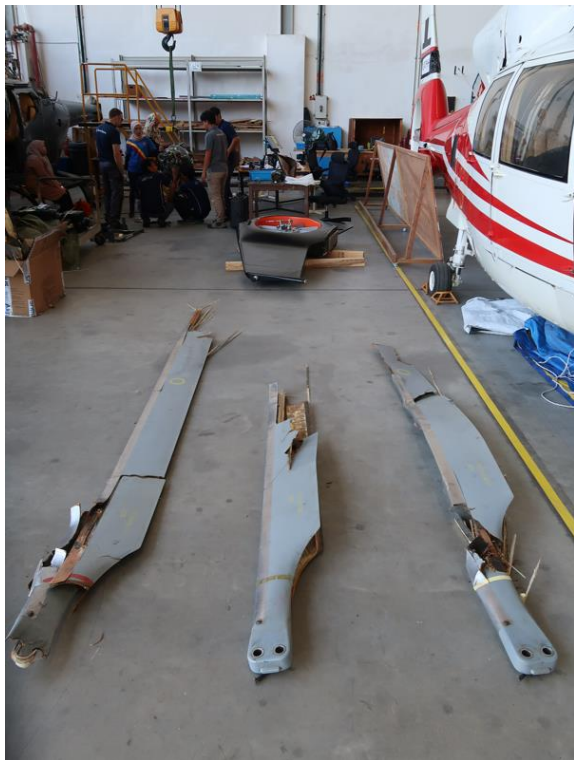
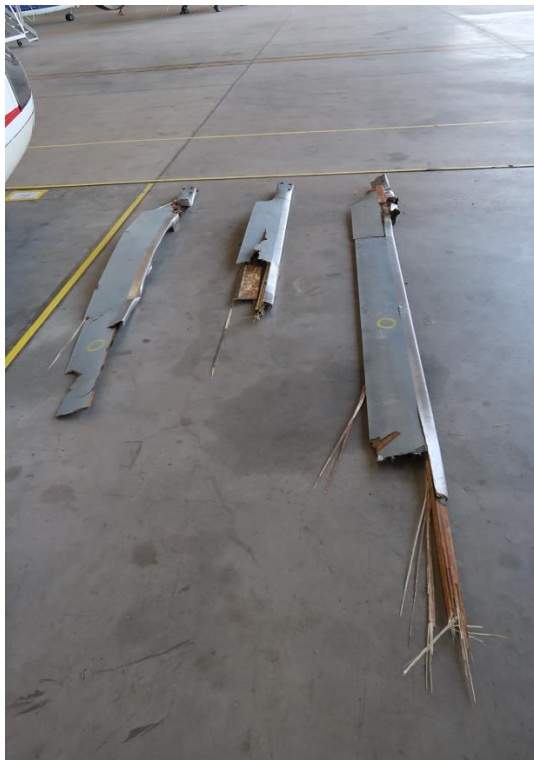
The roving of the red blade was broken at its junction with the stainless steel bushes. Approximately one third of the red blade was missing at its extremity.

Approximately two third of blue blade was missing at its extremity.

The yellow blade was broken in two pieces at its root.

Approximately one half of yellow blade was missing at its extremity.

The damage observed on the main rotor blades is consistent with an aircraft impacting obstacle with a main rotor spinning.

The damage observed on the main rotor blades is the consequence of the crash sequence (main rotor blades impact with trees and ground).

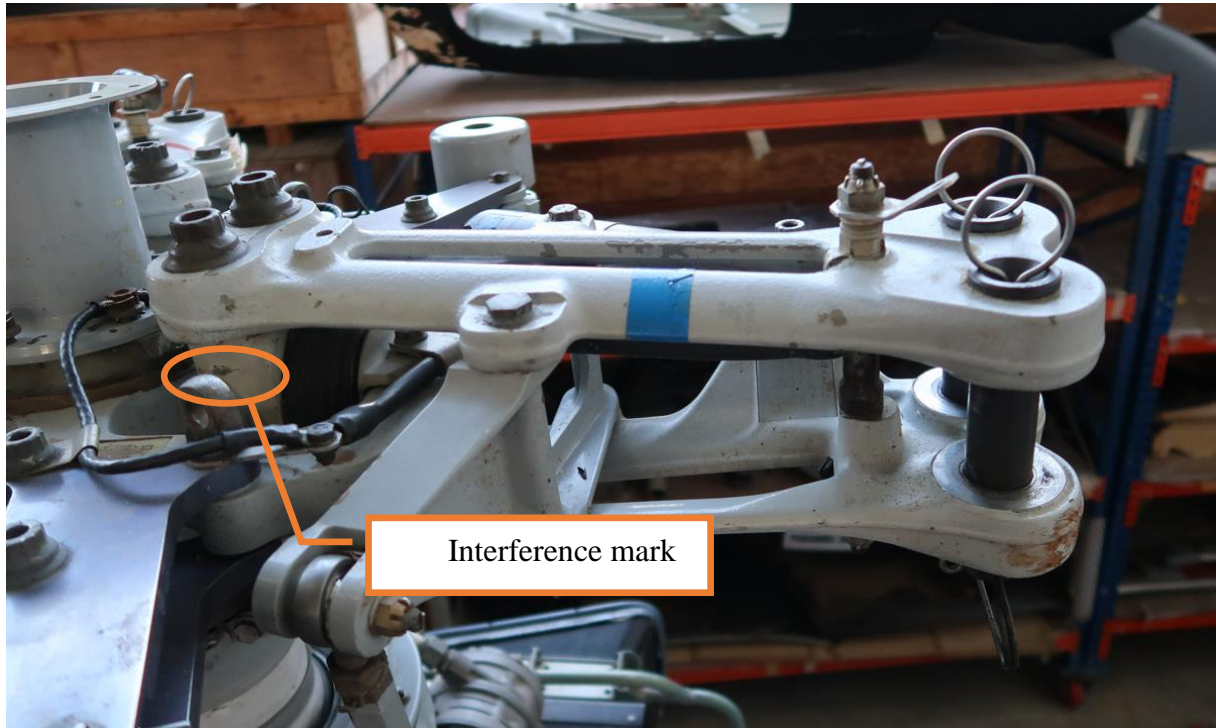
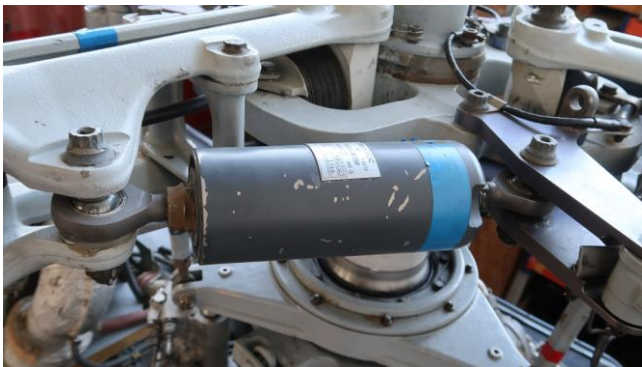
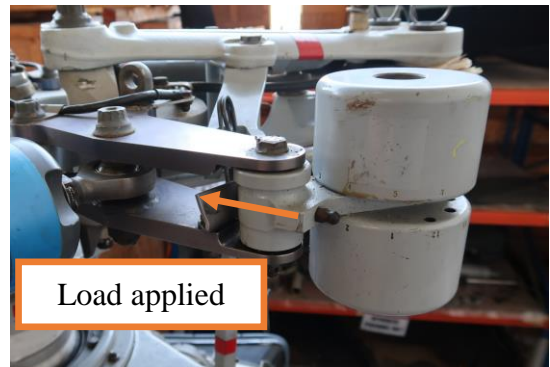
Blue sleeve assembly:

The blue sleeves didn't exhibit visible damage.

The anti-vibrator stop exhibited deformation that was consistent with a sudden main rotor deceleration (inertial movement of the anti-vibrator).

The frequency adapter didn't exhibit significant damage.
