AIRCRAFT ACCIDENT FINAL REPORT
A 05/22P
Air Accidents Investigation Bureau (AAIB)
Ministry of Transport Malaysia

Eurocopter EC120B Registration N409HH
in Hutan Simpan Chikus, Bidor, Perak, Malaysia
on the 11 September 2022

ACCIDENT REPORT NO.: A 05/22

OPERATOR : FLYSTAR GLOBAL SDN BHD
AIRCRAFT TYPE : EUROCOPTER EC120B
NATIONALITY OF AIRCRAFT : UNITED STATES OF AMERICA
REGISTRATION : N409HH
**PLACE OF OCCURRENCE : HUTAN SIMPAN CHIKUS, BIDOR,
PERAK, MALAYSIA
(4° 06' 13.8'' N, 101° 12' 45.1'' E)**
DATE AND TIME : 11 SEPTEMBER 2022 AT 1217 LT

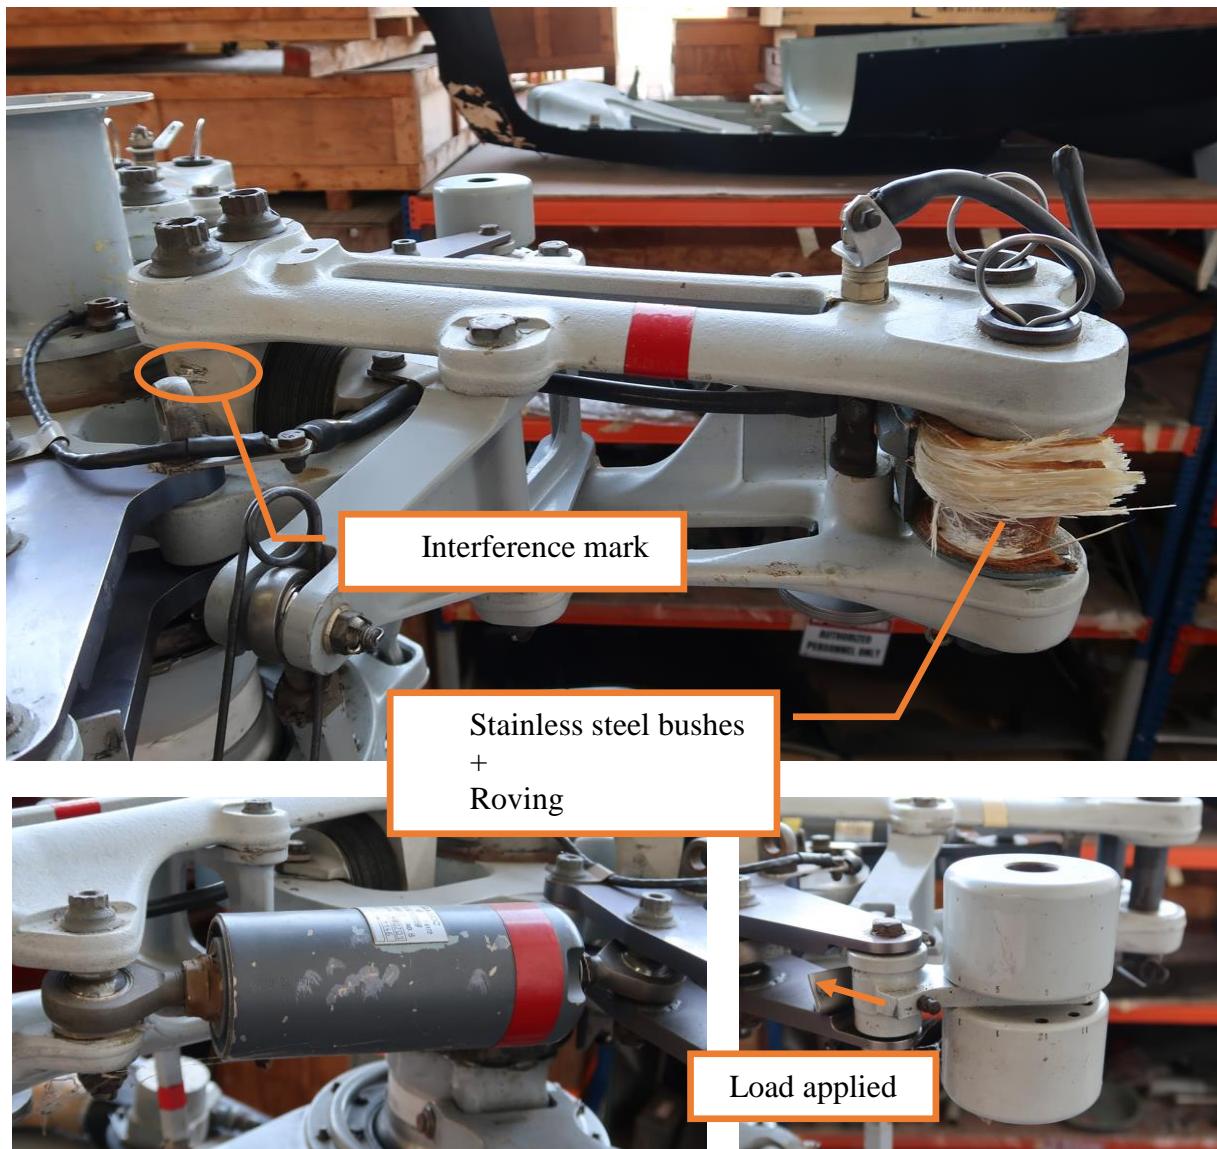
Red sleeve assembly:

The red sleeves didn't exhibit visible damage.

The frequency adapter didn't exhibit significant damage.

The stainless steel bushes and a piece of main rotor blade roving was still attached on the main rotor blade pins.

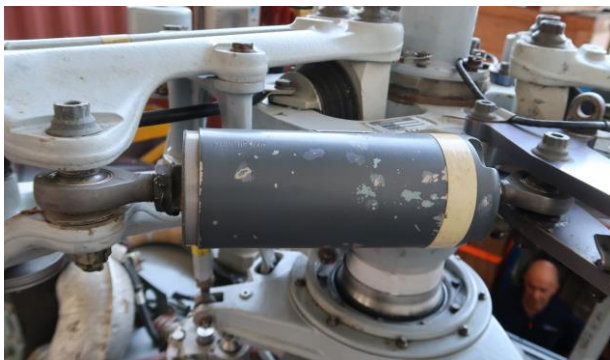
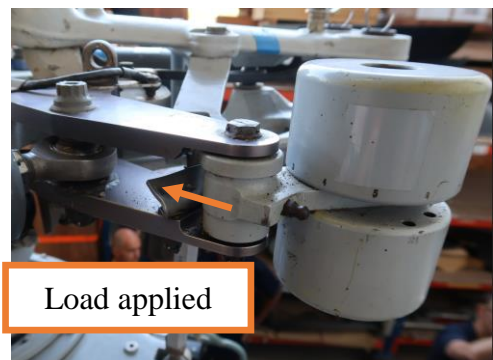
Yellow sleeve assembly:

The yellow sleeves didn't exhibit visible damage.

The anti-vibrator stop exhibited deformation that was consistent with a sudden main rotor deceleration (inertial movement of the anti-vibrator).

The frequency adapter didn't exhibit significant damage.

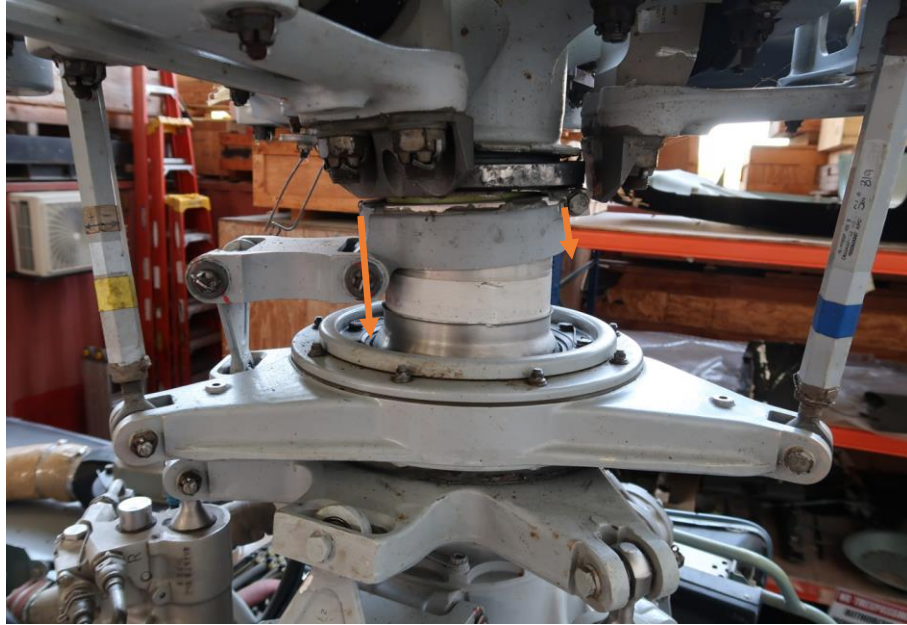
Droop restrainer ring:

The droop restrainer ring and the main rotor blades lower stops exhibited contact marks. The droop restrainer was moved down against the support of the mobile scissor, leading to its displacement.

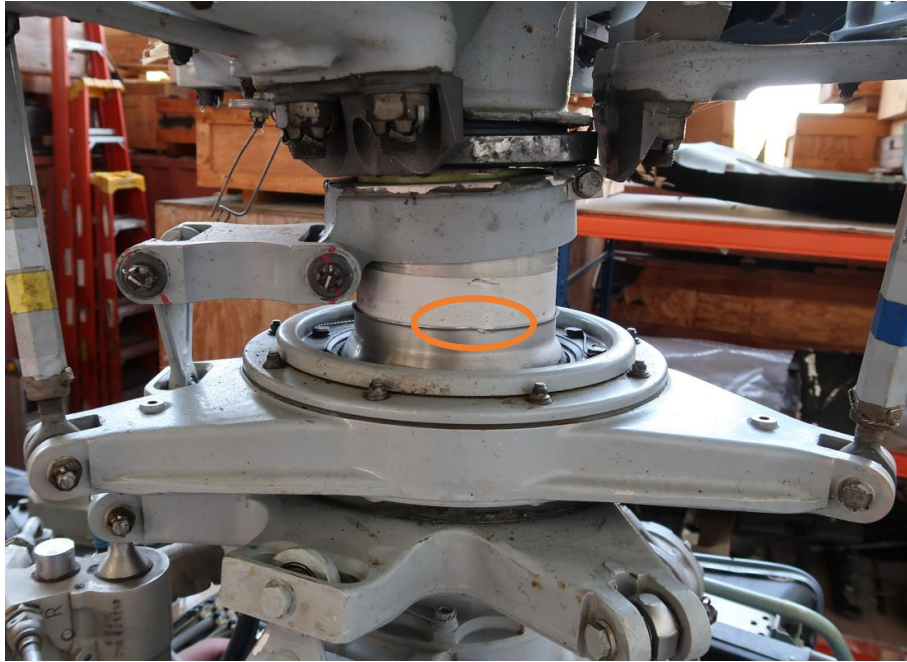
The sliding tube didn't exhibit damage, except a slight indent at its extremity.
The swashplate and its spherical joint didn't exhibit visible damage.

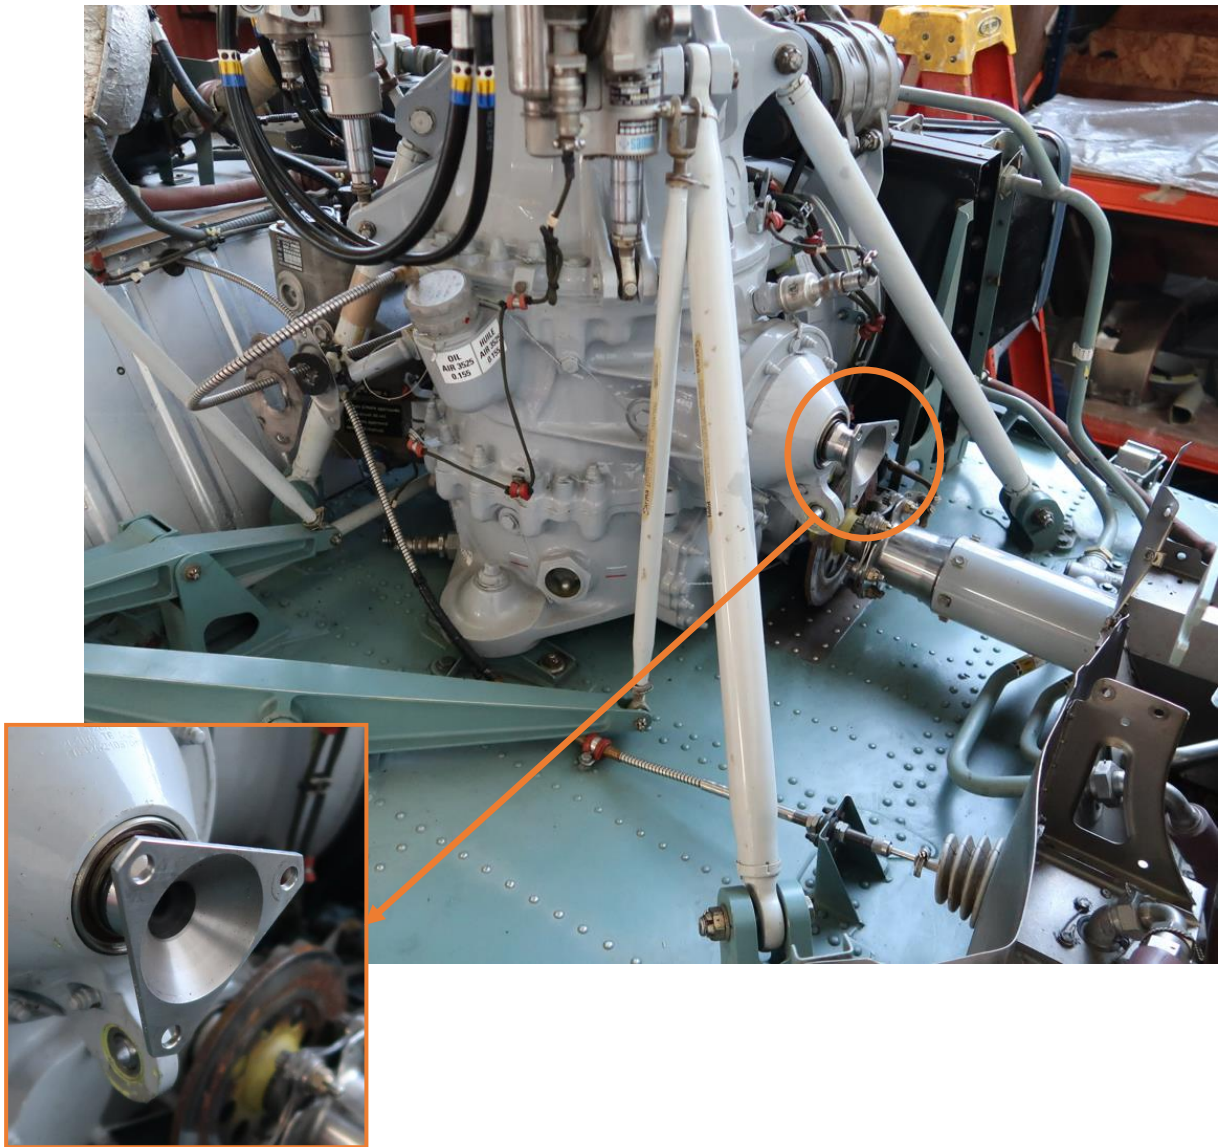
The MGB input flange didn't exhibit visible damage.

The kinematic continuity between the MGB engine input flange and the main rotor head was checked and confirmed.

The freewheel (located on MGB side) was checked and was operating properly.

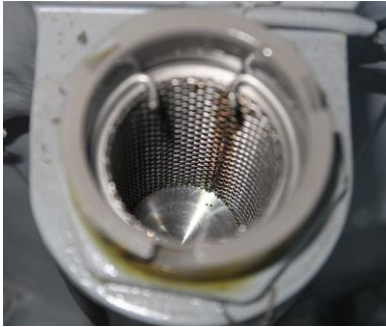
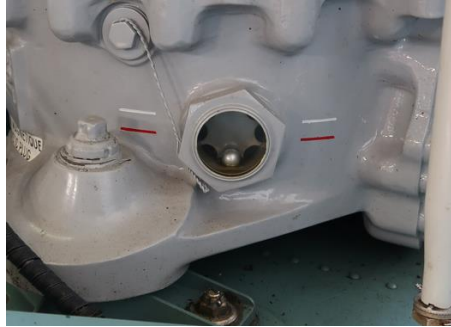
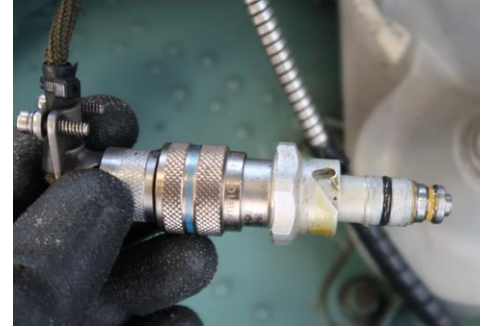
The main gear box filling port was open. The strainer was checked and found exempt of external particle.
No remaining oil was visible through the glass sight.
The magnetic plug was inspected and found exempt of any metallic particle.

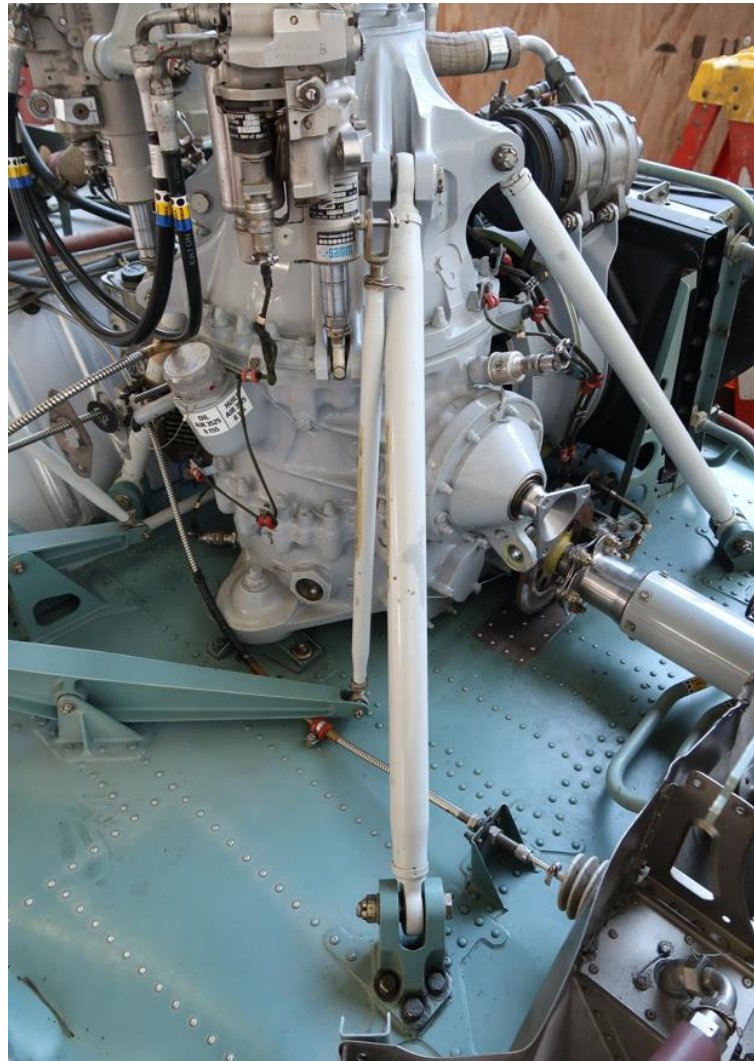
The four suspension bars didn't exhibit visible damage.
The anti-torque fitting didn't exhibit visible damage.

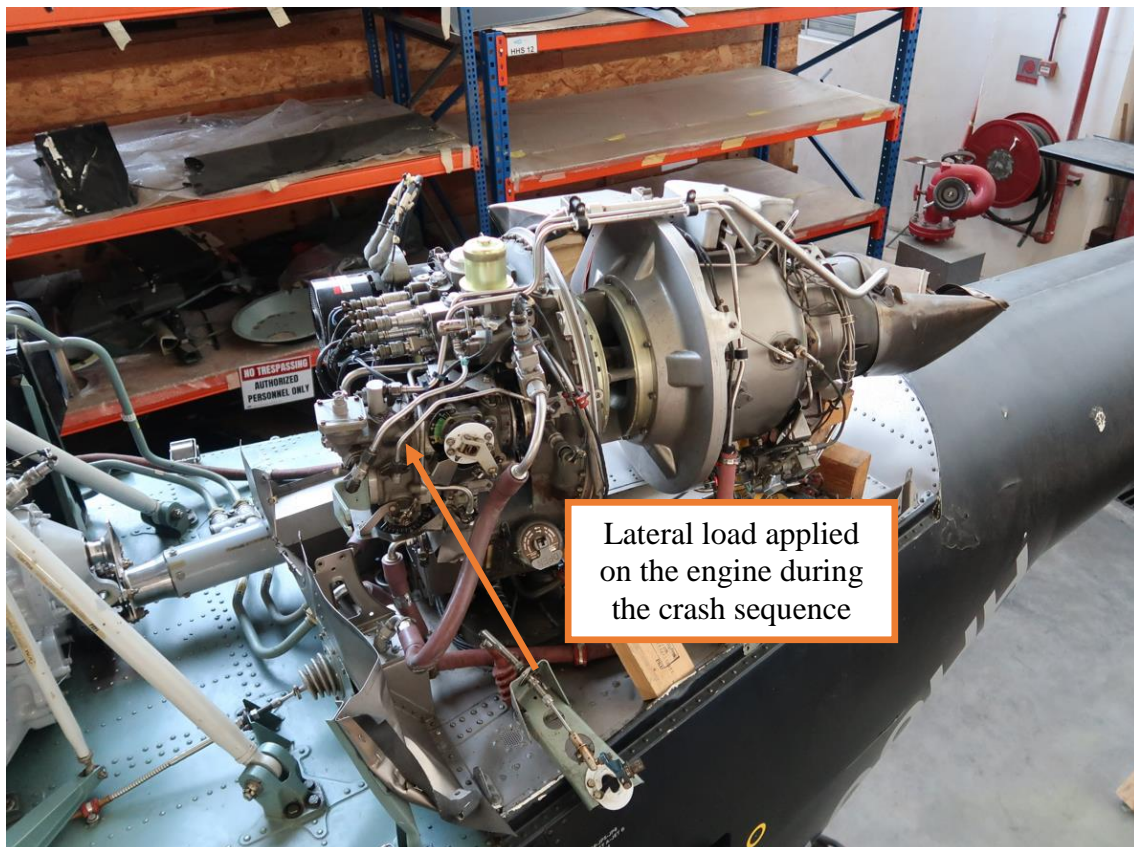
During the crash sequence the engine has most probably being pushed on its right hand side leading to following main damage:

- Rupture of the engine to MGB coupling at its junction with the engine (refer to previous chapter)
- Rupture of the engine front mounting attachments
- Indent on engine compartment firewall and tail rotor transmission shaft (refer to next chapters)
- Disconnection of engine Fuel Control Unit (FCU)
- Pinching of the fuel supply line (refer to next chapter)

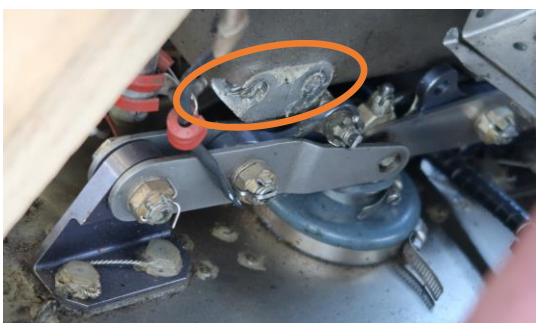
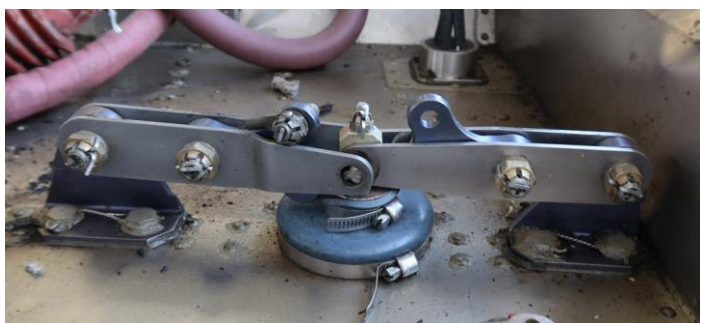
Engine front mountings:

The four studs fitted on engine casing were broken:

- one was torn off creating an engine oil leakage through the casing
- three were sheared

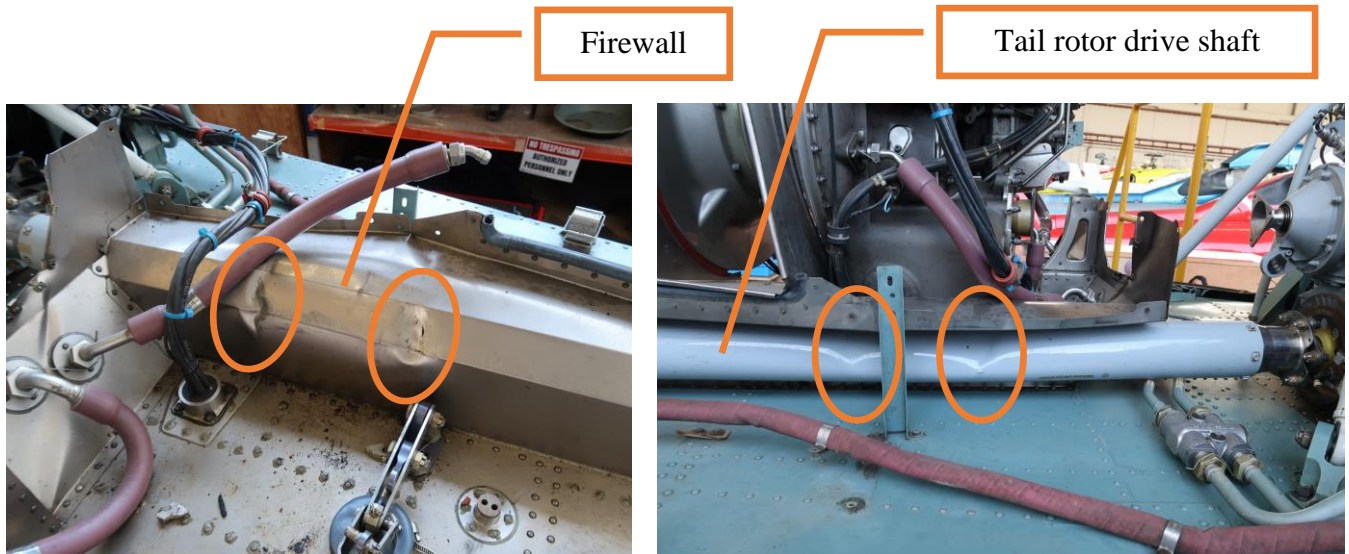
Engine compartment firewall:

The engine impacted the firewall, and the tail rotor drive shaft.

Two indent marks were visible on the internal face of the firewall and on the tail rotor drive shaft.

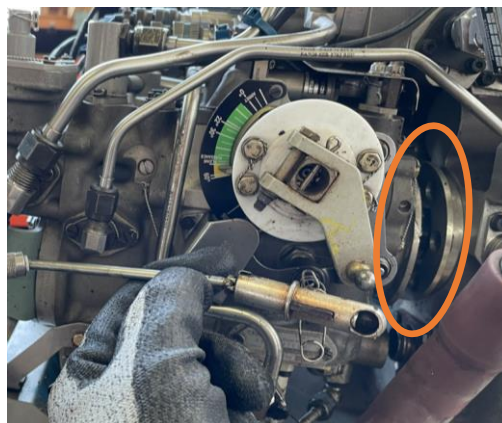
Fuel Control Unit (FCU):

The FCU was disconnected at its junction with engine Module 01 (Accessories gear box).

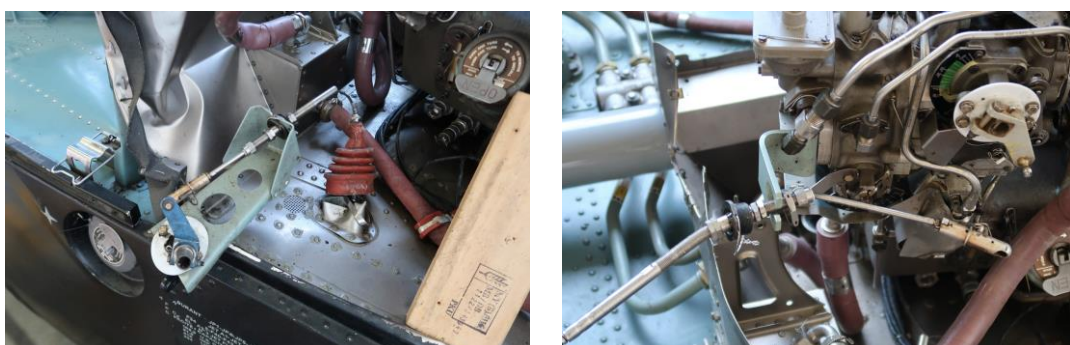
Fuel flow and anticipator controls:

The fuel flow control was disconnected at its junction with the fuel flow control lever and the anticipator control was torn out with its support as a result of the crash sequence.

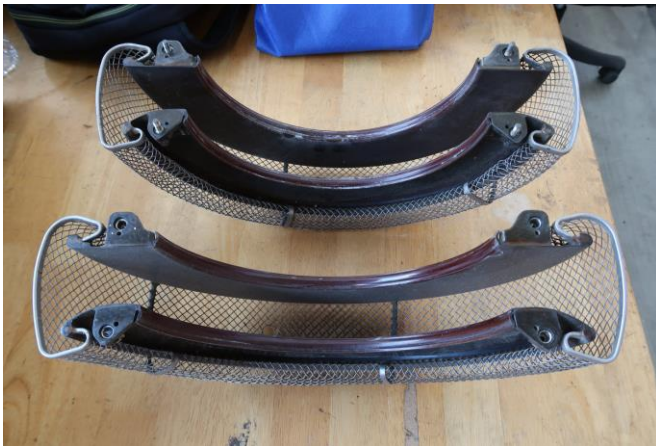
The two grids were clean and didn't exhibit damage.

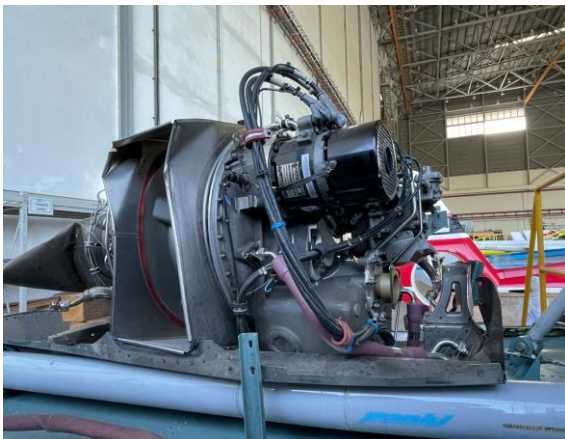
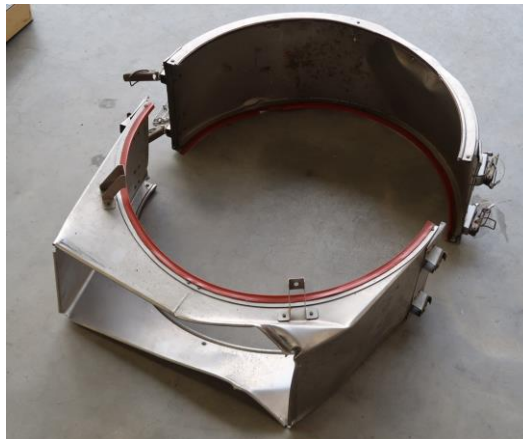
The plenum exhibited buckling on its top parts.

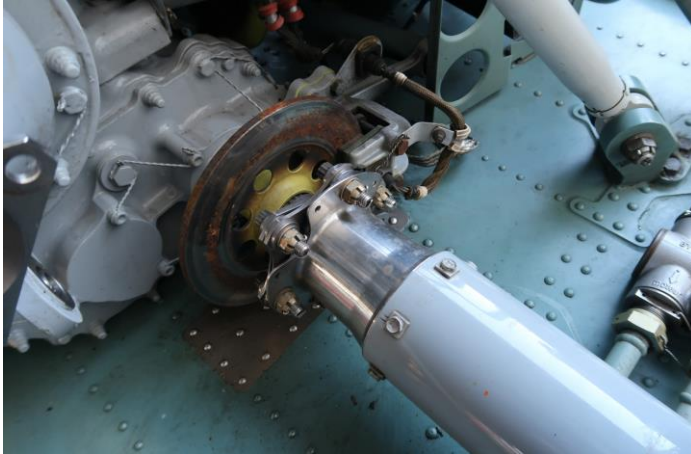
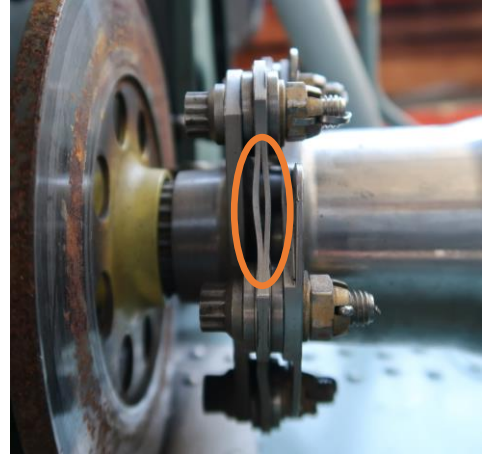
The flexible coupling installed between the forward sliding flange and the forward drive shaft exhibited bucking. This bucking is most probably the result of a torque variation load and displacement applied to the flexible couplings during the crash sequence.

The forward drive shaft exhibited two indent marks consistent with an engine lateral displacement on the right hand side during the crash sequence (refer to engine installation chapter).

The two indent marks were most probably done at the very end of the crash sequence, when aircraft has hit the ground on its left hand side.

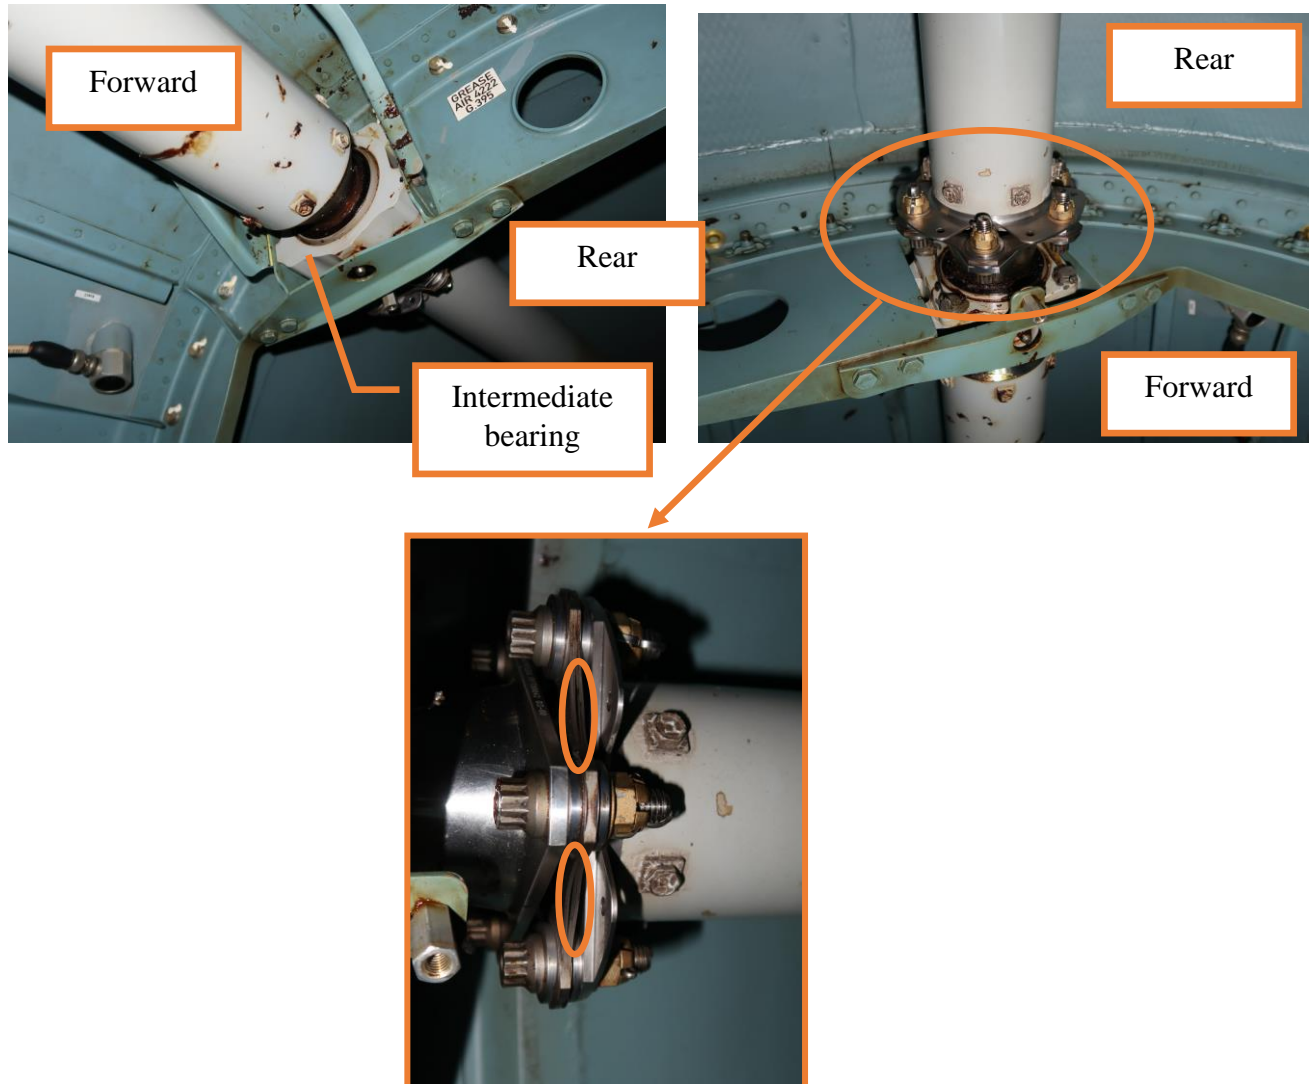
Except a slight bucking of the flexible coupling, no visible damage was observed at the junction between the forward and rear drive shaft.

This bucking is most probably the result of a torque variation load and displacement applied to the flexible coupling during the crash sequence.

The intermediate bearing was rotating freely.

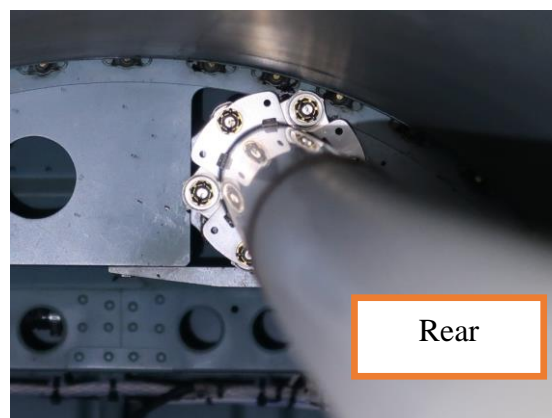
The rear drive shaft was correctly connected to the flexible coupling located at its junction with the forward drive shaft.

The damper installed on the rear drive shaft was broken in two pieces. One of them was found trapped into the tail boom honeycomb.

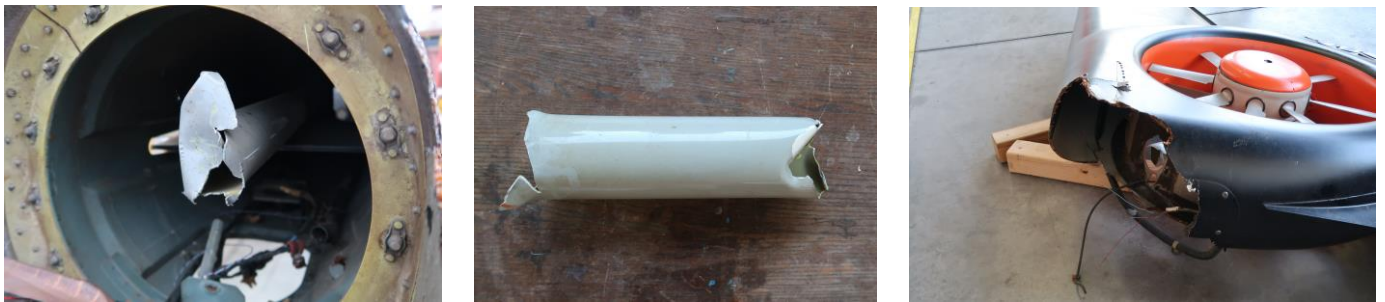
The rear drive shaft was broken in the vicinity of the junction between the Fenestron and the tail boom.

The end of the rear drive shaft was correctly connected to Tail Gear Box (TGB).

The flexible coupling located at the junction between the rear drive shaft and the TGB input flange exhibited bugling consistent with relative axial displacement or misalignment of the two conjugate flanges.

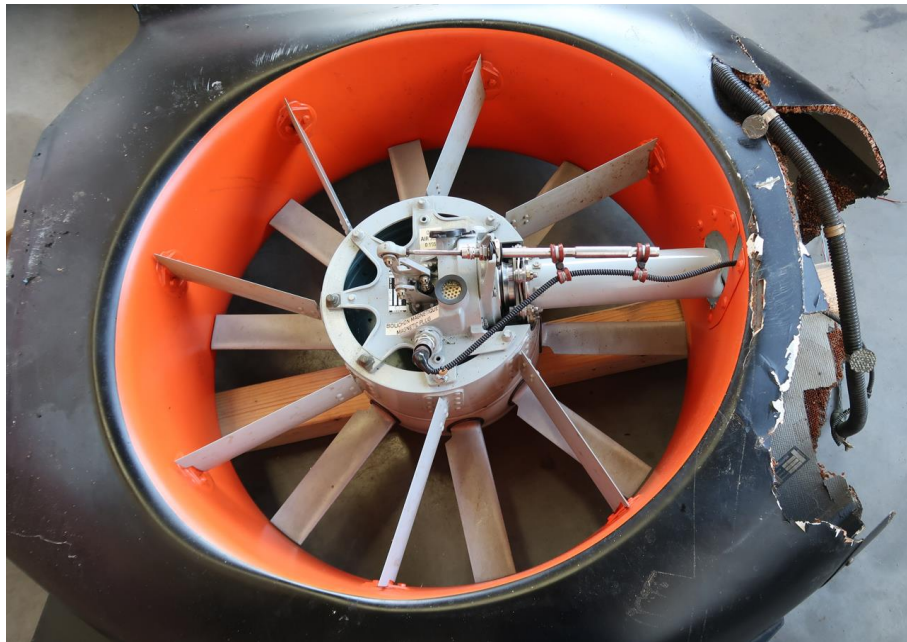
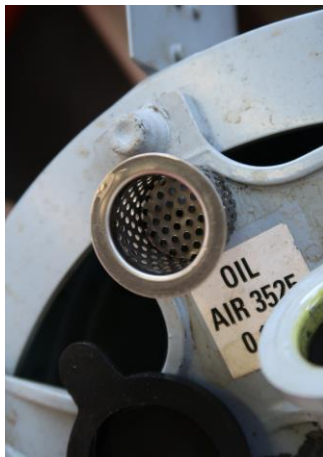
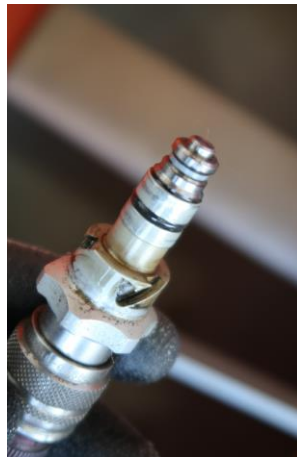
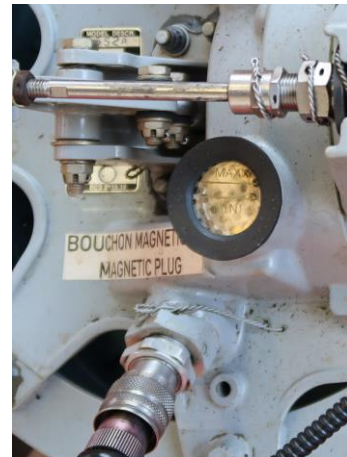
The tail gear box didn't exhibit any visible damage.
The kinematic continuity of the tail gear box was checked and confirmed.
The stator which supports the tail gear box was also in good condition.
The filler cap has been removed and no external pollution was found in the strainer.
No remaining oil was visible through the glass sight.
The magnetic plug was inspected and found exempt of any metallic particle.

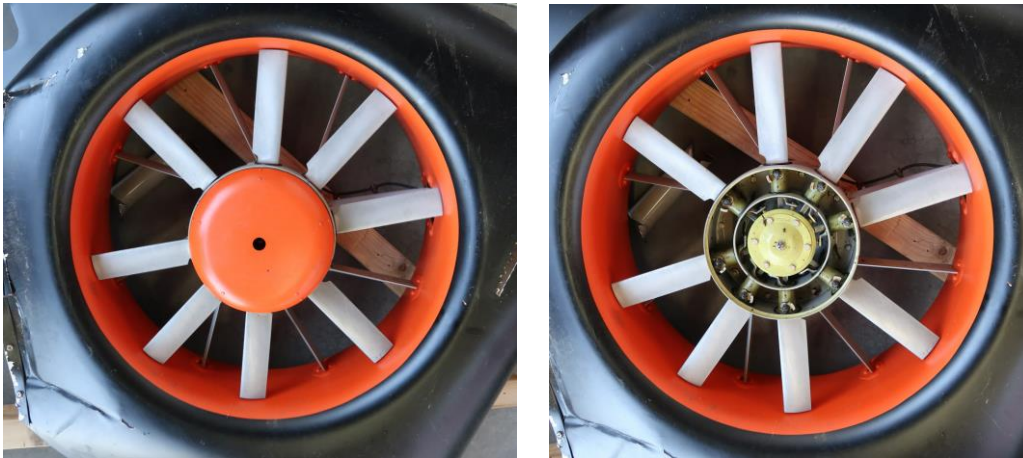
The tail rotor head didn't exhibit any visible damage.

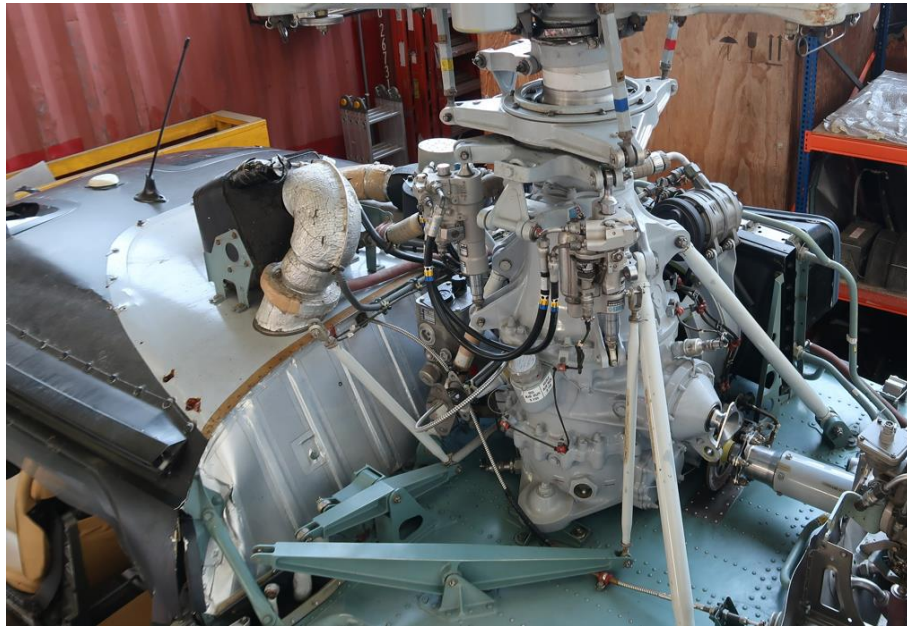
Some control rods of the main rotor flight controls were already disconnected by the AAIB Malaysia investigator in charge for inspection purpose.

The kinematic continuity between the cyclic/collective stick and the servo controls was checked and confirmed.

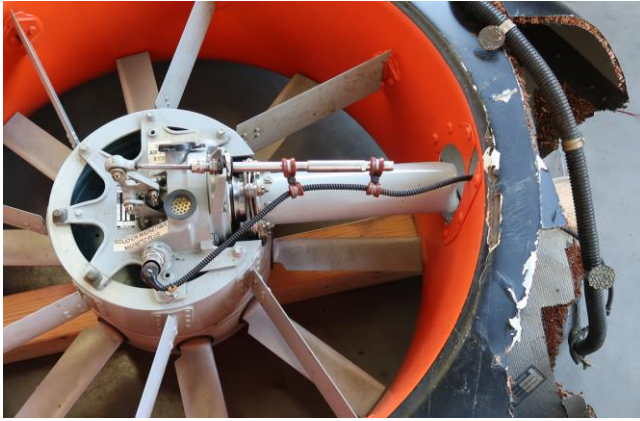
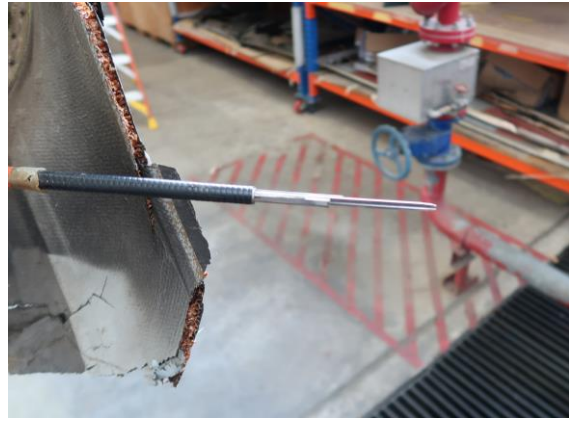
The flexible ball cable exhibited an overload rupture in the vicinity of the junction between the Fenestron and the tail boom.

No other damage was observed on the complete tail rotor flight control chain.

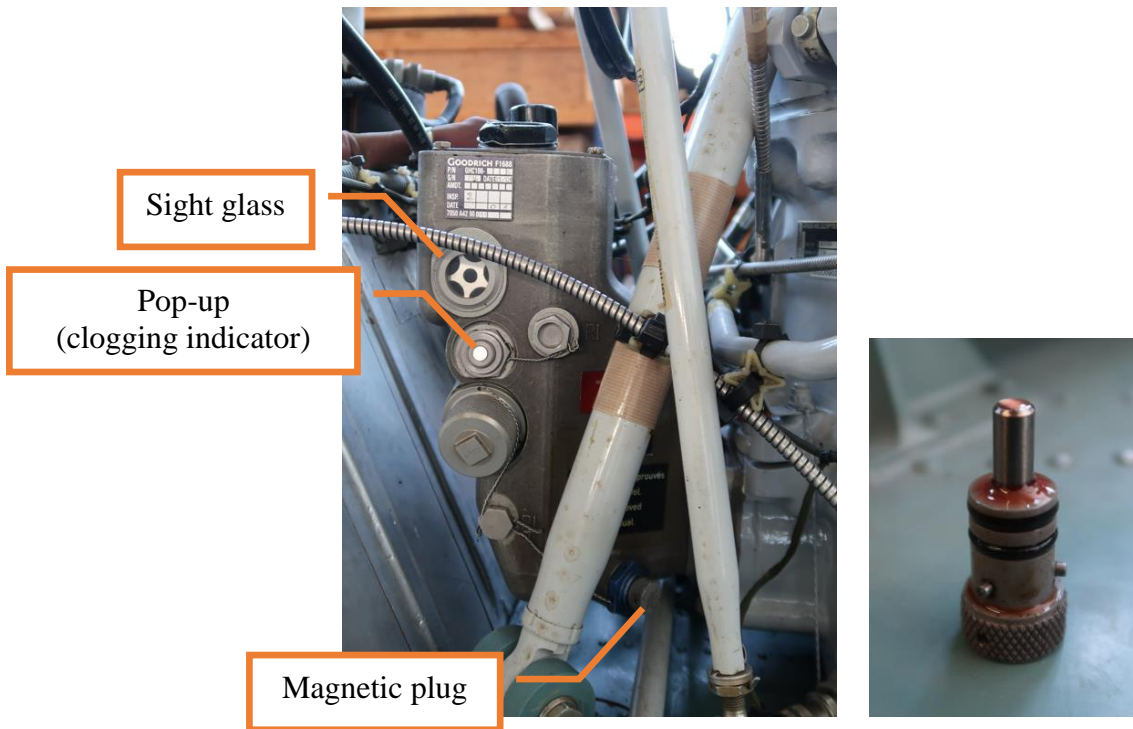
The pop-up dedicated to filter clogging monitoring didn't activate (no clogging).

The magnetic plug was inspected and found exempt of any metallic particle.

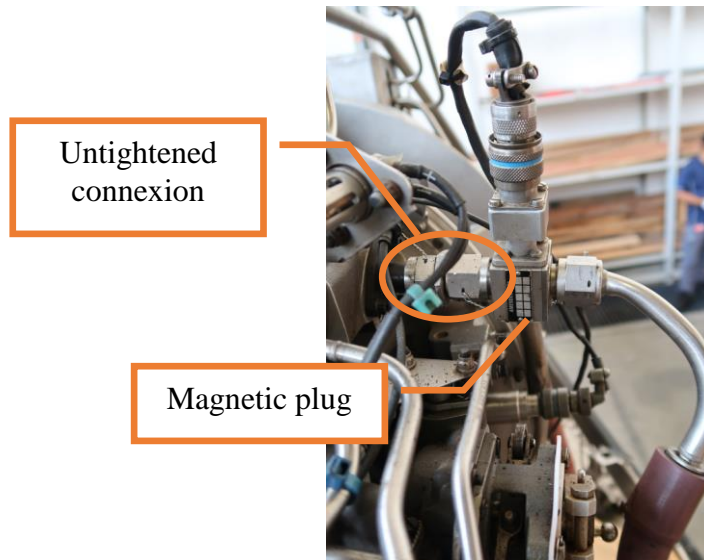
The fuel circuit was equipped with a fuel flow meter.

During the fuel circuit inspection, it was detected this assembly was slightly untightened. This was most probably the result of the crash sequence.

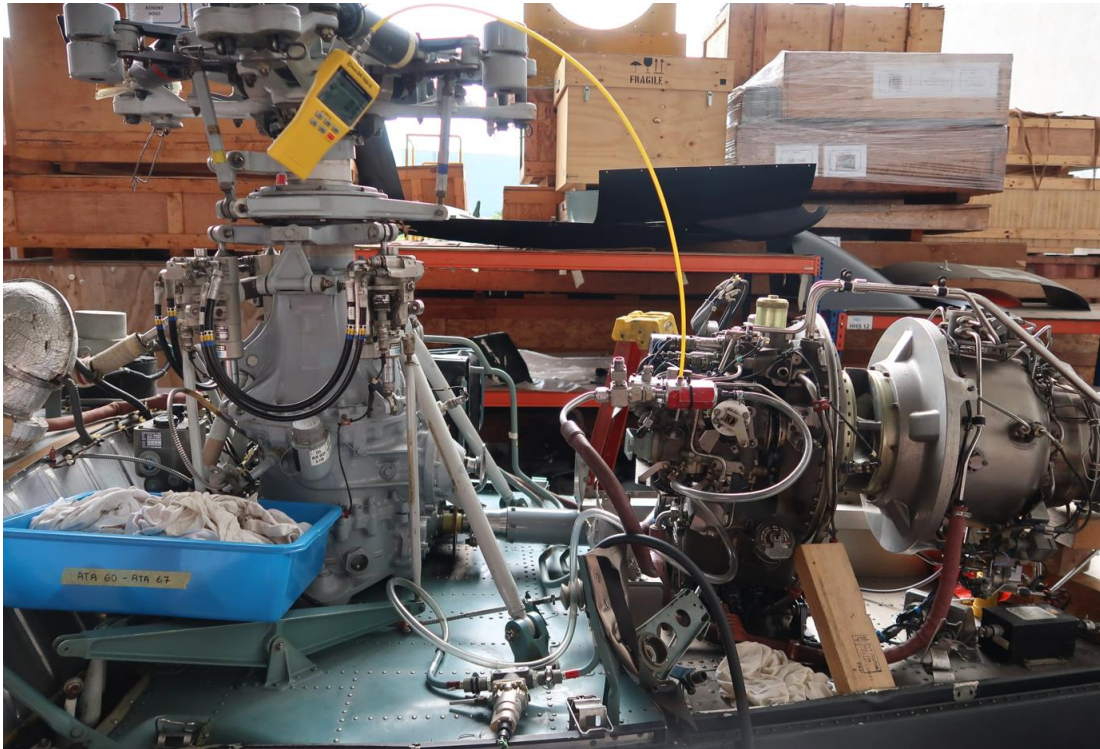
CELECTRON test bench installed:

All the tests required by the Airbus Helicopters inspection protocol were performed, no anomaly was detected.

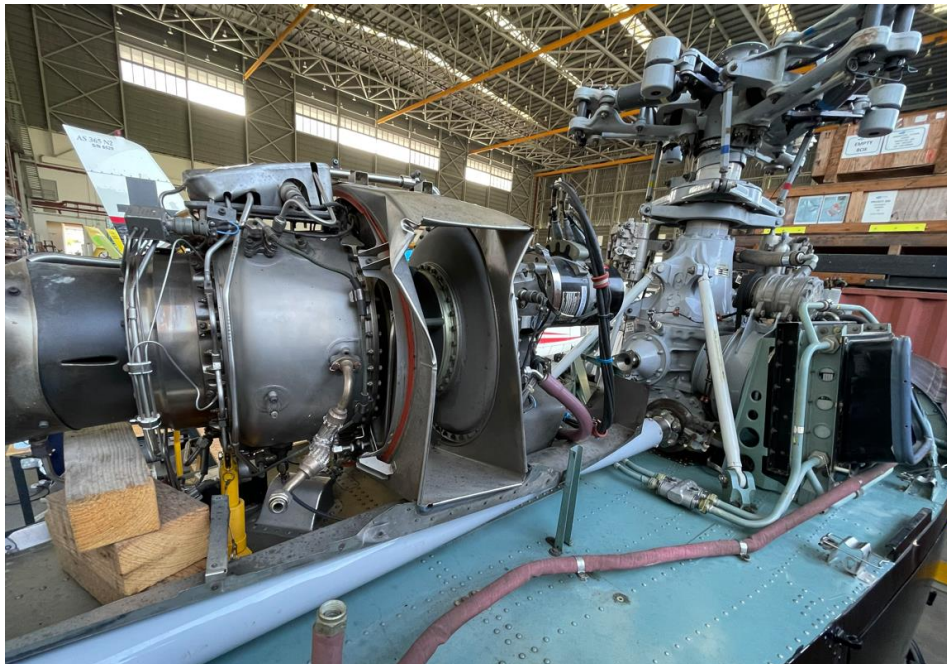
The oil circuit didn't exhibit visible damage.
No leakage was observed.

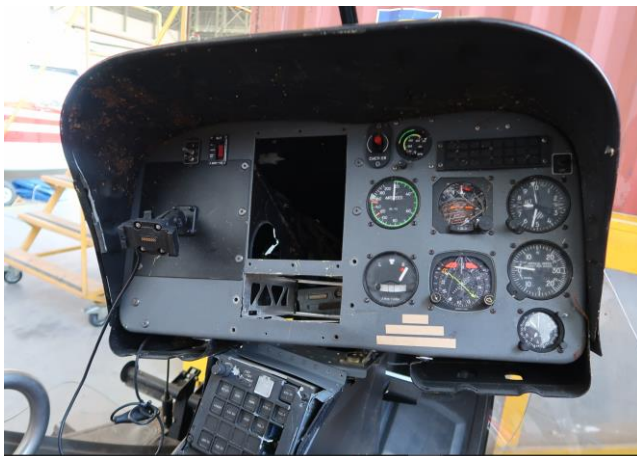
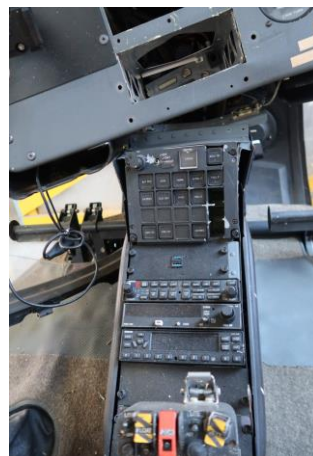
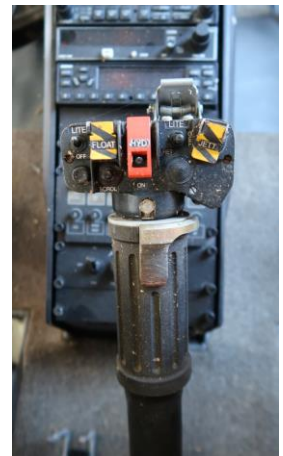
The ELT was in armed position.

The twist grip (Pilot and Co-pilot) was in the Flight notch.

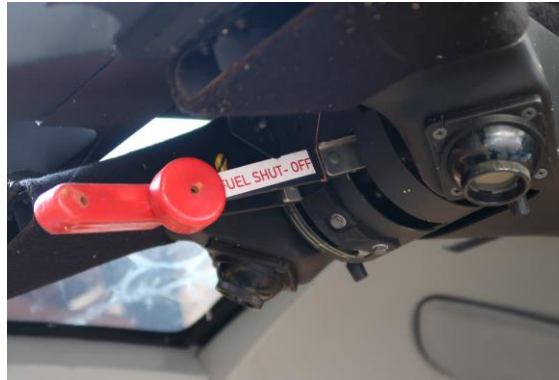
The fuel shut off valve was not activated (lever full forward position), but the safety wire was broken.
The rotor brake was not activated (lever full forward position).

The Lighting and Ancillary Control Unit exhibited damage on its right hand side and some push button were missing.

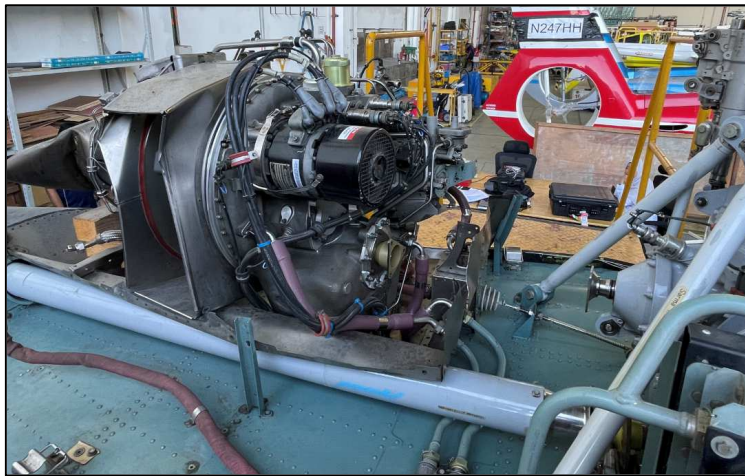
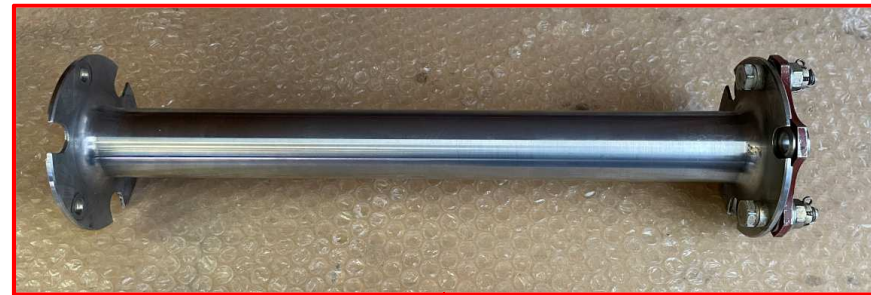
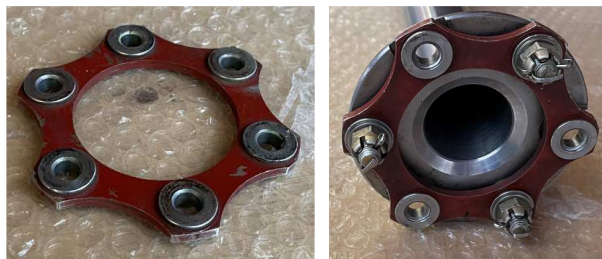
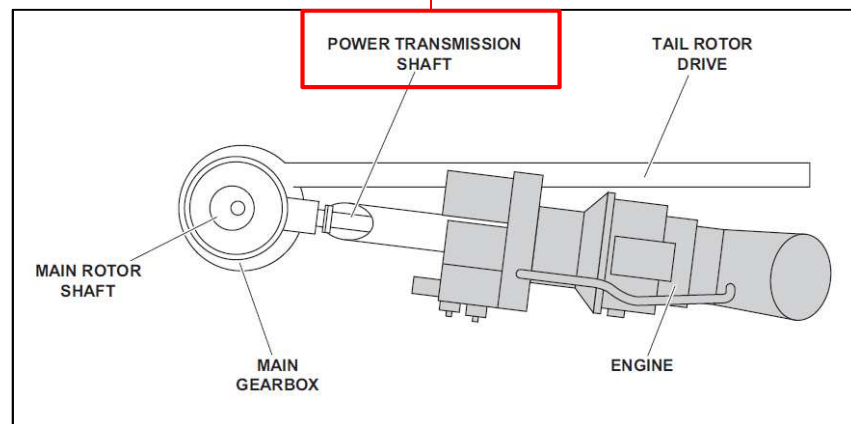
7.2.2 Engine power shaft

Engine power shaft was removed before the wreckage examination. The flectors and the shaft were in good condition. Free wheel (AH component) check was performed directly on the helicopter main gear box. It was found functionnal.

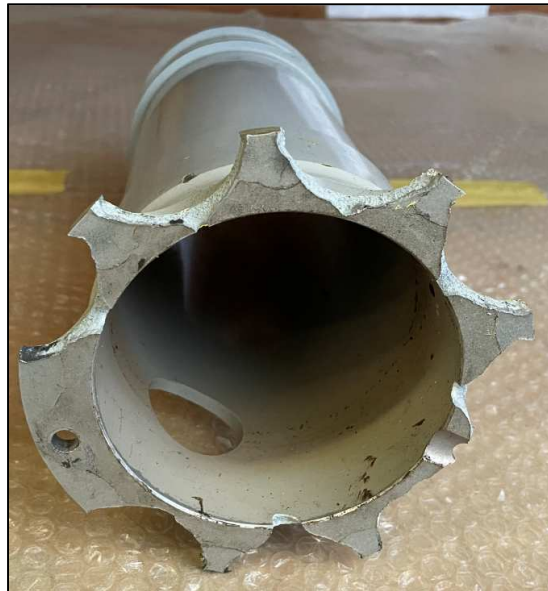
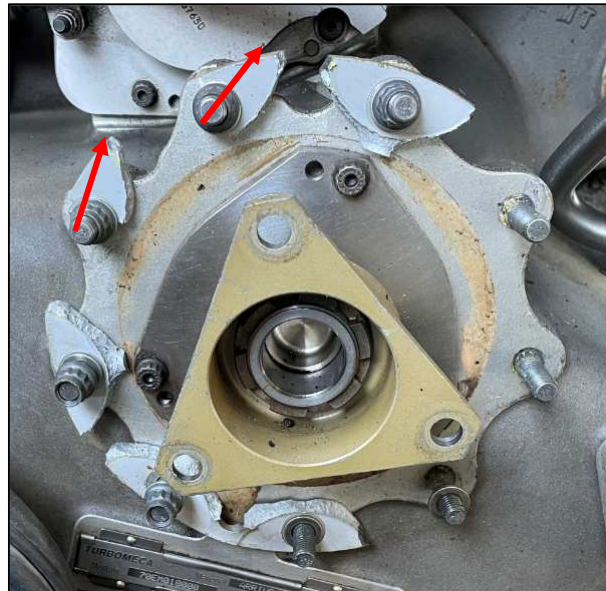
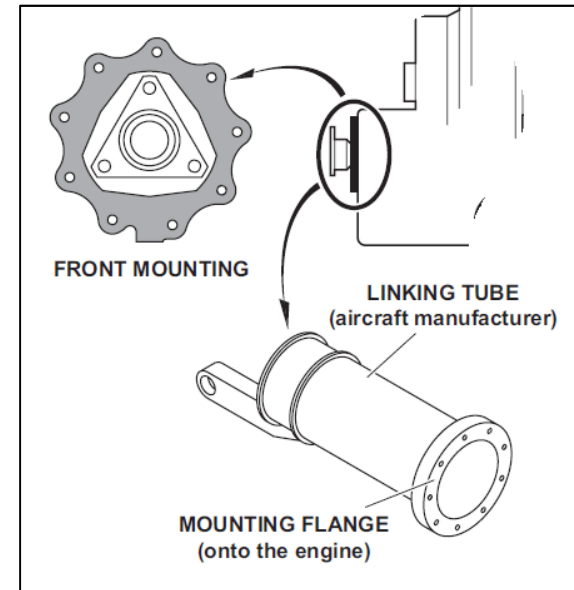
The engine front and rear mountings were totally broken.

Front linking tube damaged/teared off (static stress due to disalignment during the accident sequence).

The screws of the engine casing were found bent towards the left hand side of the engine. It was later a difficulty to set the engine on the interface tool of the engine frame because of that reason (refer to §8). Considering the torn off at two screw middle axis, the force direction was probably towards the up-left side of the engine.

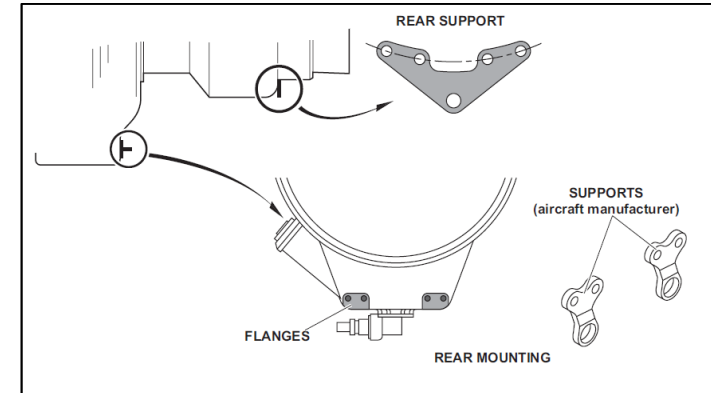
7.2.3 Engine mountings

The engine front and rear mountings were totally broken, both flanges were missing.
Casing rear left mounting was damaged (torn off), creating a hole into the casing and into the oil tank, which emptied.
