AIRCRAFT ACCIDENT FINAL REPORT
A 05/22P
Air Accidents Investigation Bureau (AAIB)
Ministry of Transport Malaysia

Eurocopter EC120B Registration N409HH
in Hutan Simpan Chikus, Bidor, Perak, Malaysia
on the 11 September 2022

ACCIDENT REPORT NO.: A 05/22

OPERATOR : FLYSTAR GLOBAL SDN BHD
AIRCRAFT TYPE : EUROCOPTER EC120B
NATIONALITY OF AIRCRAFT : UNITED STATES OF AMERICA
REGISTRATION : N409HH
**PLACE OF OCCURRENCE : HUTAN SIMPAN CHIKUS, BIDOR,
PERAK, MALAYSIA
(4° 06' 13.8'' N, 101° 12' 45.1'' E)**
DATE AND TIME : 11 SEPTEMBER 2022 AT 1217 LT

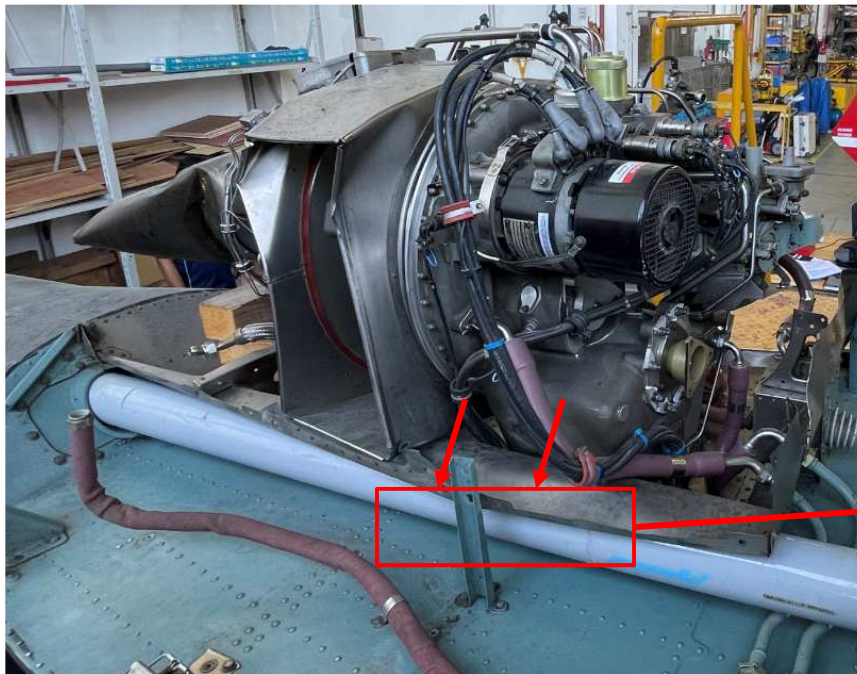
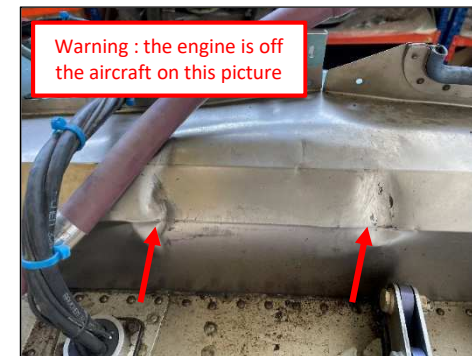
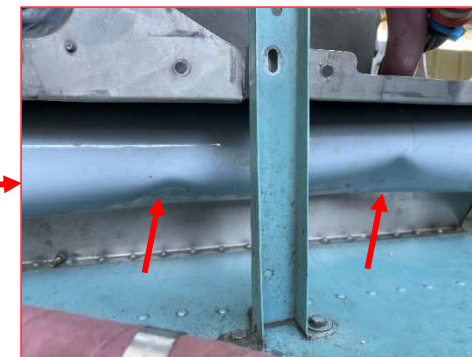
7.2.3 Engine mounting

The engine impacted the left firewall, and the rear transmission shaft. Two indent marks were visible on the internal face of the firewall and on the shaft. Rotation marks came from post crash manipulation. Possibly, these indents were done most probably during the accident sequence.

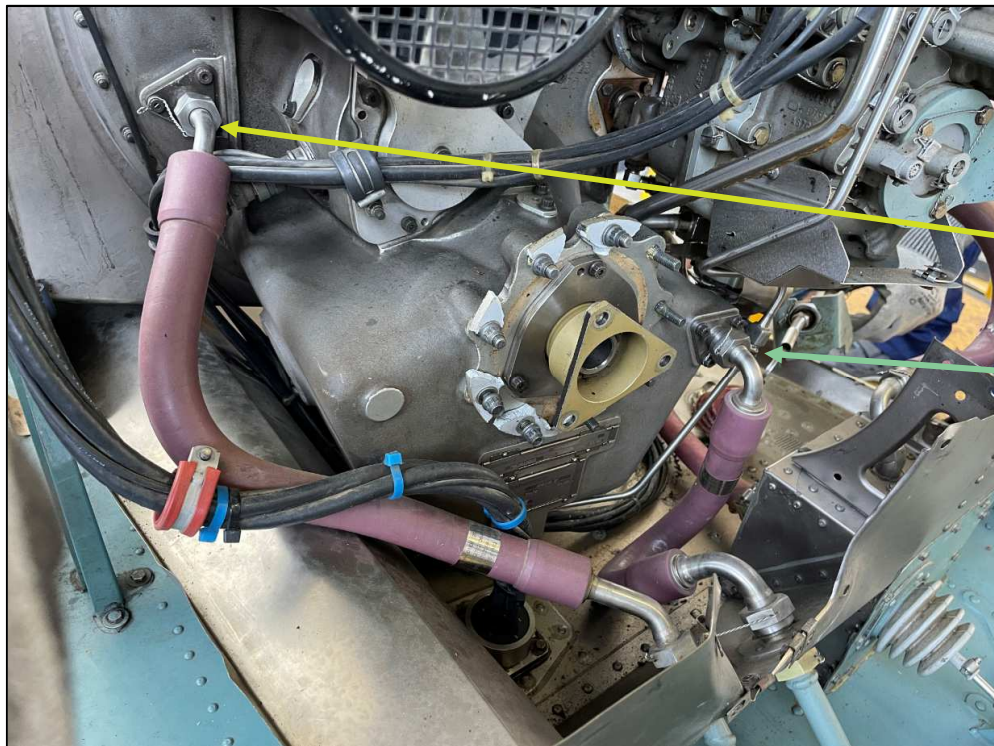
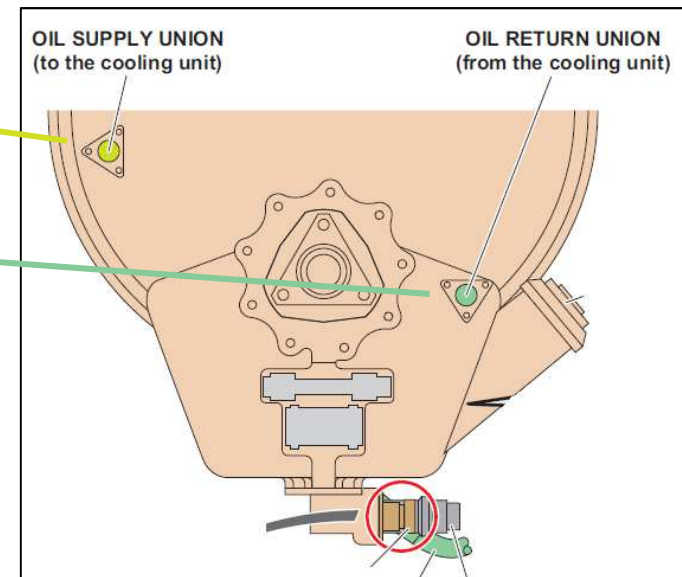
7.2.4 Engine to aircraft oil cooling system

Oil supply (input and output) to the engine were set and properly tightened and secured.

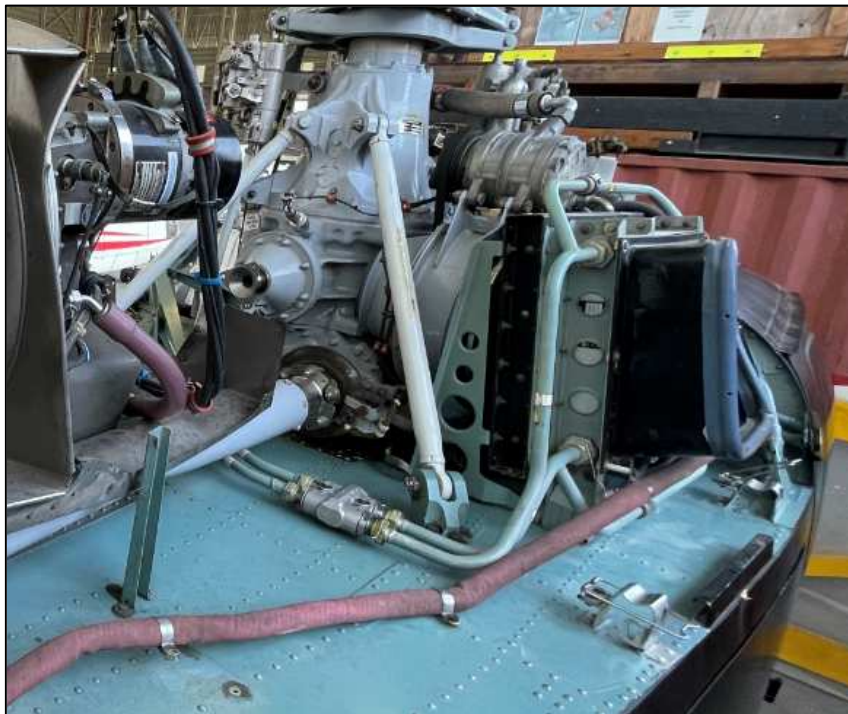
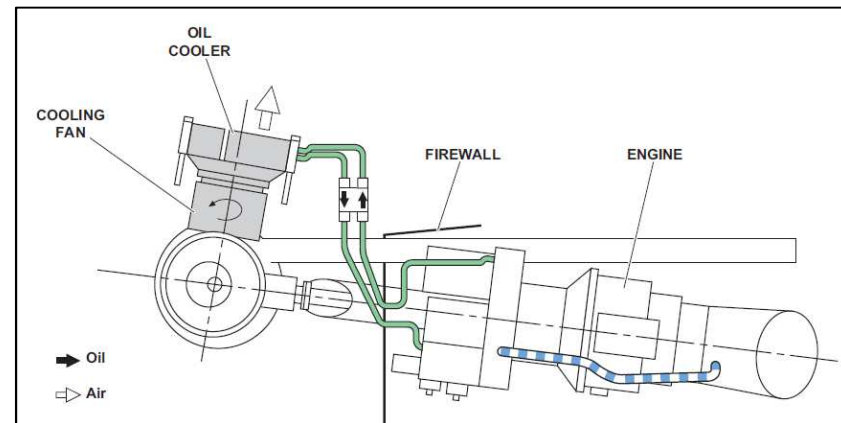
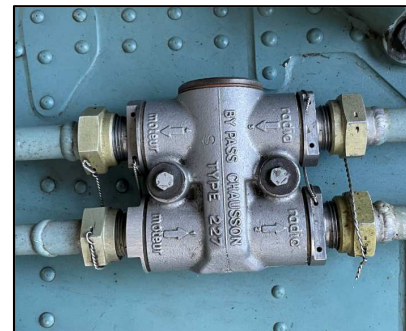
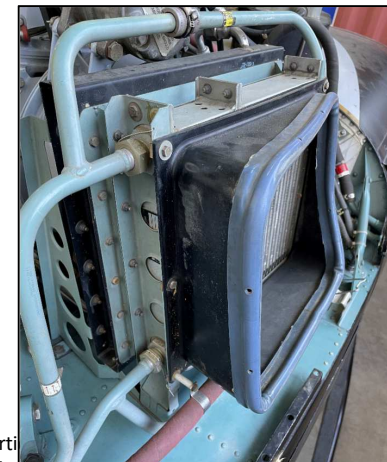
7.2.4 Engine to aircraft oil cooling system (aircraft manufacturer device)

Oil cooling system interface was set and properly tightened and secured.

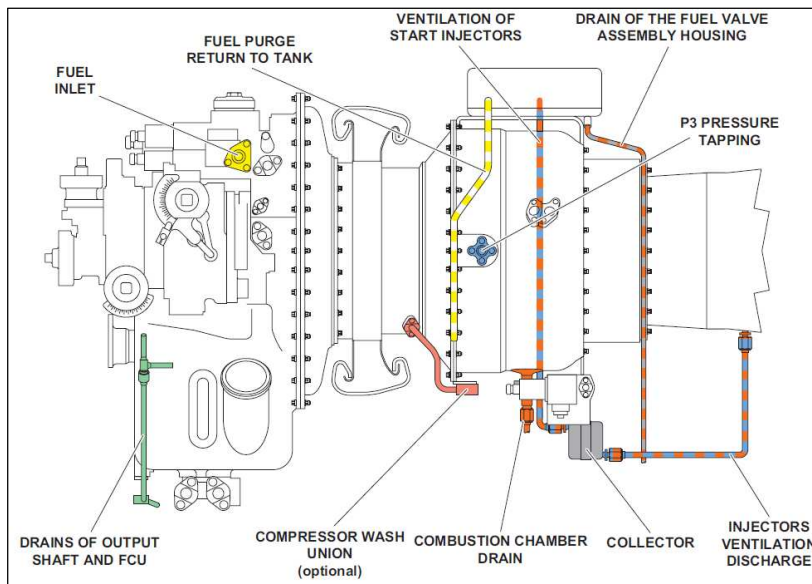
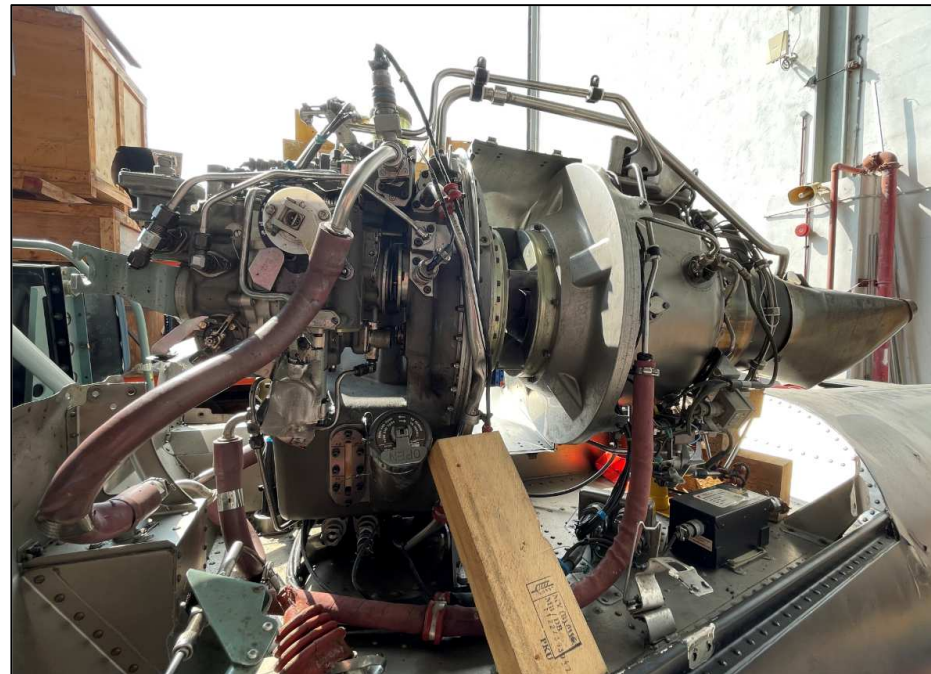
The fuel input and output were found well connected to the engine, tightened and secured.

- the fuel inlet pipe (from firewall to the fuel flow meter inlet) was compressed as a consequence of the accident ;
- the fuel flow meter outlet was slightly untightened;

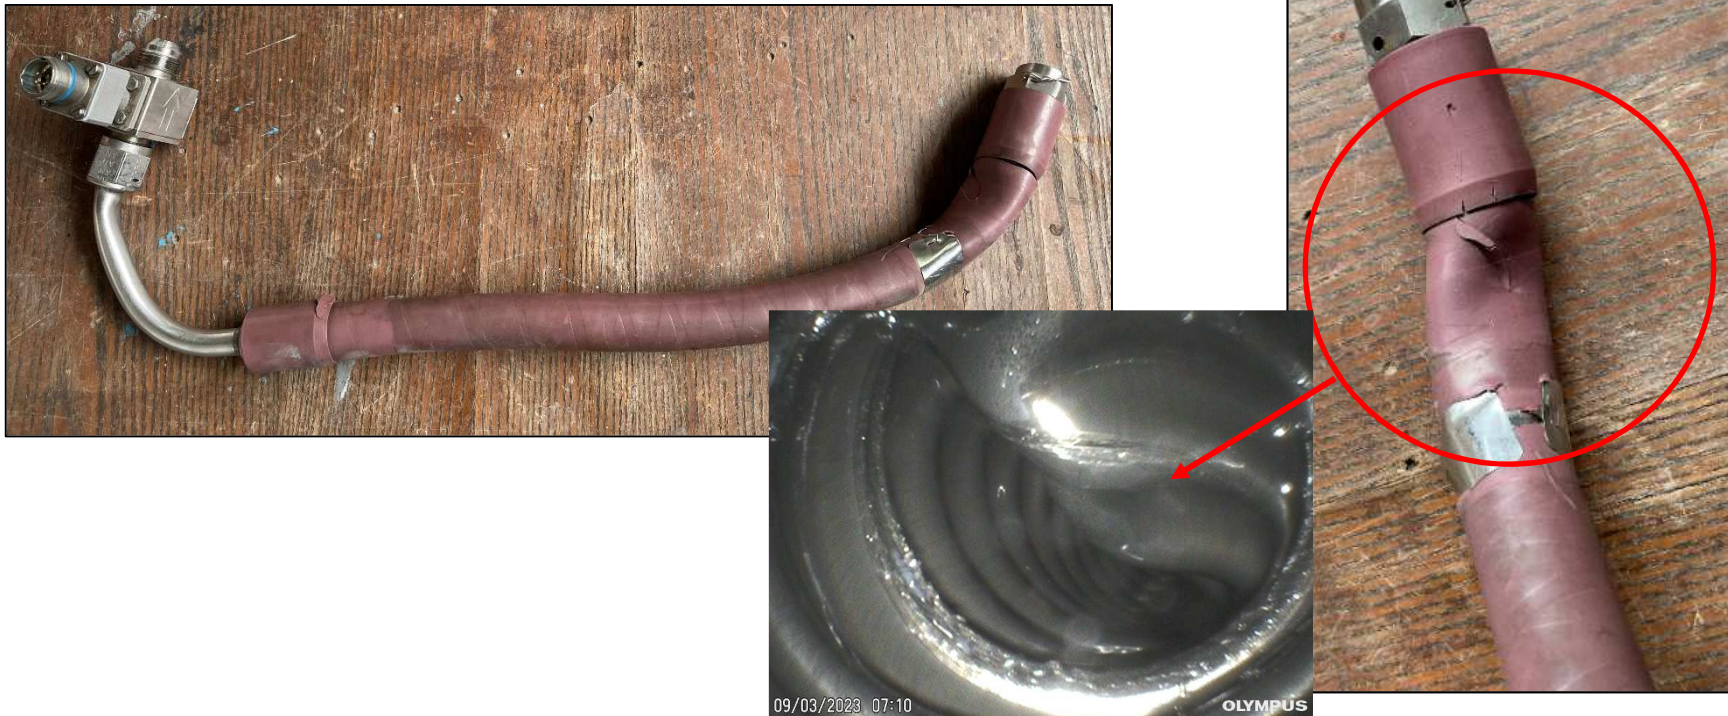
7.2.5 Aircraft to engine fuel supply

FCU inlet fuel pipe (AH part) was on the left hand side of the engine and was pinched at impact.
A borescopic inspection was performed.
This section reduction was detected during the aircraft fuel system test.
Please refer to the aircraft manufacturer's report.

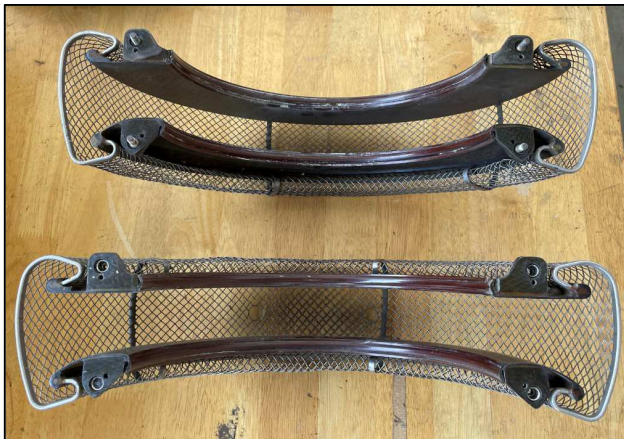
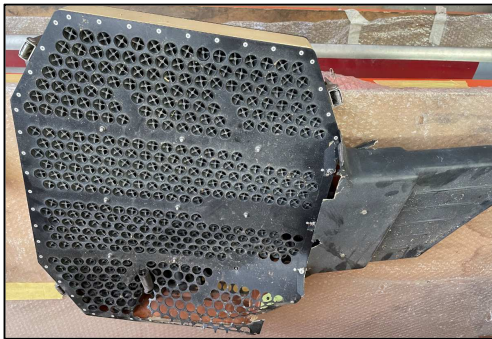
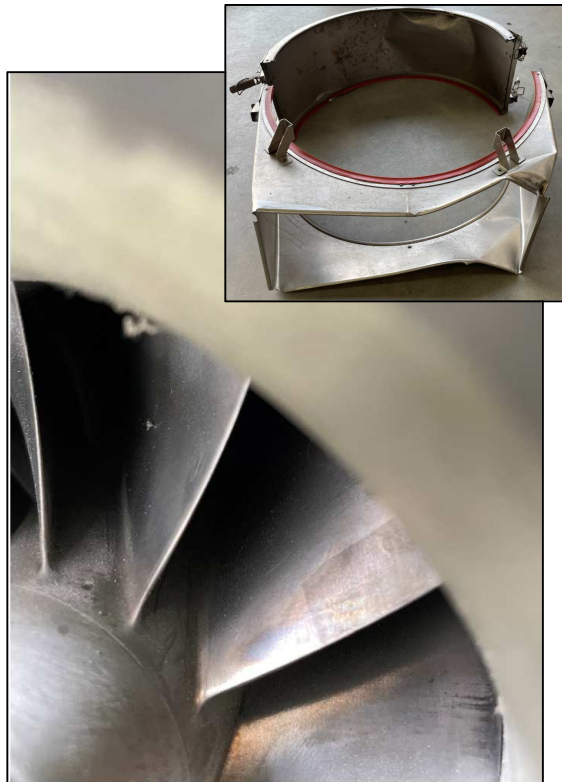
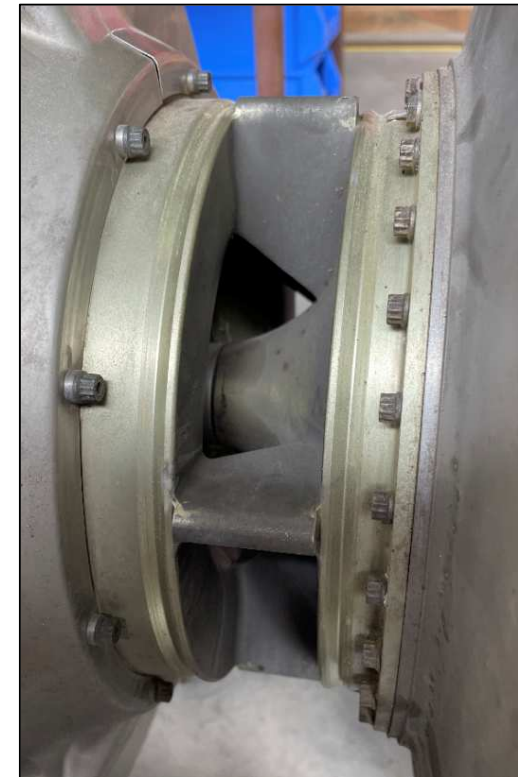
7.2.6 Air intake and exhaust

A sand filter was set at the aircraft air intake, which can explain that the airpath was free of foreign object damage. The airpath of the engine air intake was free of external pollution, and the impeller leading edge was free of damage. Air intake, air intake grid and plenum were removed before investigation.

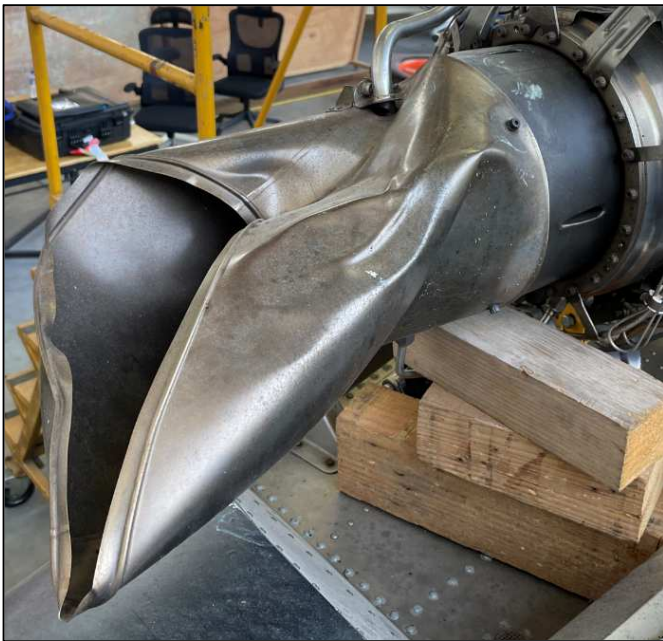
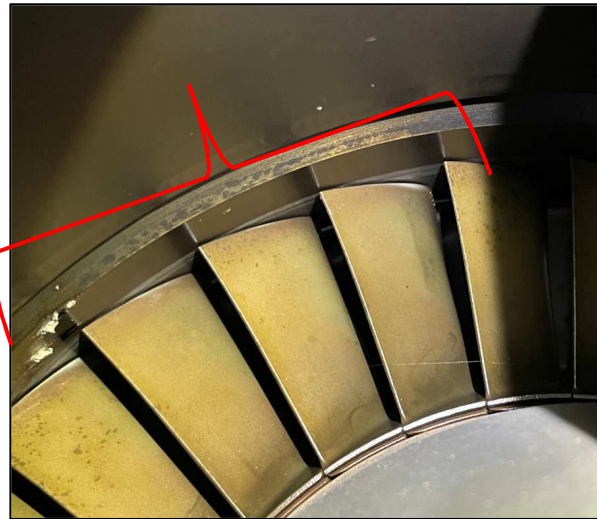
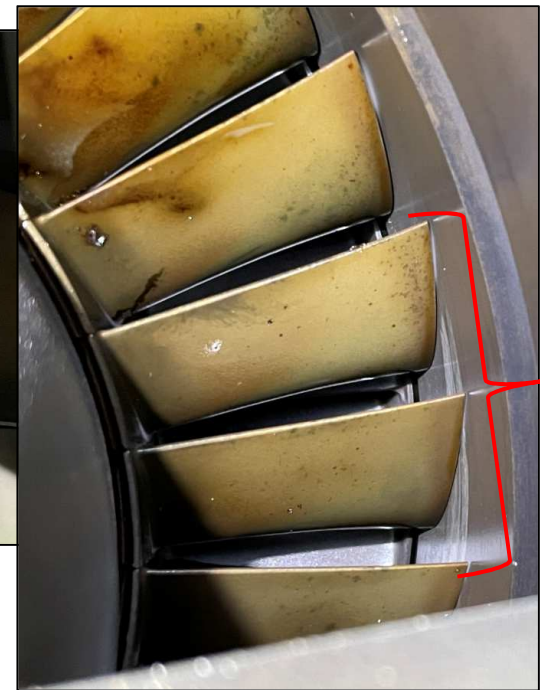
Exhaust was found severely damaged by a tree at the end of the accident sequence.

While OFF the aircraft, the exhaust was removed and power turbine was inspected : rubbing marks were found at 3 o'clock (~3 blades wide angular sector) and at 11 o'clock (~5 to 6 blades wide angular sector).

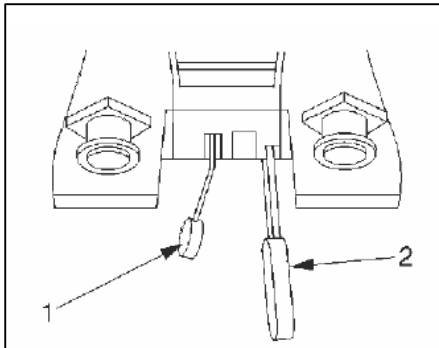
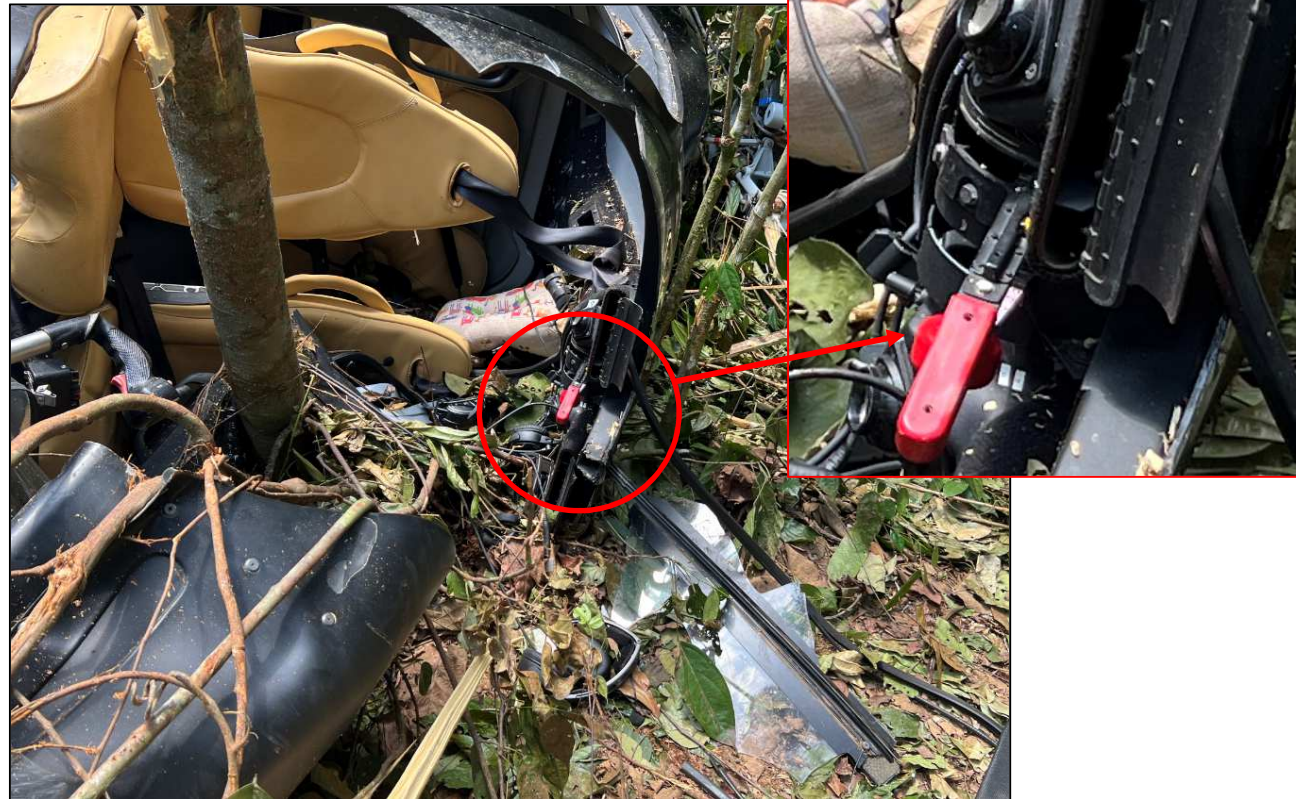
7.2.6 Engine controls in cockpit

- 1 – fuel shut off cock (forward position = OPEN)
- 2 – rotor brake lever (forward position = NOT ACTIVATED). The snapwire was still unbroken at the crash site, however it was manipulated afterwards during the exams.

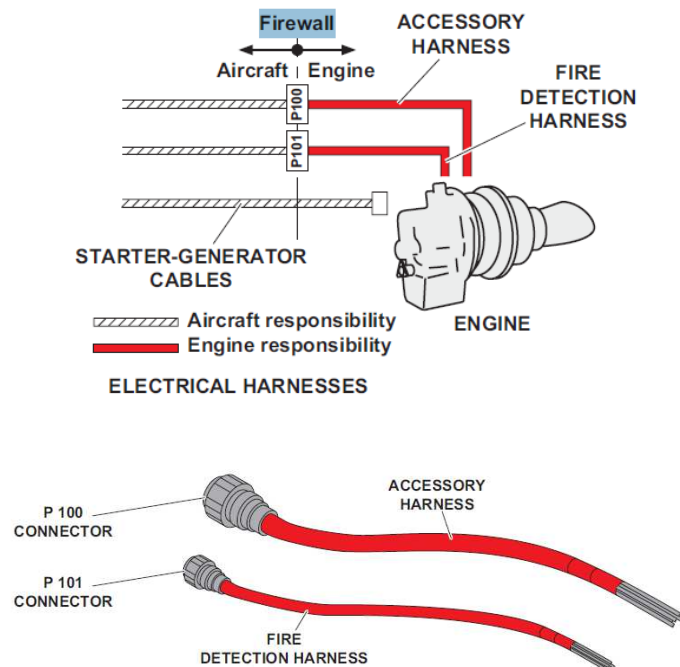
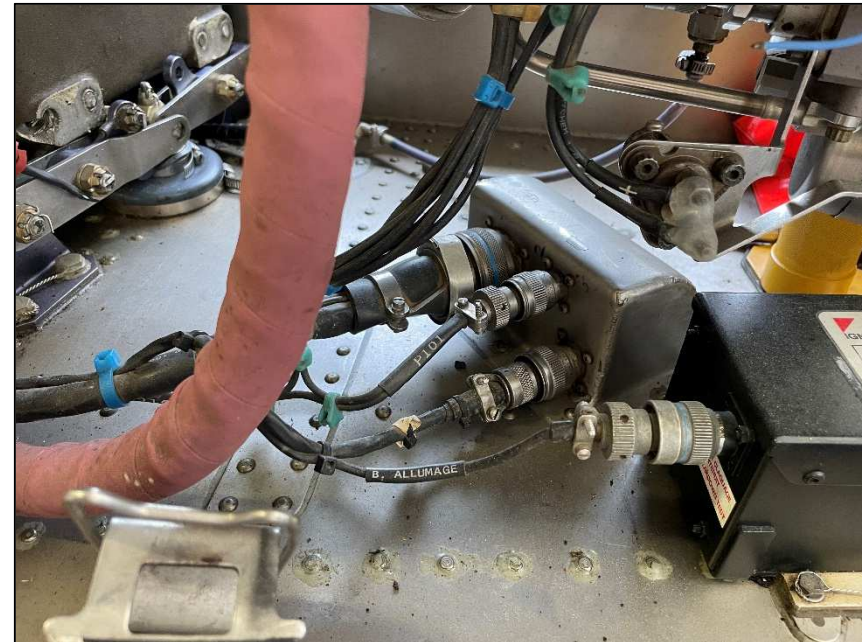
7.2.6 Engine harness

Electrical harnesses was connected and properly tightened.

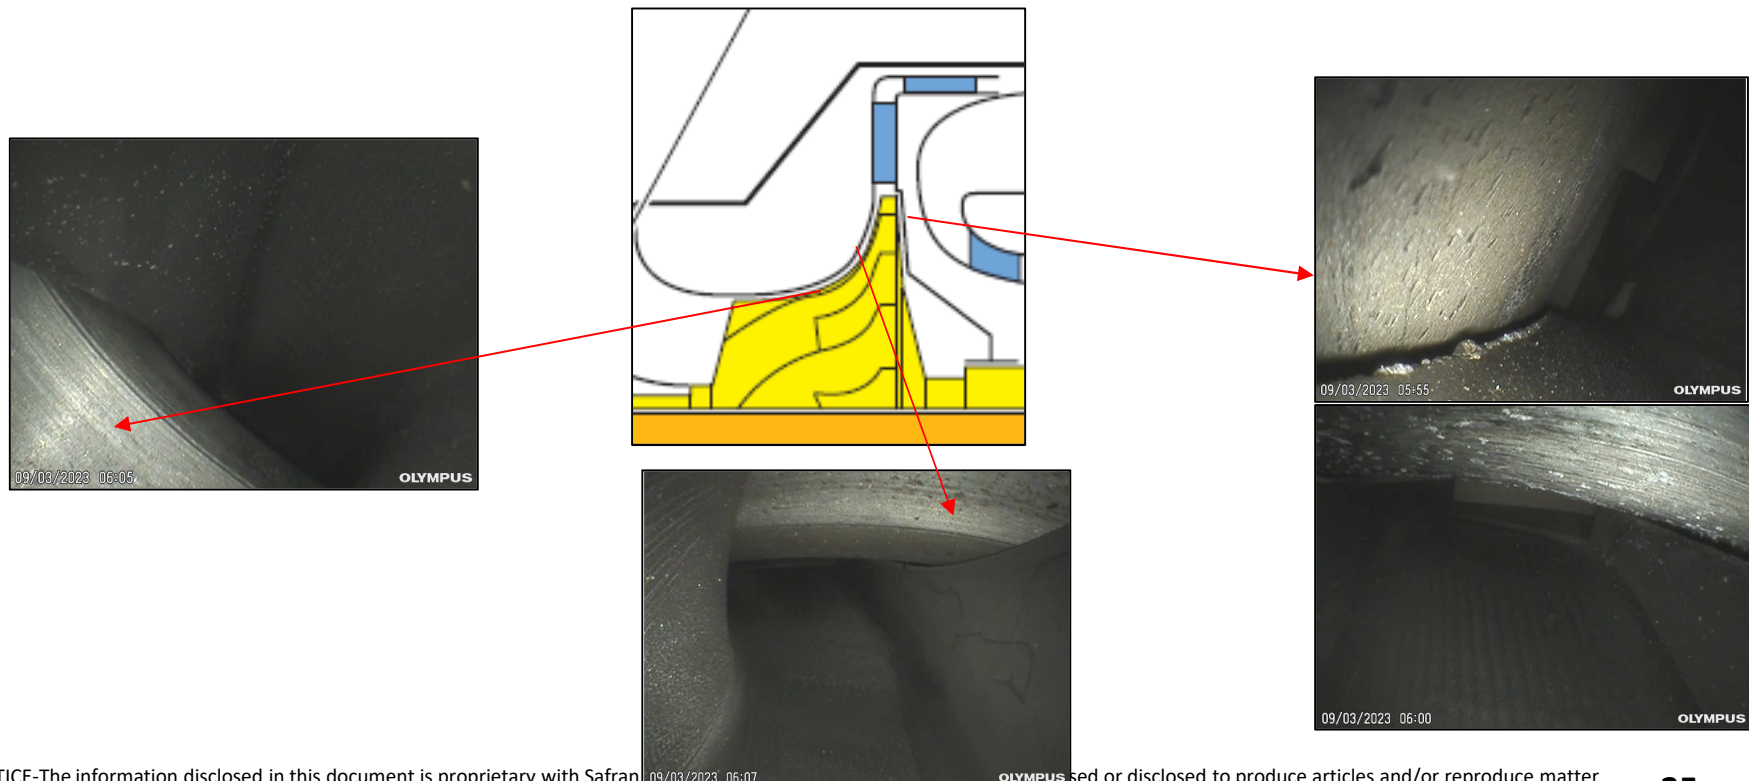
Impeller blades were found in good condition with no damage. The borescopic inspection shown the presence of :

- rubbing marks on the internal surface of the compressor cover, at the impeller's trailing edge side, and on the compressor elbow area, and on the impeller's leading edge ;
- an aggregation of compressor cover abradable coating deposit (made of aluminium) on several blades' top.

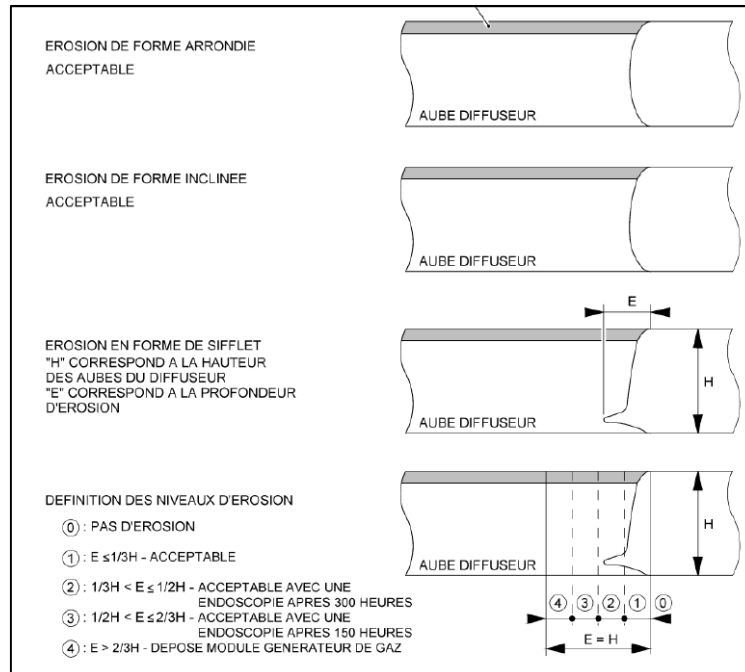
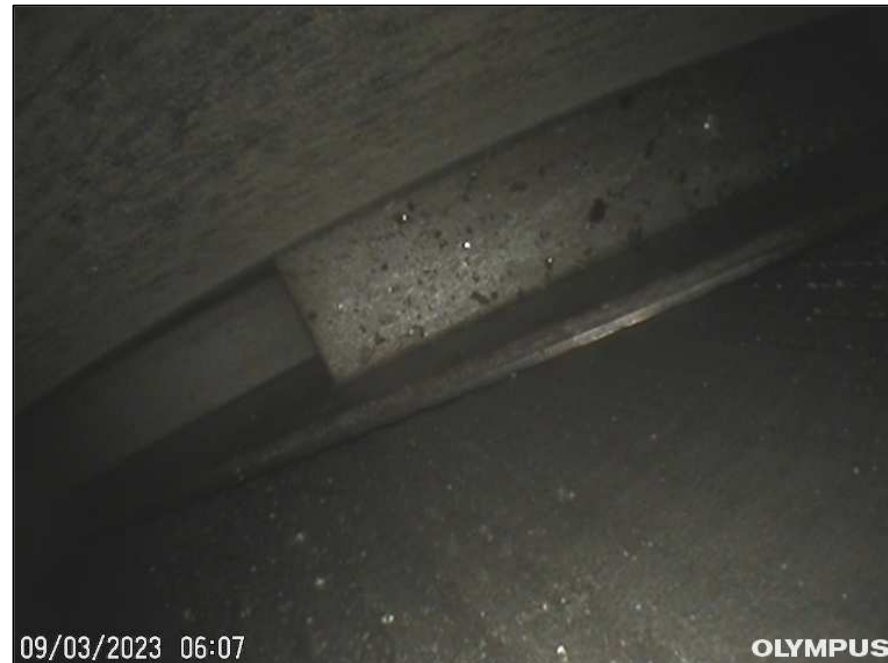
Extract of borescopic inspection task of EMM 71-02-30-280-806-B01

No erosion was found on the leading edges of the radial compressor diffuser.

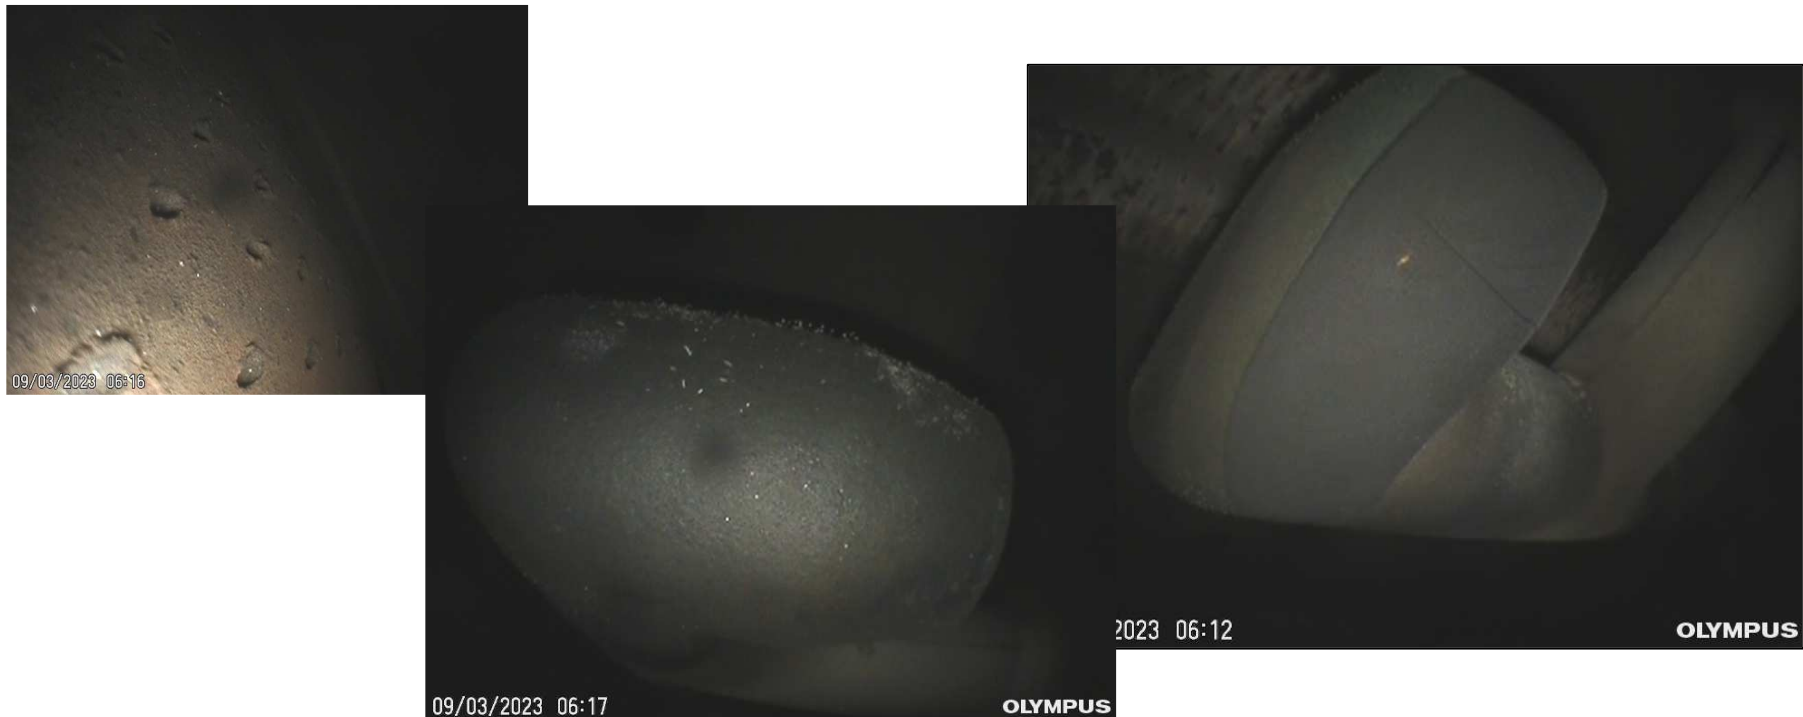
A mark was visible prevaporisation tubes. Post on-site exam, this was discussed internally at SafranHE : as the part seems free of thermal damage nor geometrical damage, it does not seem to be a crack.

Some shiny particles were pointed out on a prevaporisation tube.

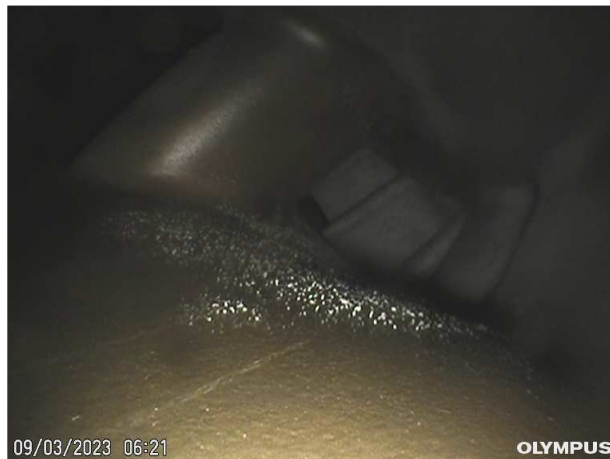
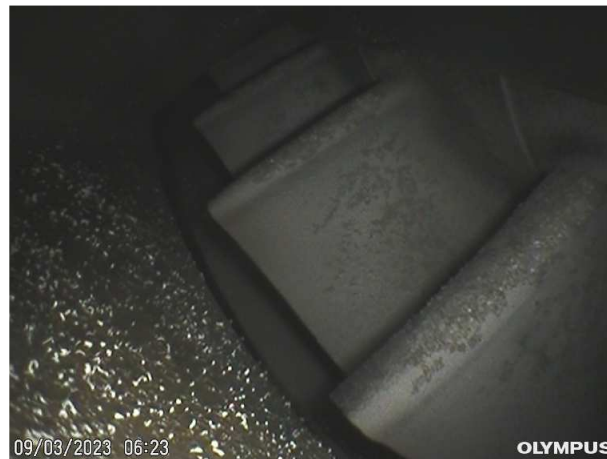
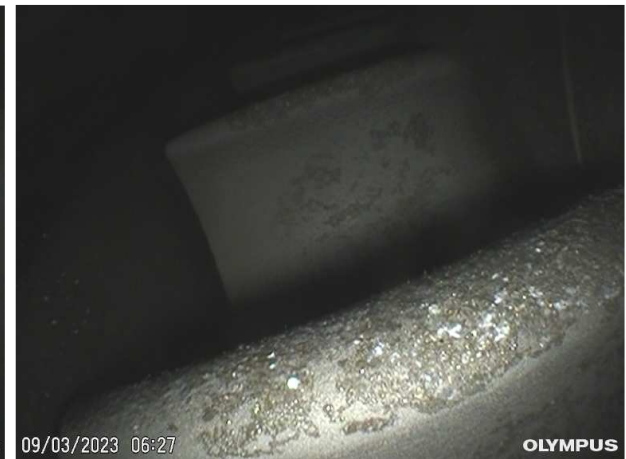
7.3.2 Engine airpath – borecopic inspection

The borescope inspection of the HP Nozzle Guide Vane and the HP turbine showed that both parts were in good condition. The presence of shiny particles was pointed out, on the airpaths of the HP NGV and the leading edges of the HP turbine blades.

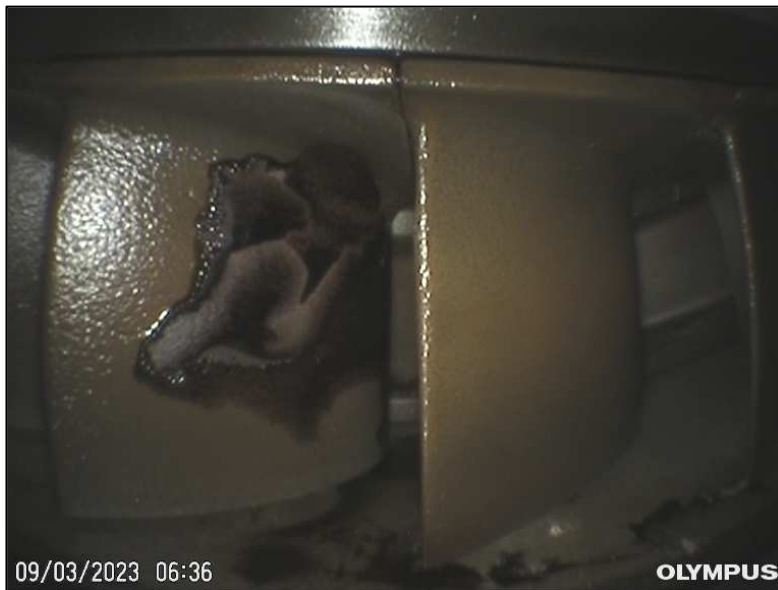
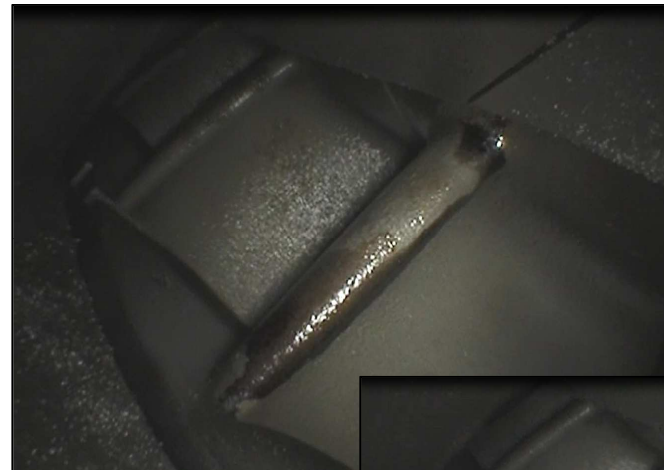
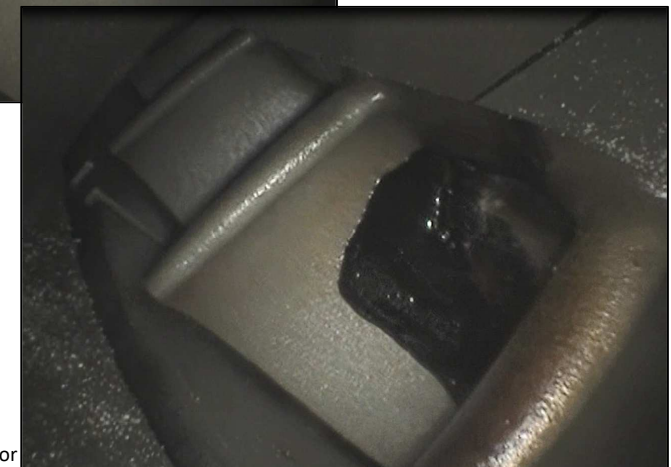
7.3.2 Engine airpath – borecopic inspection

The borescope inspection of the HP Nozzle Guide Vane and the HP turbine revealed the presence of solidified oil mainly on one HP blade pressure side but also on the leading edges of adjacent HP blades.

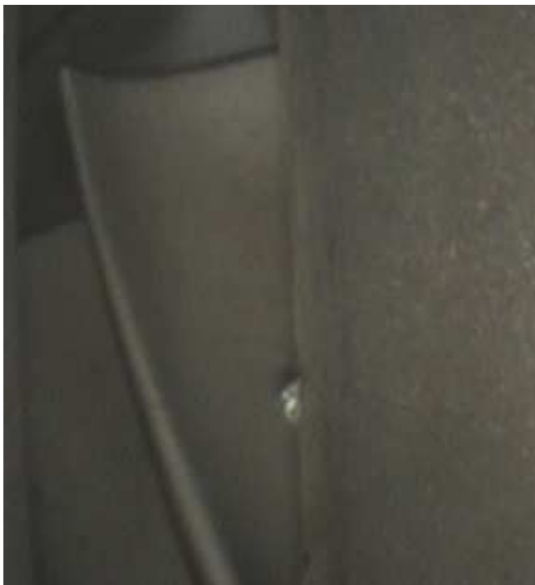
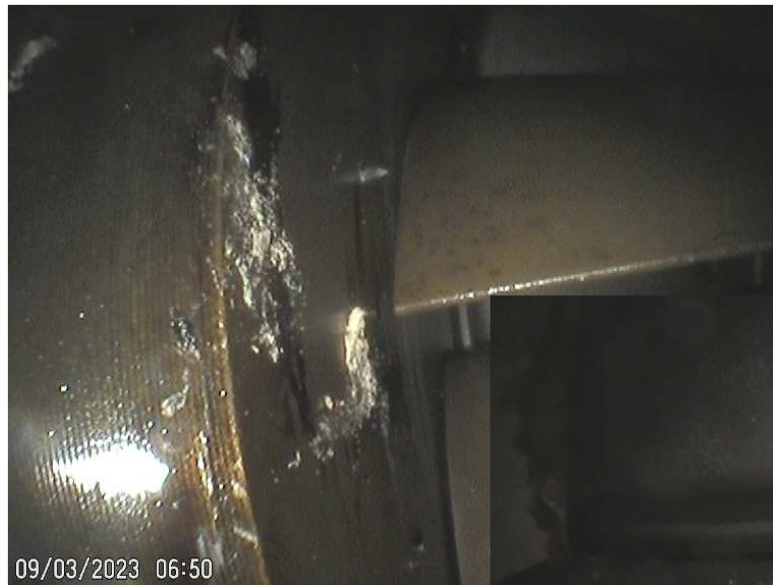
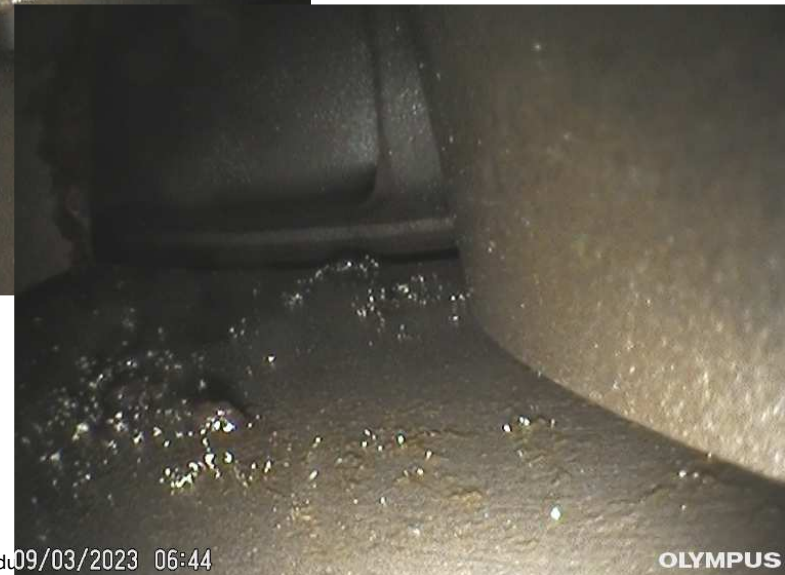
7.3.2 Engine airpath – borecopic inspection

The borescope inspection of the power turbine guide vane leading edge also revealed the presence of the shiny particles deposit, which were « glued » to the surface.

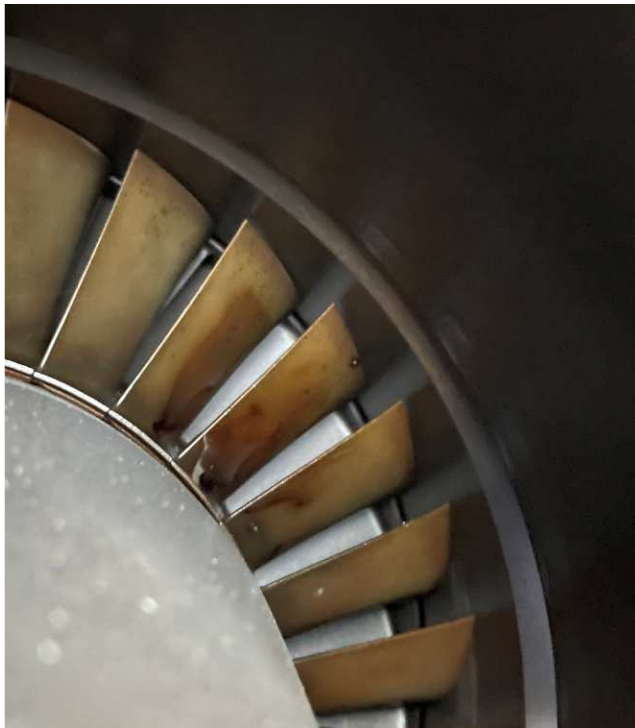
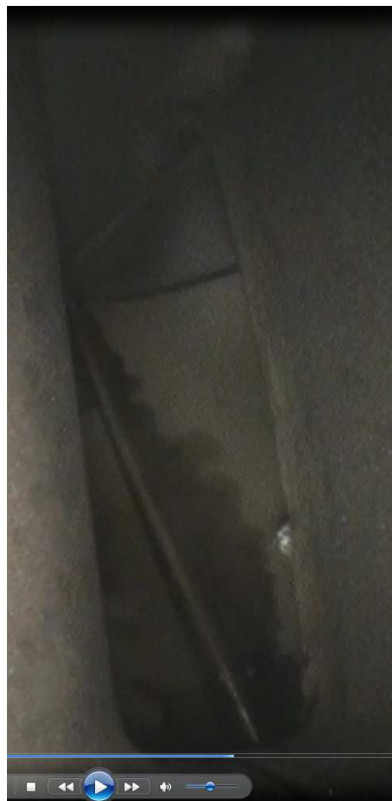
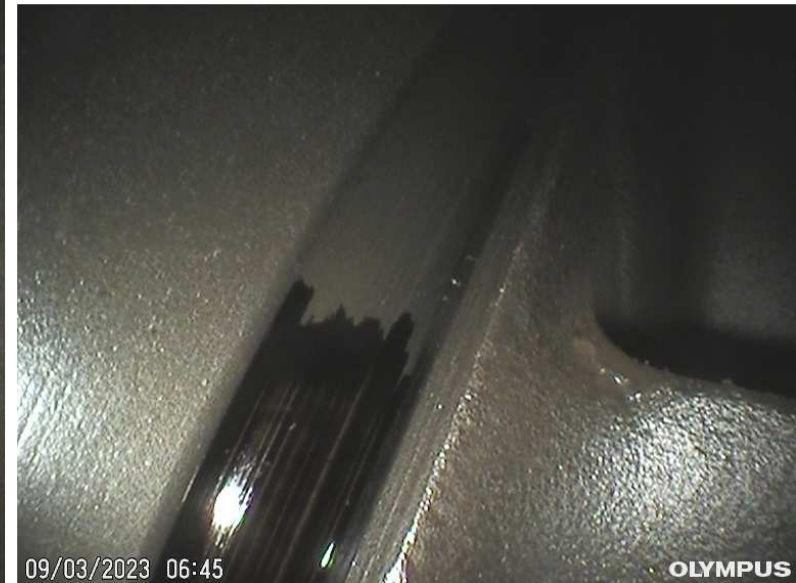
7.3.2 Engine airpath – borecopic inspection

The borescope inspection of the power turbine blades also revealed the presence of solidified oil deposit locally on two to three blades and on the stator.

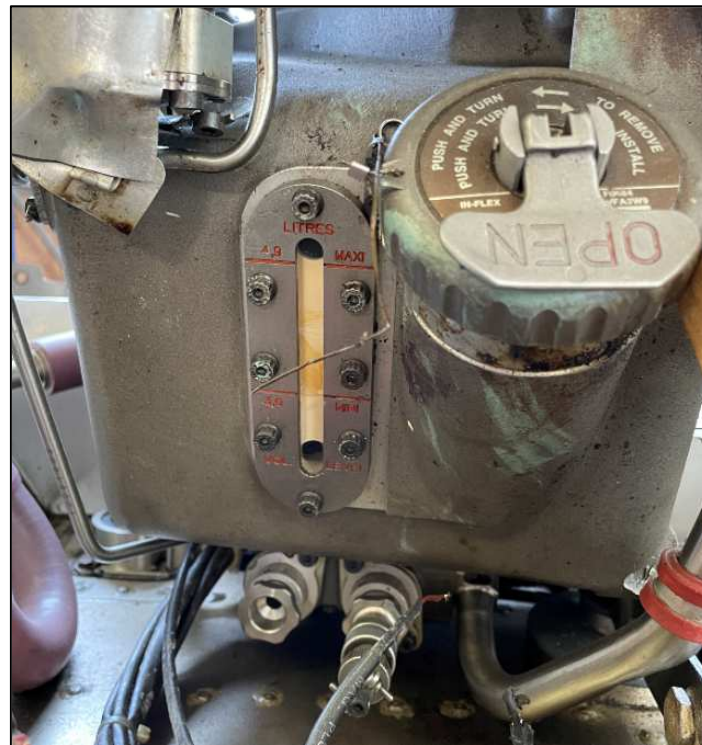
7.3.3 Oil system

The engine front and rear mountings were totally broken, both flanges were missing.
Casing rear left mounting was damaged (torn off), creating a hole into the casing and into the oil tank, which emptied.

The oil tank was found empty.

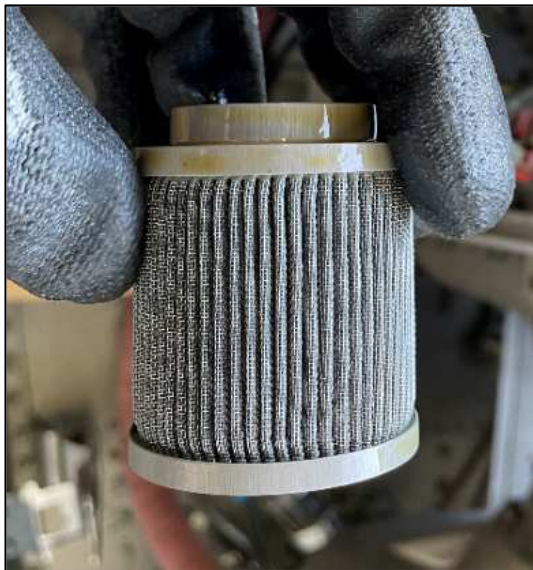
Oil filter check free of particles nor pollution.

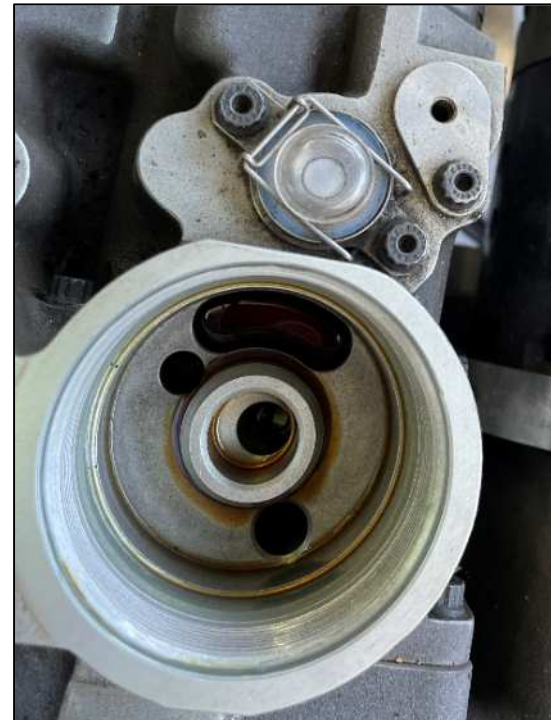
Visual pre-blockage indicator check not activated.

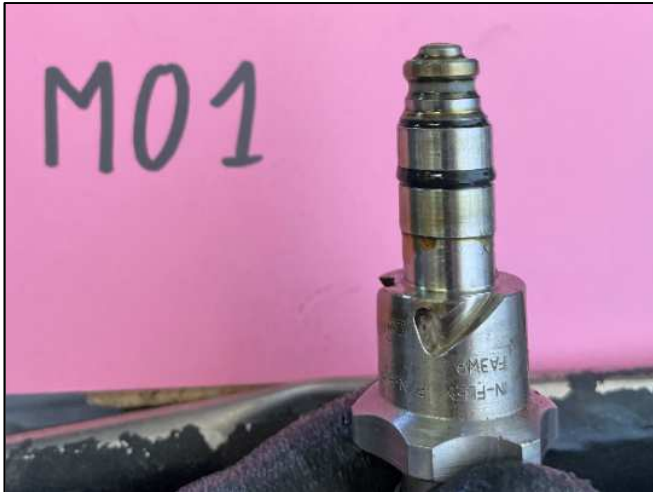
M01 Electrical magnetic plug check : clean

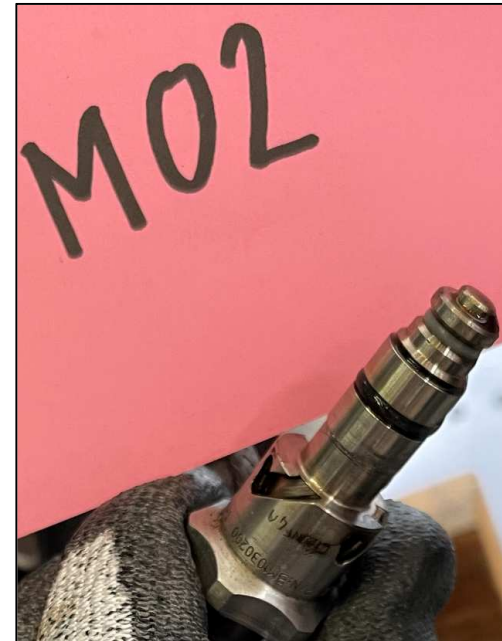
M02 Electrical magnetic plug check : clean

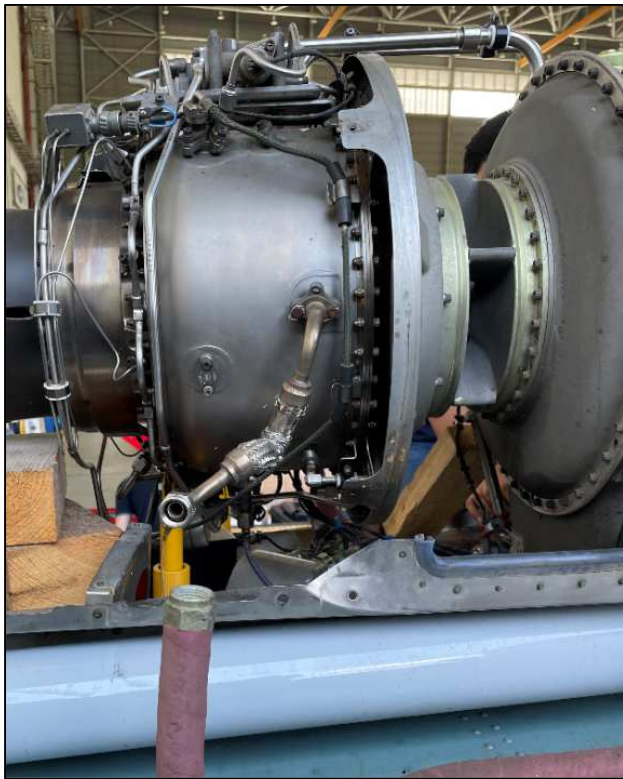
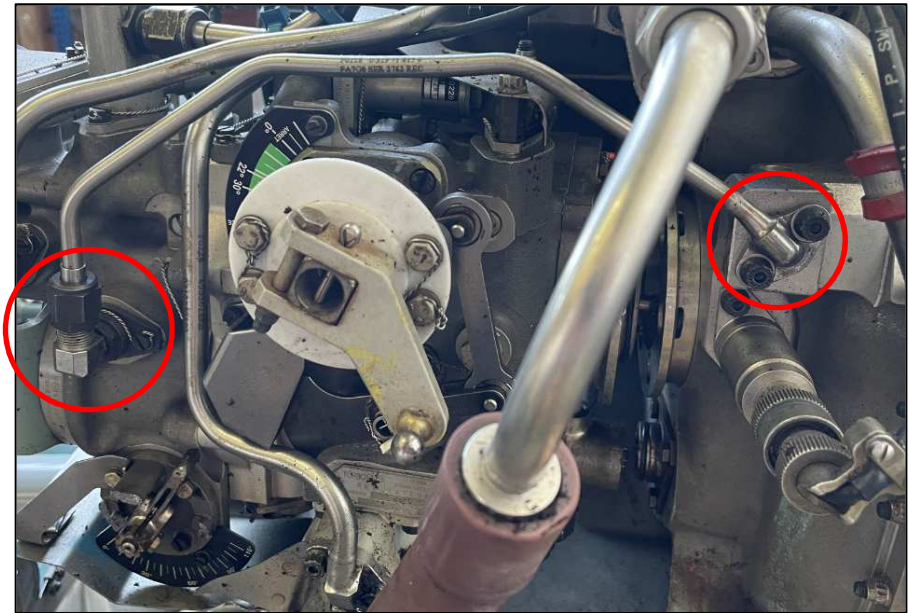
A/C P3 air picking : already removed.

P2 FCU (acceleration controller) : set properly on the FCU.
