AIRCRAFT ACCIDENT FINAL REPORT
A 05/22P
Air Accidents Investigation Bureau (AAIB)
Ministry of Transport Malaysia

Eurocopter EC120B Registration N409HH
in Hutan Simpan Chikus, Bidor, Perak, Malaysia
on the 11 September 2022

ACCIDENT REPORT NO.: A 05/22

OPERATOR : FLYSTAR GLOBAL SDN BHD
AIRCRAFT TYPE : EUROCOPTER EC120B
NATIONALITY OF AIRCRAFT : UNITED STATES OF AMERICA
REGISTRATION : N409HH
**PLACE OF OCCURRENCE : HUTAN SIMPAN CHIKUS, BIDOR,
PERAK, MALAYSIA
(4° 06' 13.8'' N, 101° 12' 45.1'' E)**
DATE AND TIME : 11 SEPTEMBER 2022 AT 1217 LT

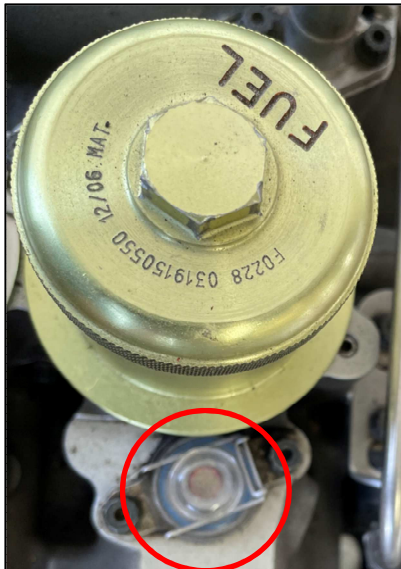
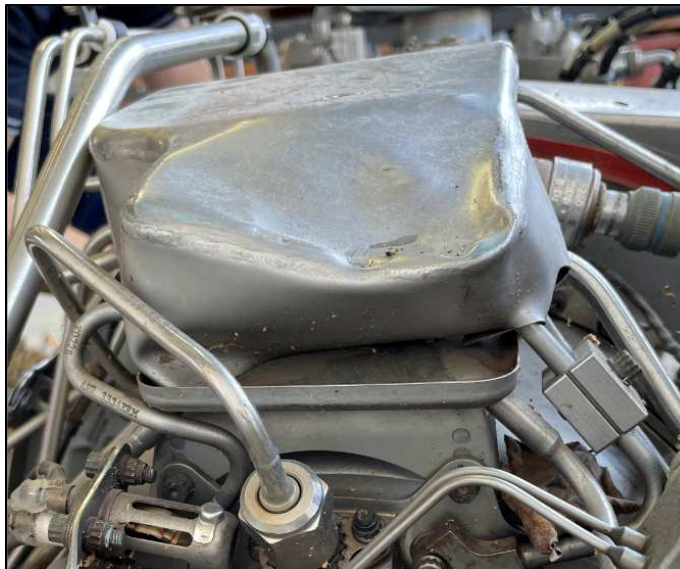
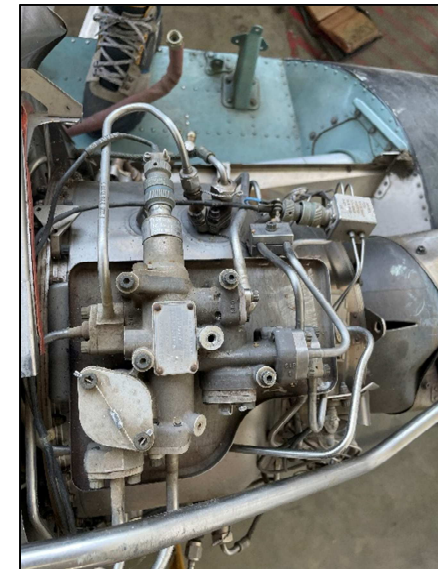
The fuel filter was not checked to preserve it into the accident condition (in case of later test or analysis).

The blockage indicator was NOT activated.

Fuel valve asy : fire cover was found damaged, all pipes set correctly.

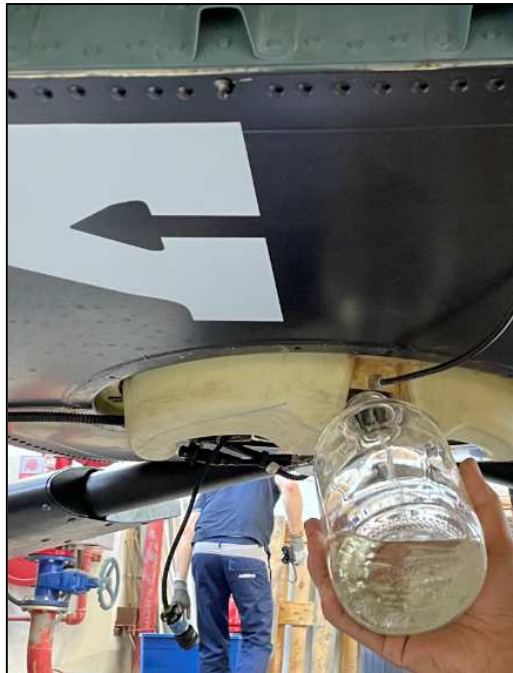
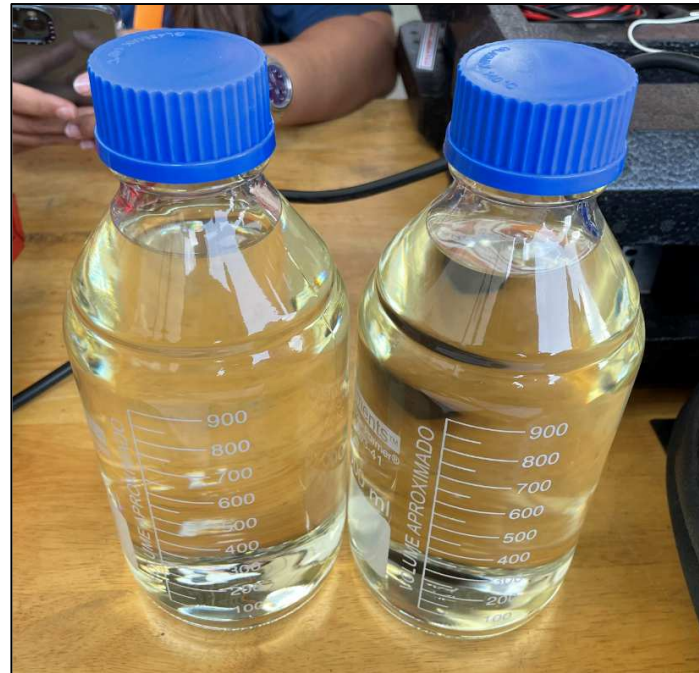
Fuel samples of 2x 1L were picked from the aircraft fuel tank, for possible later analysis and test.
The fuel looked clear and not polluted.

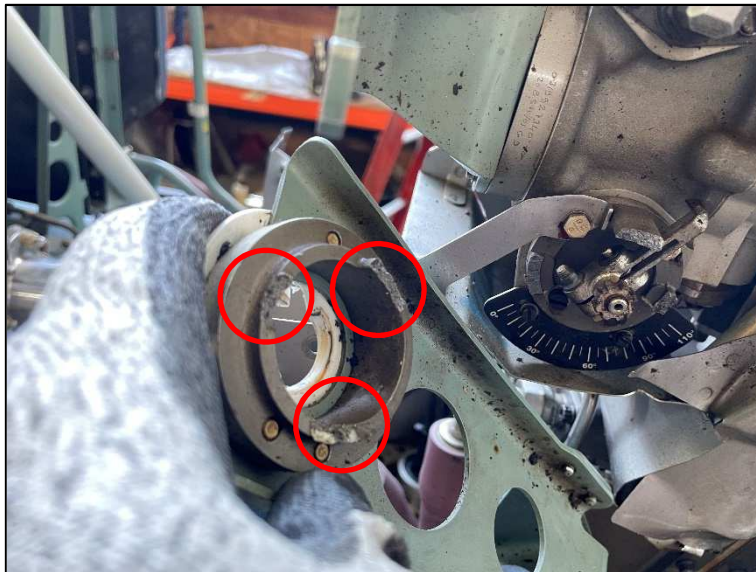
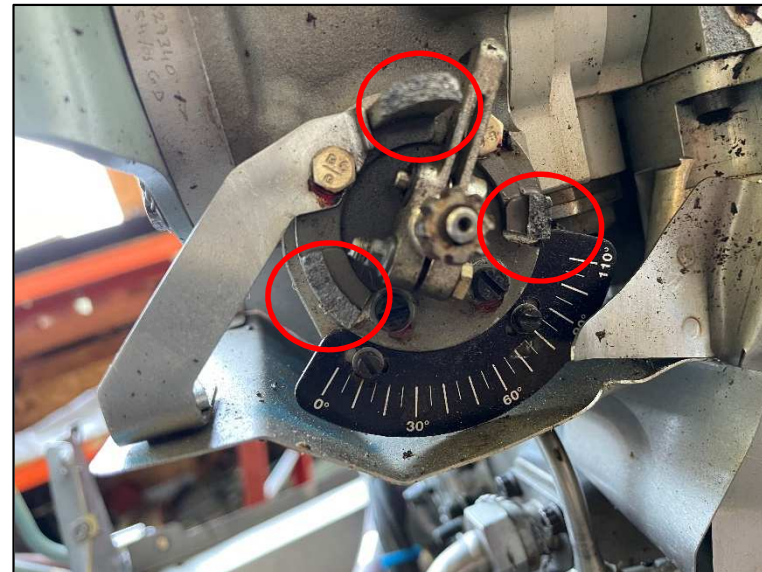
FCU anticipator lever disconnected and the support was torn off in a static rupture.

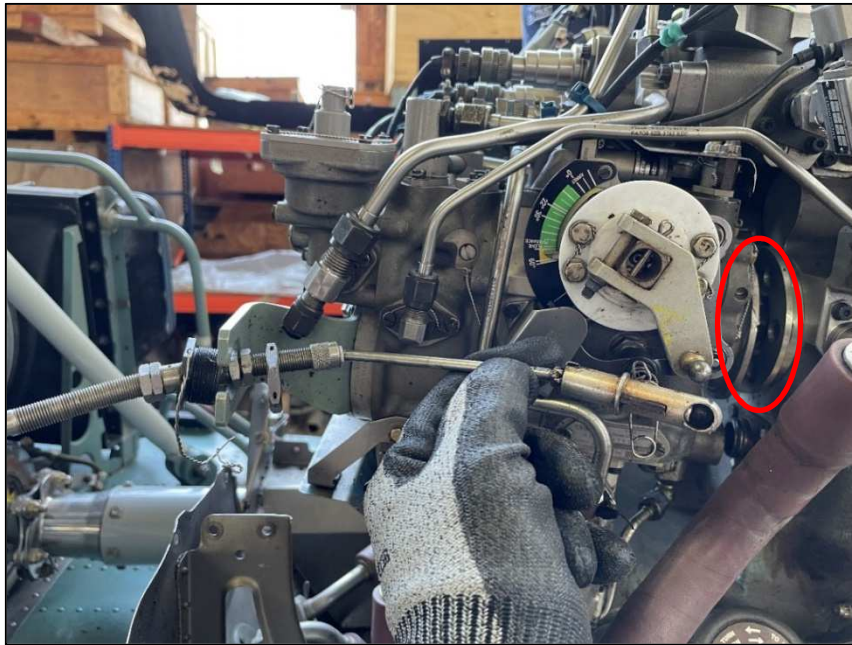
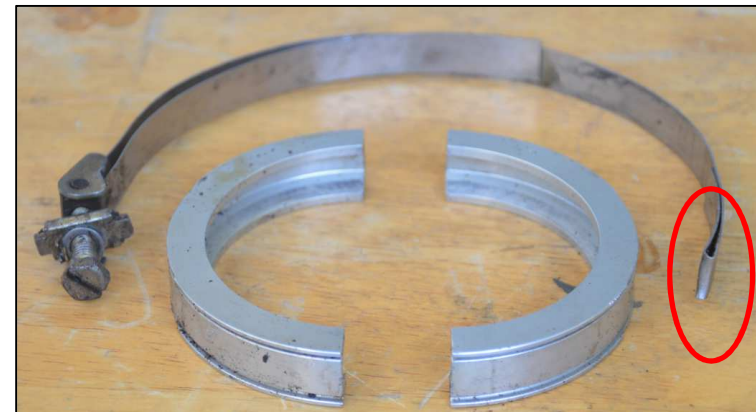
FCU was found separated from the M01 casing. In such case, the fuel pump does not work anymore and no fuel can go into the combustion chamber. The clamp was broken : one half attachment device was missing but the metallic tape was in good condition. The fuel control lever was found disconnected and torn off from the FCU. The FCU could not be set back as all the pipes were deformed. It was decided not to remove the pipes in order to preserve them as they were during the accident.

- ✓ the engine mountings were torn off (front and rear; linking tube bent screws into the left direction, broken flange of the linking tube);
 - ✓ the FCU connections were torn off, and the FCU detached from the module M01 casing, causing the engine fuel starvation (no fuel pump anymore), and therefore led to the engine flame out;

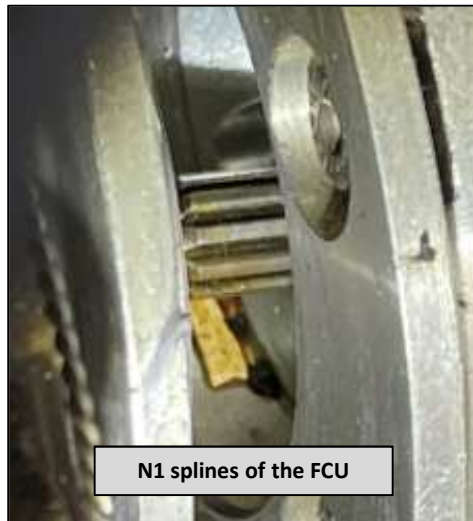
N1 splines of the FCU

N1 and N2 splines shaft of the FCU were found without clear visible damage.

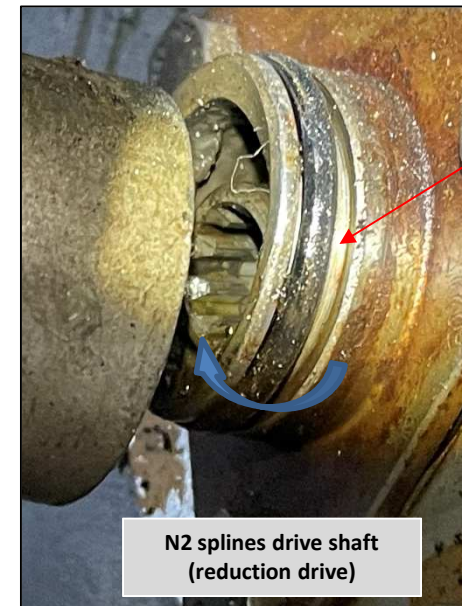
N2 splines drive shaft
(reduction drive)

However, the N2 drive on the casing side was found in contact with its housing: it seems that the external diameter of the housing was compressed and had deformed. Indeed, the o-ring groove seemed to have enlarged, and bent the external diameter back towards the inside.

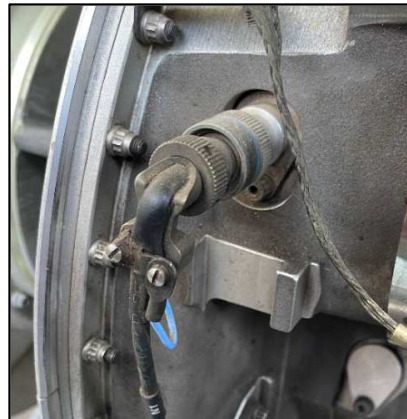
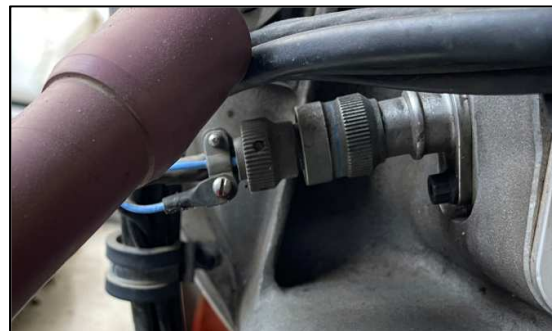
N1 and N2 sensors were correctly tightened.

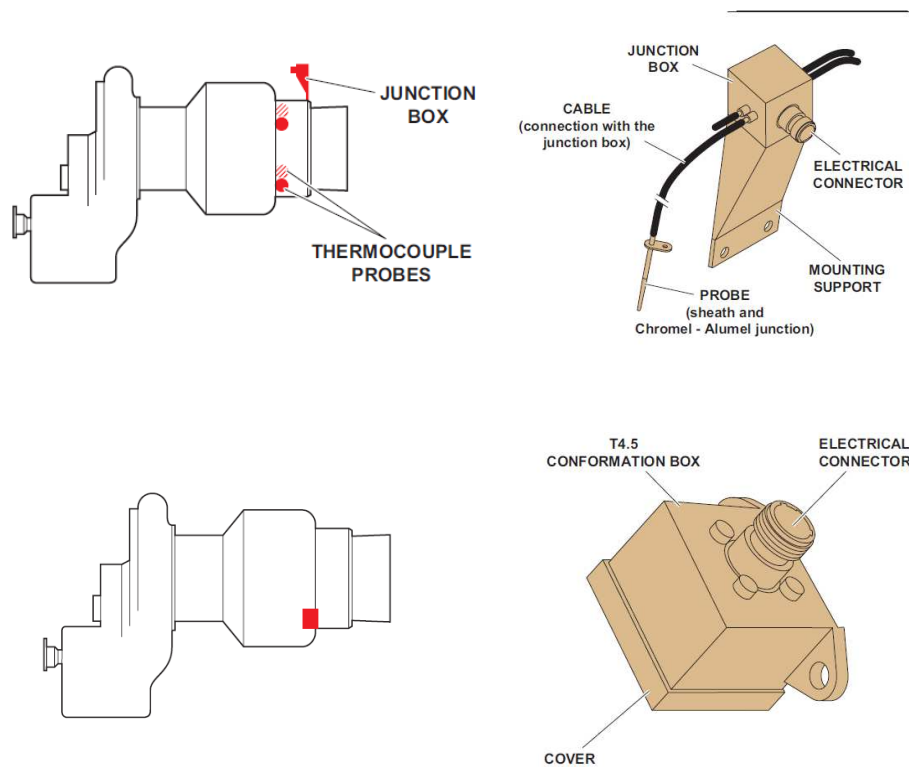
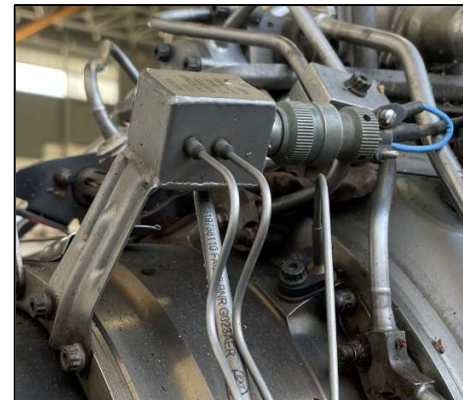
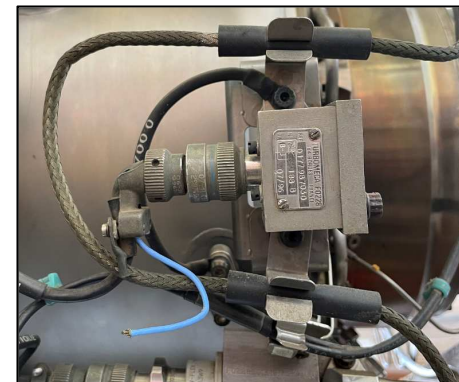
Temperature probes, junction box and conformation box were set correctly, although presenting damages related to the accident.

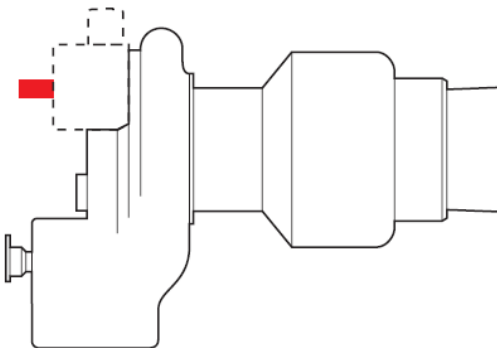
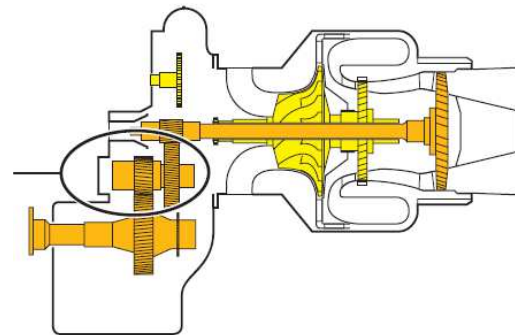
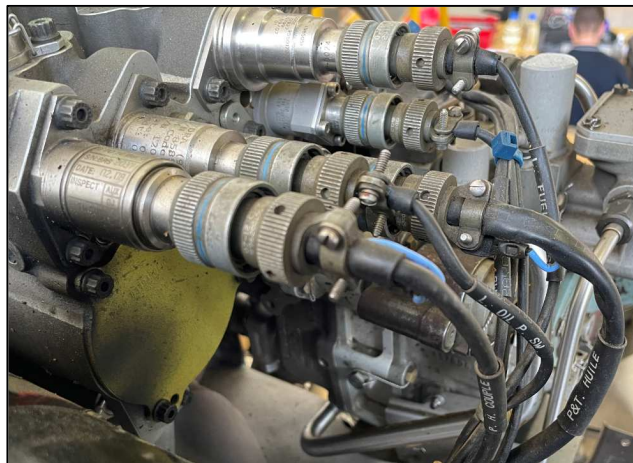
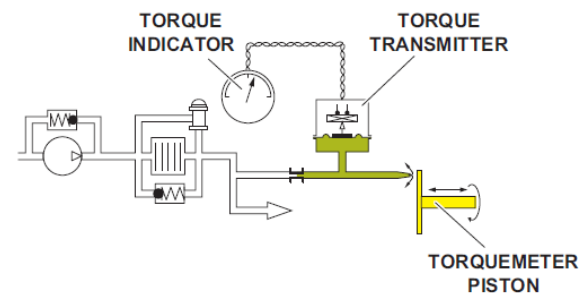
Torque sensor was connected and tightened.

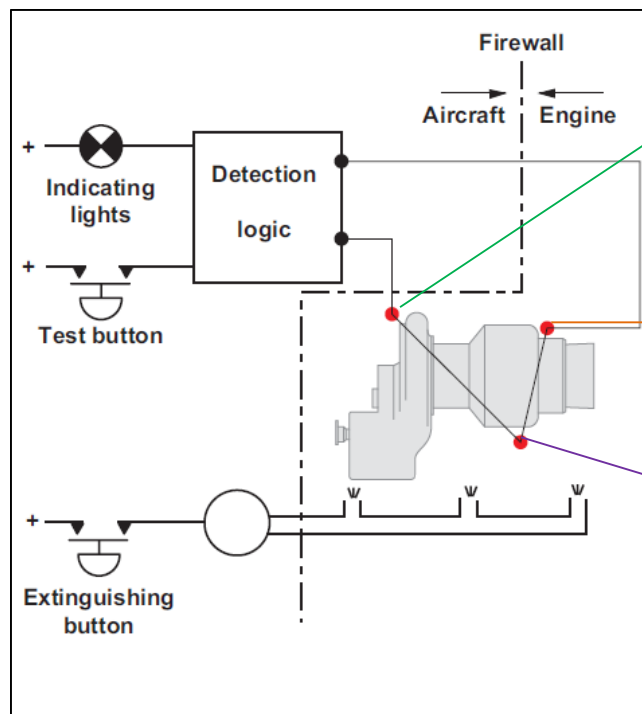
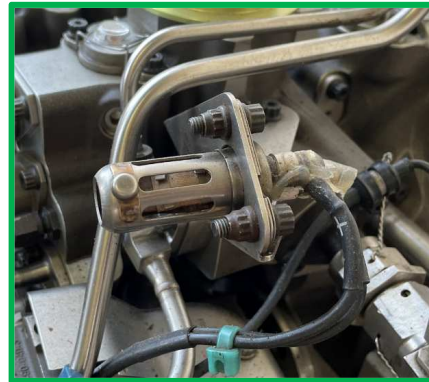
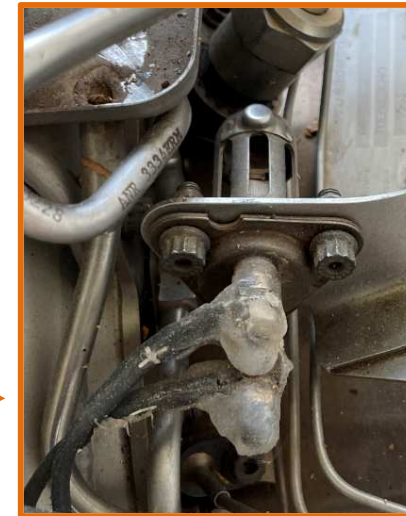
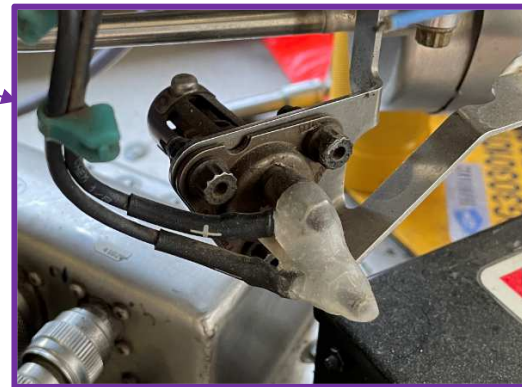
7.3.6 Measurement system

Fire dectectors present and set.

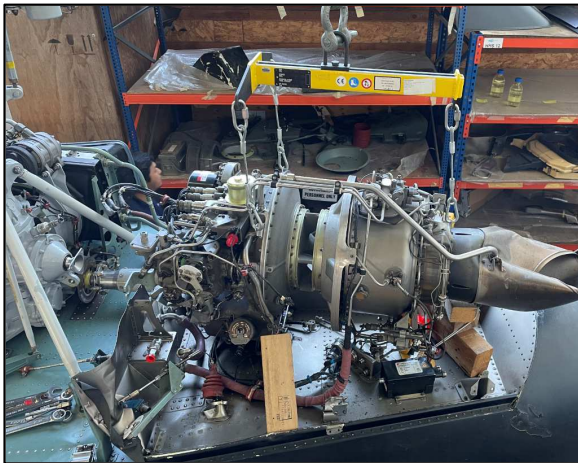
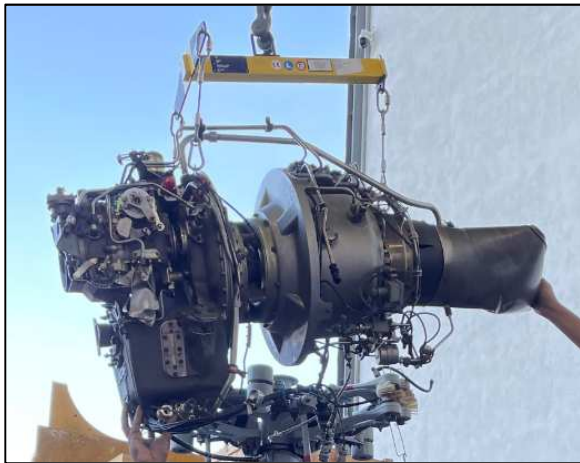
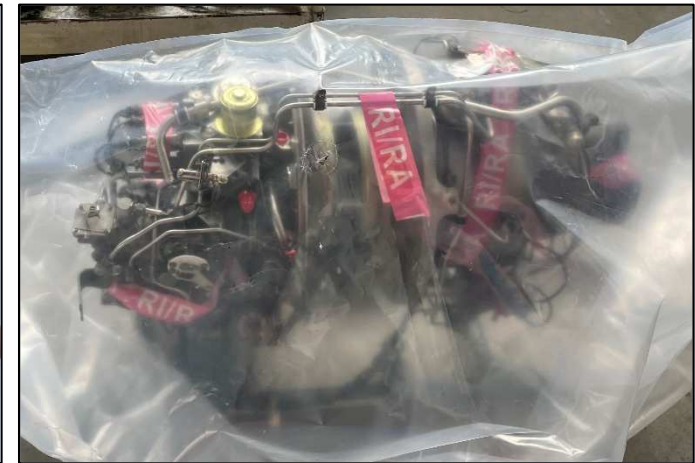
8. Engine removal from the wreckage.

Engine was removed from the wreckage without difficulties.

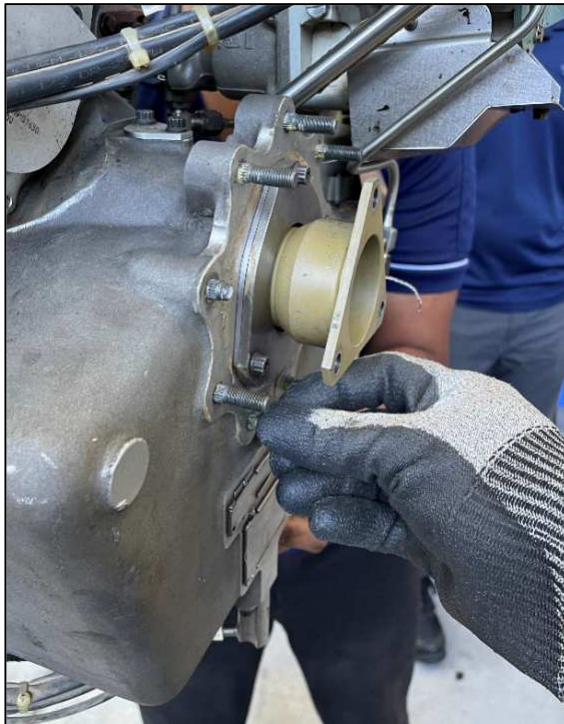
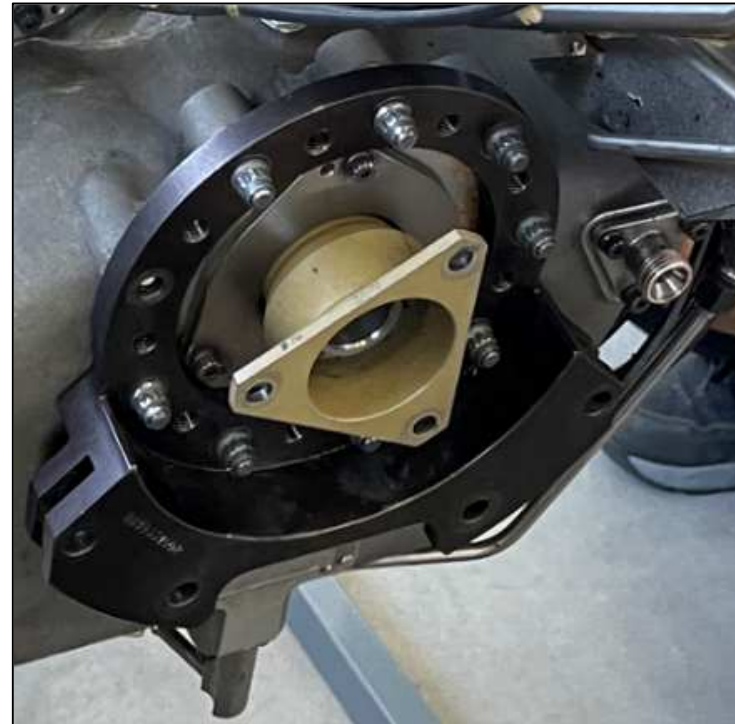
8. Engine removal from the wreckage.

It was difficult to set the tool interface at the front of the engine as all the screws used to set the linking tube were bent (towards the left hand direction). They had to be bent back straight, which led to one screw rupture in the process.
