# AIRCRAFT SERIOUS INCIDENT FINAL REPORT

## SI 04/23

Incident Involving Fixed Wing Aircraft TBM 700A, Registration N188SJ at Kota Bharu Airport, Kelantan on the 4<sup>th</sup> August 2023

#### REPORT NO : SI 04/23

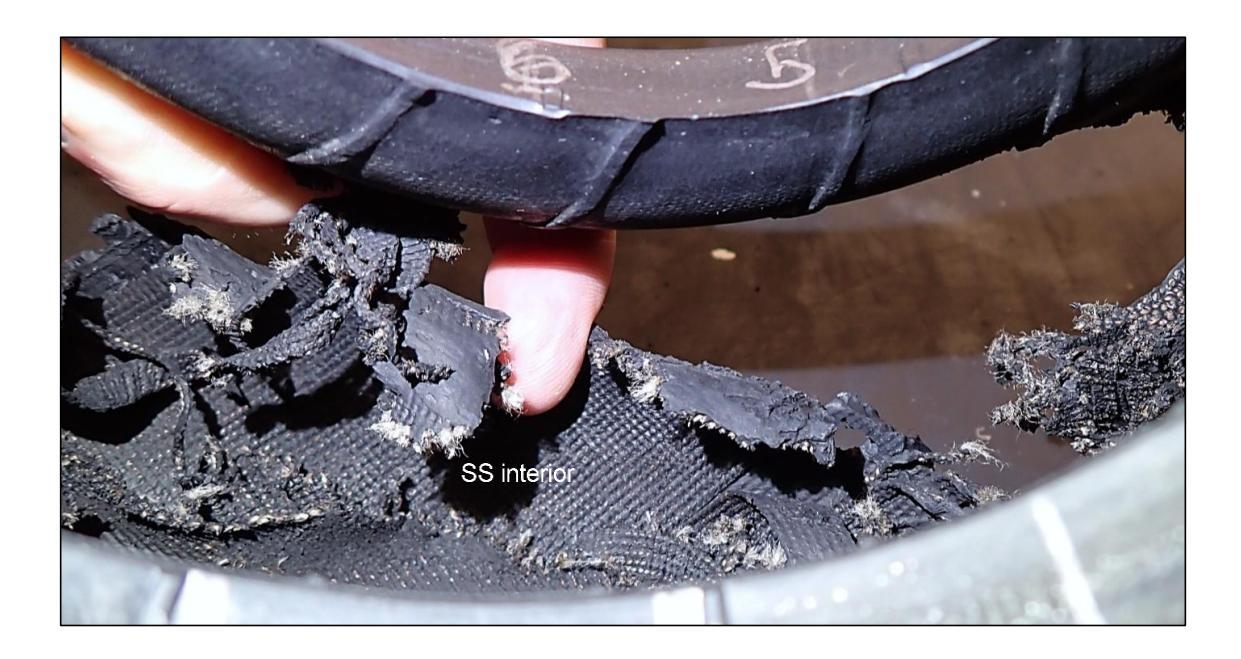
The interior of the tire shows severe abrasions, exposed/broken/frayed ply cord, and wrinkling at various locations around the tire.

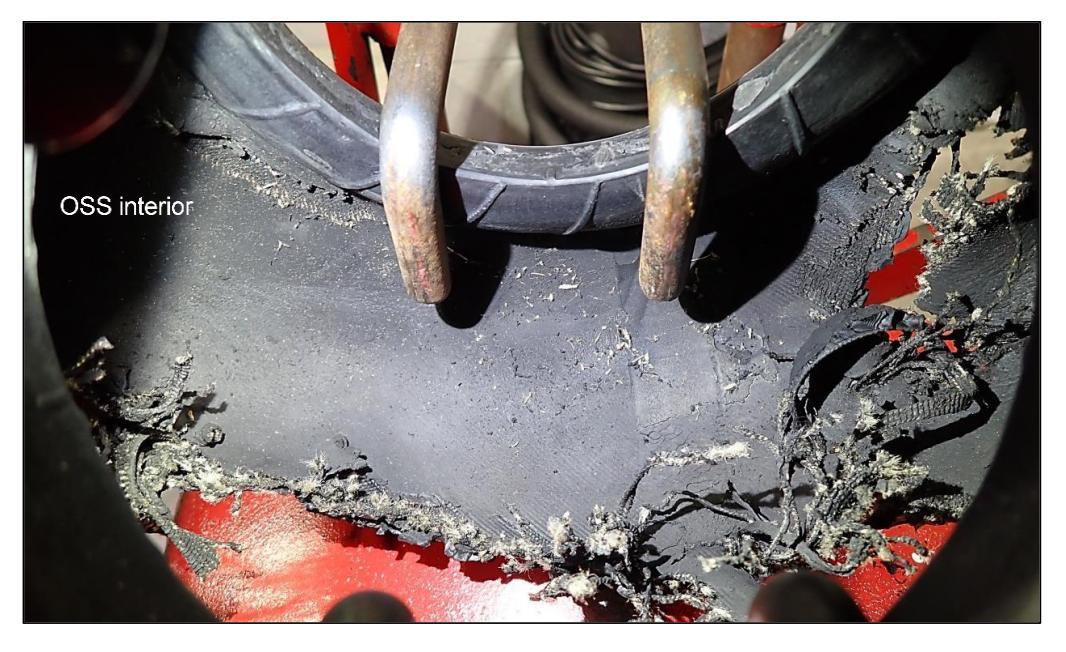
The interior of the tire shows severe abrasions, exposed/broken/frayed ply cord, and wrinkling at various locations around the tire.
