AIRCRAFT SERIOUS INCIDENT

SI 01/23

Piper Archer III PA28-181, Registration 9M-SKJ

at an Open Construction Area in Jasin, Malacca

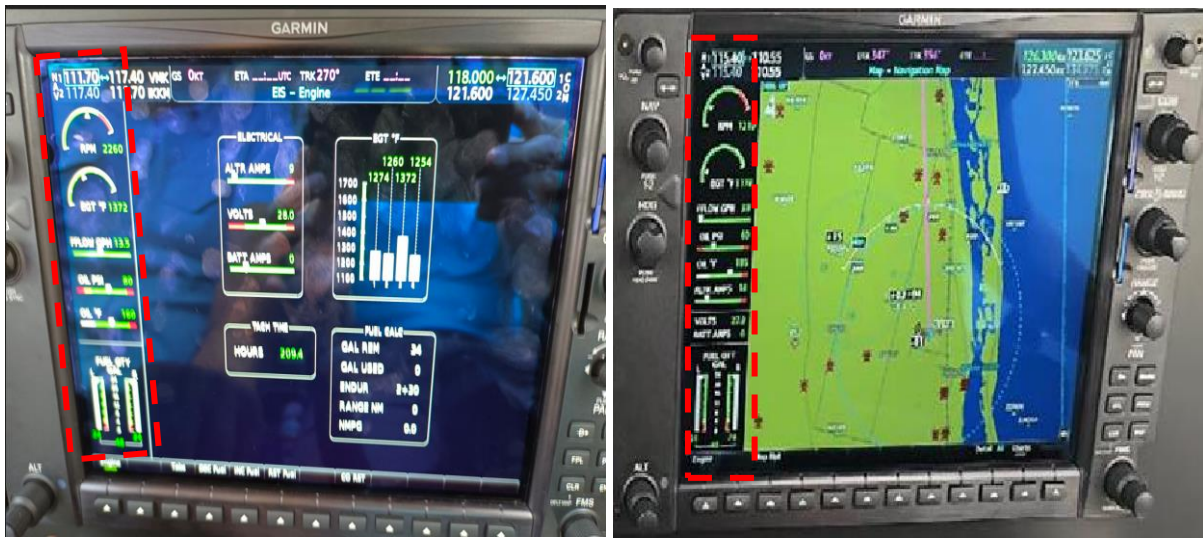
Figure 19: Engine Indicating System Page on Multi-Function Display

The MFD also incorporates a dedicated Engine Indicating System (EIS) page along the left side of the MFD window that displays engine parameters, electrical system parameters, and fuel quantity as shown in Figure 19.

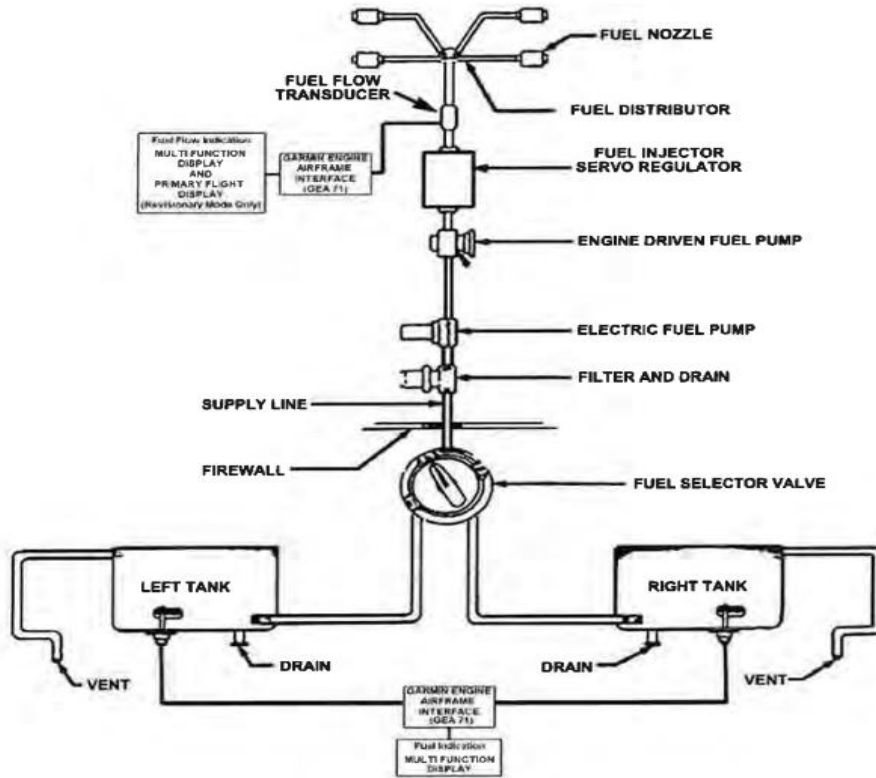
Figure 20: Fuel System Schematic – Fuel Injection Engine

Based on the Fuel System Schematic at Figure 20, the FIS regulates meter fuel flow proportionally with airflow and maintains the mixture for all engine speeds. The fuel flow divider receives metered fuel and distributes fuel to each cylinder fuel nozzle. Based on the EIS data recording (Figure 21), the fuel flow remains consistent with the power output.
