# Runway excursions on take-off involving Airbus A330-323, 9M-MTL, and Boeing 787-9, VN-A819

Melbourne Airport, Victoria, on 7 and 18 September 2023

Aviation Occurrence Investigation (Systemic)

AO-2023-043

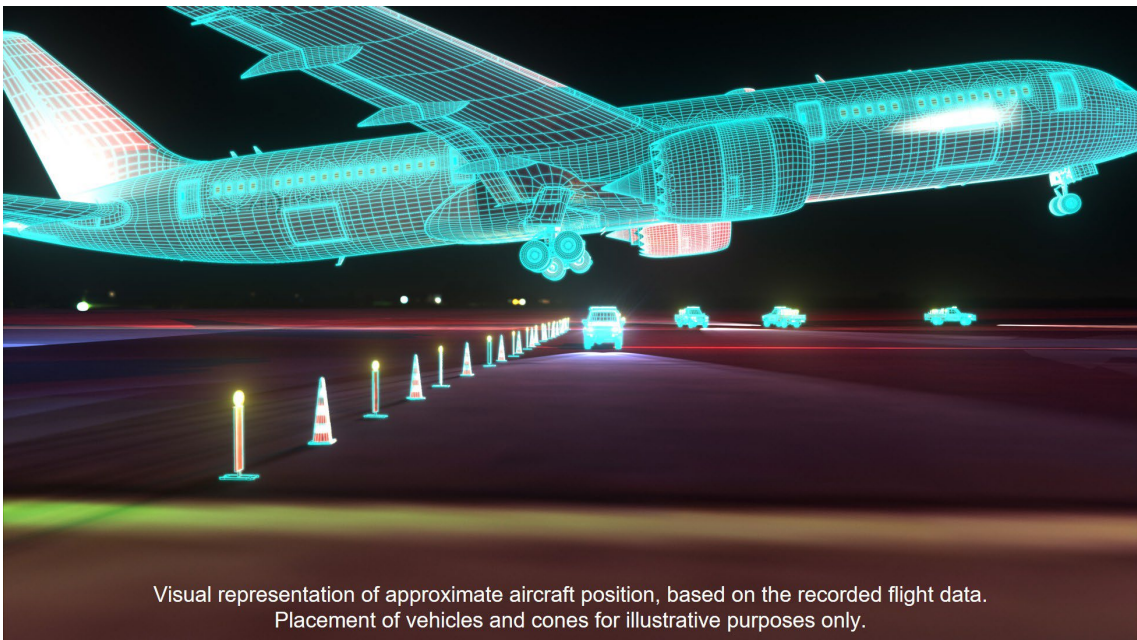
Visual representation of approximate aircraft position, based on the recorded flight data.  
Placement of vehicles and cones for illustrative purposes only.

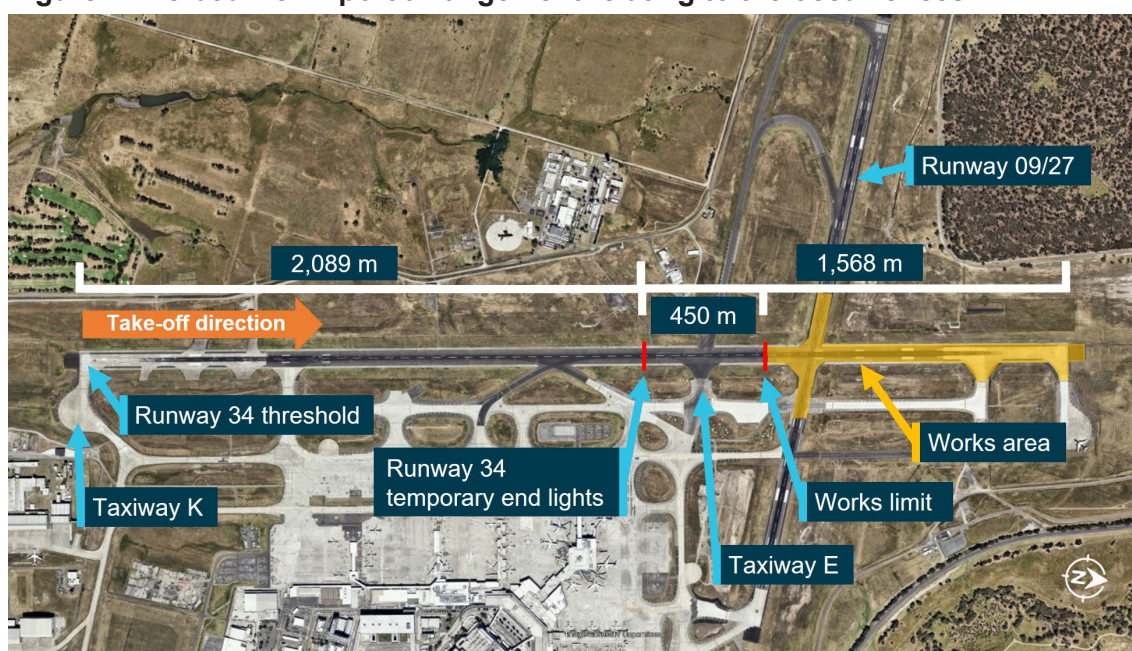
**Figure 1: Melbourne Airport arrangement relating to the occurrences**

The works were divided into 16 stages, with stage 8 of the works concerning the intersection of runways 16/34 and 09/27. The works plan involved closure of runway 09/27 and, to maintain an operational runway during the works, the runway 16 threshold was displaced, shortening the length of runways 16 and 34 (Figure 1).

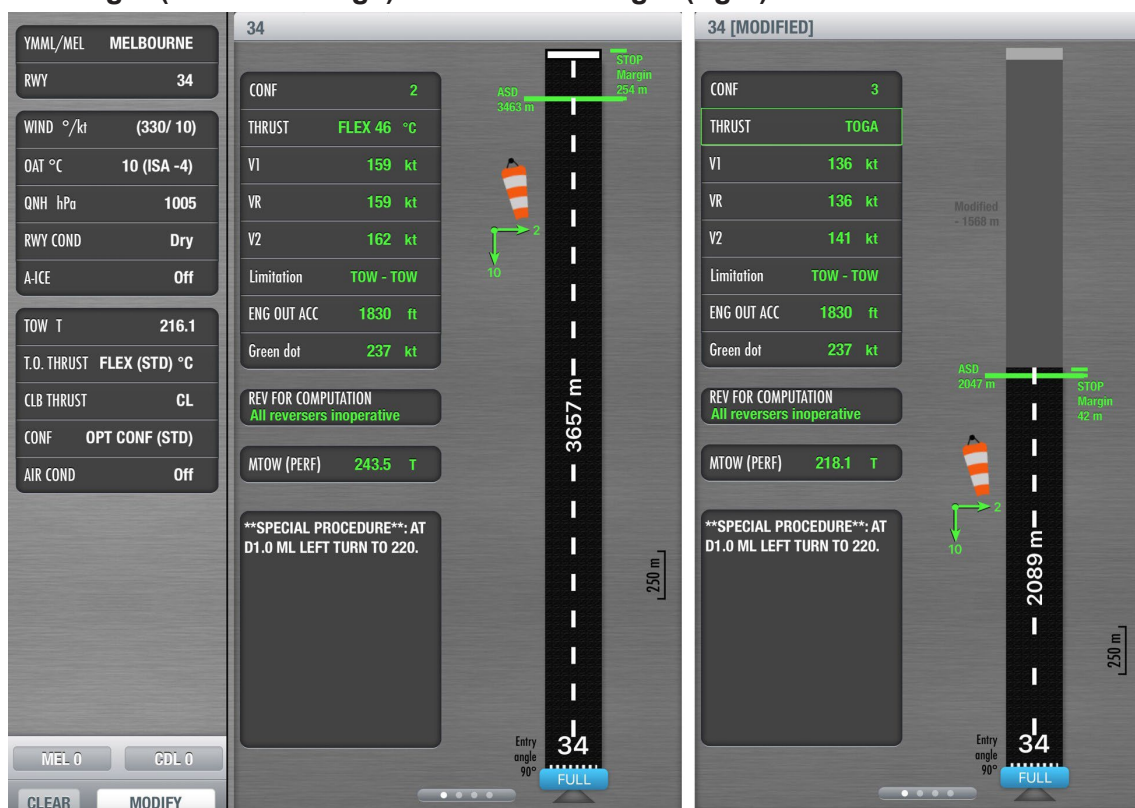
**Figure 8: Airbus *Flysmart* screen images showing performance comparison for 9M-MTL for conditions representative of 7 September 2023. Melbourne runway 34 full-length (centre of image) and reduced-length (right).**

A comparison of the calculations made by the systems for a full-length and reduced-length runway applicable to each occurrence, with example performance tool screenshots are shown in Table 3, Figure 8 (MAB) and Table 4, Figure 9 (BAV). In addition to the performance data, both performance tools displayed a graphical representation of the runway and the take-off distances required.<sup>36</sup>

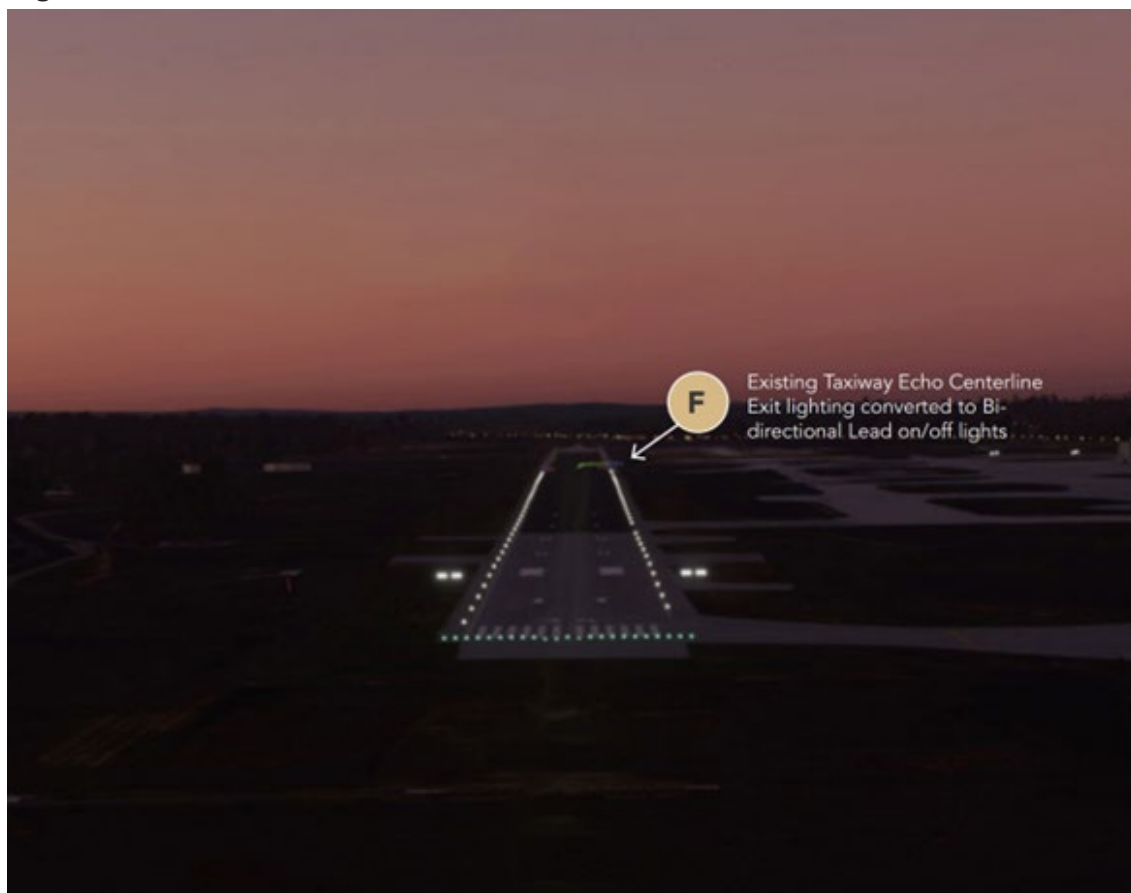
**Figure 13: Illustration indicative of modified runway 34 lighting on approach at night**

Additionally, the runway works area also had its own lighting to facilitate the works, and all vehicles operating in the works area were required to have an amber beacon fitted, visible from 360° and up to 200 m from the vehicle in normal daylight conditions. APAM included a representative image of the runway 34 lights on approach in the airline operator brief (Figure 13). The image note advised that it was indicative only and that airfield taxiway lighting, and lighting related to the construction works, were not illustrated. Imagery from the threshold of runway 34 showing the occurrence pilot's perspective of the works was not available to the investigation.

The unserviceability lights and orange strobe lights at the works limit were visible in CCTV video of the occurrence take-offs, with the camera located on the roof of the terminal building at a distance of approximately 900 m.

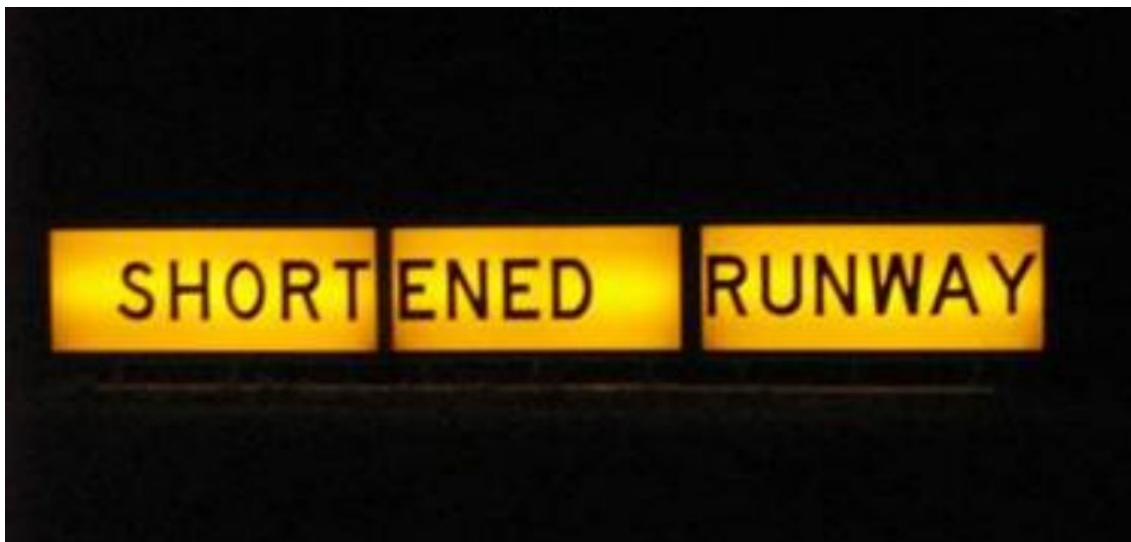
**Figure 18: Shortened runway sign used at Changi Airport during resurfacing works**

Illuminated information signs were used in an attempt to highlight the shortened runway. The existing TORA sign insert was replaced with the temporary runway length, and a yellow SHORTENED RUNWAY sign (Figure 18) was positioned on the opposite side of the runway to the taxiway entrance, where such a sign would not normally be located. The investigation report discussed that the flight crew did not recall seeing the signs,

which was probably because they were not expecting a change to the take-off length. The report also noted that the amended TORA sign was 'of the same size, font and colour indicating the shortened distance' and that the sign 'did not contain any attention-getter to draw the crew's attention to the reduced TORA'.

Among the immediate safety actions taken by Singapore ATC, was to ensure that all aircraft assigned to runway 20C were reminded of the reduced TORA by having air traffic controllers highlight the information to them during flight crew communications with both the clearance delivery and runway controllers.

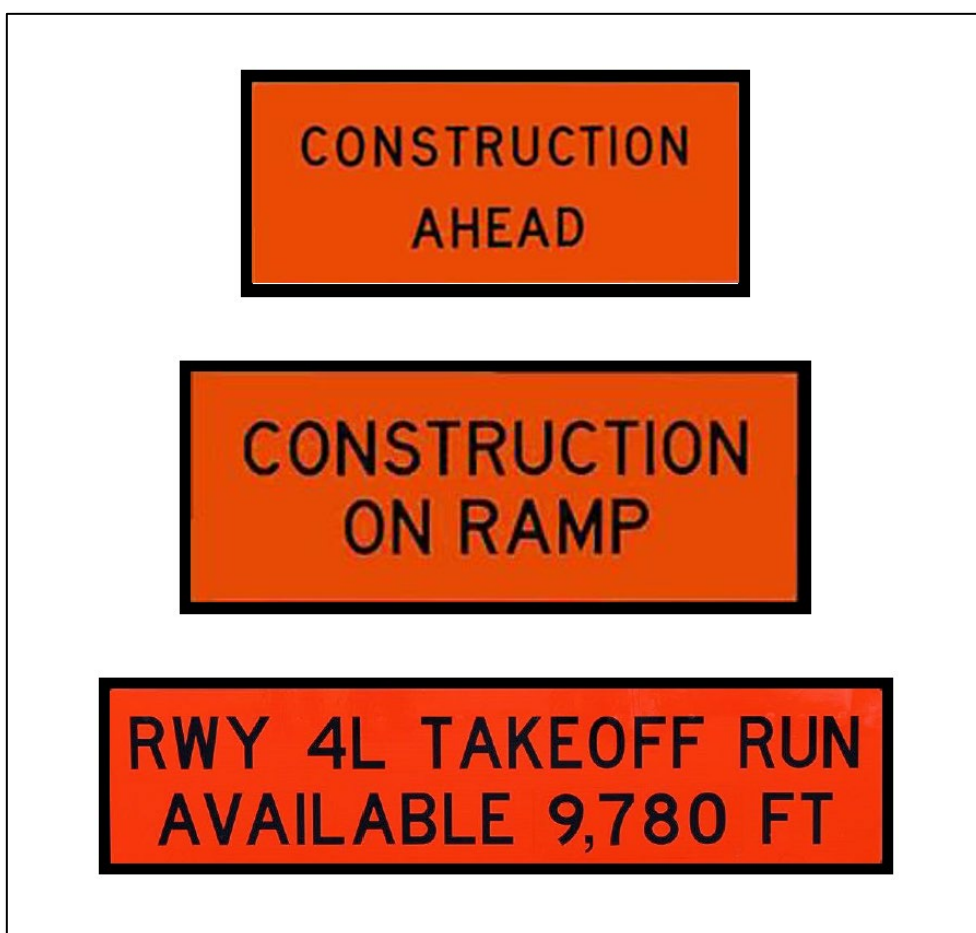
**Figure 19: FAA approved construction sign legends**

orange construction signs. The purpose of the signs was to increase pilot situational awareness, where needed, of change conditions on the movement area. Use of the signs was optional for airport operators and included the guidance to ‘use temporary signs judiciously, striking a balance between the need for information and the increase in pilot workload.’ The AC included 3 permissible sign legends, which were (Figure 19):

1. CONSTRUCTION AHEAD,
2. CONSTRUCTION ON RAMP, and
3. RWY XX TAKEOFF RUN AVAILABLE XXX FT.
