FINAL REPORT

SI 01/24

Fixed Wing Aircraft Piper PA28-181 Archer III

Registration 9M-ITX

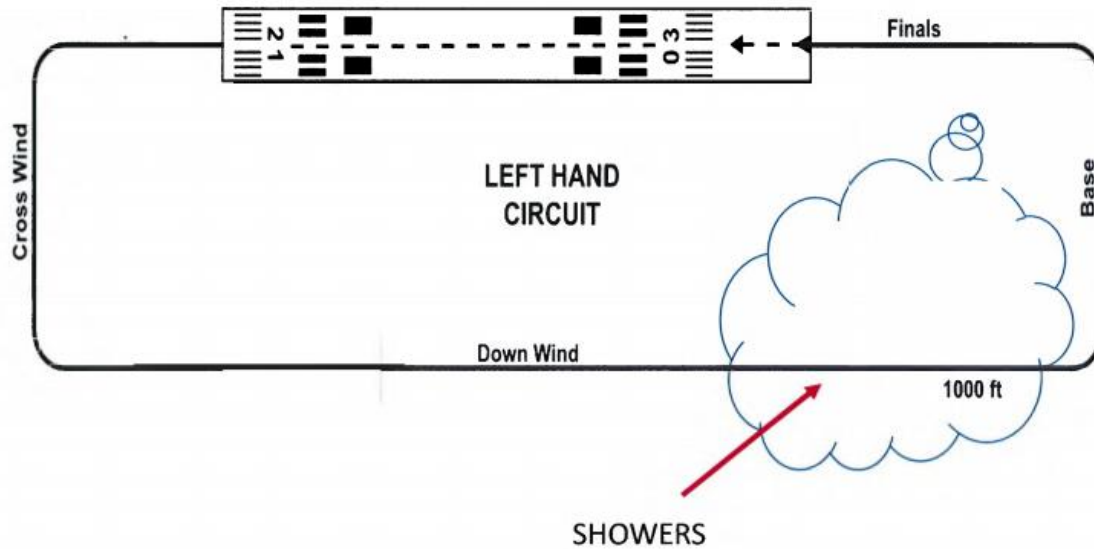
Figure 5: Cloud and rain showers position

The incident occurred at 1507 LT. At that time, Runway 03 was in use, with visibility reported at 7 kilometres. The wind was from 210 degrees at 3 knots. Rain was observed approaching from the western side and moving towards the airfield.

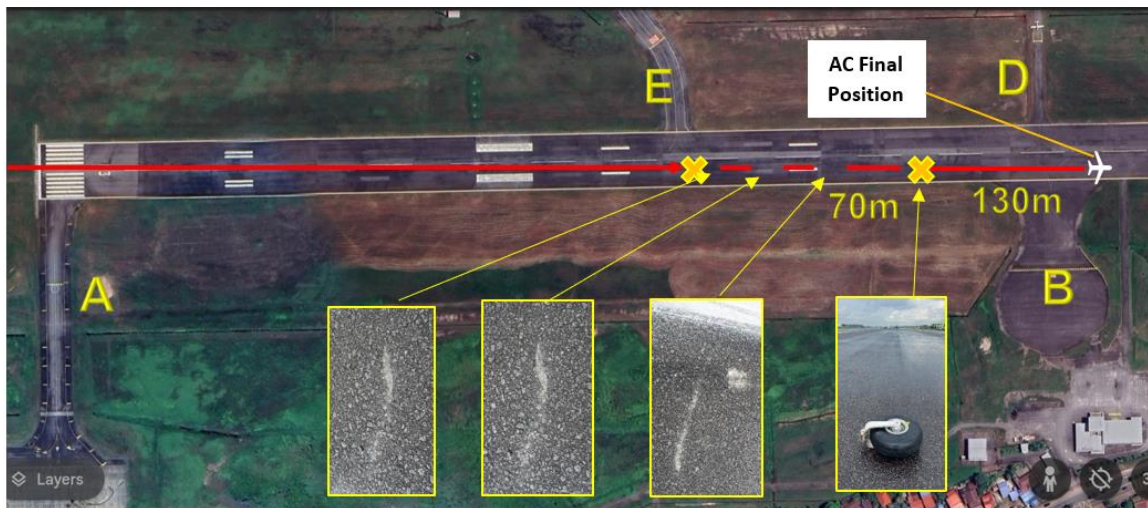
Figure 12: General map of the 9M-ITX incident

During the runway inspection, the AAIB investigation team identified three distinct scratch marks on the runway. These marks, consistent with propeller strikes as confirmed by the CP, validate the CP's description of the hard landing and provide tangible evidence of the impact that occurred (see Figure 12). This evidence, combined with the flight data and video recording, is used to determine the cause and contributing factors of the incident.
