AIRCRAFT ACCIDENT FINAL REPORT A 03/24 Air Accident Investigation Bureau (AAIB) Ministry of Transport Malaysia

Fixed-Wing Aircraft Blackshape BK 160TR, Registration I-POOC at Kapar, Selangor on 13 February 2024

FINAL REPORT NO: A 03/24

AVIATION SAFETY TECHNOLOGY PTE LTD,
SINGAPORE (PRIVATE OPERATOR) ¹
BLACKSHAPE BK 160TR
ITALY
I-POOC
KAMPUNG TOK MUDA, KAPAR, SELANGOR
MALAYSIA
13 FEBRUARY 2024 AT 1336 LT (0536 UTC)

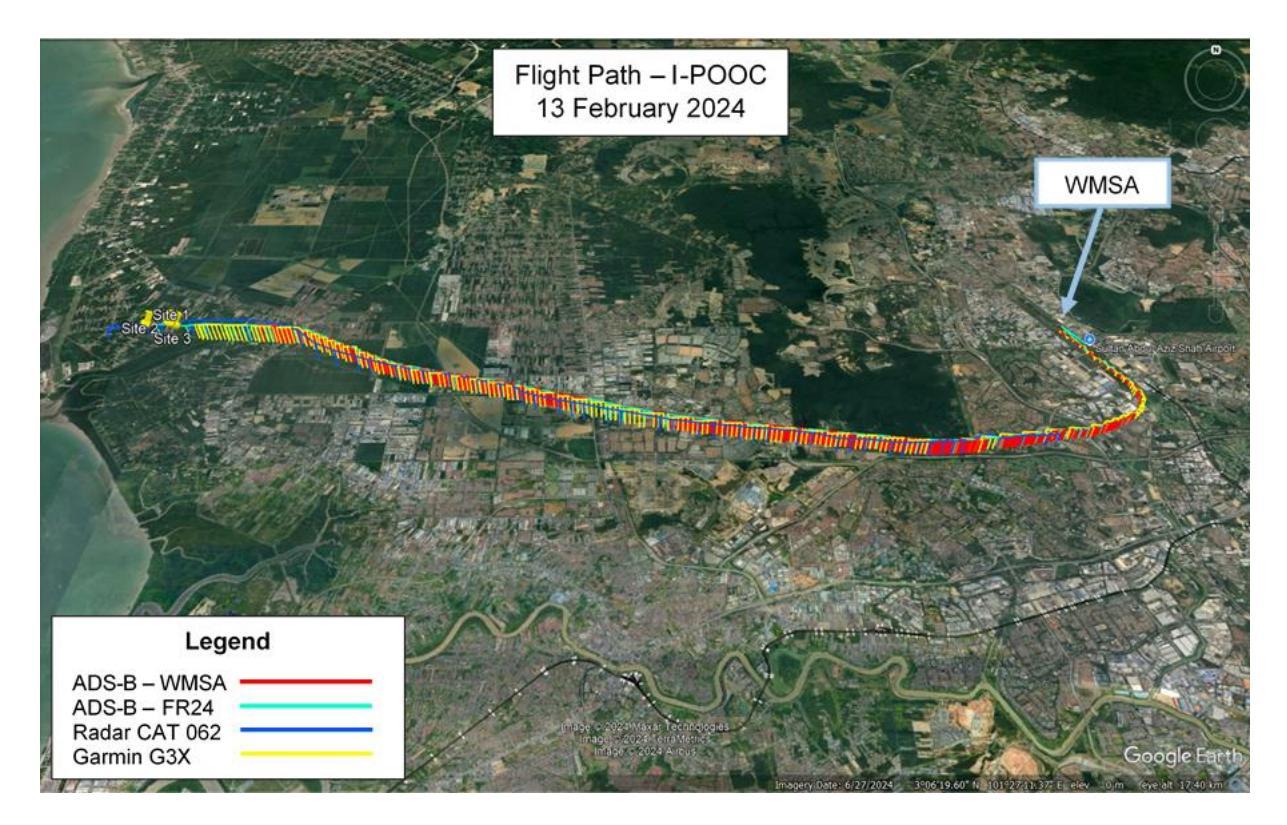
Figure 1. ADV429 Flight Path

The flight paths from all four data sources are well-aligned. Although the Garmin G3X display shows a jagged path due to unsmoothed data points, its overall trajectory is consistent with the other sources.

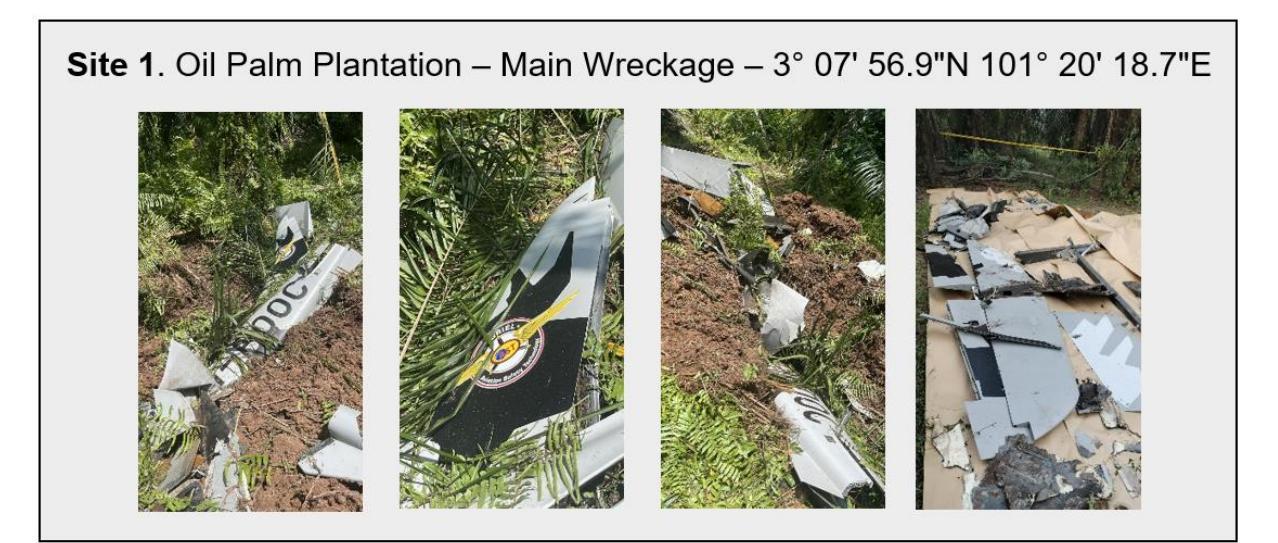
Figure 4. Site 1

Figures 4 to 7 show the locations of the wreckage and debris. Site 1 marks the location of the main wreckage, including the bodies of the pilot and passenger. Sites 2 to 4 are within an area approximately 250 to 300 metres in diameter, where various aircraft debris were scattered. Before investigators arrived, most of the scattered debris were found by local villagers, who had collected and pooled much of it, particularly at Sites 3 and 4. Site 2, the closest of the three debris sites to the main wreckage, is located about 560 metres east of Site 1.

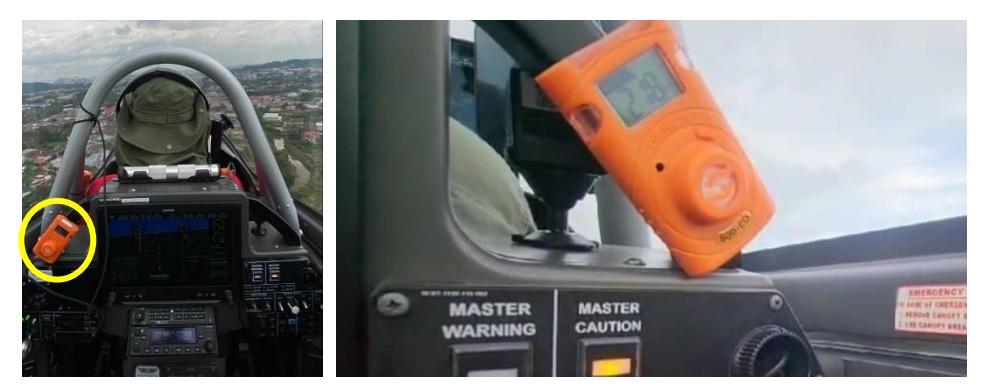
The pilot reported to Blackshape that the aircraft's Master Caution and CO Master Caution alerts on the Garmin G3X flight display occasionally activated during flight. Additionally, the CO indicator strip in the front cockpit was observed to be partially black, suggesting elevated levels of CO in the cockpit.

Figure 15. Jury-Rigged Portable CO Detector

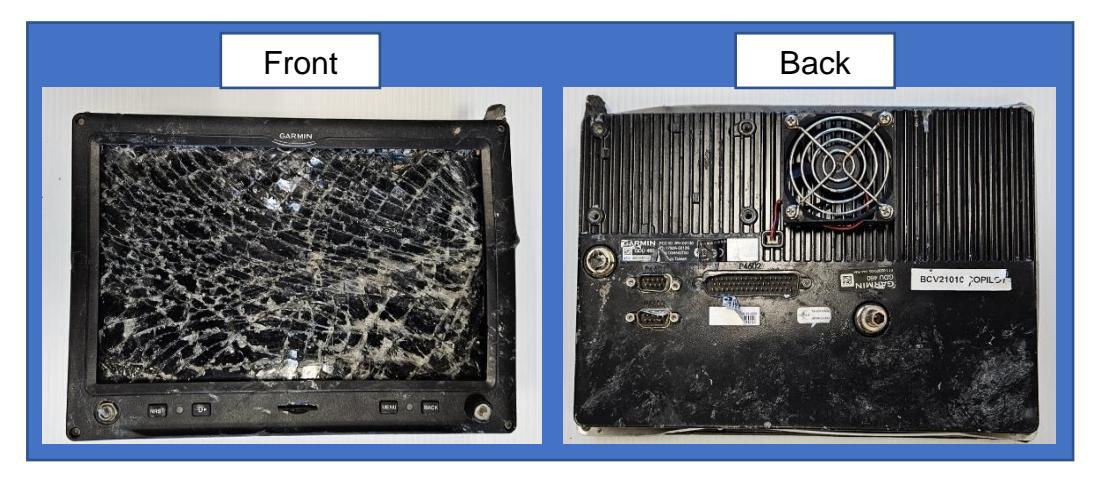
Figure 16. Damaged Garmin G3X GDU 460

The aircraft was not equipped with either a Flight Data Recorder (FDR) or a Cockpit Voice Recorder (CVR). However, it was fitted with two Garmin G3X GDU 460 primary flight displays, one in each cabin. Following the accident, the GX3 GDU 460 unit from the rear cockpit was recovered in heavily damaged condition and sent to the NTSB in the United States for data recovery and analysis. The details of the unit are as follows:

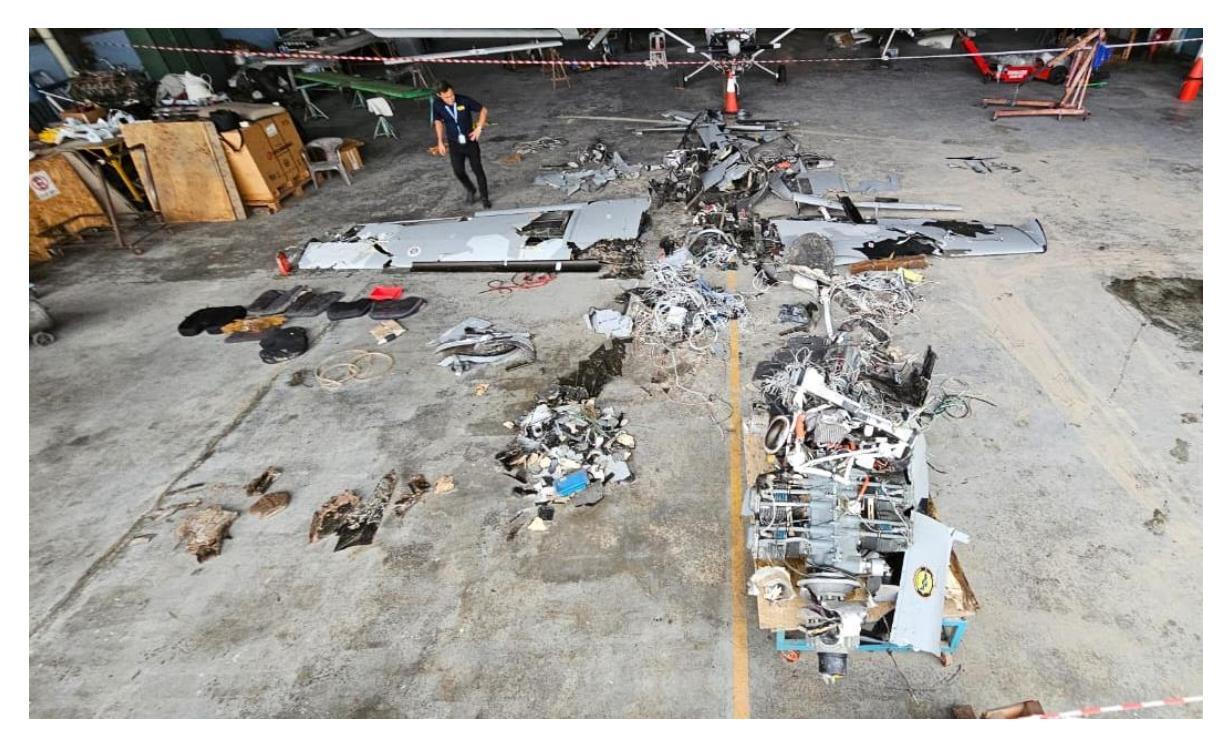
Figure 18. Layout of the Aircraft Wreckage
1.12.2 Impact Point of Main Wreckage

The front portion of the main aircraft wreckage, including the engine and forward section of the cockpit, was buried approximately two metres deep in the relatively soft ground of the oil palm plantation. The rear section of the fuselage, with the tail and vertical stabiliser, remained above ground.

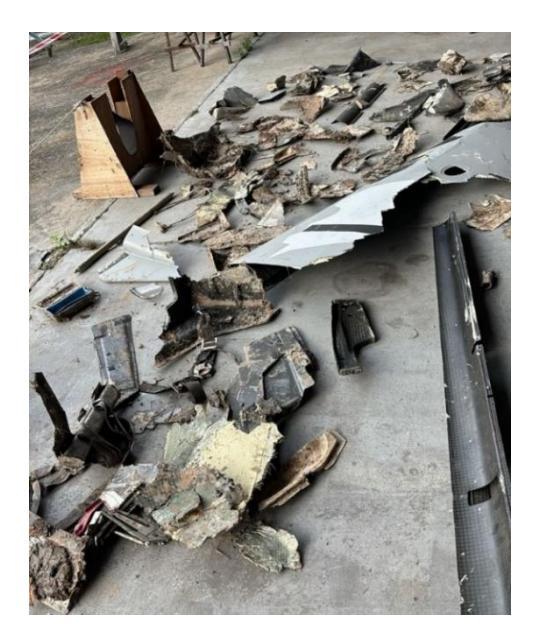
Due to the high-energy impact, the container of the I-POOC aircraft was shattered into pieces, failing to prevent intrusion by external objects and leading to fatal injuries for the occupants.

Figure 25. Container Shattered into Debris Survivability Almost Impossible

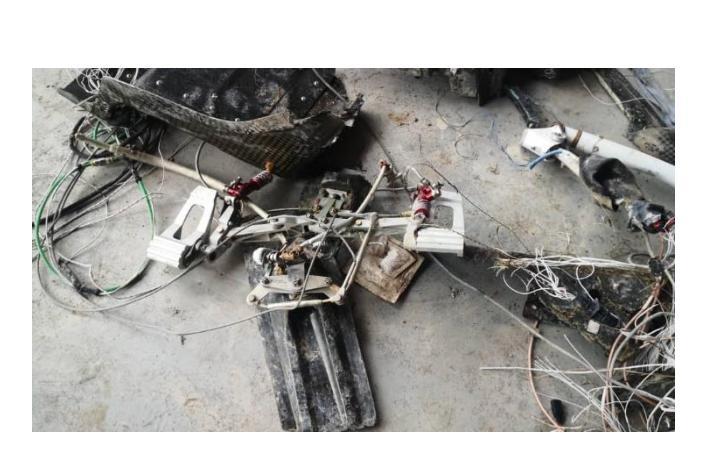
Figure 26. Rear Seat Rudder Pedal Relatively Intact

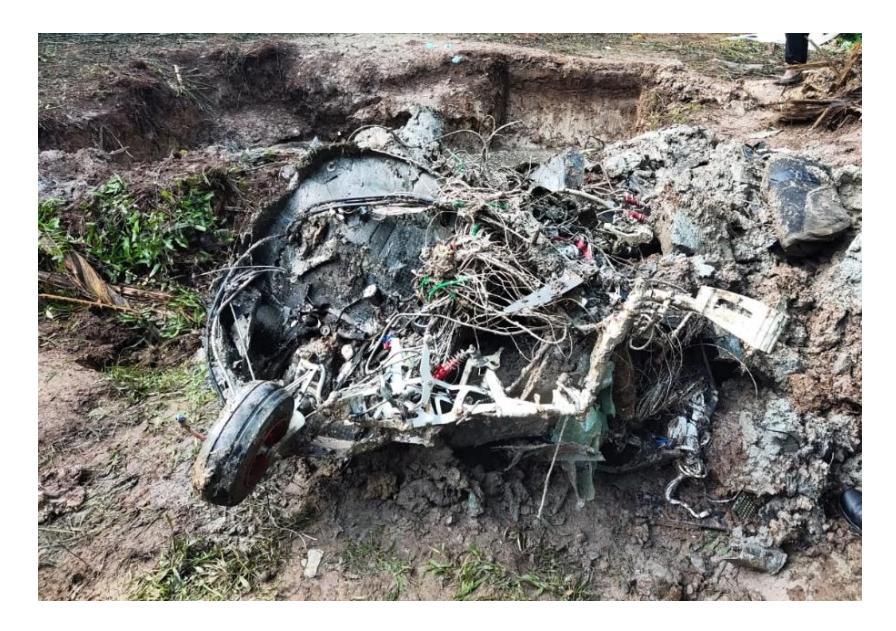
1.15.5 Energy Absorption

Figure 30. Nose Wheel Retracted; Impact Not Absorbed by Landing Gear.

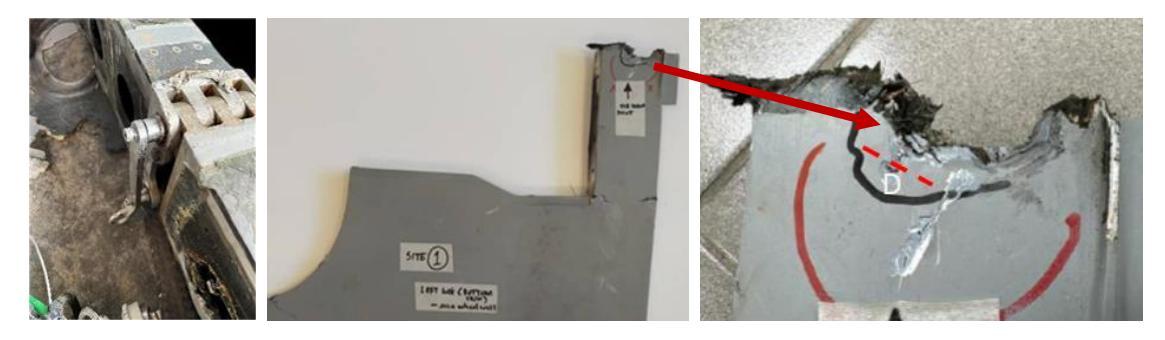
Figure 37. LH Wing – Tie-Down Ring and Man-Made Hole (Fragmented Portion)

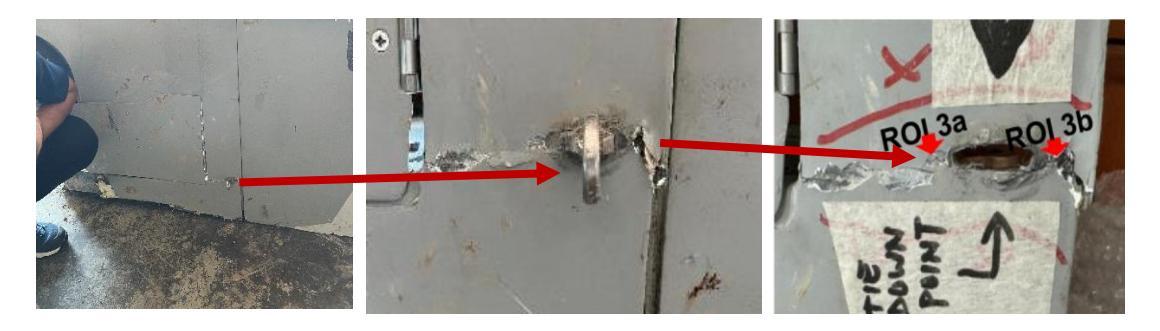
Figure 38. RH Wing – Tie-Down Ring and Man-Made Hole

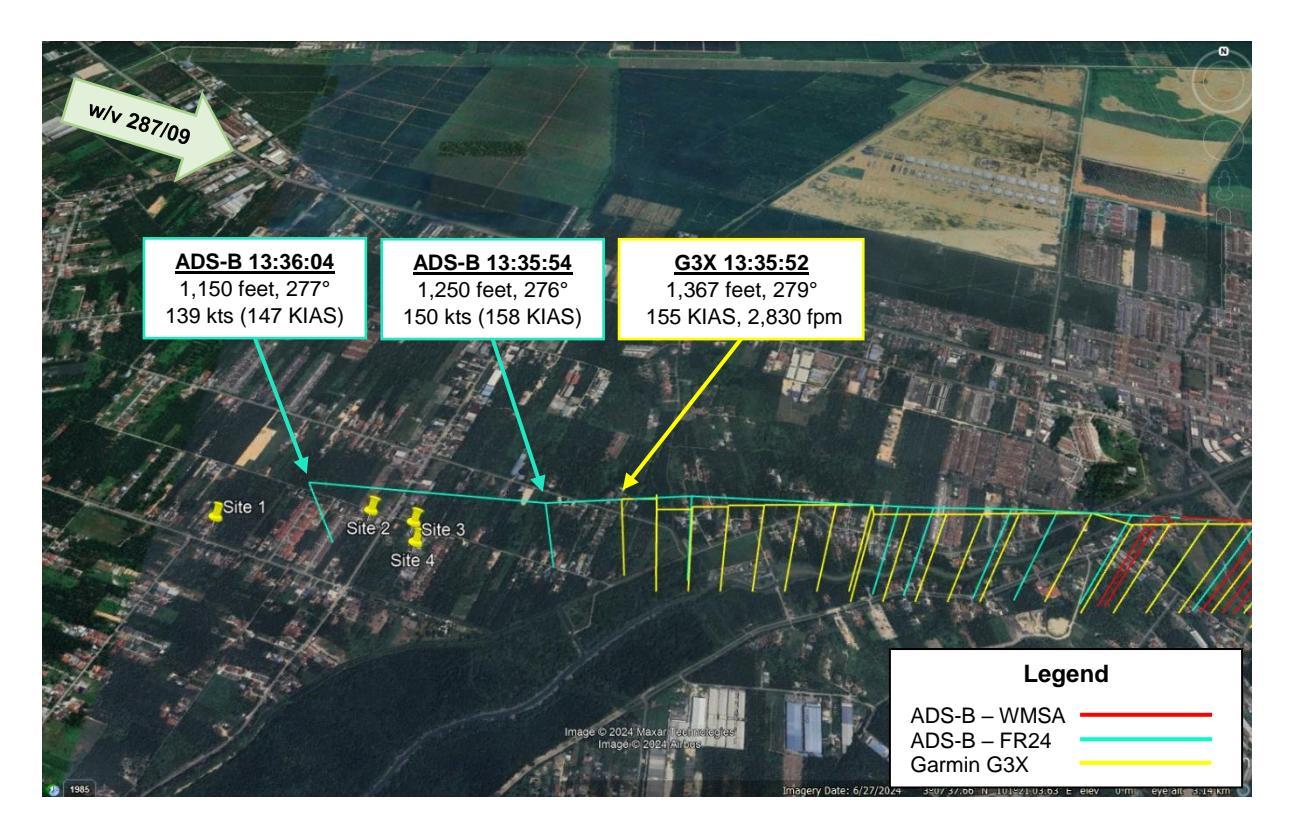
Figure 39. Final Phase of ADV429 Flight

At 13:35:45 LT—around 7:46 minutes into the flight and shortly after the pilot's final ATC radio transmission at 13:35:34 LT—the data show the initiation of a controlled dive manoeuvre, with stable roll and yaw angles and a gradual pitch decrease to approximately -17 degrees, which was then held steady. Roll remained within ±5 degrees, indicating wings-level flight, and there was no sign of instability in yaw.

During this descent, the power setting was recorded at approximately 75% maximum continuous power (MCP), beginning from a pressure altitude of 1,650 feet and descending to 1,367 feet. Airspeed increased from 130 KIAS to 155 KIAS, and the controlled parameters of roll, pitch, yaw, and power suggest an intentional, stable descent within the aircraft's operational limits (although the airspeed had reached the V_{NO} limitation of 155 KIAS). No signs of instability or aerodynamic stall were observed, and the aircraft appeared responsive to control inputs.

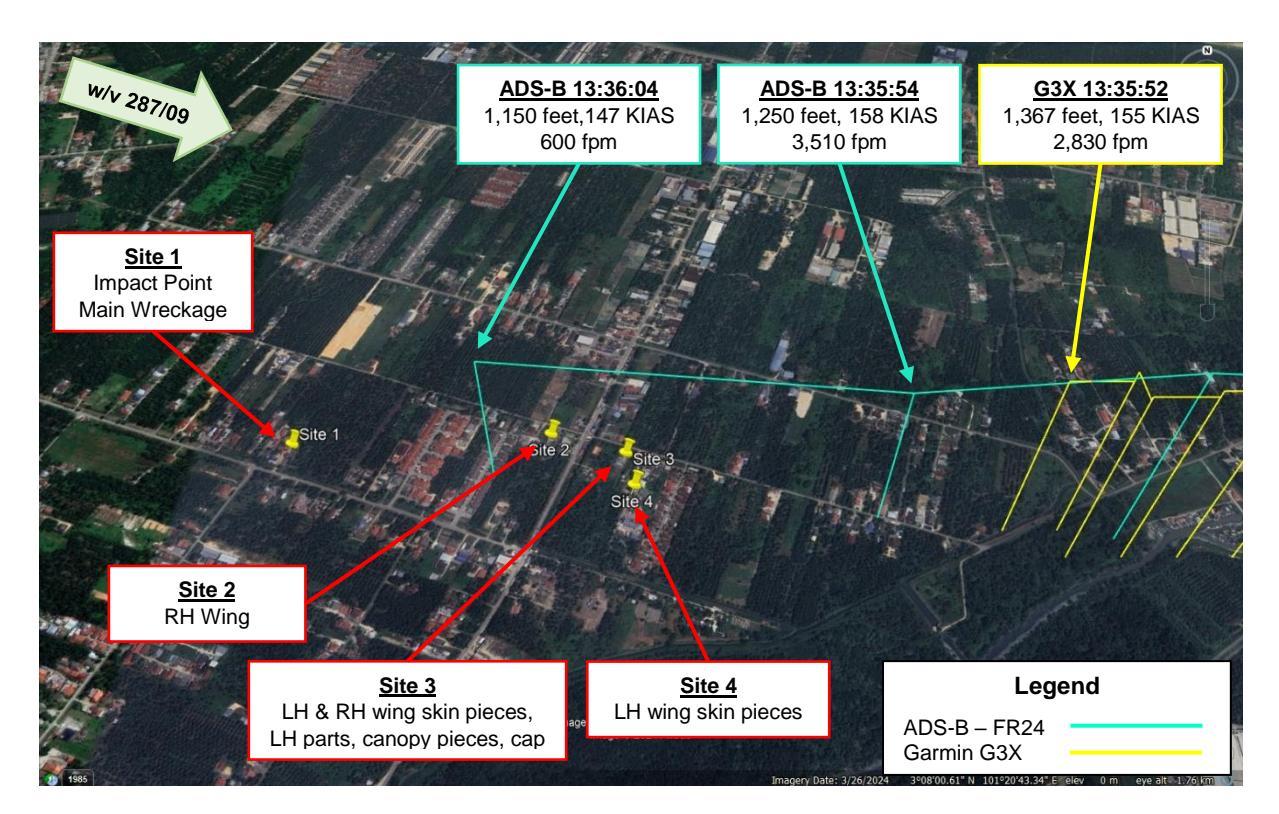
Figure 40. Flight Parameters Changes and Wreckage Distribution

Wreckage Distribution and Sequence of Events: The wreckage distribution
provides important clues to the sequence of the breakup. Large sections of the
LH wing skin were located at Site 4, the farthest wreckage site to the east of
the main impact area, indicating that the LH wing skin was likely the first
component to detach. Additional smaller fragments, including the LH wing lower
skin, RH wing inner upper skin, LH aileron, and LH wing tip, along with cockpit

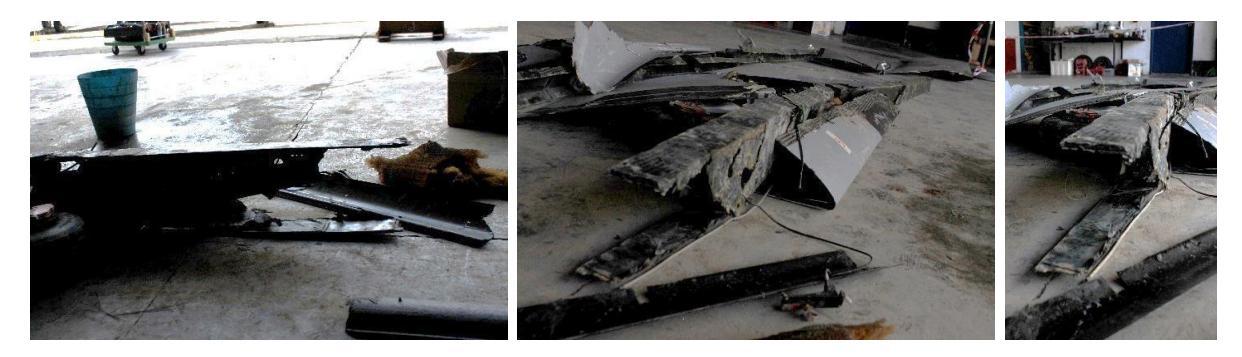
Figure 7. Main Spar Fuselage

The web of the main spar is totally lost.

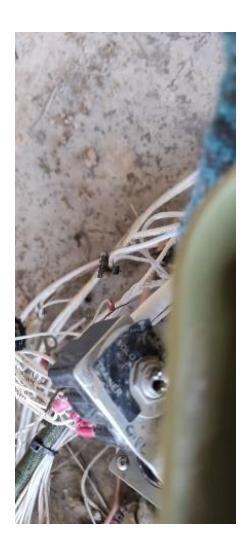
Figure 17. Mode Selector (Passenger Mode Selected)

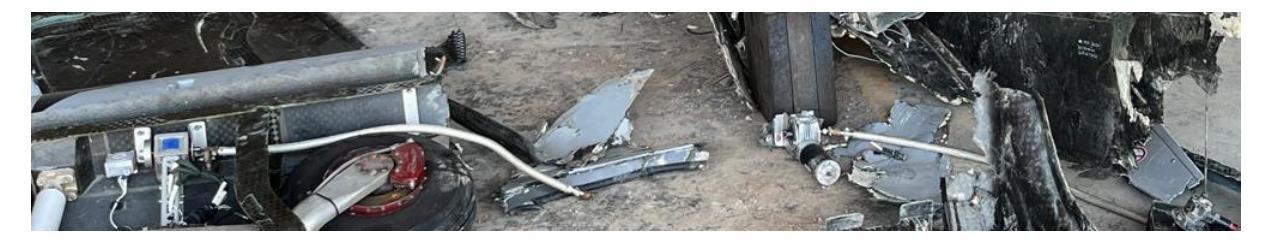
Figure 23. Flap Control System: Flap Motor and Connecting Rods

12.4 Flap Control. The flap motor is found detached from the rear spar, compatible with high energy impact. The RH connecting rod is disconnected from the gear motor and from the wing flap actuator by the rotating joints. The RH connecting rod is bent, probably due to the in-flight RH wing detachment.

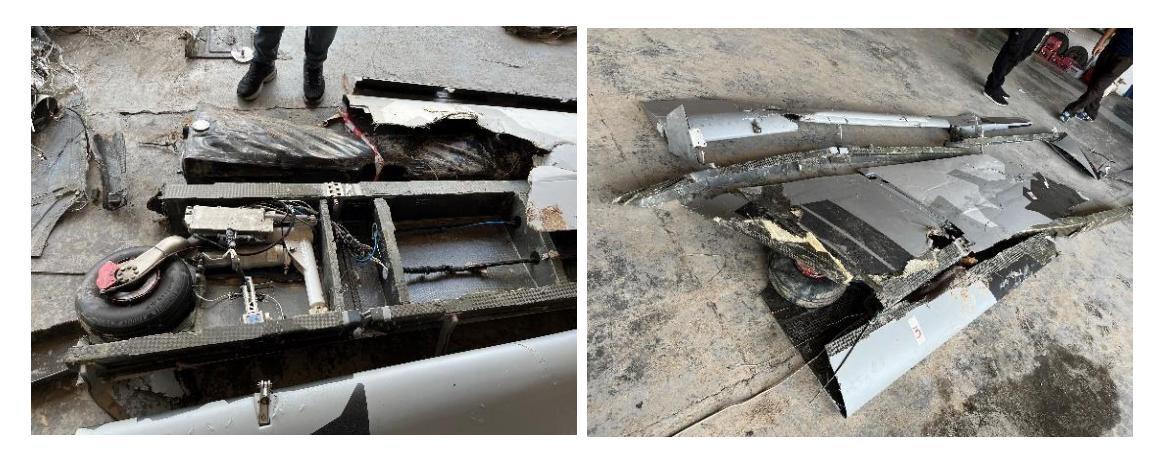
Figure 24. Main Landing Gear (LH and RH)

The RH Main Landing Gear (MLG) was found installed in its compartment (RH wing box) apparently in retracted position. The LH MLG was found attached on the LH wing main spar only. The Nose Landing Gear (NLG) was found installed in its position (engine mount), apparently in retracted position.

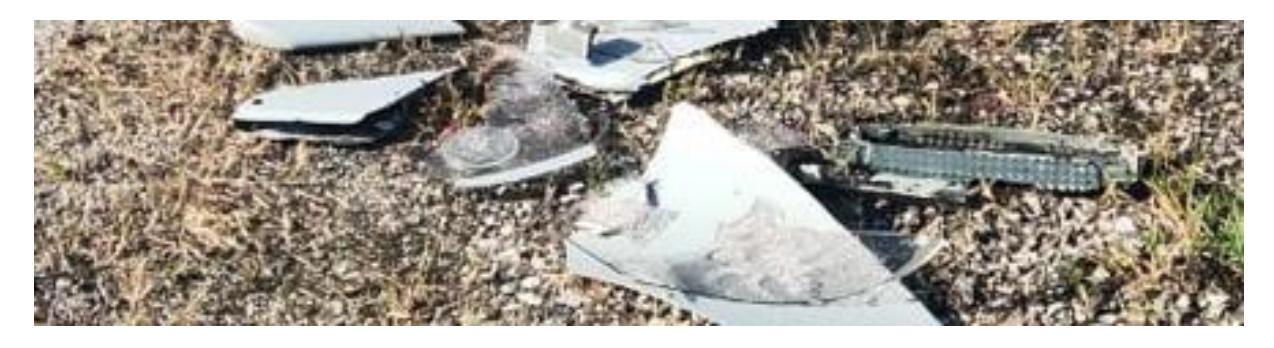
Fragments of the canopy was found at or around Site 3. The front canopy handle was retrieved. The position of the handle was not closed. However, the opening system was broken.

Figure 26. Fragments of Canopy Found at or Around Site 3

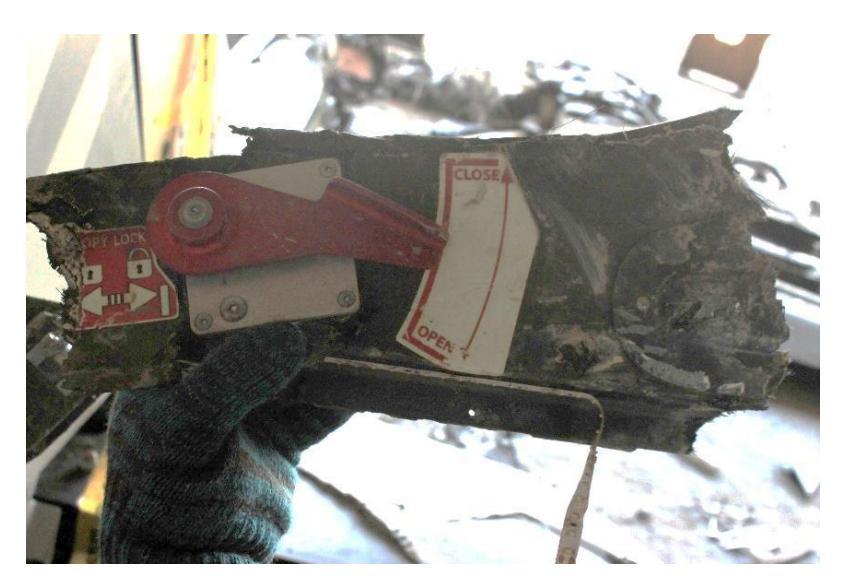
Figure 27. Front Canopy Opening Handle

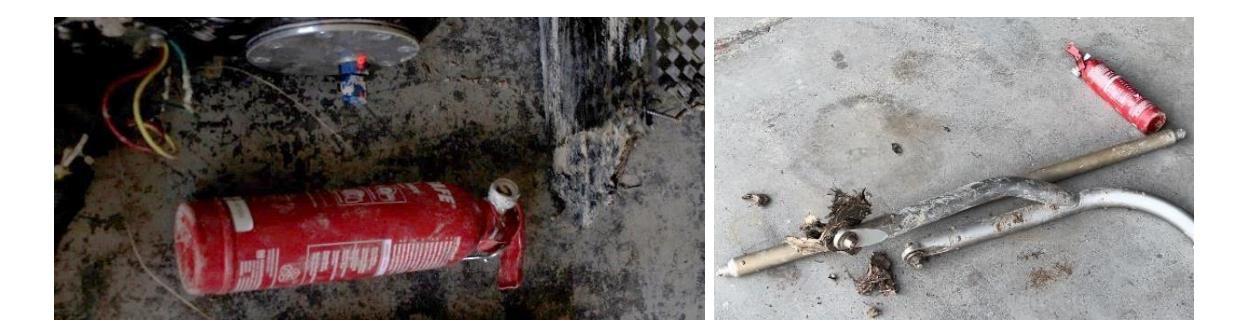
A fire extinguisher was found together with the wreckage. It was not part of the approved configuration. There is no provision of a storage place in the cabin for the fire extinguisher.

Figure 29. Fire Extinguisher

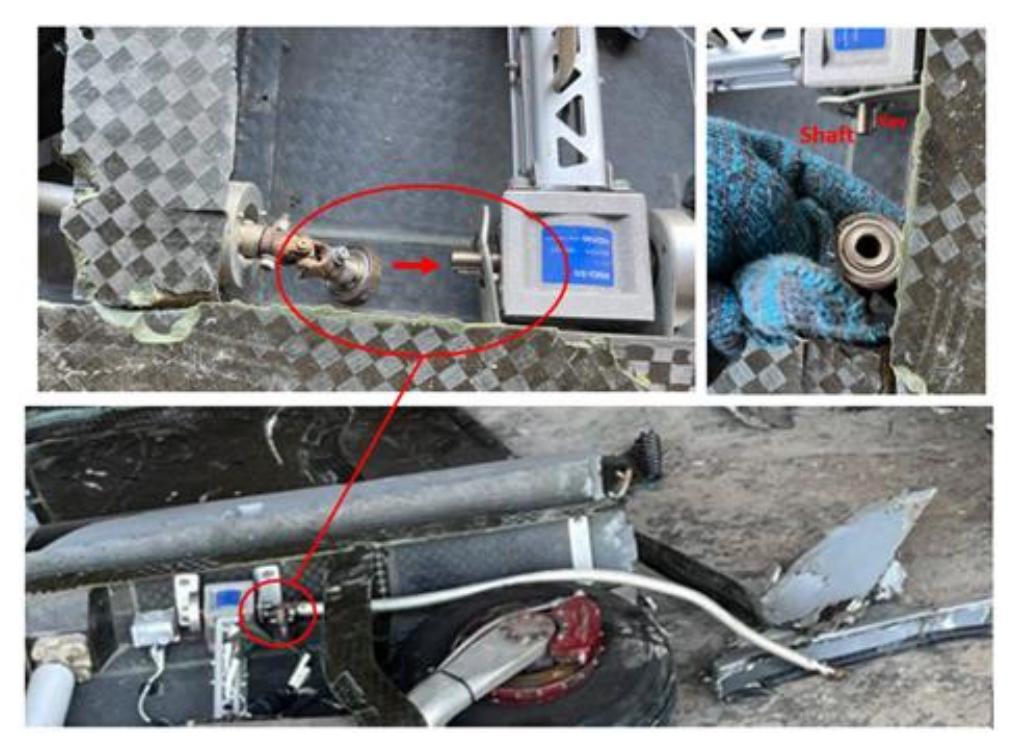
An additional wreckage assessment was conducted on the RH flap connecting rod to evaluate the bending of the right wing. The RH flap rod joint was re-connected onto the shaft of the flap actuator (wing side), as depicted in Figure 30 below. The shaft has a key that ensures a precise positioning within the joint. Assessing the bending of this flap rod indicates that the direction of wing bending was up.

Figure 30. RH flap connecting rod joint re-connected to flap actuator shaft

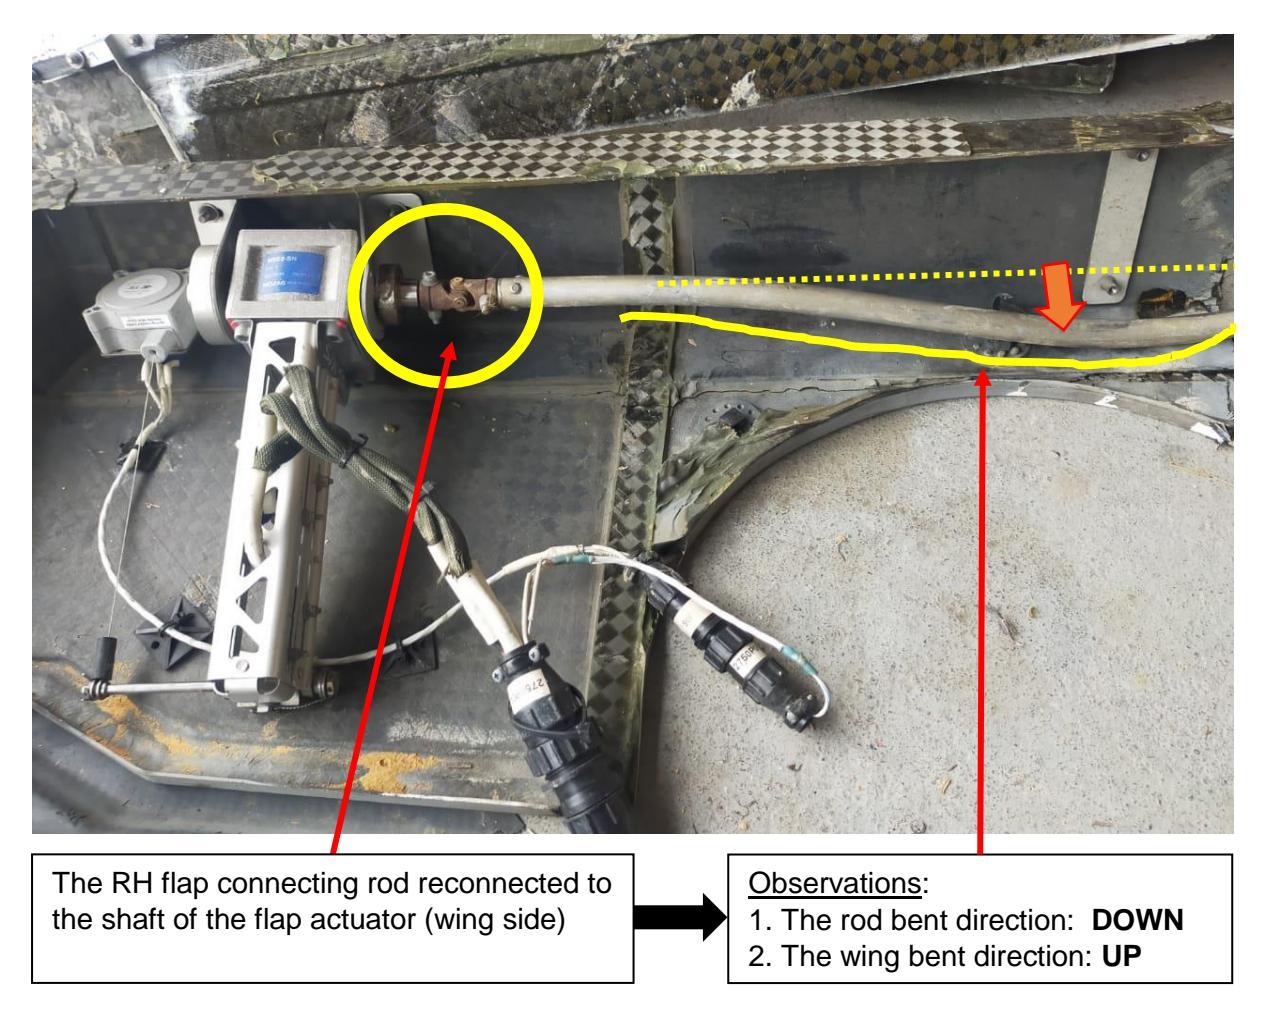
Figure 32. Wing Bent Direction

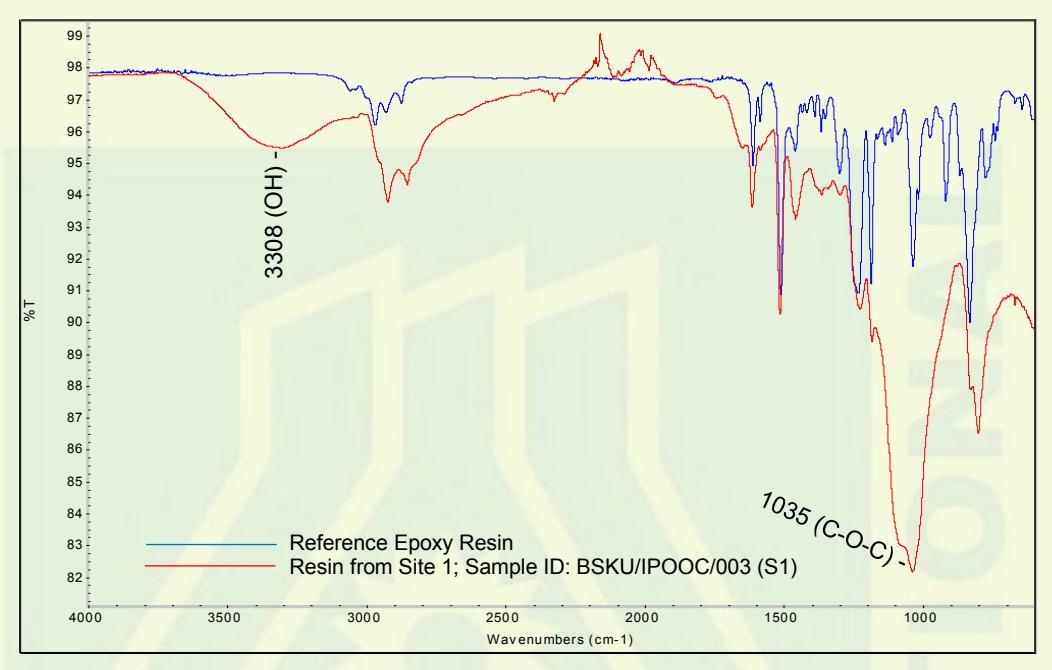
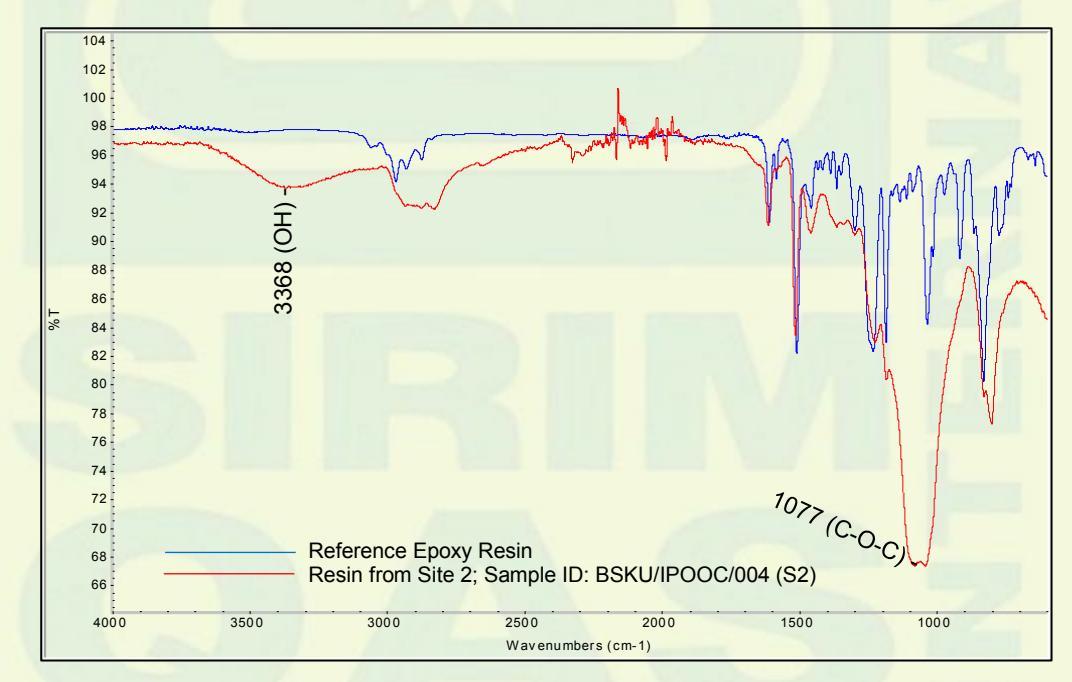
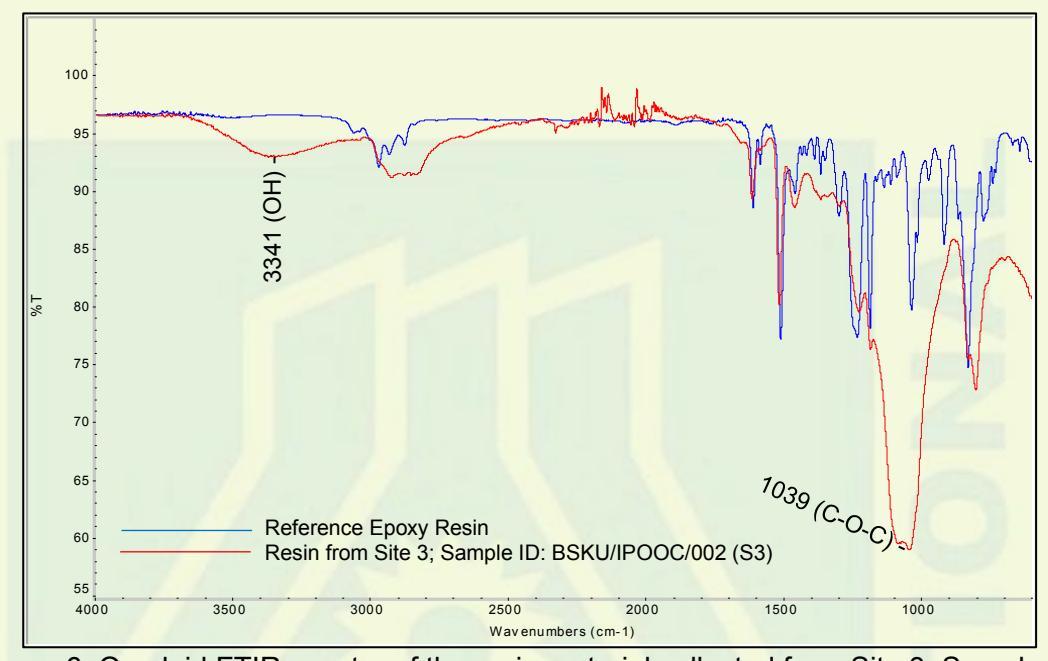
The overlaid FTIR spectra indicates that the FTIR spectrum of both tested samples are relatively similar to that of the reference epoxy resin except at the absorption peak at approximately (3308 – 3368) cm⁻¹ and (1035 -1077) cm⁻¹. Explanation regarding these additional peaks are as follows:

- Peaks at about 3308 cm⁻¹, 3341 cm⁻¹ and 3368 cm⁻¹: These peaks are often associated with O-H stretching vibrations, which can indicate the presence of hydroxyl groups. Hydroxyl groups can be formed as a result of material hydrolysis, especially in the case of water absorption or chemical breakdown involving water. In epoxy resins, this peak may suggest moisture uptake or possible hydrolytic degradation.
- Peaks at 1035 cm⁻¹, 1039 cm⁻¹ and 1077 cm⁻¹: These peaks are commonly attributed to the C-O-C stretching vibrations of ether groups, which are part of the epoxy structure. It could also be indicative of aliphatic ether linkages, which are typical in many epoxy-based materials. This peak does not specifically suggest degradation but rather the inherent chemical bonds in the cured resin.

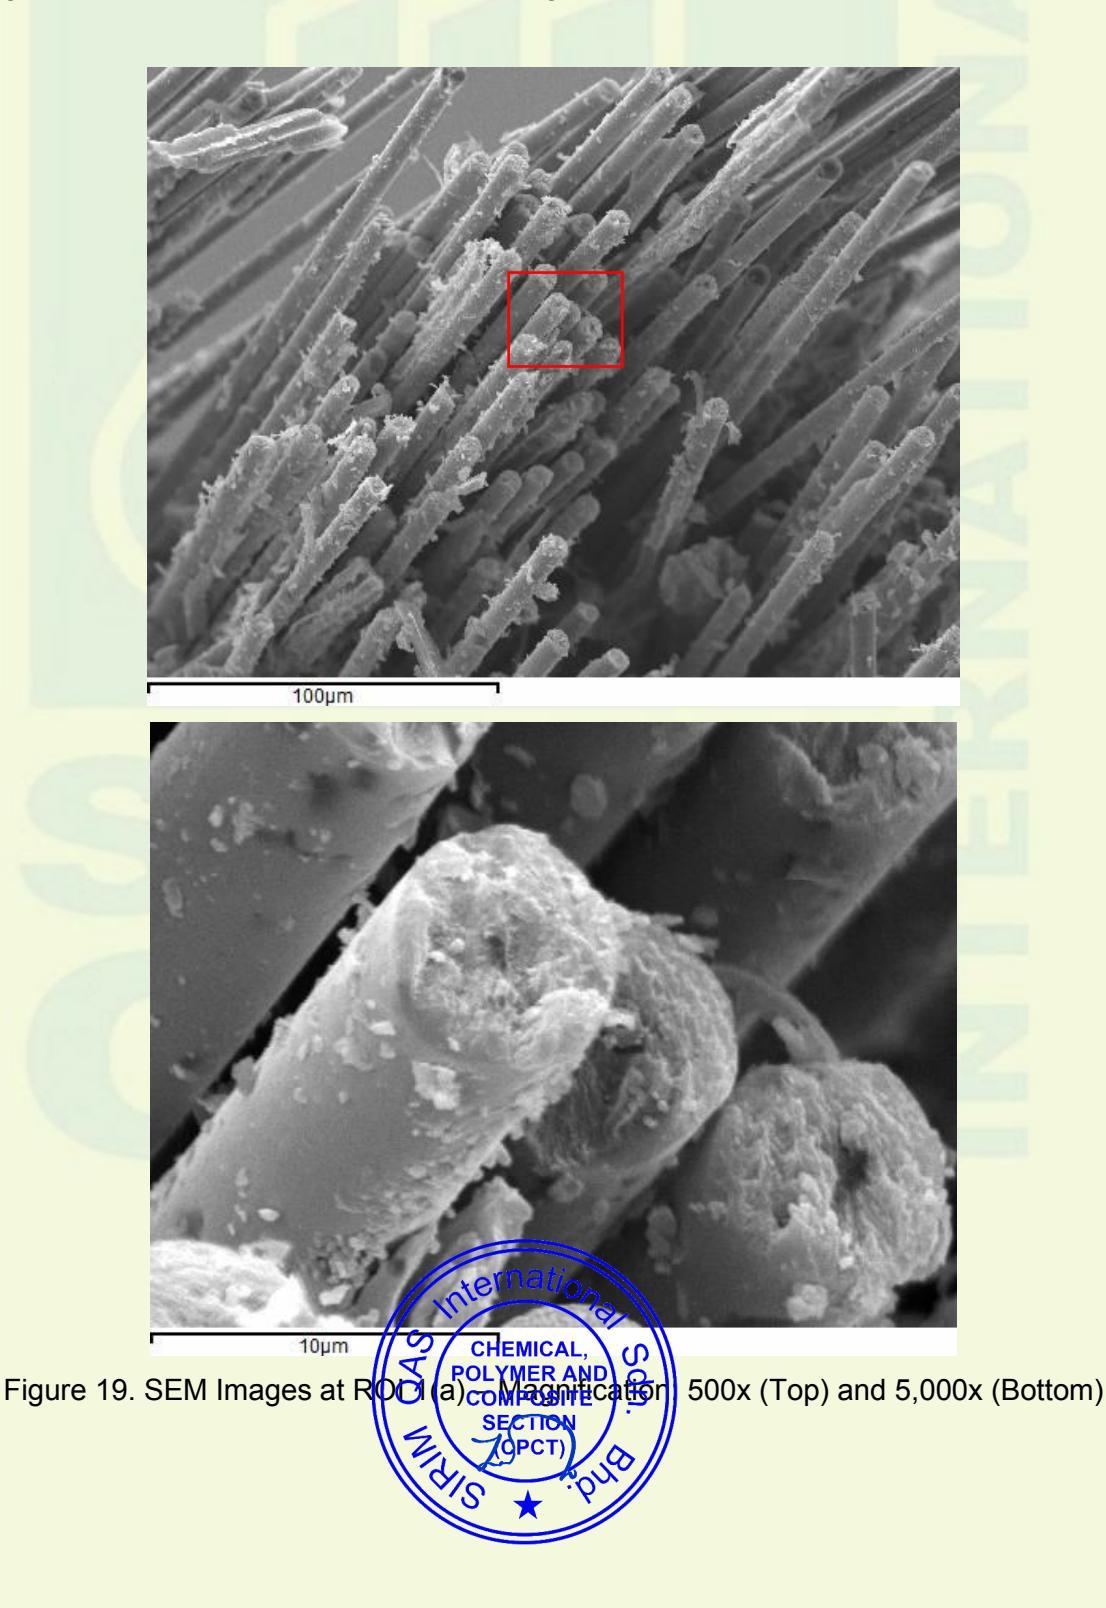
The SEM images of cracked surfaces found at the ROIs in Site 2; Sample ID: BSKU/IPOOC/004(S2) - Right wing - near to the wheel well, are shown in Figures 19 to 23.

The SEM images of the carbon fibres in the failed CFRP (Carbon Fiber Reinforced Polymer) component shows some key features that suggest certain failure mechanisms:

- i. **Fiber Pull-out:** The exposed and partially separated fibres in the image indicate a weak fiber-matrix bond, which often leads to fibre pull-out. This could suggest that the failure initiated due to poor adhesion between the epoxy matrix and the carbon fibres, which is commonly caused by environmental factors like moisture (related to hydrolysis), poor curing, or degradation over time.

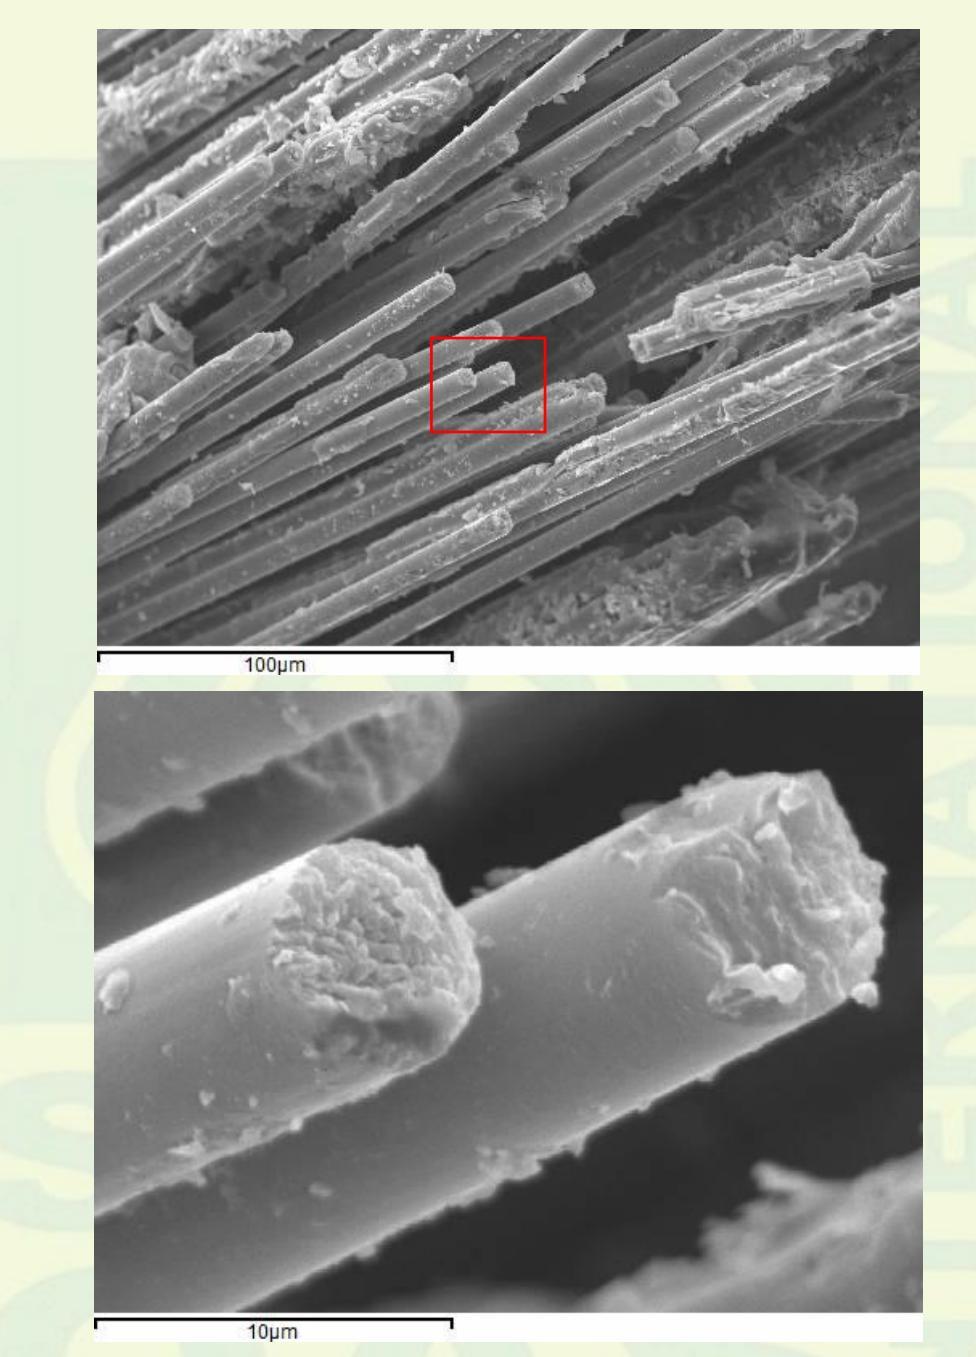
Figure 20. SEM Image at ROI 1(b) – Magnification: 500x (Top) and 5,000x (Bottom)

- ii. **Fiber Breakage:** Some fibres appear to have rough, fractured ends, indicating they underwent brittle failure. This could be due to mechanical overload or a fatigue-related failure mechanism, where repeated stress leads to crack propagation through the fibres themselves.

- iii. Debonding and Surface Degradation: The presence of debris on the surface of the fibres and the lack of continuous matrix around some of them suggests that environmental degradation, such as hydrolysis (from moisture absorption), might have led to debonding. This would cause a loss of load transfer between fibres and the matrix, leading to failure.

- iv. **Matrix Cracking:** Although the matrix is not clearly visible, the combination of fibre pull-out and breakage suggests that matrix cracking or delamination likely occurred. This could have been initiated by environmental degradation (such as hydrolysis), mechanical stress, or thermal cycling.

The failure mechanism described above likely involves environmental degradation (hydrolysis) due to moisture absorption, leading to fibre-matrix debonding, and mechanical overload or fatigue, resulting in fibre breakage. This combination can cause the overall composite structure to weaken and fail under service loads.

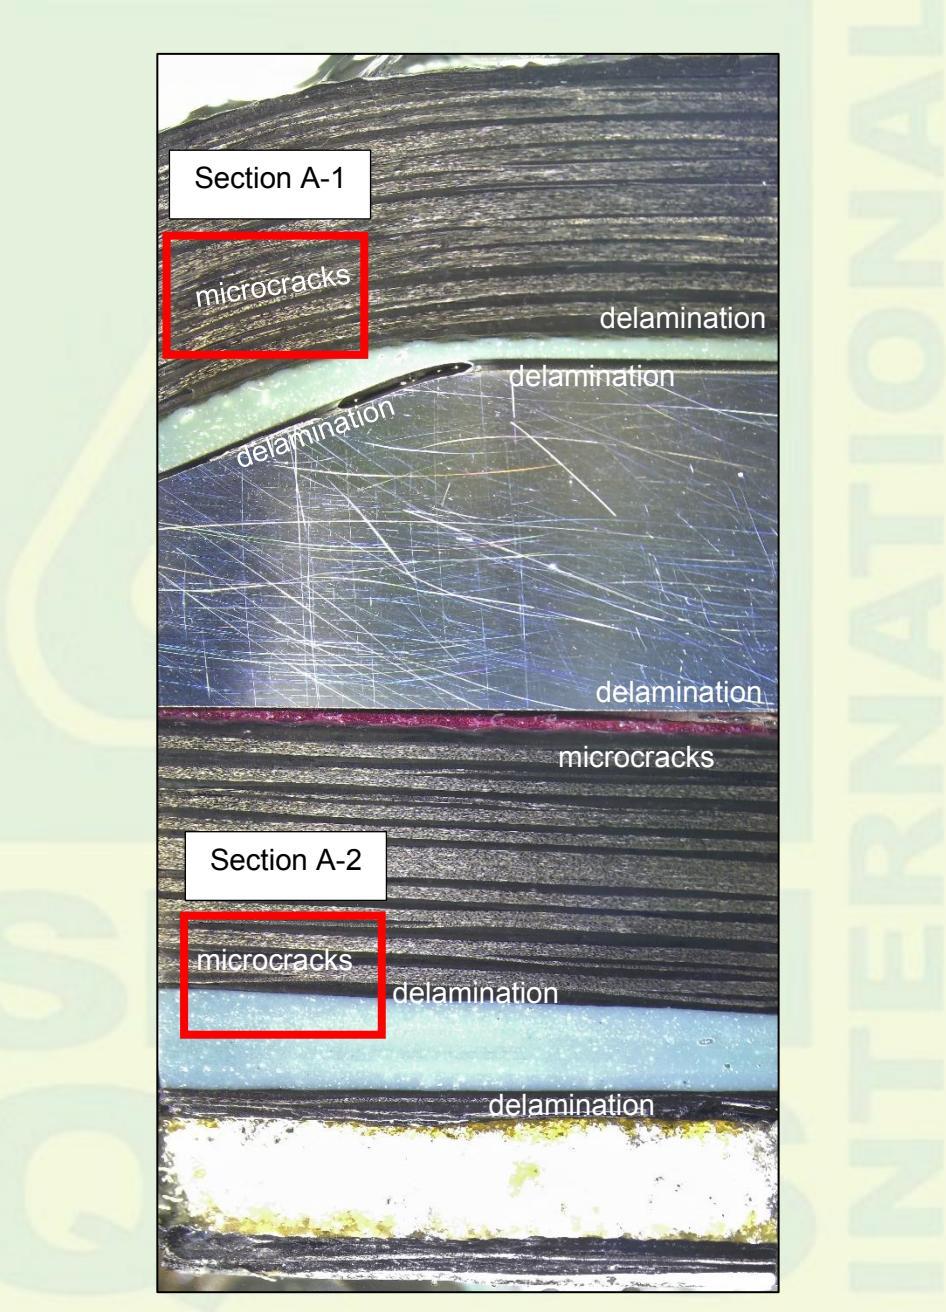
Figure 24. Cross Sectioned Image at Cut Section A – Using Stereo Microscope; Magnification: 10x

- i. **Microcracks in the Matrix**: The microcracks appear between the fibre layers, particularly within the resin matrix. Microcracks can form due to several reasons such as thermal cycling, mechanical stress, or chemical degradation (e.g. hydrolysis as found the FTIR and TGA analysis). The presence of microcracks can lead to:

- **Delamination**: If these cracks propagate, they could result in delamination, which is a significant failure mode in composite structures. Delamination can drastically reduce the strength and stiffness of the component.

- ii. Crack Propagation Direction: The orientation of the cracks relative to the fibres seems parallel or slightly inclined. If these cracks align with the primary stress directions or continue to propagate under operational loads (such as in-flight mechanical stresses), they could contribute to material failure over time.

While the microcracks are not catastrophic on their own, they are a sign of underlying issues that could eventually lead to failure. The accumulation of these cracks under repeated load cycles can result in:

- i. **Fatigue Failure**: Over time, cyclic stresses could propagate these microcracks, leading to larger fractures.
- ii. **Moisture Ingress**: In composite structures, microcracks can allow moisture to penetrate, leading to hydrolysis or other chemical degradation (especially in the epoxy matrix).
