AIRCRAFT ACCIDENT FINAL REPORT A 03/24 Air Accident Investigation Bureau (AAIB) Ministry of Transport Malaysia

Fixed-Wing Aircraft Blackshape BK 160TR, Registration I-POOC at Kapar, Selangor on 13 February 2024

FINAL REPORT NO: A 03/24

AVIATION SAFETY TECHNOLOGY PTE LTD,
SINGAPORE (PRIVATE OPERATOR) ¹
BLACKSHAPE BK 160TR
ITALY
I-POOC
KAMPUNG TOK MUDA, KAPAR, SELANGOR
MALAYSIA
13 FEBRUARY 2024 AT 1336 LT (0536 UTC)

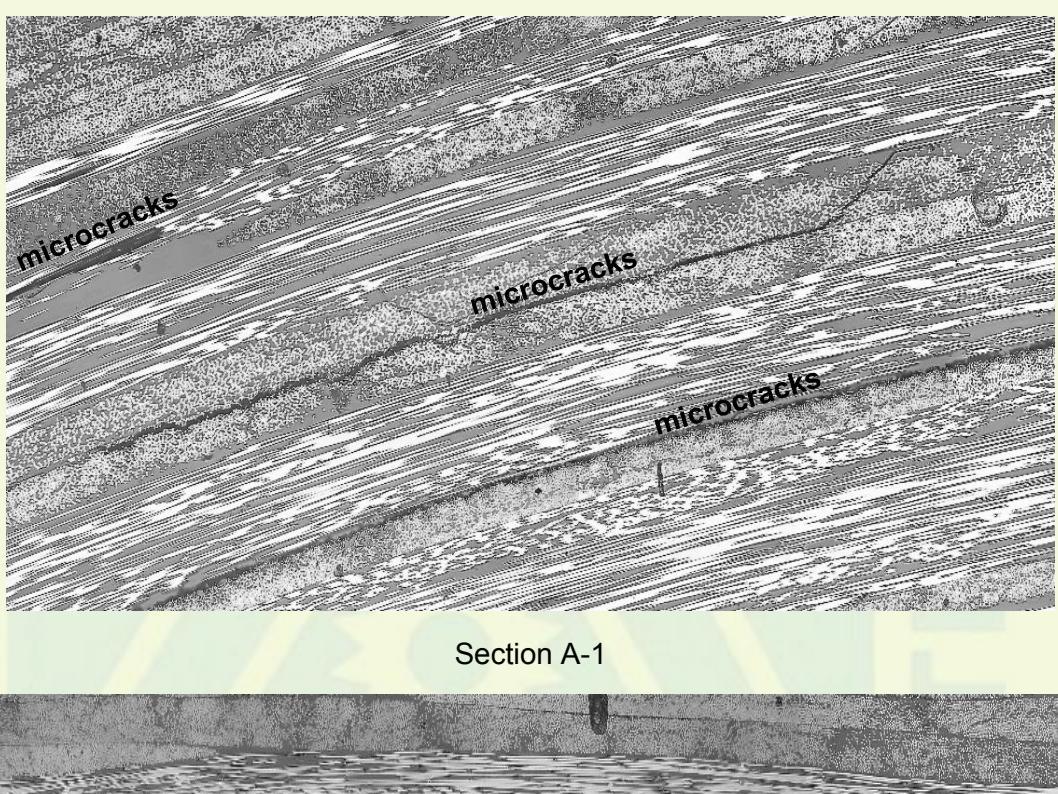
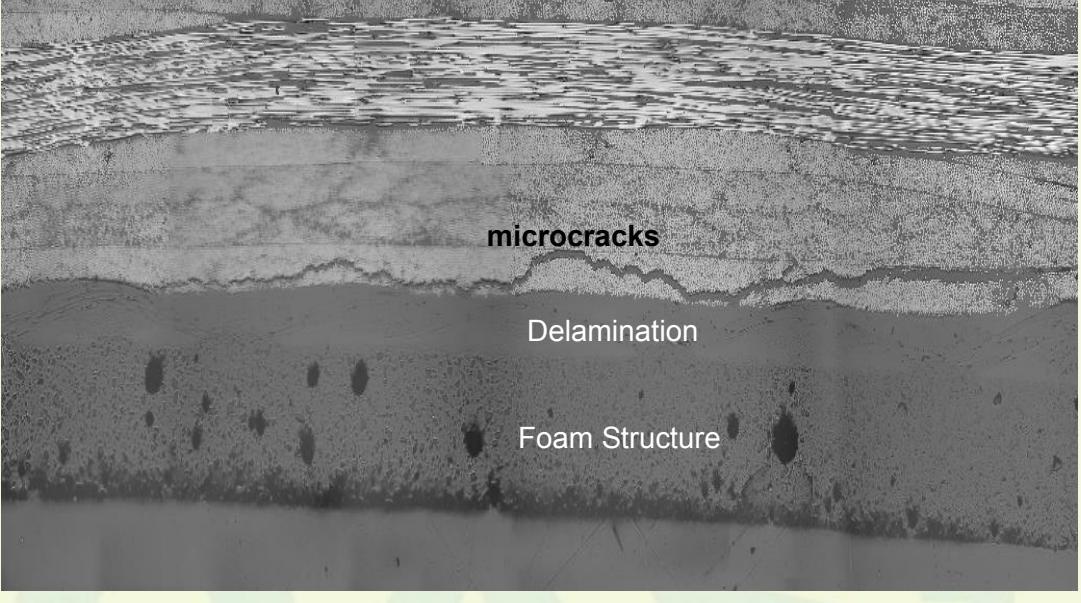
Figure 25. Cross Sectioned Image at Cut Section A – Using Compound Microscope; Magnification: 50x

- i. **Microcracks in the Matrix**: The microcracks appear between the fibre layers, particularly within the resin matrix. Microcracks can form due to several reasons such as thermal cycling, mechanical stress, or chemical degradation (e.g. hydrolysis as found the FTIR and TGA analysis). The presence of microcracks can lead to:

- **Delamination**: If these cracks propagate, they could result in delamination, which is a significant failure mode in composite structures. Delamination can drastically reduce the strength and stiffness of the component.

- ii. Crack Propagation Direction: The orientation of the cracks relative to the fibres seems parallel or slightly inclined. If these cracks align with the primary stress directions or continue to propagate under operational loads (such as in-flight mechanical stresses), they could contribute to material failure over time.

While the microcracks are not catastrophic on their own, they are a sign of underlying issues that could eventually lead to failure. The accumulation of these cracks under repeated load cycles can result in:

- i. **Fatigue Failure**: Over time, cyclic stresses could propagate these microcracks, leading to larger fractures.
- ii. **Moisture Ingress**: In composite structures, microcracks can allow moisture to penetrate, leading to hydrolysis or other chemical degradation (especially in the epoxy matrix).

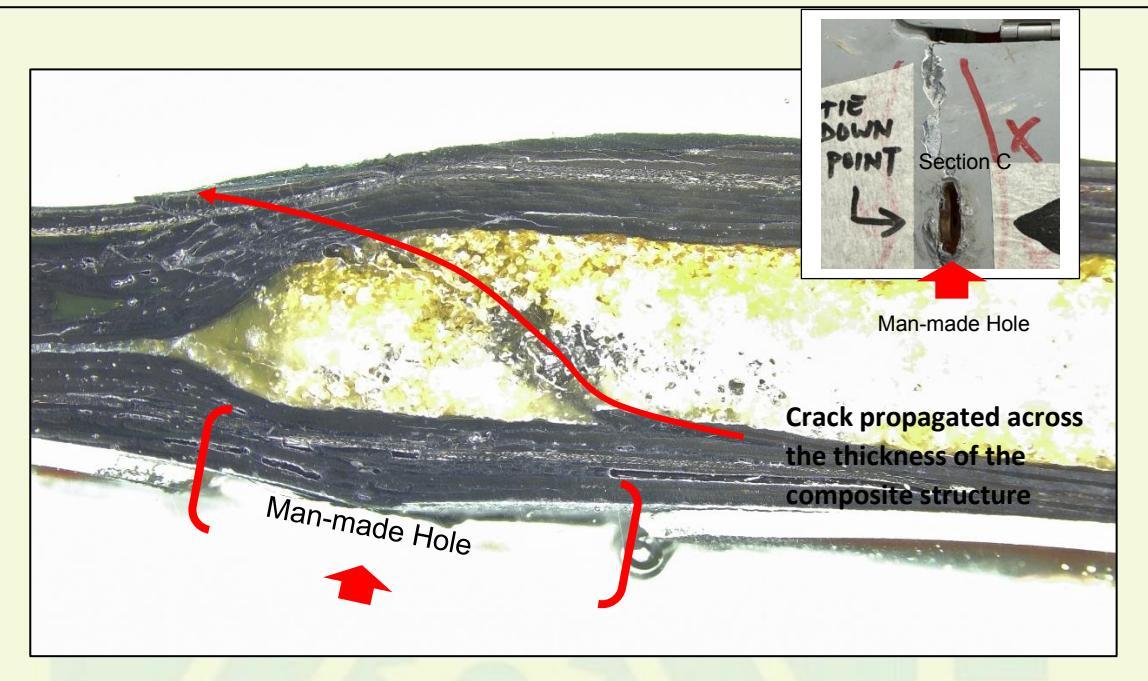
Figure 28. Cross Sectioned Image at Section C – Using Stereo Microscope; Magnification: 10x

The surface morphology shown in Figure 28 to 31 present more significant signs of damage than the previous one. They key observations that can be made from these images are as follows:

- Impact on Mechanical Strength: The presence of these voids creates stress concentrations, meaning that even small loads (e.g. drilling a hole) can cause localized stress peaks around the voids, potentially leading to crack initiation and propagation. This dramatically increases the likelihood of failure under service conditions.

- ii. Microcracks:
 - Similar to the previous images, microcracks are visible near the fibre layers. However, the
 extent of these cracks appears more severe, particularly in areas adjacent to the voids. This
 suggests that microcracks have developed as a result of the stress concentrations induced by
 the voids.

- Poor bonding during the manufacturing process (due to the voids).
 - Cyclic loading causing the cracks to spread, leading to further separation.
 - Environmental factors such as moisture ingress (particularly relevant if hydrolysis or chemical degradation is present).

iv. Layer Delamination:

There is evidence of interlayer delamination, which is a typical failure mode in composite materials. The delamination is likely exacerbated by the presence of voids and microcracks, causing the material to lose cohesion between the composite layers.

The combined presence of **voids**, **extensive microcracks**, **and fiber-matrix separation** points to significant material degradation. The voids alone could cause a major reduction in mechanical strength, while the presence of microcracks further compromises the material's structural integrity especially after it has been exposed to external load during drilling process to make the man-made hole which has led to formation of severe cracking across the thickness of the composite structure.

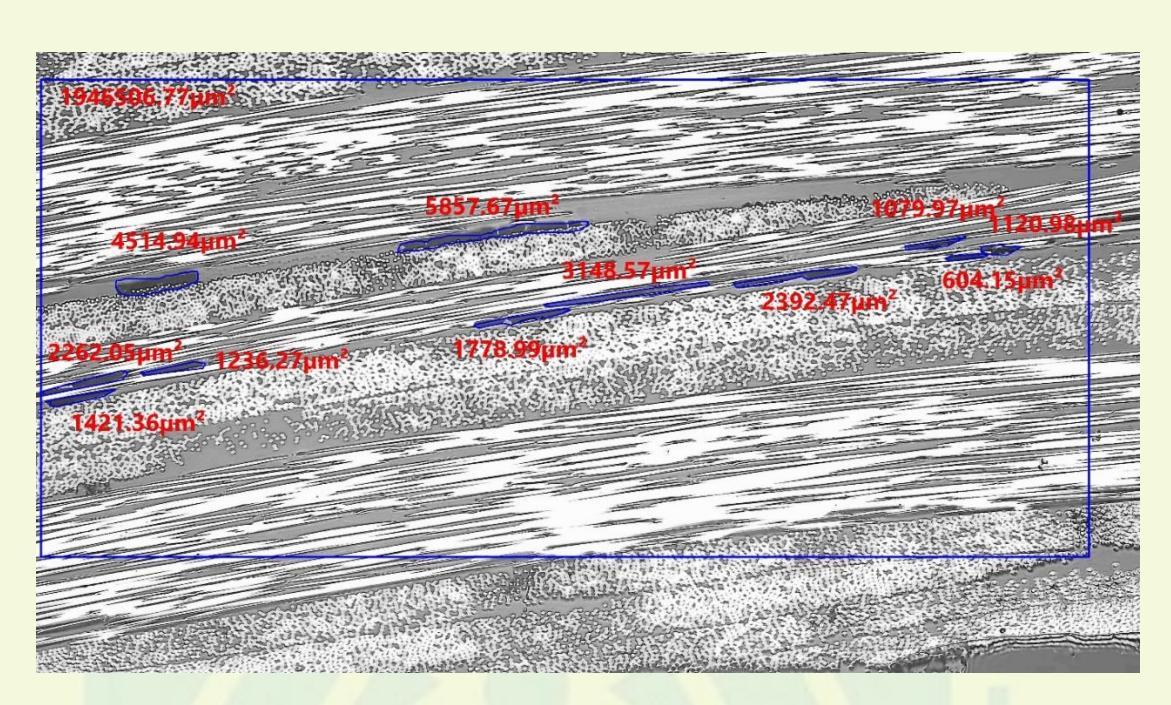
Figure 34. Area Used for the Calculation of Void Content

For the area marked in blue rectangle the calculated void content is approximately 1.2% and the ply/laminate thickness for the 90° fibre orientation is approximately 114 μ m (0.114 mm)

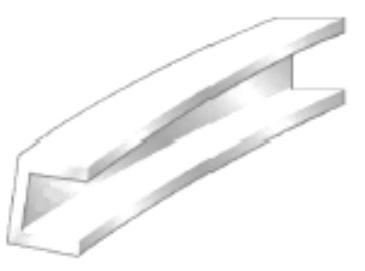
Figure 4-8 Sketch showing deformation of a C shaped spar

IMPORTANT NOTE: In case of left-wing skin loss, the torsion stiffness is greatly reduced, and the rear "C" shaped spar is exposed to higher deformations (in plane, out of plane, torsion) that would have led to additional stress to the aileron hinges attachment points. Under the loads reported in the table above, this could have caused the complete aileron detachment.

From the above evaluations, based on the data available so far, the hypothesis of aileron loss following a full right stick deflection to recover from the left-wing skin loss is considered a plausible scenario.

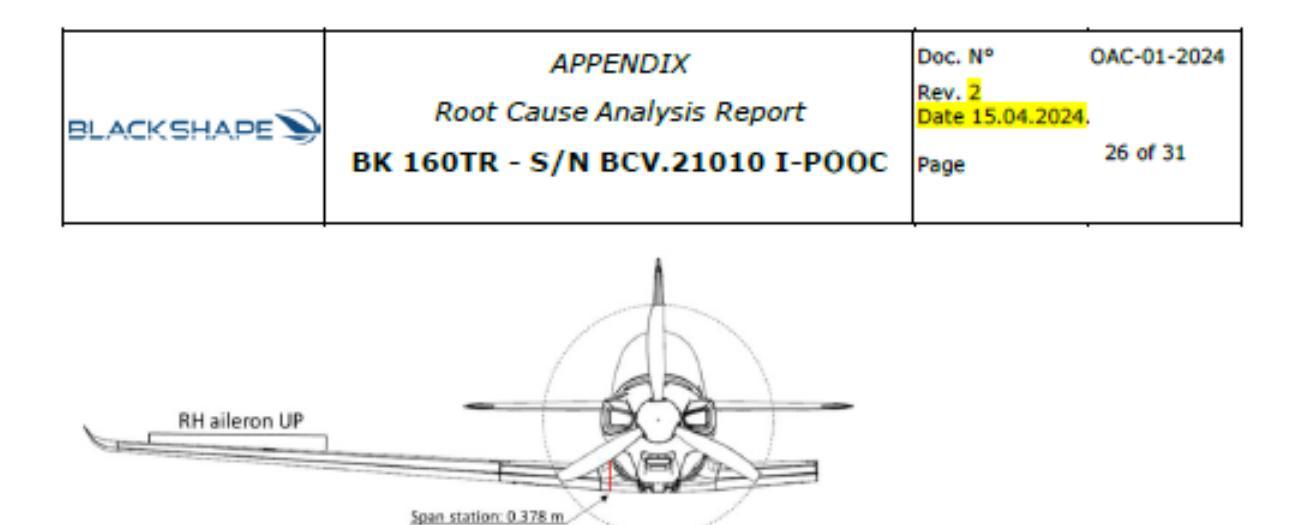
Figure 4-9 Schematic representation of the RH wing condition and its span corresponding to the break-up location for which the load is calculated

In Figure 4-9 is shown a schematic representation of the RH wing condition and its span corresponding to the break-up location for which the load is calculated:

² It is supposed that the pull-up brought the RH wing to the maximum angle of attack (maximum lift coefficient), while the LH wing was stalled due to the loss of the skin.

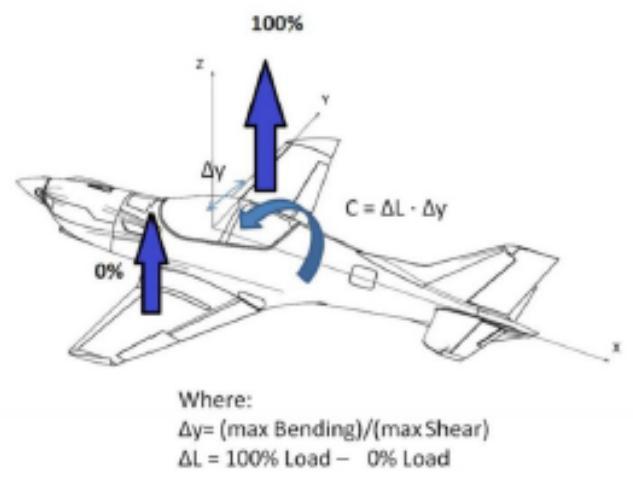
Figure 4-10 Rolling moment generated by unbalanced lift

The unbalanced lift generates a rolling moment as shown in Figure 4-10, while the aileron deflection generates a rolling moment in the opposite direction. Both contributions are considered to calculate the rolling acceleration as shown below:

The roll moment is calculated considering the difference between the lift of the RH wing and the lift of LH wing, considered equal to 0 for the loss of the skin.
