**AIRCRAFT ACCIDENT
FINAL REPORT
A 05/23P**

**Air Accident Investigation Bureau (AAIB)
Ministry of Transport Malaysia**

**Accident Involving Fixed Wing Aircraft Hawker Beechcraft 390 Premier 1,
Registration N28JV, at Elmina, Shah Alam, Selangor
on 17 August 2023**

Issued on 16 August 2024
MOT.(S).600-5/4/99

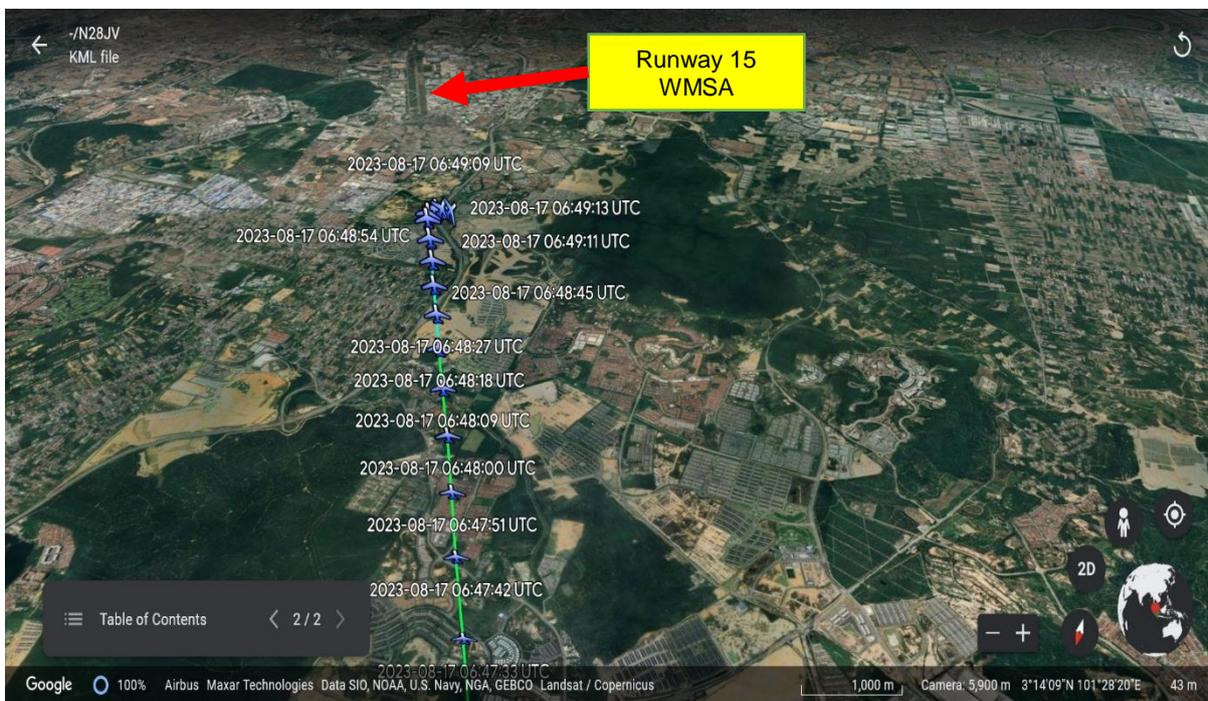
Figure 1. N28JV Flight Path on Final Runway 15.

Automatic Dependent Surveillance–Broadcast (ADS-B) data indicated that at 1447:24 LT, at an altitude of 2,600 feet, the aircraft began a speed reduction and descent. At approximately 1449:06 LT, at an altitude of 1,025 feet, the aircraft initiated a right turn, continuing until about 1449:14 LT, when it was at an indicated height of 550 feet. This was the last recorded data transmission from the accident flight, which was near the accident location. The ground speed during the right turn ranged between 146 and 154 knots. The aircraft crashed at Persiaran Elmina, Elmina, Shah Alam.

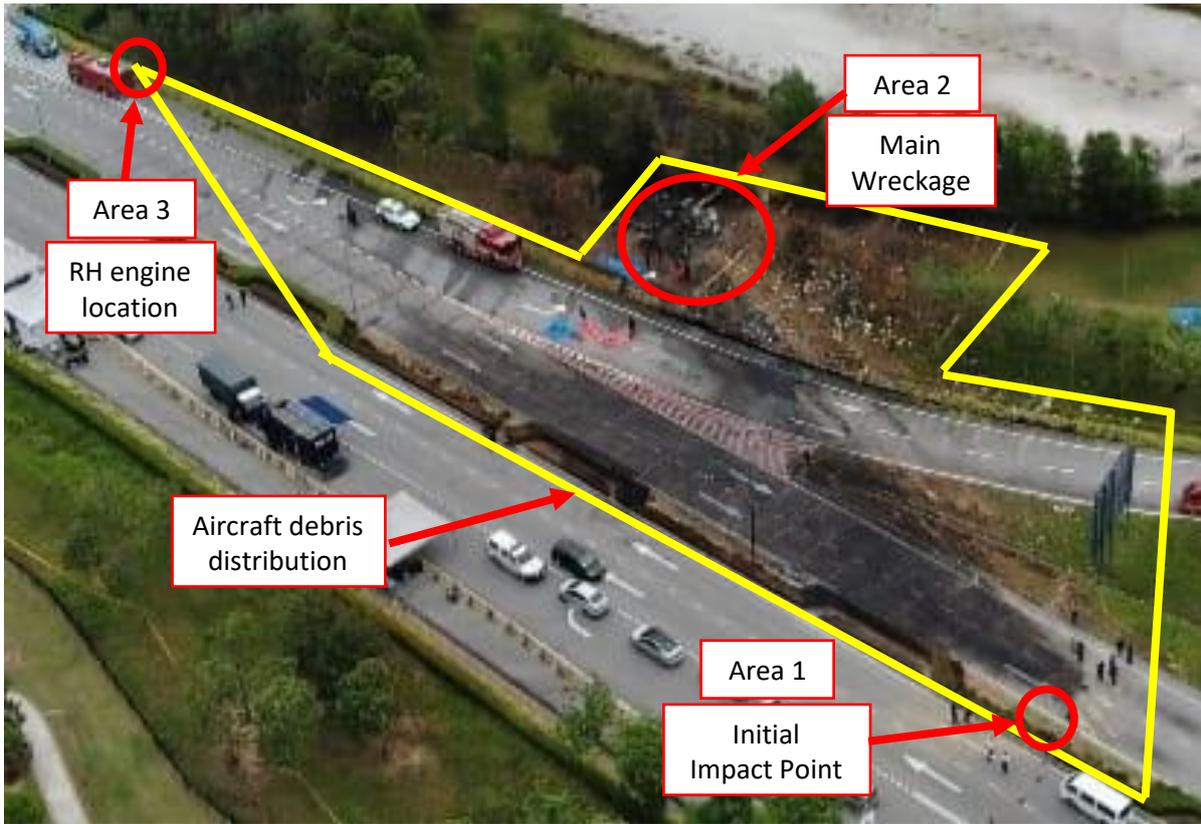
Figure 6. General Map of Wreckage and Impact Information.

The aerial photo of the crash site (impact point position – 3°10'51.9"N 101°30'53.5"E) in Figure 6 provides a general illustration of the site, indicating the initial ground impact point, the location of the main wreckage, and the location of the right engine. Area 1 (the red line circle) denotes the initial ground impact point. Area 2 (the red line circle) highlights the main wreckage, while Area 3 (the red line circle) indicates the location of the right engine. The yellow line illustrates the distribution area of the aircraft debris.

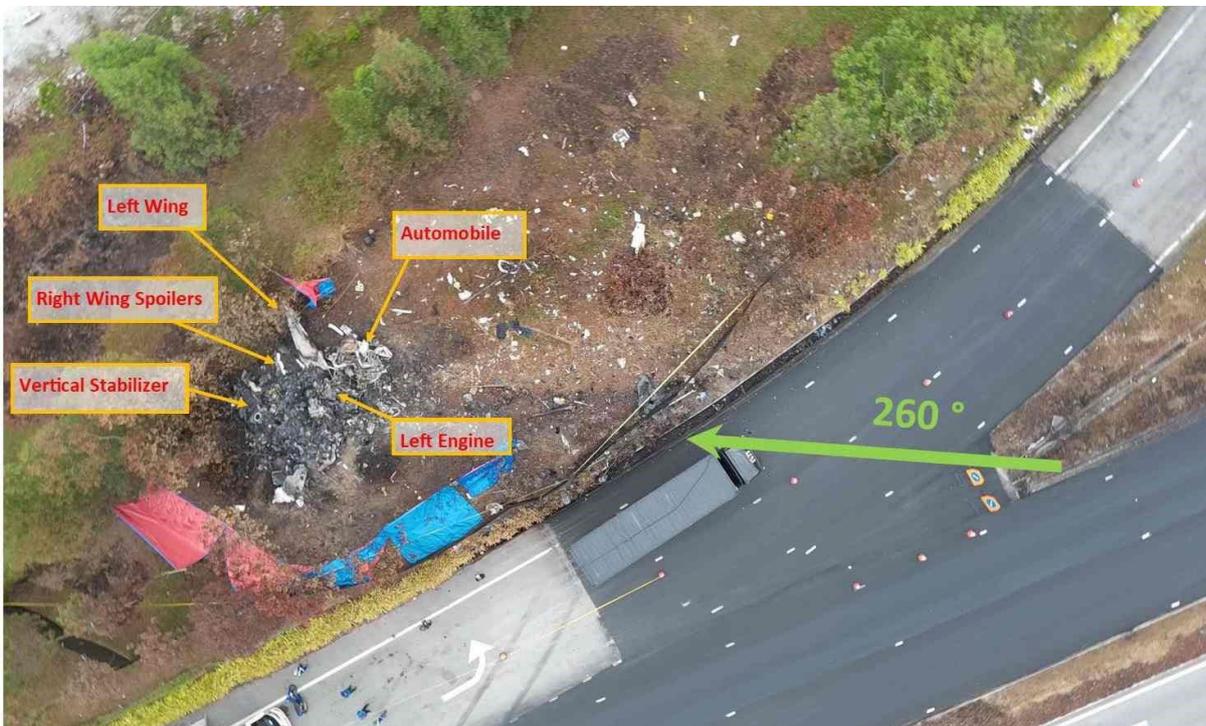
Figure 7. Main Wreckage at the Accident Site.

The first identified point of impact was characterised by a 5-ft-long ground scar, on a heading of 260° (Figure 7), in the central median of the highway about 3 miles northwest of the approach end of WMSA airport Runway 15. Fragments of the green navigation light lens were located within the disruption.

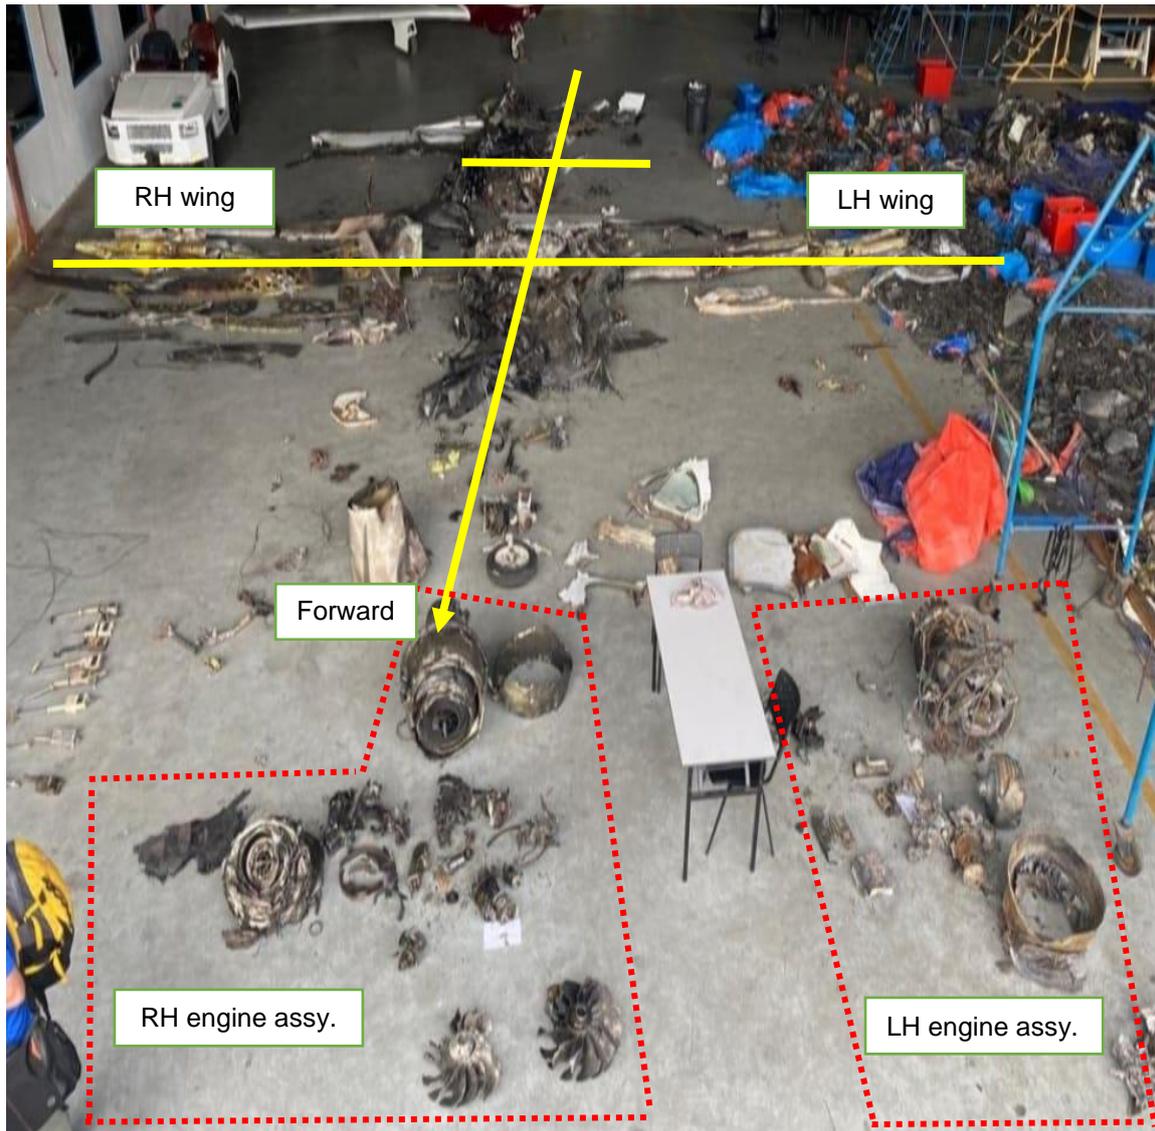
Figure 8. Layout of the Aircraft Wreckage.

A basic reconstruction method of the aircraft wreckage was used to identify the aircraft parts, components and power plants assembly for further investigation (Figure 8).

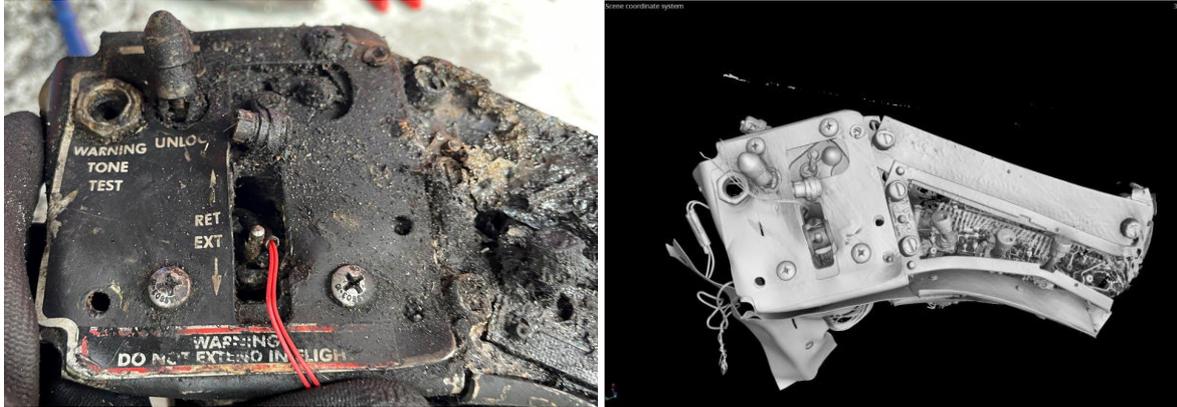
extension of the lift dump is strictly prohibited, as stated clearly on the lift dump panel: “WARNING – DO NOT EXTEND INFLIGHT.” Examination details for the components of the lift dump system are provided in Appendices E and F. For reference, systems description of the speed brake/lift dump spoilers is provided in Appendix G.

Figure 11. Lift Dump Panel (Left) and CT Image of the Panel (Right).

The details of the examination of the accident aircraft lift dump panel using CT is provided in Appendix F. The CT images confirmed that the lift dump handle was extended at the time of the accident. The photograph of the accident lift dump panel and CT image of the panel are provided in Figure 11. Photographs of the accident lift dump panel and an exemplar lift dump are shown in Figures 15 and 16 respectively:

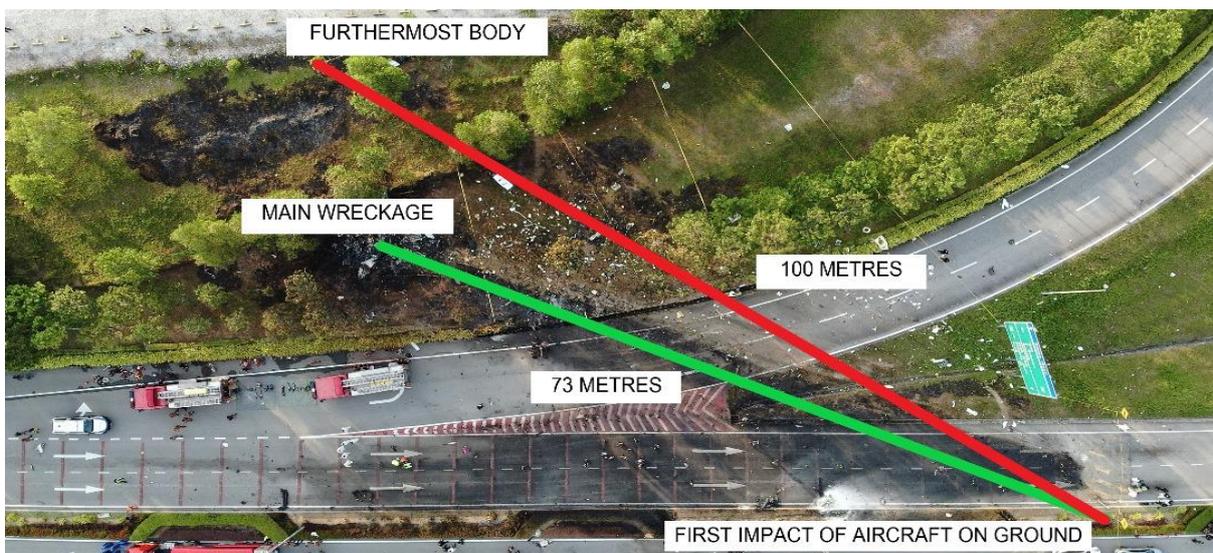
Figure 12. Distance between first impact and wreckage and furthest body.

The distance between the first impact of the aircraft on the ground and the furthest body found was approximately 100 meters. The main wreckage came to rest about 73 meters from the initial impact point (Figure 12). A massive post-crash fire engulfed the aircraft immediately after the collision.

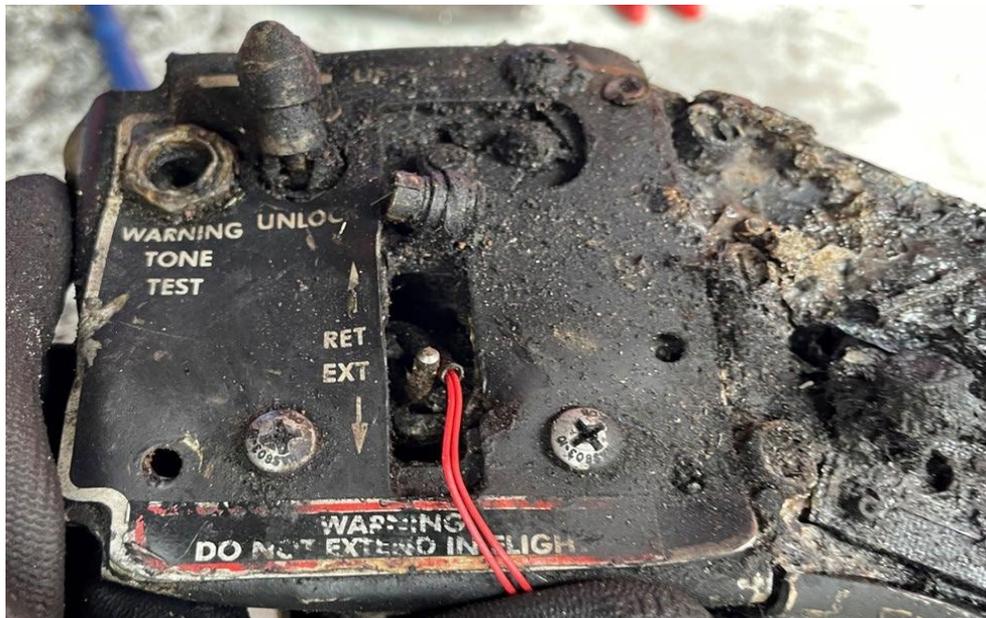
Figure 15. Lift Dump Panel

The details of the examination of the N28JV aircraft's lift dump panel using CT imaging confirm that the lift dump handle was in the EXT (extend) at the time of the accident.

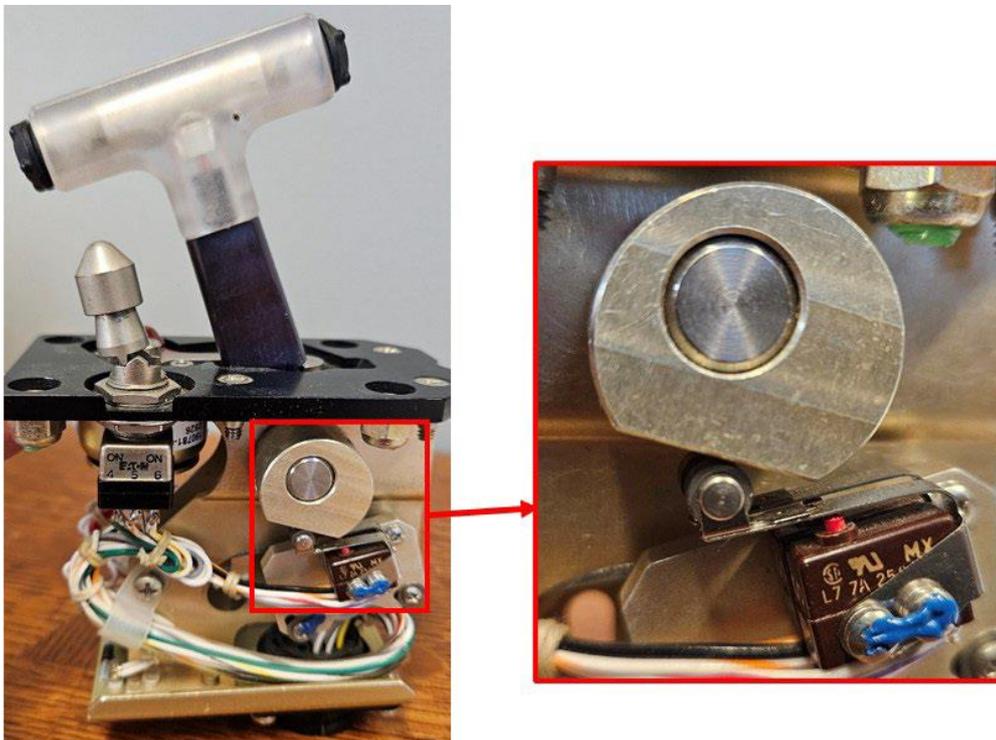
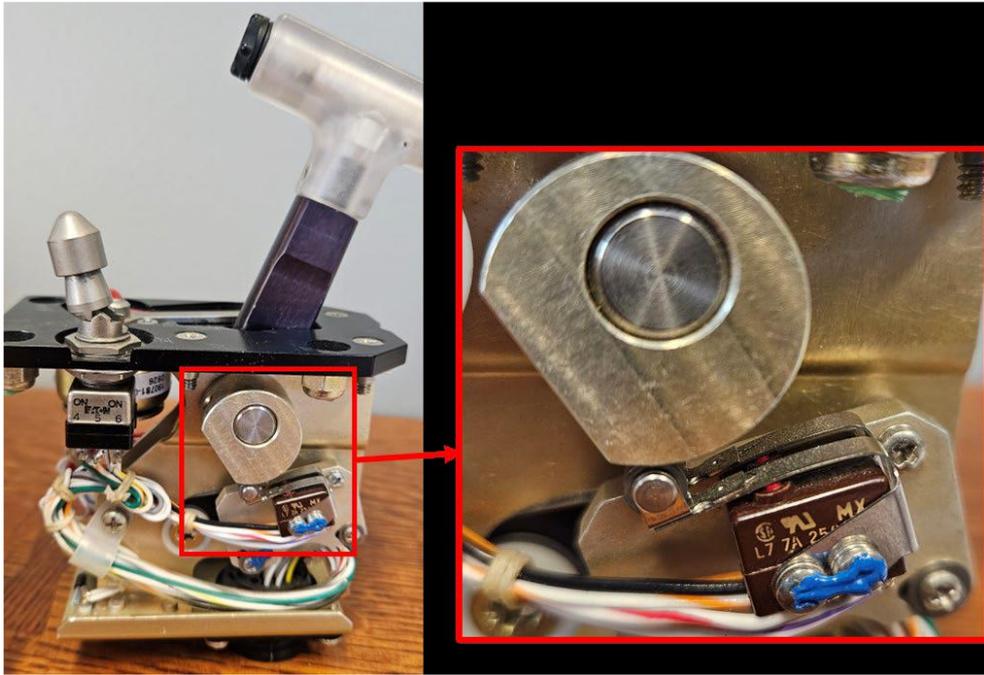
Figure 17: Photographs of exemplar lift dump handle – showing the left side in the RET (retract) position including a zoomed in view of the microswitch.

Figure 18: Photographs of exemplar lift dump handle – showing the left side in the EXT (extend) position including a zoomed in view of the microswitch.

Comparison of the exemplar lift dump handle photographs showing the RET (retract) and EXT (extend) positions in Figures 17 and 18 with the CT images in Figure 19 of the N28JV lift dump handle confirms that the lift dump handle was in the EXT (extend) position. Additional photographs, CT images, and detailed information from the CT examination are provided in Appendix F.

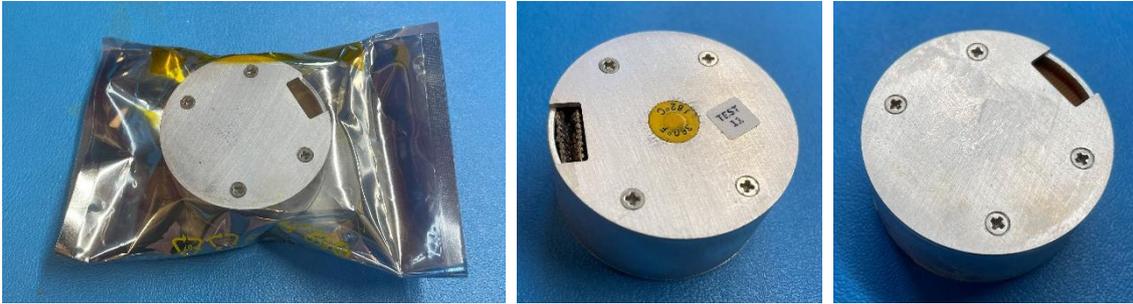
Figure 3: (Left). CVR memory module handed over to L3Harris.
(Centre): Front side. (Right): Back side.

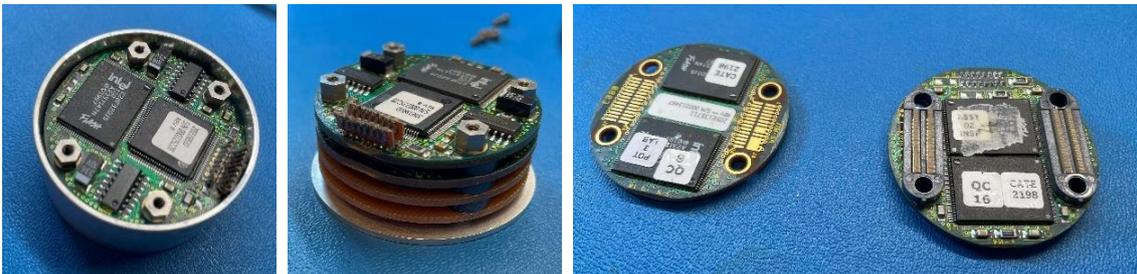
Figure 4: Disassemble of the memory module.

Disassembly of the memory module, including the removal of the remaining cable assembly components, was uneventful (Figures 4 and 5). Safe-to-power measurements performed after the cable remnants removal were within specification.

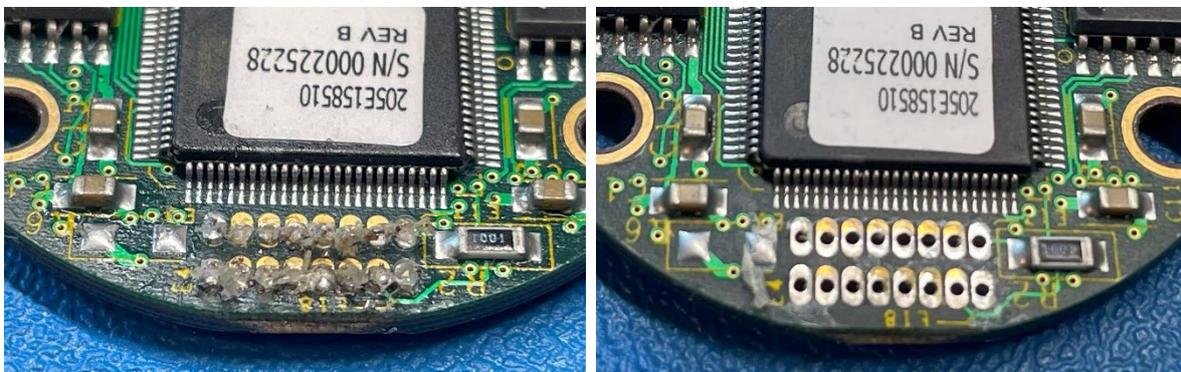
Figure 5. Removal of the remaining cable assembly. (Left): Before. (Right): After.

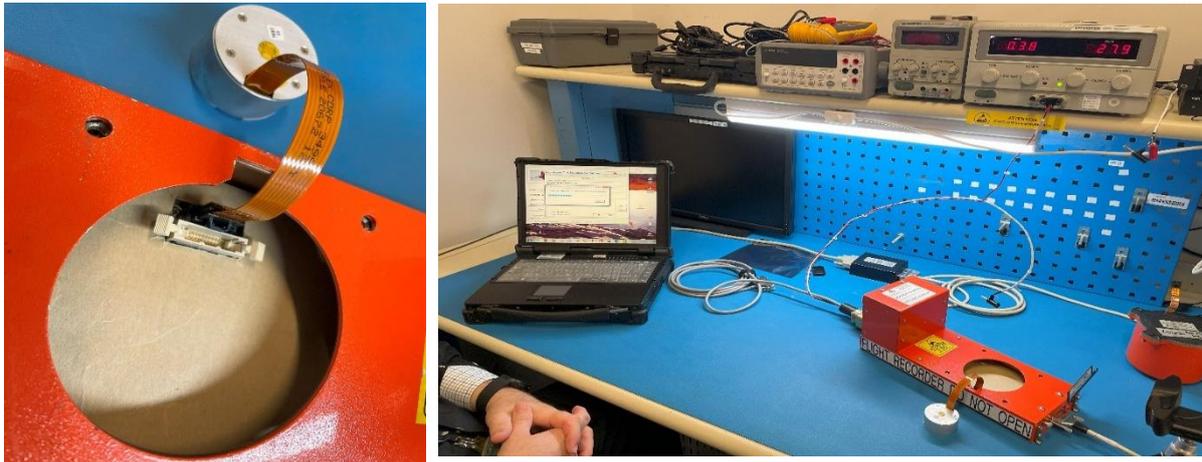
The FA2100 Accident Investigator's Kit (AIK) Golden Chassis was inspected, and a known good "golden" CSMU was used to demonstrate the functionality of the AIK. After successfully downloading the golden CSMU, the accident memory module (with replacement cable) was installed and downloaded (Figure 7). The download and subsequent data reconstruction/decompression were uneventful.

Figure 7. Accident memory module (with replacement cable) installed to (Left) and downloaded with the FA2100 AIK Golden Chassis (Right).

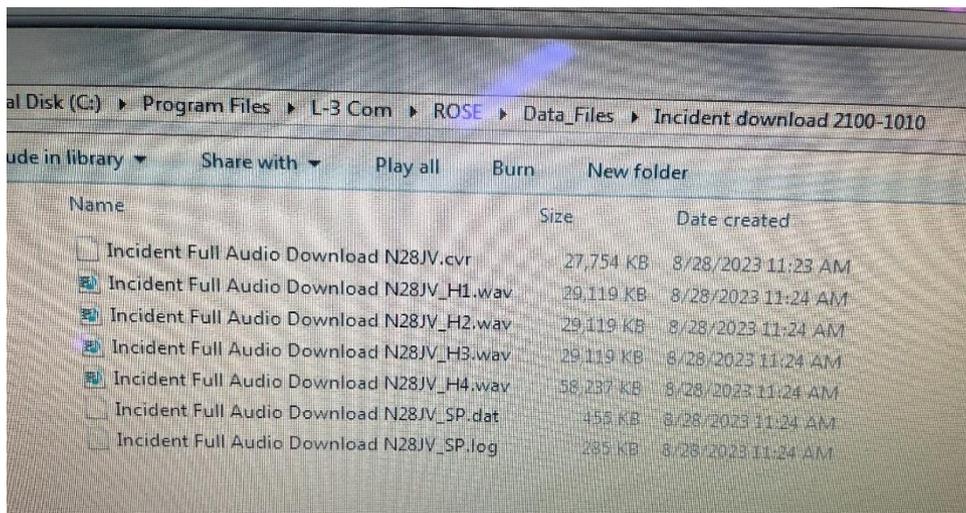
The downloaded audio files were then provided to the AAIB/TSIB/NTSB team for their analysis. The team reviewed the audio files retrieved, concluding that the files were complete and that the accident CVR data recovery was successful.

Figure 8. (Left): Complete and successful accident CVR data recovery.

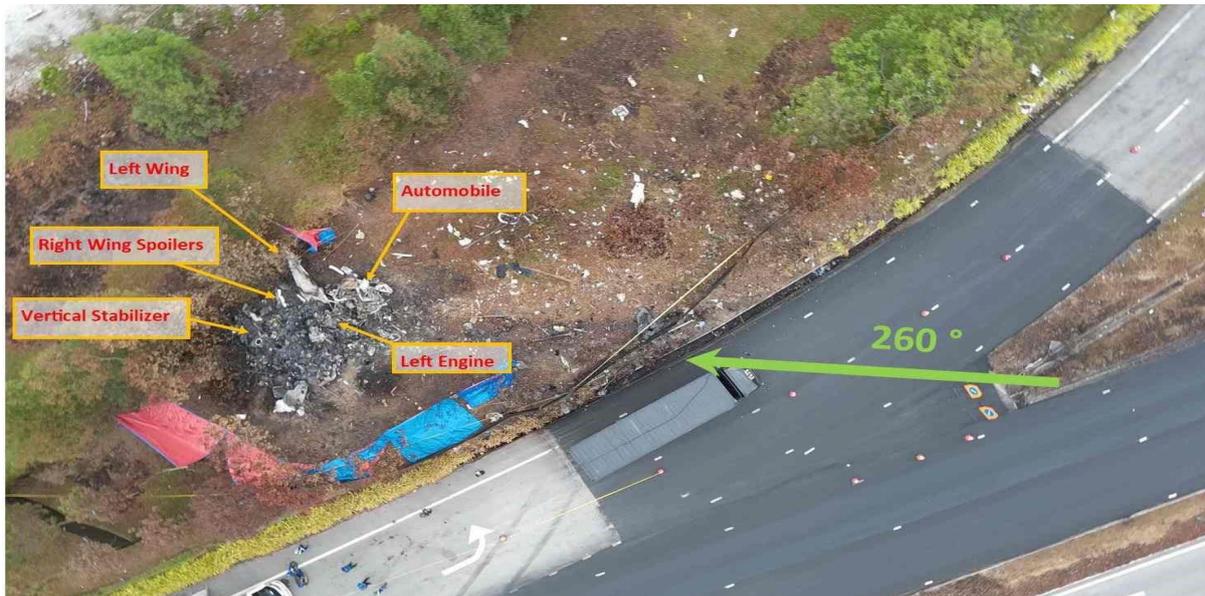
Figure 1. Accident Site.

The first identified point of impact was characterised by a 5-ft-long ground scar, on a heading of 260°, in the centre median of the highway about 3 miles northwest of the approach end of WMKL airport Runway 15 (Figure 1). Fragments of the green navigation light lens were located within the disruption.

Within the main wreckage area, the cabin had come to rest on a reciprocal heading from the debris and was resting against the left engine and a crushed automobile. The left wing remained partially attached to the cabin and was pointing north. The vertical stabiliser assembly was about 10 ft west of the cabin, and the left and right main landing gear remained with the main wreckage and attached to their respective wing attachments. The trunnion/upper section of the nose landing gear was found in the main wreckage. The nose gear piston/wheel was found in the immediate vicinity of the main wreckage.

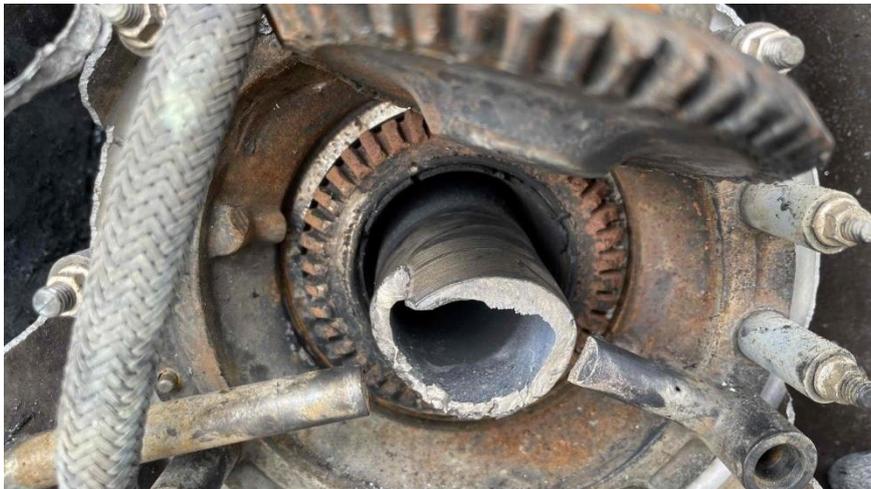
Figure 8. Left Engine LP Shaft.

Number 2 bearing and the 1st reduction bevel gear assembly remained in position, and the LP shaft remained in position but had twisted and separated, causing the shaft to twist in the opposite direction of rotation (Figure 8).

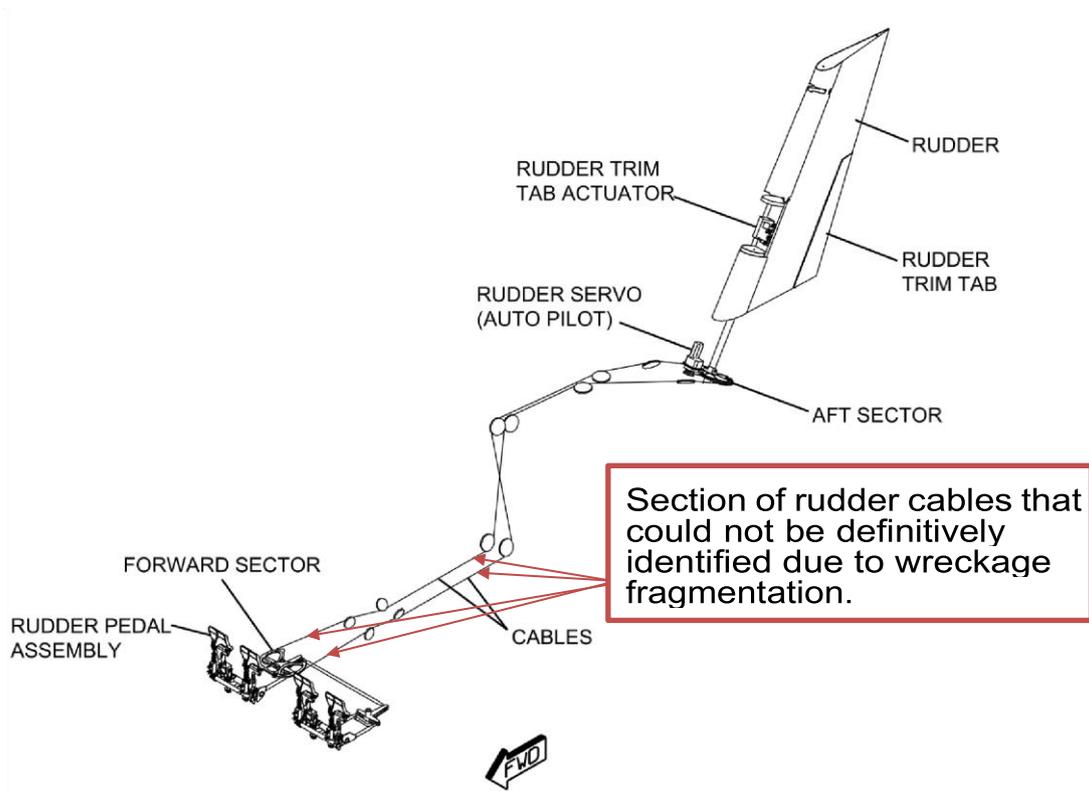
Figure 13. Rudder control system components examined during investigation.

The rudder system was retrieved from the wreckage and examined. Portions of the rudder pedals and forward sector were found in the wreckage debris (Figure 13). The rudder cables from mid fuselage to the rudder were found and examined. Most breaks in the cable had ends that had a splayed, broom straw appearance consistent with tension overload. One break in a “right rudder” cable was retained for further examination. The rudder cables from mid fuselage to the rudder pedals could not be definitively identified due to wreckage fragmentation.

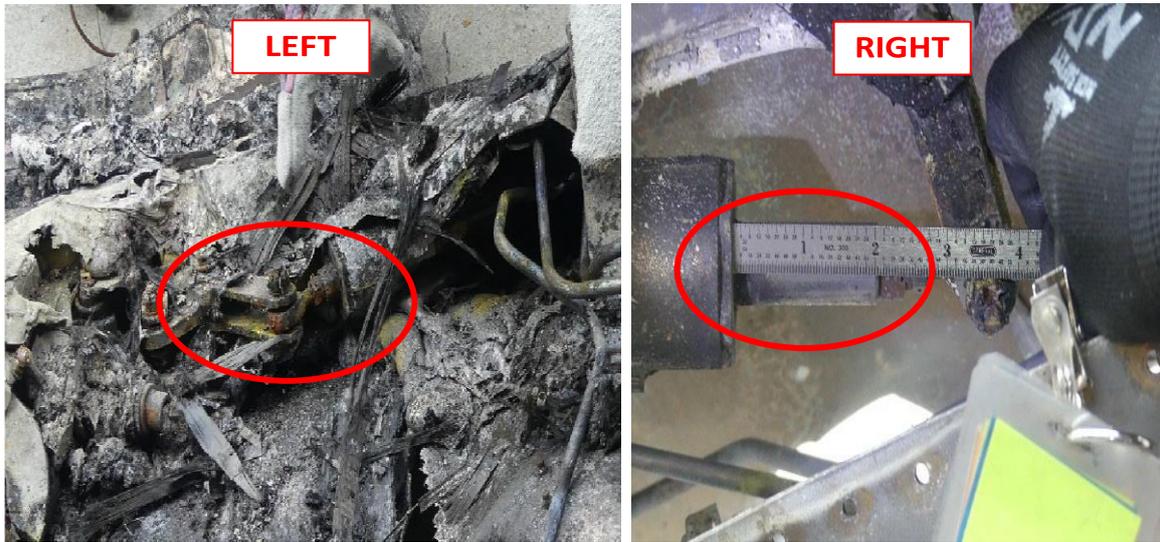
Figure 15. Left and Right Lift dump Actuators.

right lift dump panel was bent from impact (Figure 16). Both the left and right middle and outboard spoilers were in the stowed position.

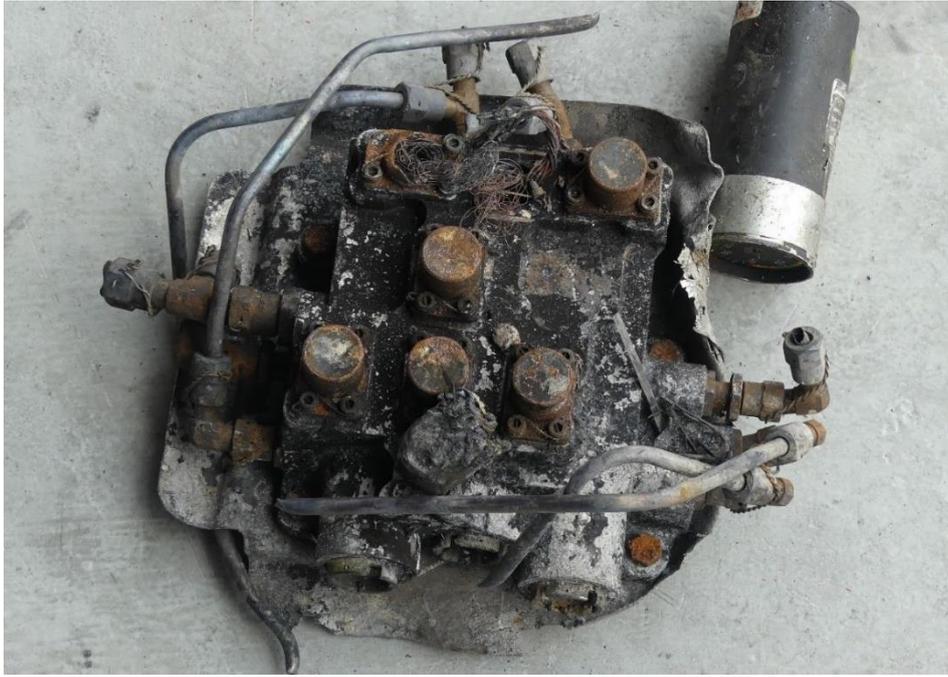
Figure 17. Hydraulic Spoiler Control Module (HSCM).

The Hydraulic Spoiler Control Module (HSCM) was impact and thermally damaged (Figure 17). It was retained for further examination. The Spoiler Control Unit (SCU) was thermally damaged (Figure 18).

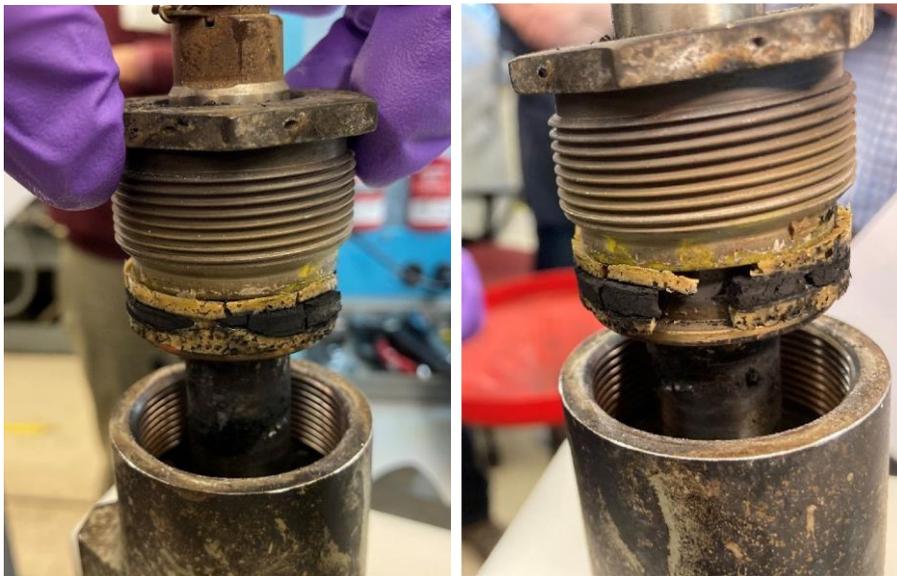
The actuator was disassembled. The threaded gland nut was removed. The back-up rings and the O-ring were thermally damaged (Figure 3). They were removed from the gland and placed in a zip-lock bag. The piston did not move in the actuator. The actuator was sectioned to evaluate the inside of the actuator.

Figure 3. Right lift dump actuator gland nut after removal.

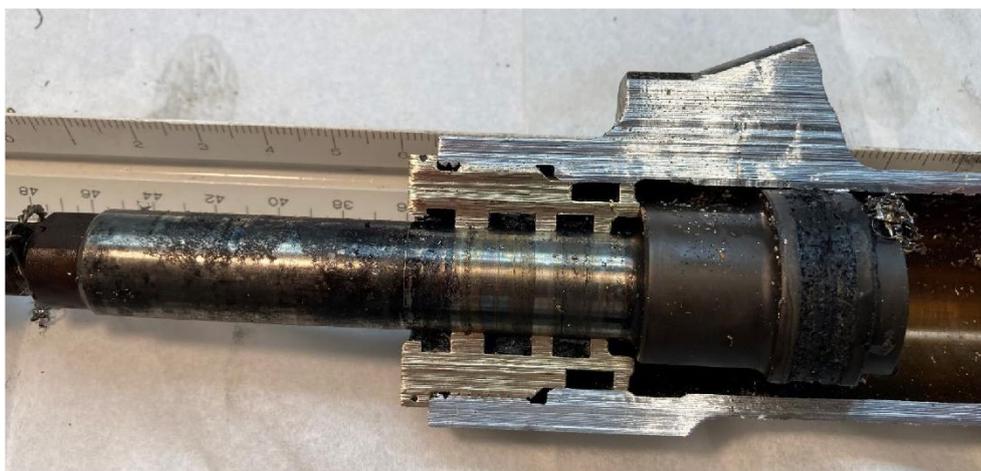
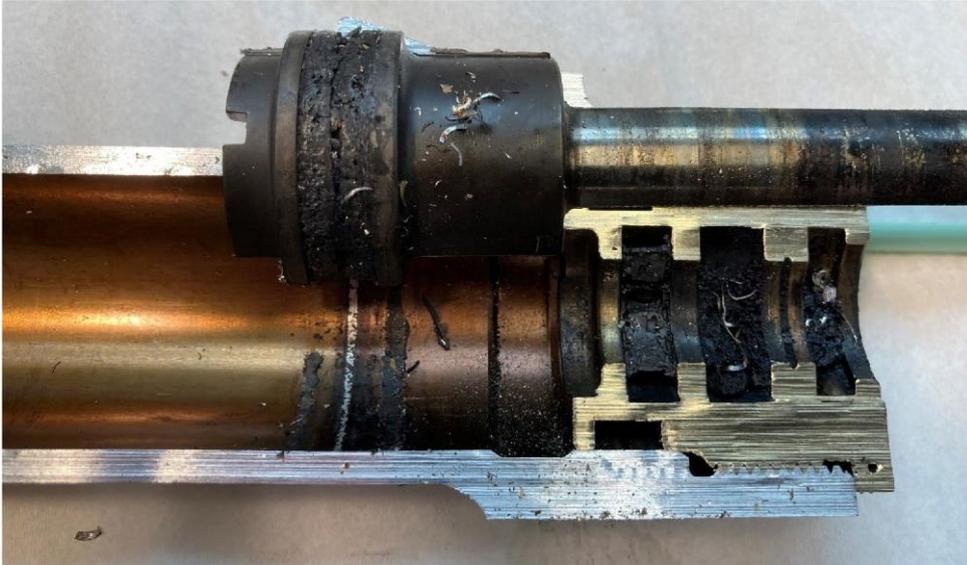
The gland nut was re-installed. The actuator was placed on a band saw. The actuator was sliced in half (approximately) to show a cross section view (Figures 4 and 5). The piston and body components were compared and the marks on these parts confirmed that the actuator was in the fully extended position during the accident and remained there until the actuator was sectioned.

Figure 4. Right lift dump actuator after sectioning – half 1.

Figure 5. Right lift dump actuator after sectioning – half 2.

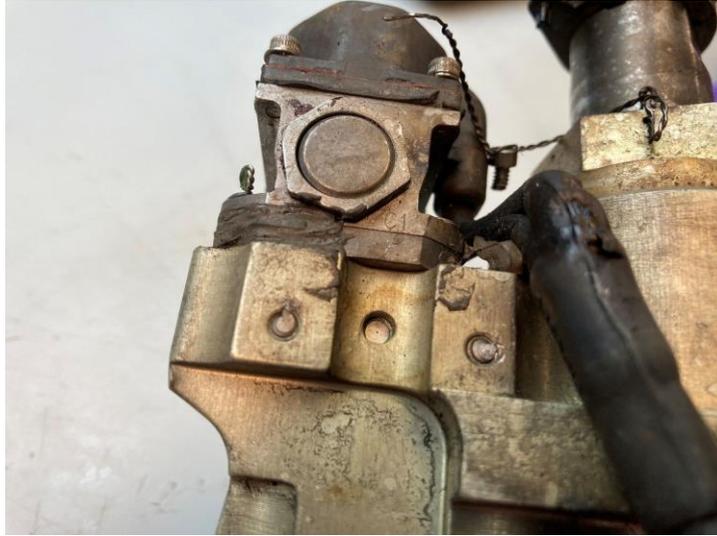
Figure 7. Right roll control actuator showing where the cable retainer screws for the wire harness retainer were sheared off.

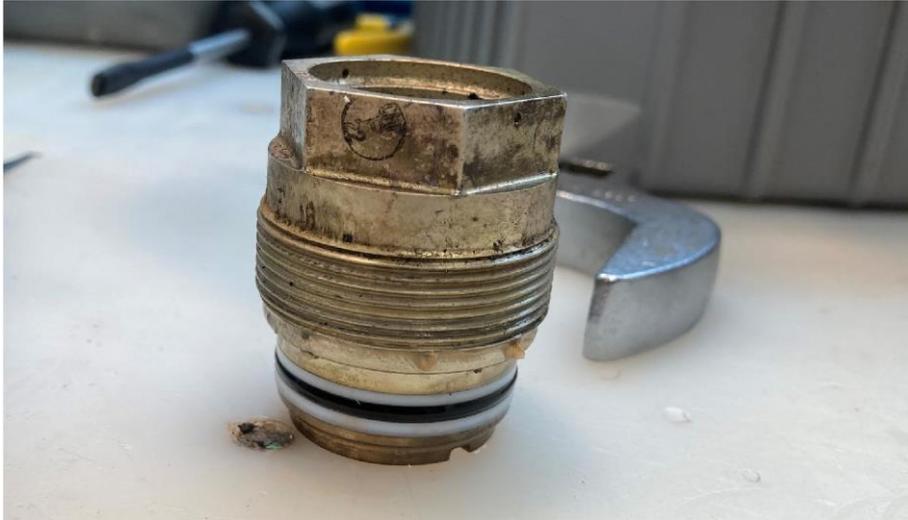
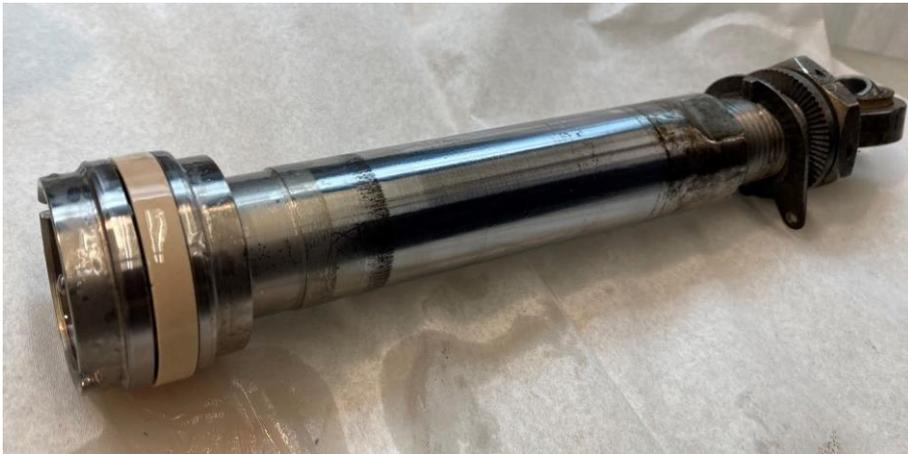
The actuator was disassembled (Figures 9 and 10). The rod end jam not safety wire was removed. The rod end jam nut was removed using finger pressure. (Note that the CMM specifies a torque of 180-210 in-lbs for this jam nut.) The retaining nut for the rod end was removed. Fluid was drained from the unit into a sample bottle. The piston was extracted. The actuator piston was inspected for witness marks but no witness marks were observed. Normal radial wear marks were observed. Material transfer from a seal was observed on the piston.

Figure 9. Right roll control actuator gland nut after removal.

Figure 10. Right roll control actuator piston.

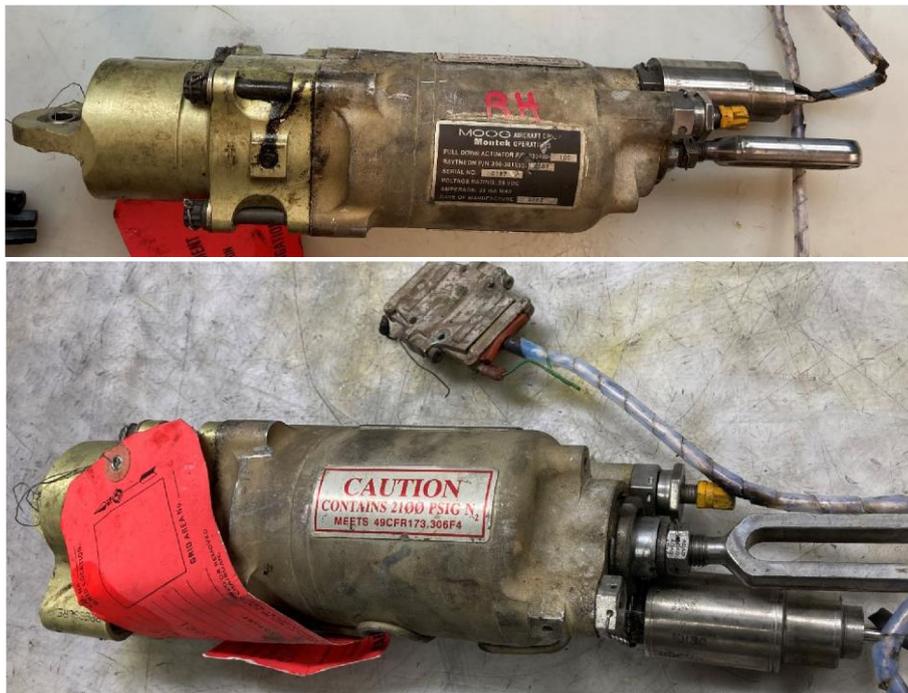
Figure 11. Right pull down actuator.

The aircraft side of the electrical connector was removed. The wire harness was connected to the test stand to measure the nitrogen charge of the actuator. The pressure transducer output was recorded as 2.33 volts and was within limits. (CMM allows a value of 2.44 +/- 0.25 volts for a full nitrogen charge of 2100 psi.)

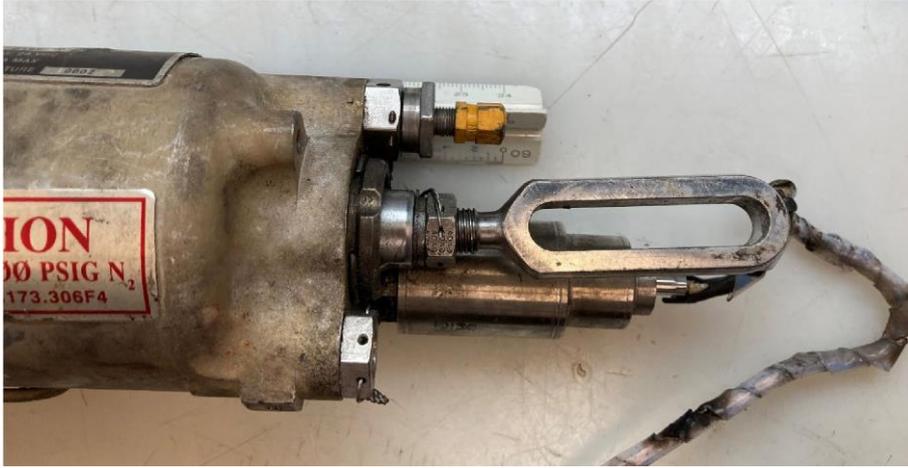
Figure 12. Right pull down actuator showing the bent slotted rod end.

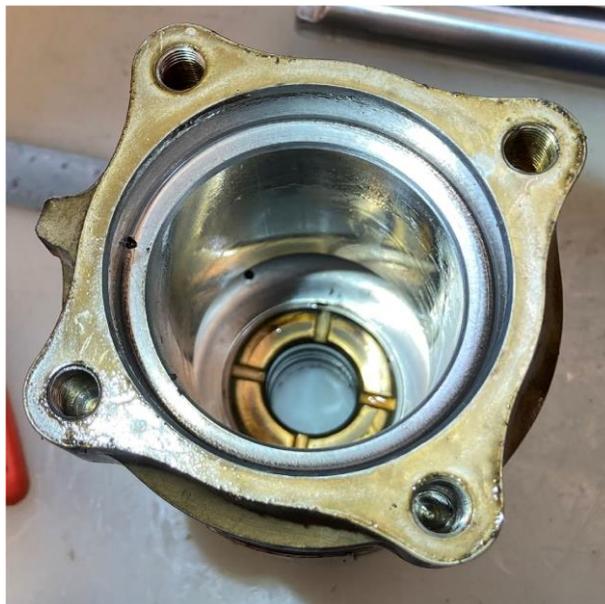
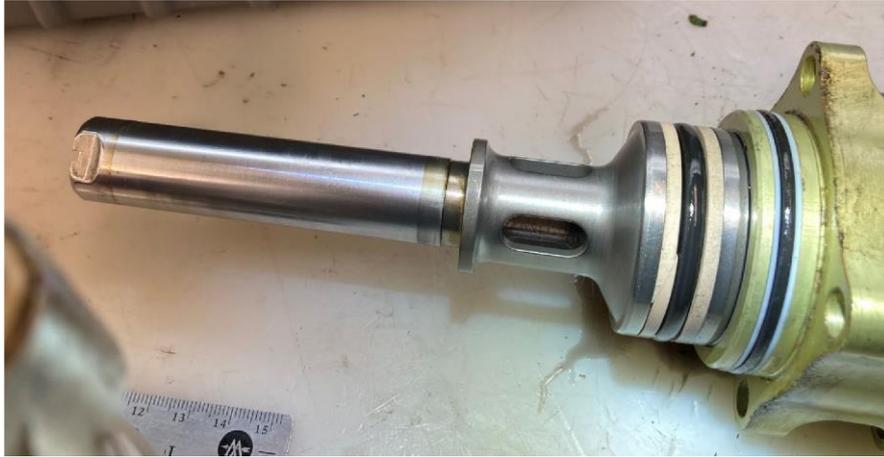
The actuator was disassembled. The nitrogen charge was released from the actuator. The actuator piston and cylinder were inspected for witness marks but no witness marks were observed. Normal radial wear marks were observed (Figures 14 and 15).

Figure 14. Right pull down actuator showing the inside of the cylinder.

Figure 15. Right pull down actuator piston.

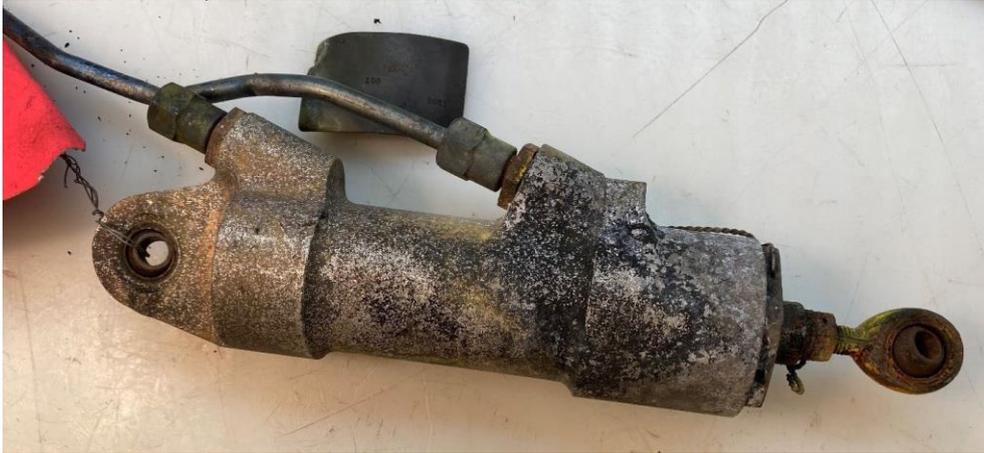
Figure 16. Left lift dump actuator.

The actuator could not be disassembled. The threaded gland nut could not be removed. The actuator was placed on a band saw. The actuator was sliced in half (approximately) to show a cross section view (Figures 19 and 20). The piston and body components were compared and the marks on these parts confirmed that the actuator was in the fully retracted position when it experienced the heat damage.

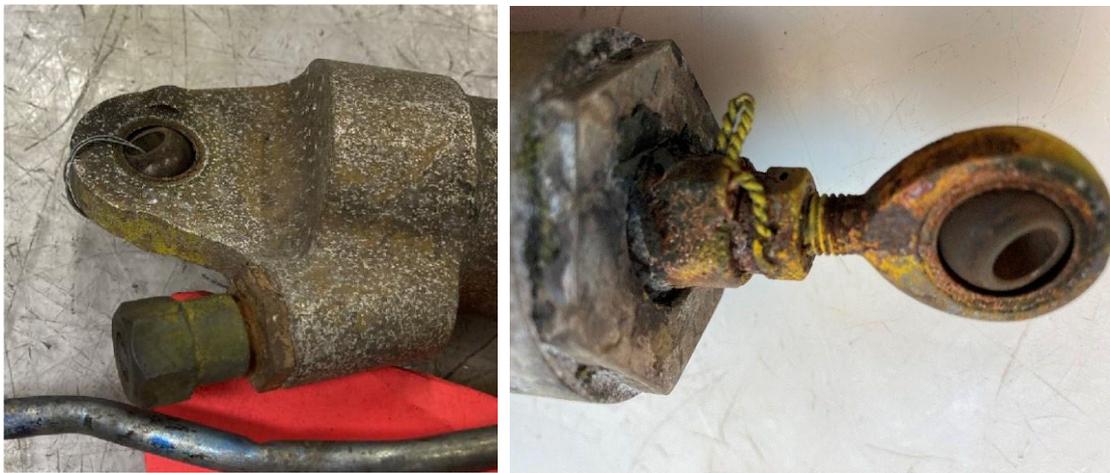
The name plate was not in the bag with the actuator but was included with the right lift dump actuator. There was extensive heat damage to the actuator (Figures 16 and 17). The rod end bearing and the fixed end bearing exhibited signs of heat damage. A portion of hydraulic line was attached to the retract port. The hydraulic line fitting and the port fitting were removed using finger pressure. The extension port had a hydraulic fitting but no hydraulic line. The fitting was removed using finger pressure. The O-ring below the fitting was severely thermally damaged.

Figure 17. Left lift dump actuator tail side and rod end bearings.

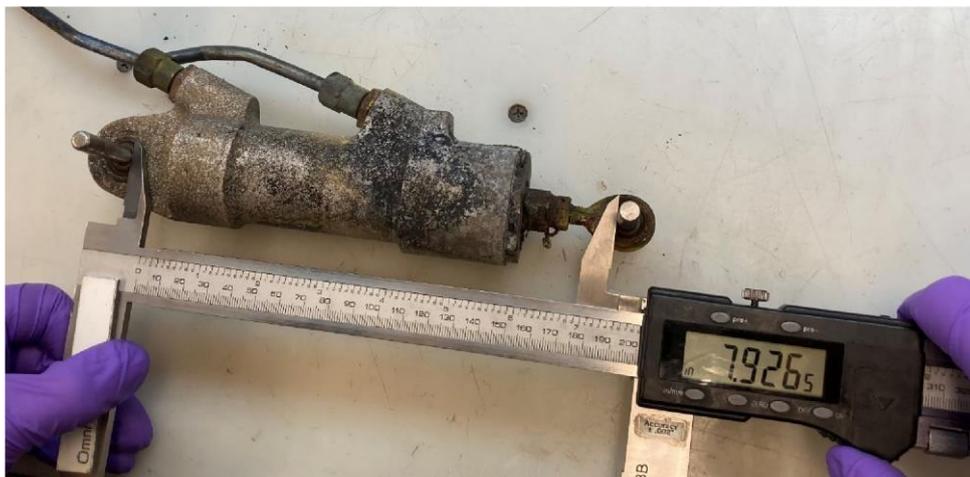
Several dimensions of the actuator were measured as detailed in the Table below (Figure 18).

Figure 18. Left lift dump actuator inside pin to pin measurement (must add 0.31 pin diameter to get actual pin to pin measurement).

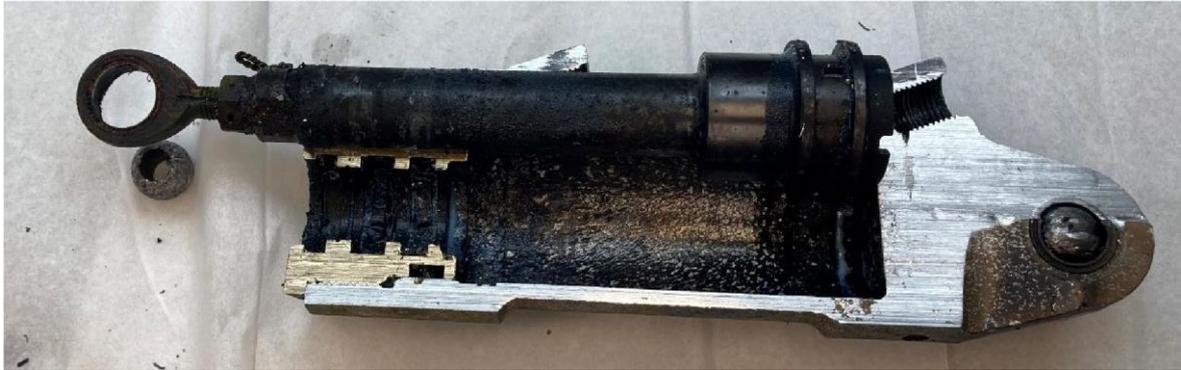
Figure 19. Left lift dump actuator after sectioning – half 1.

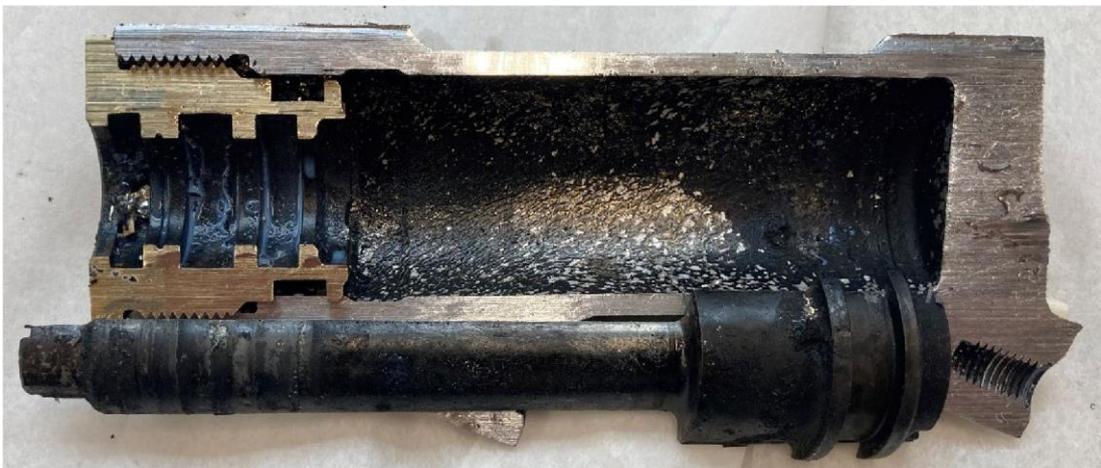
Figure 20. Left lift dump actuator after sectioning – half 2.
