**AIRCRAFT ACCIDENT
FINAL REPORT
A 05/23P**

**Air Accident Investigation Bureau (AAIB)
Ministry of Transport Malaysia**

**Accident Involving Fixed Wing Aircraft Hawker Beechcraft 390 Premier 1,
Registration N28JV, at Elmina, Shah Alam, Selangor
on 17 August 2023**

Issued on 16 August 2024
MOT.(S).600-5/4/99

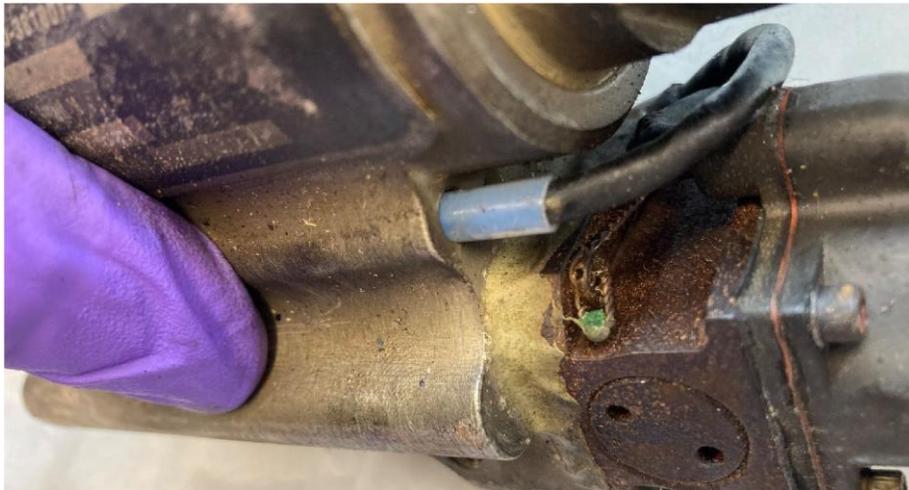
The name plate was inspected and the following info was confirmed: part number was 390-381007-0003 and serial number was 0214R. The rod end jam nut had a safety cable. (It is shipped from Moog with safety wire.) A portion of hydraulic line was attached to the retract and extend ports. The wire harness retainer was present. The wire harness was present including the mating connector from the aircraft and a small section of aircraft wiring (Figure 21). The tamperproof sealant was intact on the servo valve. The safety wire for the servo valve was sheared at the second hole (Figure 22).

Figure 22. Left roll control actuator showing sheared safety wire near the servo valve.

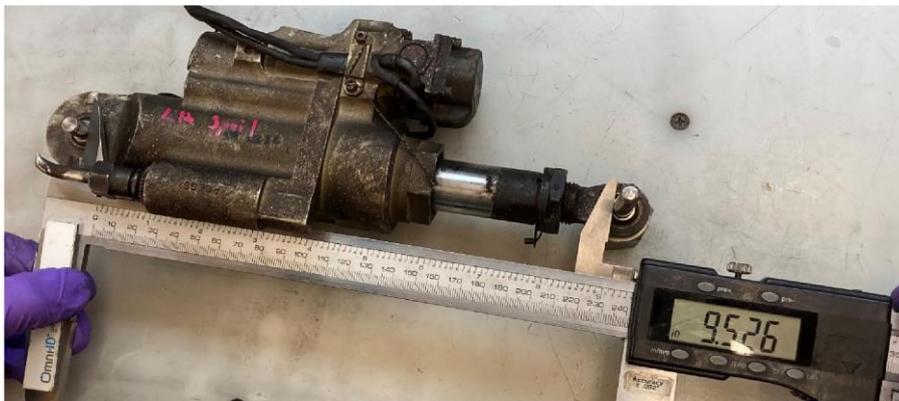
Several dimensions of the actuator were measured as detailed in the Table below (Figure 23). (Note that for the roll control actuator, the actuator fully retracted position

Figure 23. Left roll control actuator as received inside pin to pin measurement (must add 0.31 pin diameter to get actual pin to pin measurement).

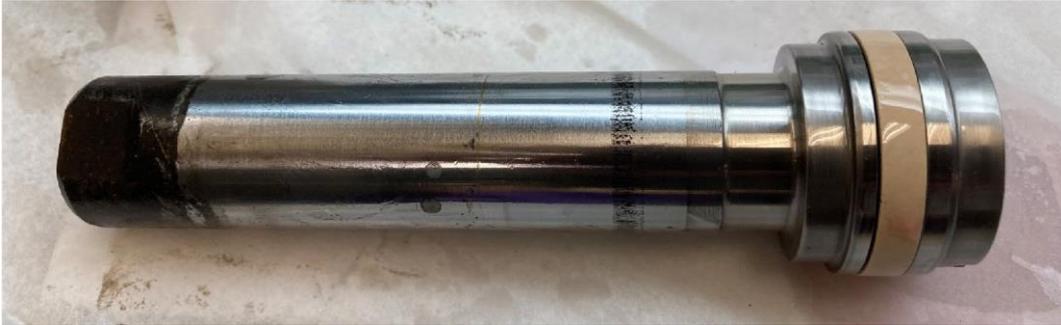
The actuator was disassembled. The piston was extracted. The actuator piston was inspected for witness marks but no witness marks were observed. An area of the shaft with seal material transfer was observed. In addition, there was an abrasion area approximately 180 degrees around the shaft that corresponds to the scrapper seal when the actuator is fully extended (Figures 24 – 26). (This is the actuator's normal position for spoilers stowed.) There were also some unknown deposits on the piston that were easily rubbed away.

Figure 24. Left roll control actuator piston showing the seal material transfer area.

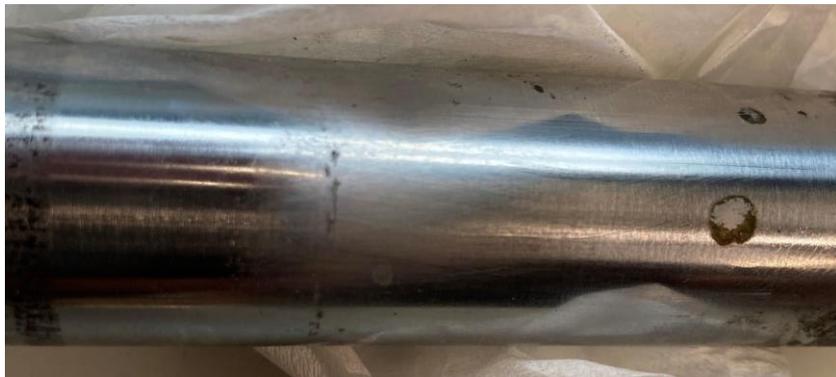
Figure 25. Left roll control actuator piston showing the abrasion area and material deposits.

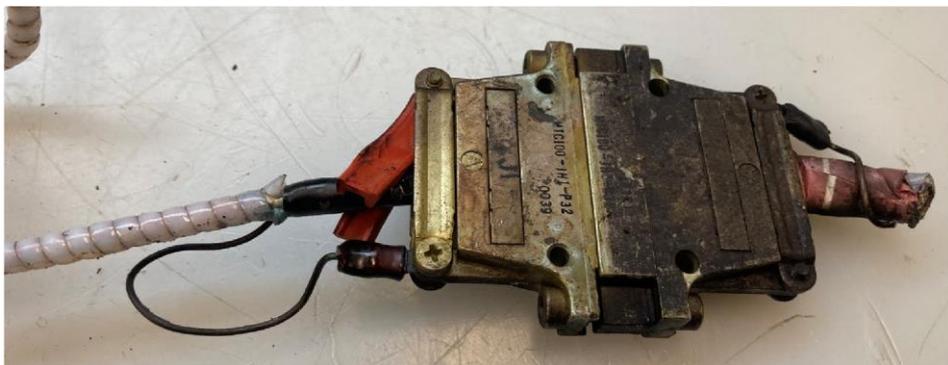
The name plate was inspected and the following info was confirmed: part number was 390-381010-0001 and serial number was 0202. The wire harness was present including the mating connector from the aircraft and a small section of aircraft wiring (Figure 27). The electrical grommet was visibly protruding from the electrical connector (Figure 28). The rod seal lubrication transfer tube was crushed (Figure 29). The slotted rod end was bent (Figure 30). There were some impact marks on the rod end of the actuator. The hydraulic fittings were intact with portions of the hydraulic lines. The rod end scraper seal of the actuator was protruding (Figure 31). The lock wire on the jam nut was damaged.

Figure 28. Left pull down actuator showing the electrical grommet of the connector.

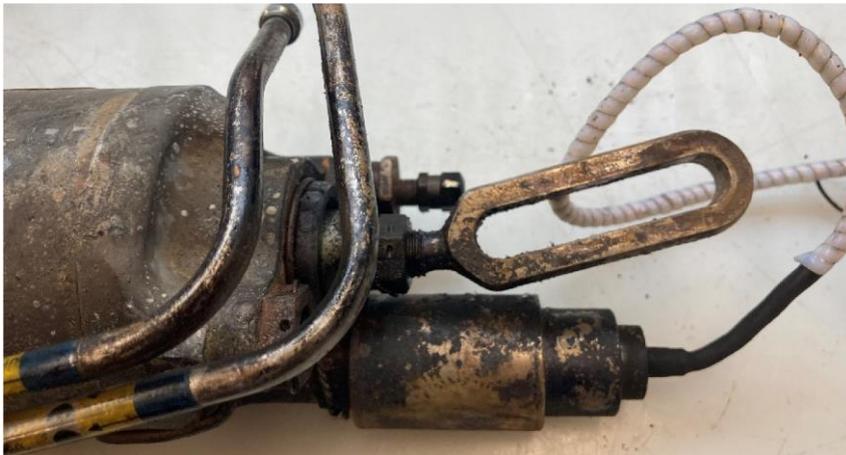
Figure 30. Left pull down actuator showing the bent slotted rod end.

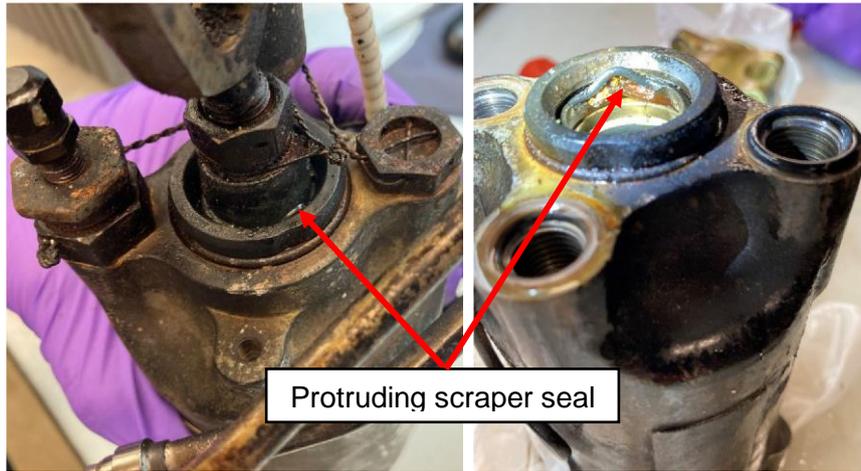
Figure 31. Left pull down actuator showing the protruding scraper seal on the rod end of the actuator.

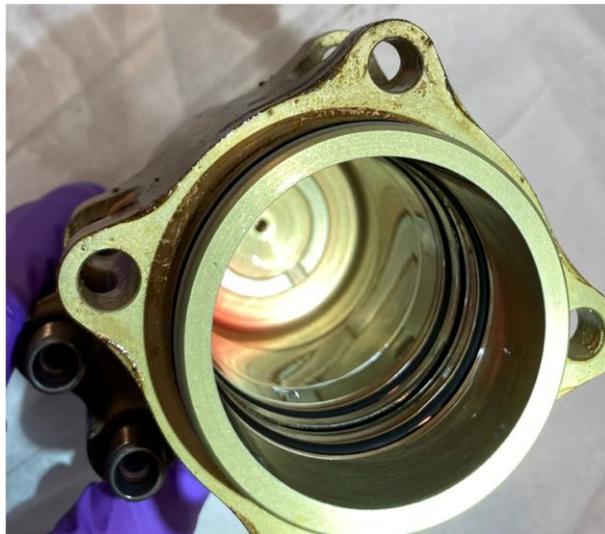
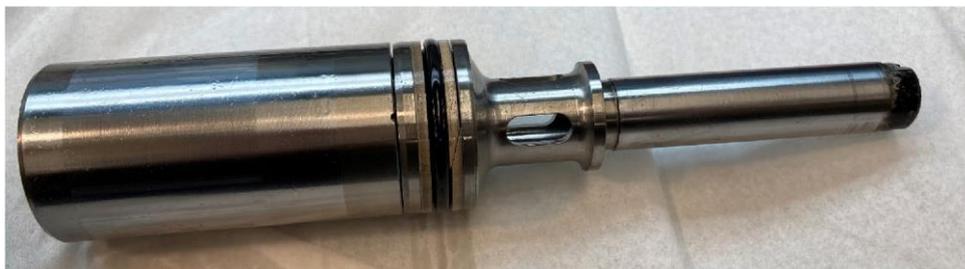
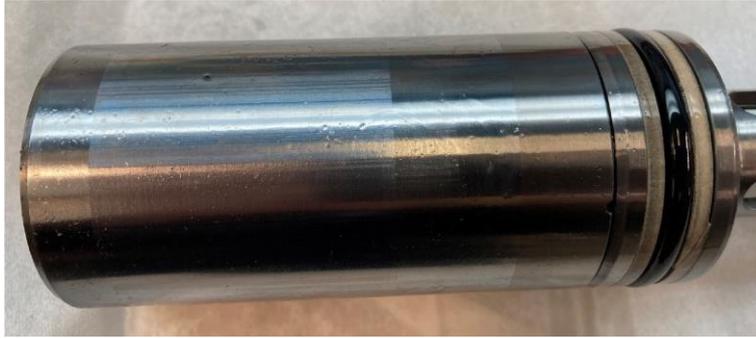
The actuator was disassembled. The nitrogen charge was released from the actuator. Approximately 25% of the scrapper ring was missing. The actuator piston was inspected for witness marks but no witness marks were observed. Normal wear marks were observed (Figures 32 – 34).

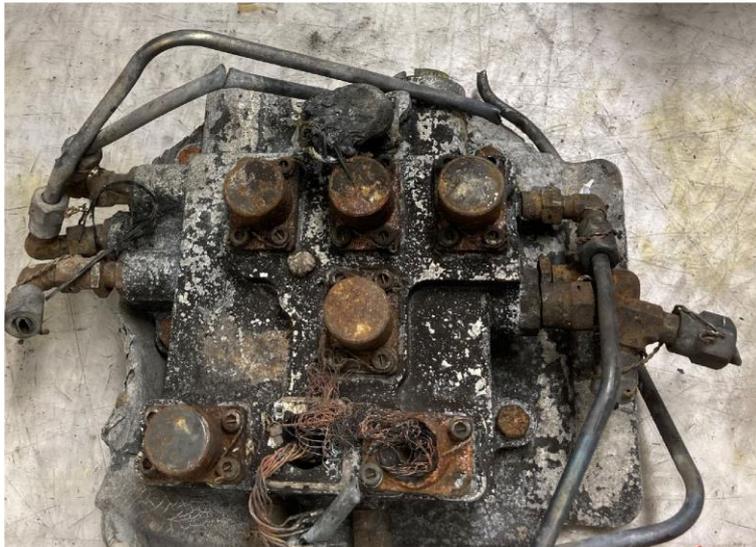
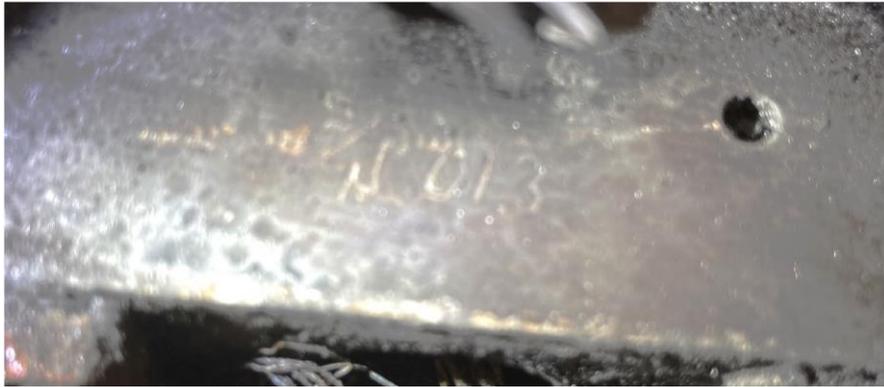
The unit was inspected but the name plate was not present (Figure 35). The serial number of the manifold was located. The manifold was serial number 013 (Figure 36). The build paperwork for the manifold was no longer available due to Moog's document retention policy. The unit was too thermally damaged to be tested.

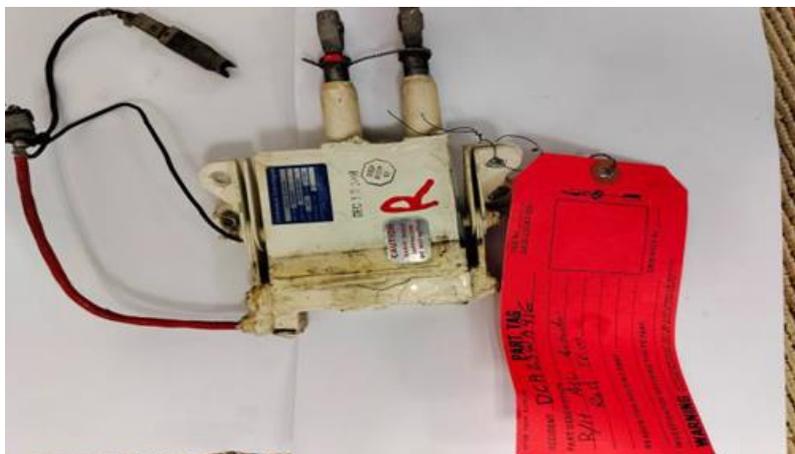
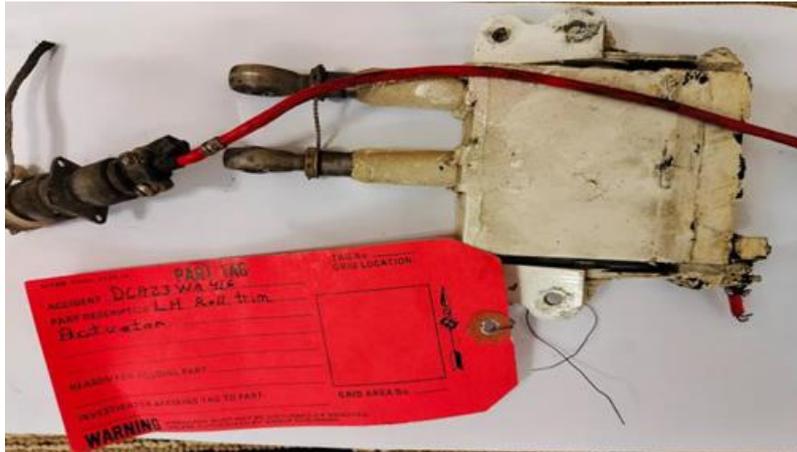
The aileron trim actuators were removed and examined (Figures 37 and 38). The acceptance test was completed on each unit. S/N 080 (left wing) operated and passed the ATP except for 1) time to extend was 29.03 seconds and retract was 27.78 seconds which exceeded the limit of 20-27 seconds; 2) maximum force for extend did not achieve the 100 lbs. minimum; 3) midpoint potentiometer check was 7.18 volt versus a requirement of 7.4-7.6 volts; and 4) end play was 0.011 versus a requirement of below 0.010. S/N 67 (right wing) operated and passed the ATP except for mid-point potentiometer checks were 6.97 volts for potentiometer 1 and 6.9 volts for potentiometer 2 versus a requirement of 7.4-7.6 volts.

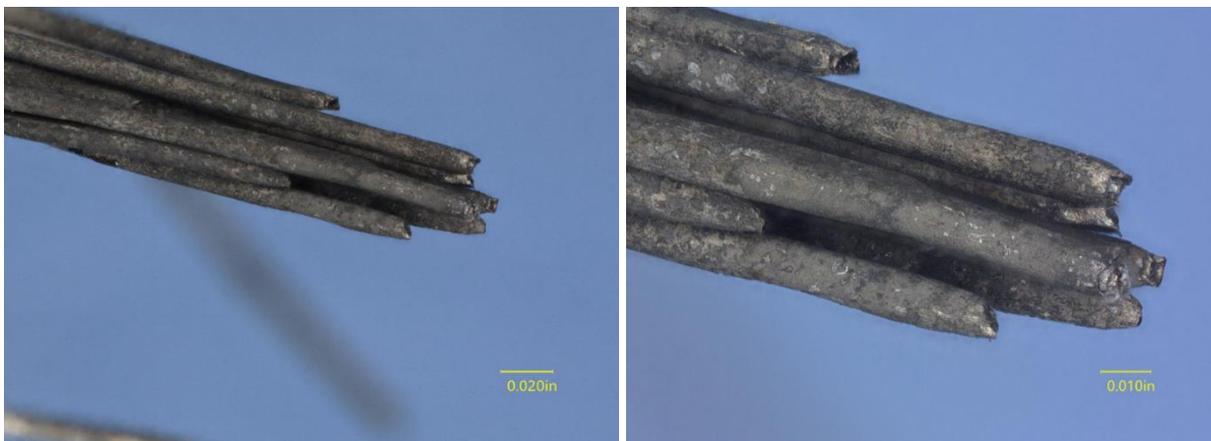
The cables consisted of multiple twisted wires. Both cables were separated into two pieces. The ends of the separation were visually examined to determine the mode of separation. The ends of the individual wires exhibited "cup and cone" morphology with associated areas of thinning and necking. These morphologies are consistent with overstress. These surface features are shown in the photographs below (Figure 39).

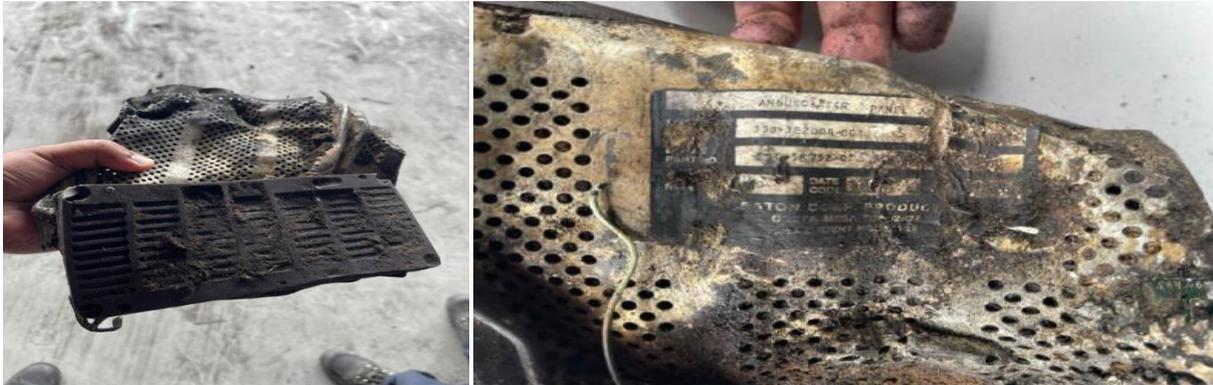
The front cover of the annunciator panel (Figure 40) was removed to facilitate examination during the field investigation. It was determined that the panel contained LED light bulbs. The illumination status of the LED light bulbs at the time of the

accident cannot be determined. No further examination of this component was possible due to thermal damage.

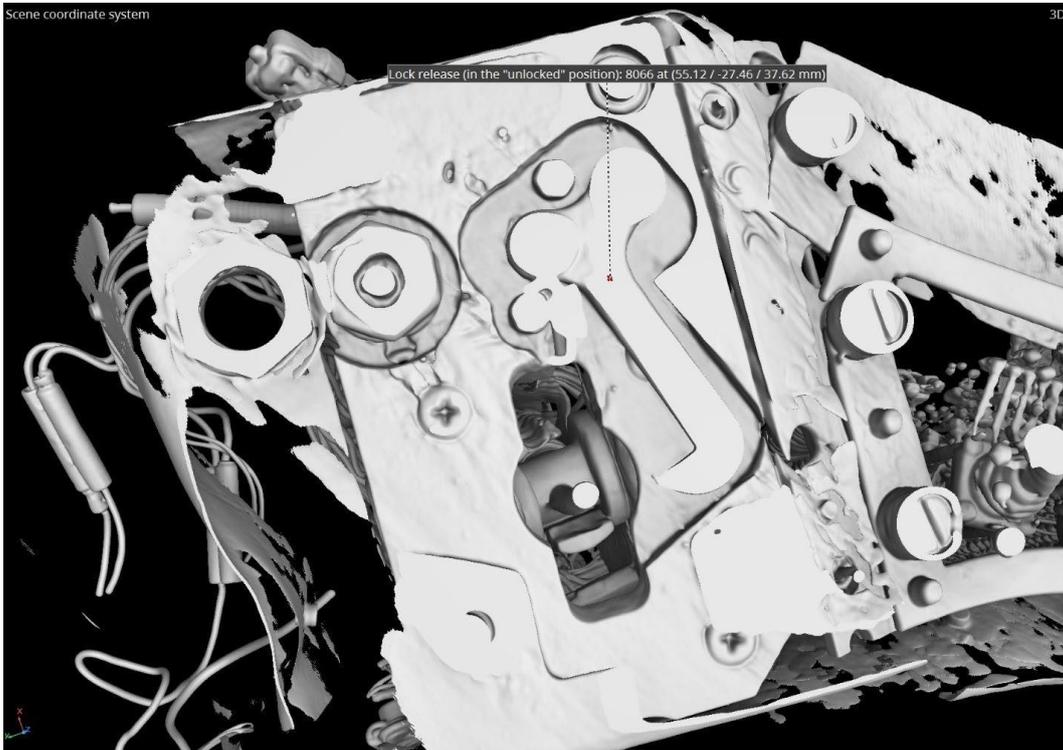
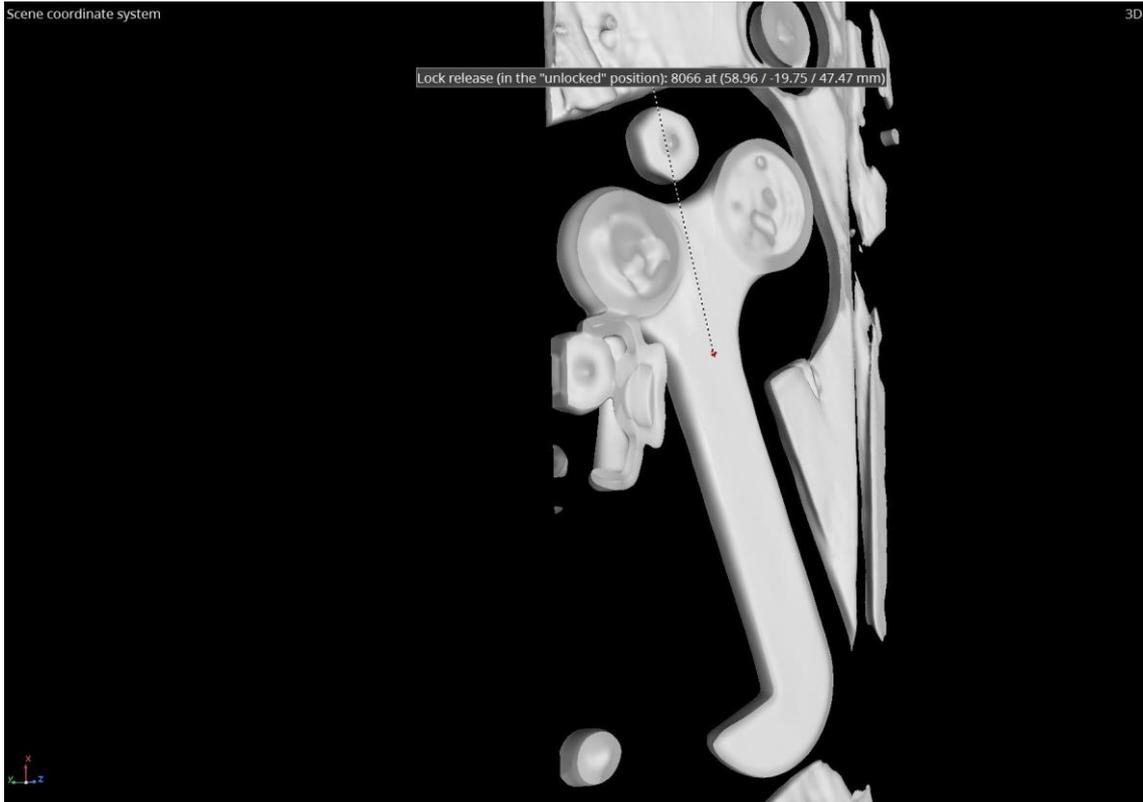
The CT results for the lift dump panel are shown in Figures 8 through 16. Review of the images determined that the handle was in the “EXT” position when the scan was completed. The lock release was in the “unlocked” position. The lock release did not exhibit indications of deformation at the end that engages the lift dump handle. (Figure 10.) The inner microswitch on the right side and both microswitches on the left side of the lift dump handle were depressed which corresponds to the EXT (extend) position. (Figures 11 to 14.) The outer microswitch on the right side was in contact with the side of the lift dump handle cam versus along the running surface. (Figure 11 and 12.) The

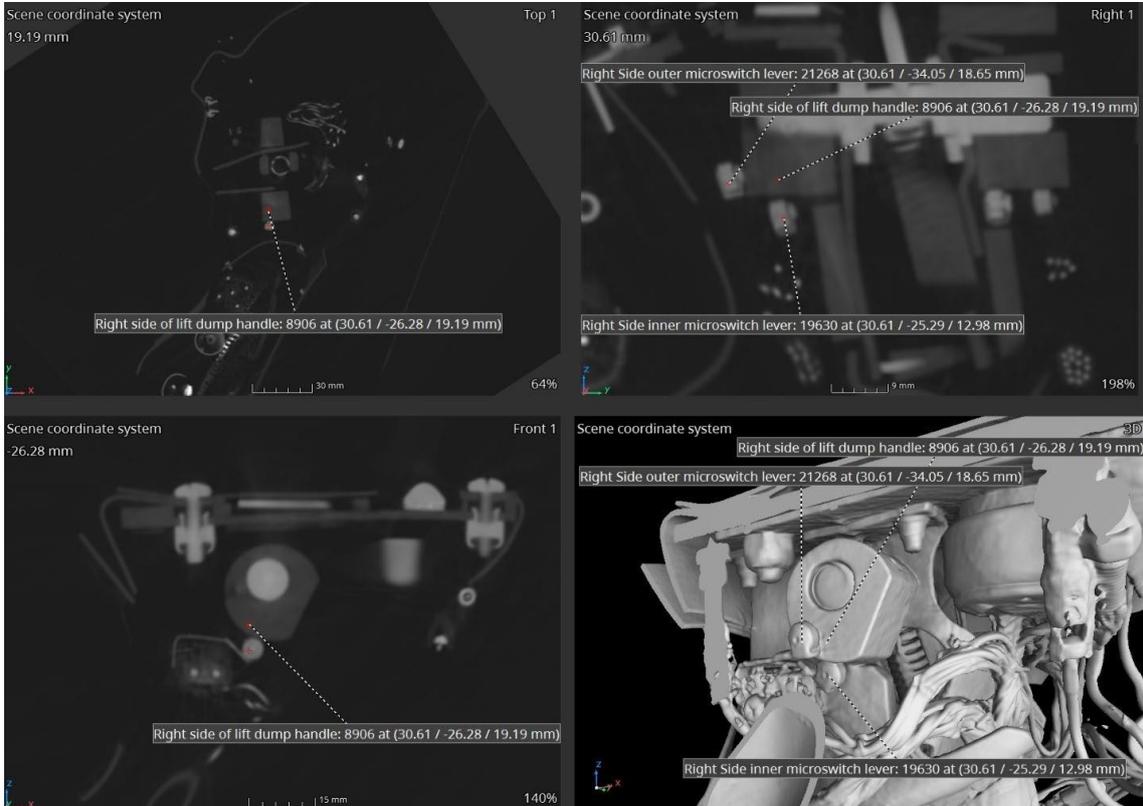
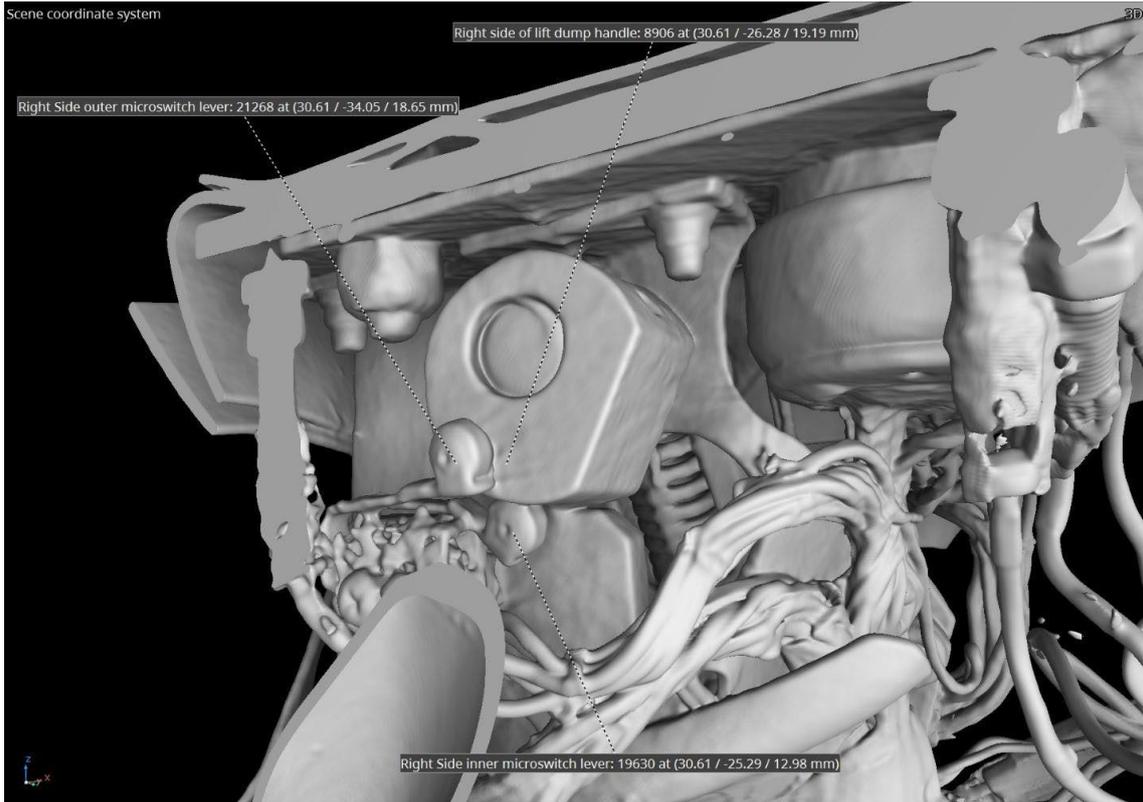
inner microswitch lever on the right side appears to have a sharp bend. (Figure 11 and 12.) The structure of the lift dump panel was deformed. Figure 15 and 16.)
