## **AIRCRAFT ACCIDENT**

### **FINAL REPORT**

**A 06/25**

**Fixed Wing Aircraft Piper PA-28-181 Archer III,  
Registration HS-AMY at Pangkor Island Airport, Perak  
on 30 July 2025**

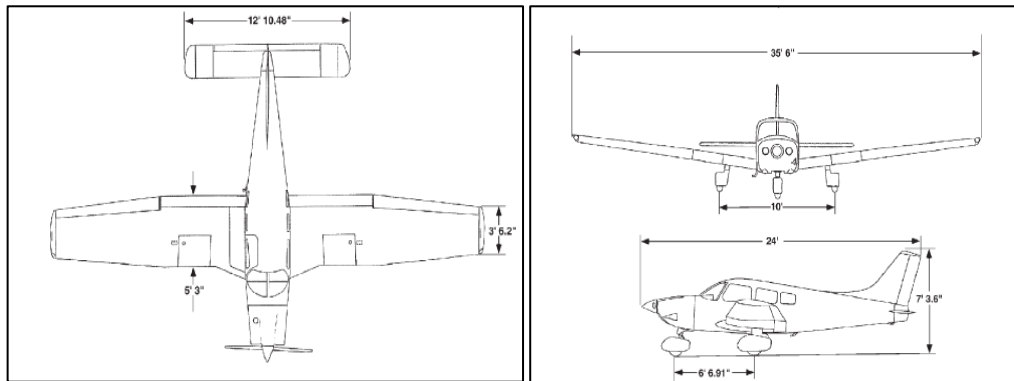
Figure 7: Three views of the aircraft

The Piper PA-28-181 Archer III is a single-engine aircraft designed and manufactured by Piper Aircraft, Inc. Florida, United States. The aircraft features a low-wing design, fixed landing gear, fixed-pitch propeller and is powered by a 180-horsepower Lycoming O-360-A4M engine. A view of the Piper PA-28-181 Archer III is shown in Figure 7.

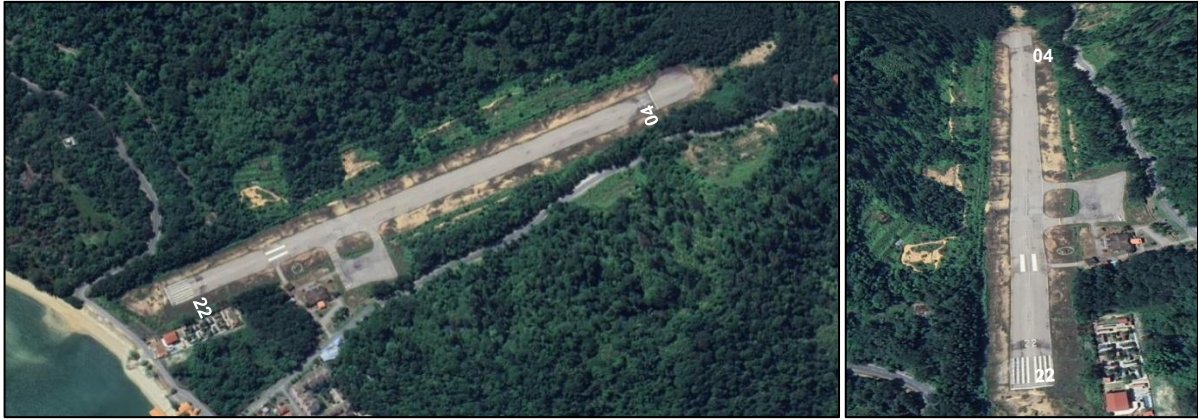
Figure 9: Aerial view of Pangkor Island Airport

Pangkor Island Airport (IATA: PKG, ICAO: WMPA) located on the coast of the state of Perak in northwestern Peninsular Malaysia, approximately 10 km of from Marina Island Jetty Complex. The airport's coordinates are N4°14.68' / E100°33.20'. It features a single runway, Runway 04/22, with a length of approximately 732 meters, the runway width is 30 metres, and the airport elevation is 13 metres.

WMPA has a relatively short runway with limited clear areas within the vicinity of the runway strip. The presence of vegetation and small trees near the runway edge was considered relevant to the damage sustained by the aircraft following its landing on Runway 22.
