## **AIRCRAFT ACCIDENT**

### **FINAL REPORT**

**A 05/25**

**Accident Involving Airbus Helicopter AS355N,  
Registration 9M-PHG, at Sungai Pulai, Gelang Patah, Johor  
on 10 July 2025**

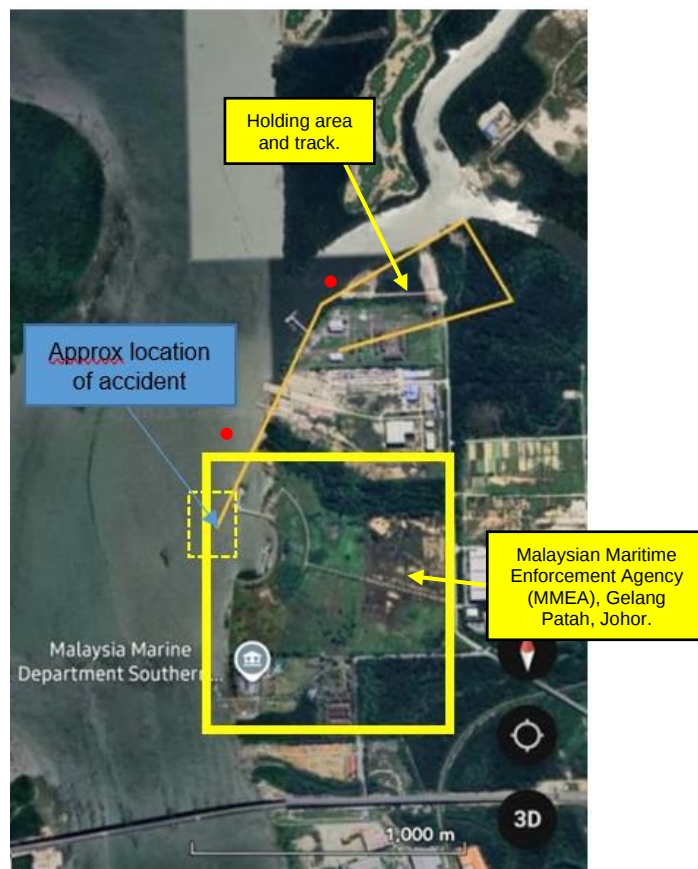
Figure 2: Accident site and MMEA vicinity in Sungai Pulau, Gelang Patah, Johor.

As illustrated in Figure 2, the accident area was located within the Sungai Pulau waterway, approximately 150 metres southwest of the Muara Laut Jetty at the MMEA Gelang Patah base. The site, marked by the broken yellow line, lies within the MMEA Gelang Patah vicinity indicated by the thick yellow line. The surrounding environment comprises a tidal river channel approximately 250–300 metres wide, flanked by mangrove shorelines to the north and south.
