**AIRCRAFT ACCIDENT  
FINAL REPORT  
A 07/18**

**Accident involving Rotorcraft Helicopter Robinson R66  
Registration 9M-RML  
at Sultan Abdul Aziz Shah Airport,  
Subang, Kuala Lumpur  
on the 15<sup>th</sup> August 2018**

**ACCIDENT REPORT NO. : A 07/18**

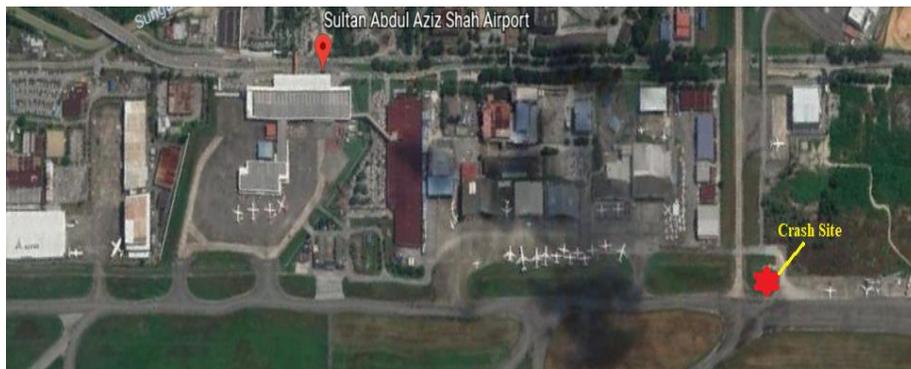
**Diagram 1:** Location of the crash site

There is an open area adjacent to taxiway Oscar and taxiway Sierra where it has been known as a location for regular sloping ground take-off and landing activities. This grass area is not a designated area provided for training but it is considered as a suitable area and has been used for sloping ground training by helicopter pilots.

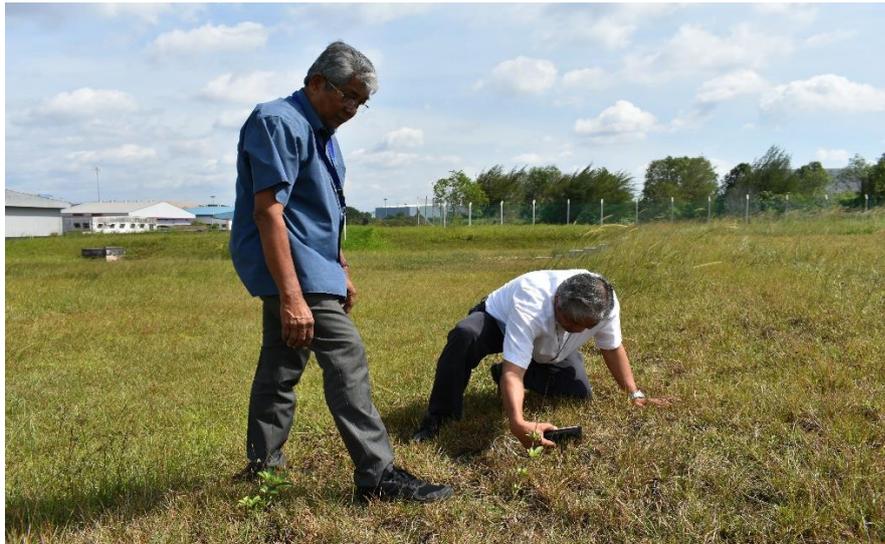
**Figure 12:** Investigator is measuring the slope angle

This place was accepted by trainers due to its nature of uneven surface with sloping angles varies from 8° to 12° as per shown below.

It should also be emphasized here that the maximum recommended rate of angle for sloping ground exercise is  $5^\circ$ , while the actual angle of slope for the surface used during the occurrence is approximately from  $8^\circ$  to  $12^\circ$  which is on the high side. However, the angle of the slope couldn't be accurately determined by the pilot while flying the helicopter during hover.

3.1.8 The approximate angle of the slope area for the sloping ground exercise is from 8° to 12°, whereby the maximum recommended angle for sloping exercise is 5°.

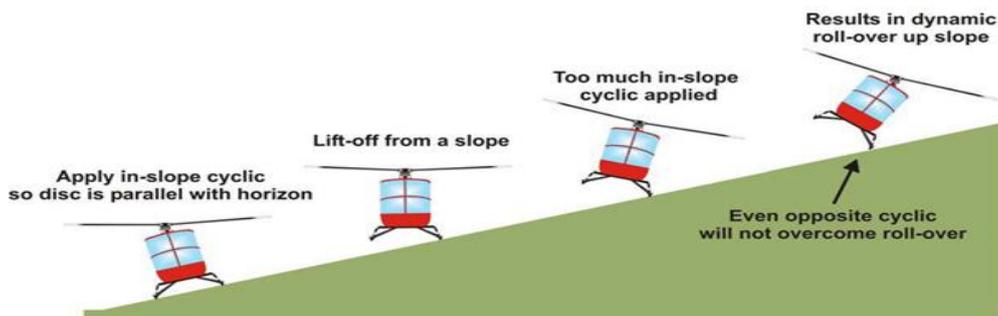
**Diagram 2:** Dynamic roll over

2.2.2 Dynamic roll over – Dynamic roll-over will occur if there is an excessive application of collective while the cyclic is displaced laterally. When this occurs, one side of the undercarriage becomes a lateral pivot point and the helicopter rolls rapidly as it is forced to pivot around that side of the undercarriage instead of rolling around its C of G. Diagram below illustrates the dynamic roll over.

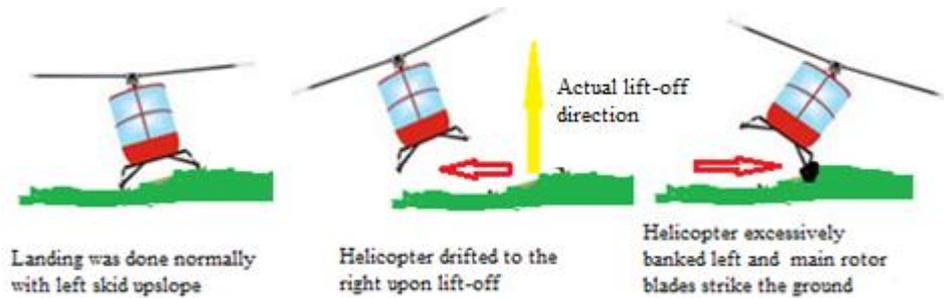
**Diagram 3:** Sequence of event during the lift-off until blades strike the ground

Based on the interview statement given by the PIC, it was a familiarity flight to a PPL pilot with lapsed LPC whom was on the controls at that time following through by the PIC while demonstrating landing and take-off on sloping ground. The landing was done normally with the left skid upslope. When they commenced the take-off with right skid up sloped, the downhill skid needs to be raised without moving the uphill skid. To achieve this, the vertical component of total rotor thrust (VTRT) must be enough to lift on side of the helicopter. Whilst applying sufficient lateral force to the rotor mast to roll the helicopter to a level altitude around the upslope skid, as the right skid break contact with the ground, the helicopter started to drift to the right. The PIC who is also Instructor pilot (occupying LHS), without calling 'I have control' grabs the control and tries to correct the situation. Instead of bringing the helicopter to normal hover, it excessively bank to the left and subsequently

the main rotor blades strike the ground. This was believed due to the startled effect from the PIC.

The cause of the accident is due to a 'loss of lateral control' during lift-off leading to dynamic roll over.
