AIRCRAFT ACCIDENT REPORT SI 05/15

**Air Accident Investigation Bureau
Ministry of Transport, Malaysia**

**Final Report on the Serious Incident involving
Fixed wing aircraft ATR72-600 Registration 9M-LMG
in Penang, Malaysia on 28th May 2015**

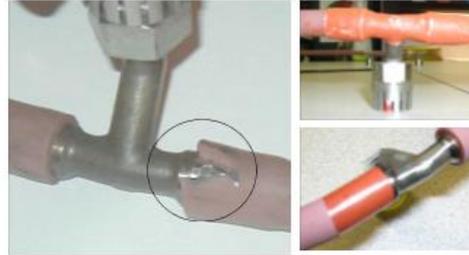
Minor repair per EMM, 72-01-00
 Limited to fire retardant protection
 Manifolds did not receive this repair

Major repair
 Proprietary repair to HS-Marston
 No cracked B-nut were received for repair

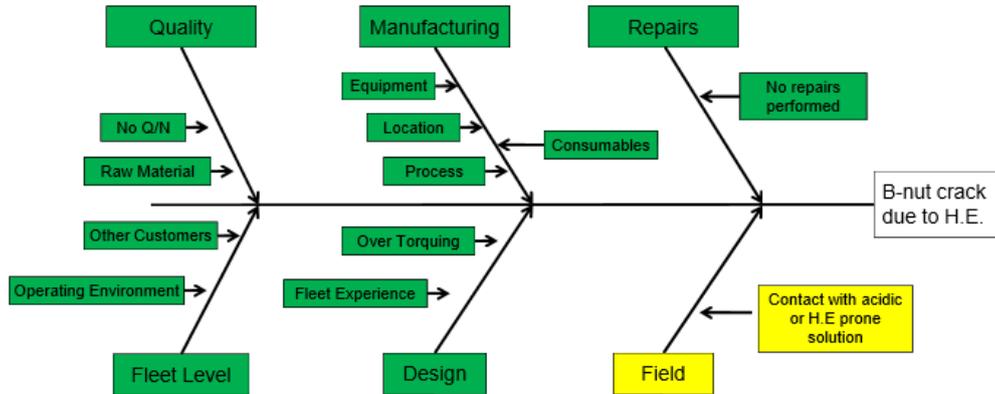
INVESTIGATION SUMMARY

- Source of Hydrogen Embrittlement (H.E.) not identified
- No methods available to segregate manifold affected to H.E.
- No repair possible for parts affected by H.E.
- H.E. causes sudden failure of parts when under stress
