## AIRCRAFT ACCIDENT PRELIMINARY REPORT

A 06/20

Accident Involving Two Guimbal Cabri G2

Registration 9M-HCA & 9M-HCB

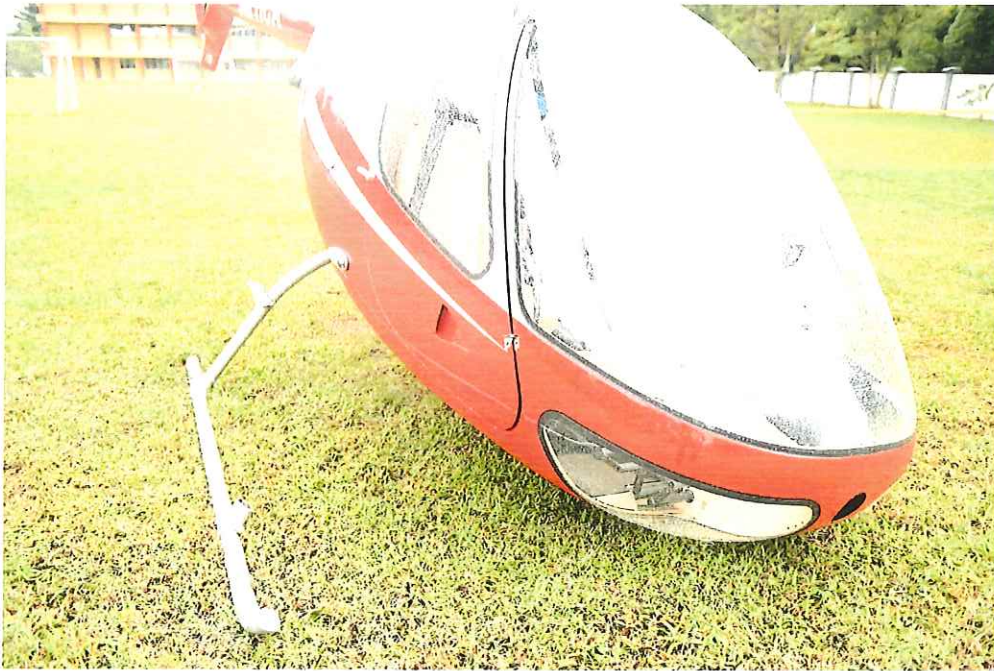
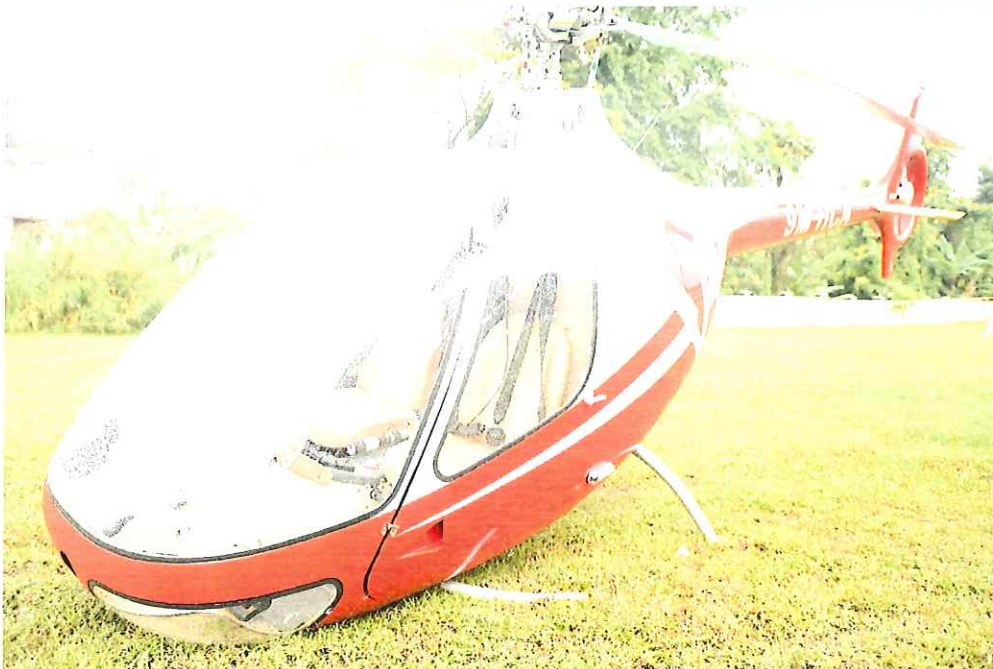
At approximately 1145 both helicopters collided with one another. The exact circumstances of the collision will be discussed in detail later in this report. 9M-HCA received damage to its landing skids but was still controllable and the pilot managed to land safely on a nearby school field.

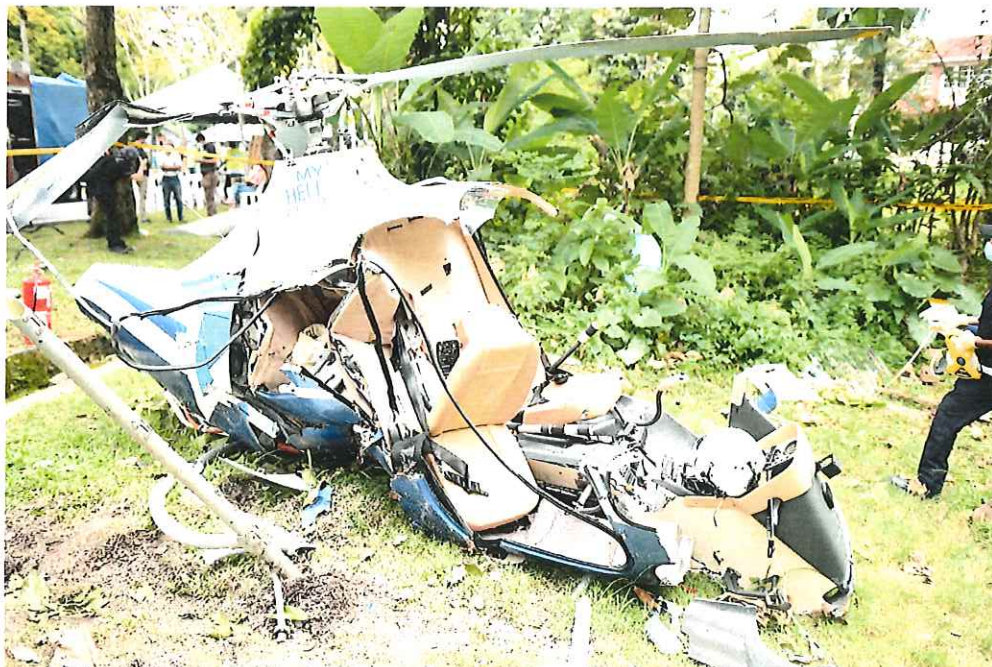
**9M-HCB**

9M-HCB on the other hand severely damaged its main rotor blades and immediately began auto-rotating but crash landed onto a road shoulder not far away. Civilians from the surrounding area were the first to reach the crash site. This was followed minutes later by both the Police and Fire & Rescue Services.

A visual assessment at the crash site revealed that 9M-HCB descended at a very steep angle. This was ascertained by its descent through and damage to a nearby tree to the point of impact.

From its final resting position and pattern of damages it can be deduced that 9M-HCB came down in a relatively level attitude with the right front quarter of the helicopter taking the brunt of the impact. There

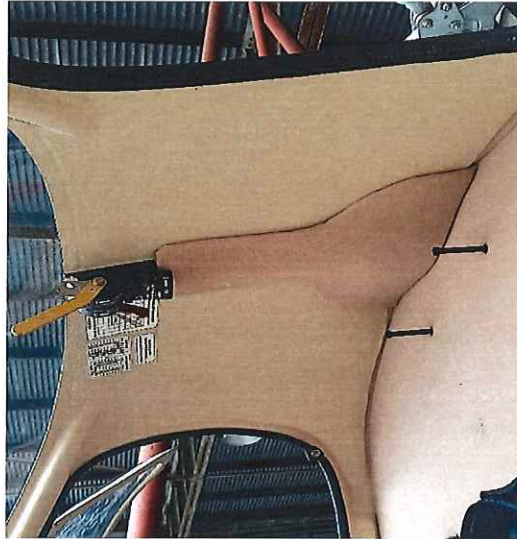
- i. Visual inspections on the insides of the cabin also has been carried out and found no cracks on the upper side of the cabin ceiling or on the aft wall.

*Picture 14 shows the upper cabin ceiling of the cabin of the aircraft.*

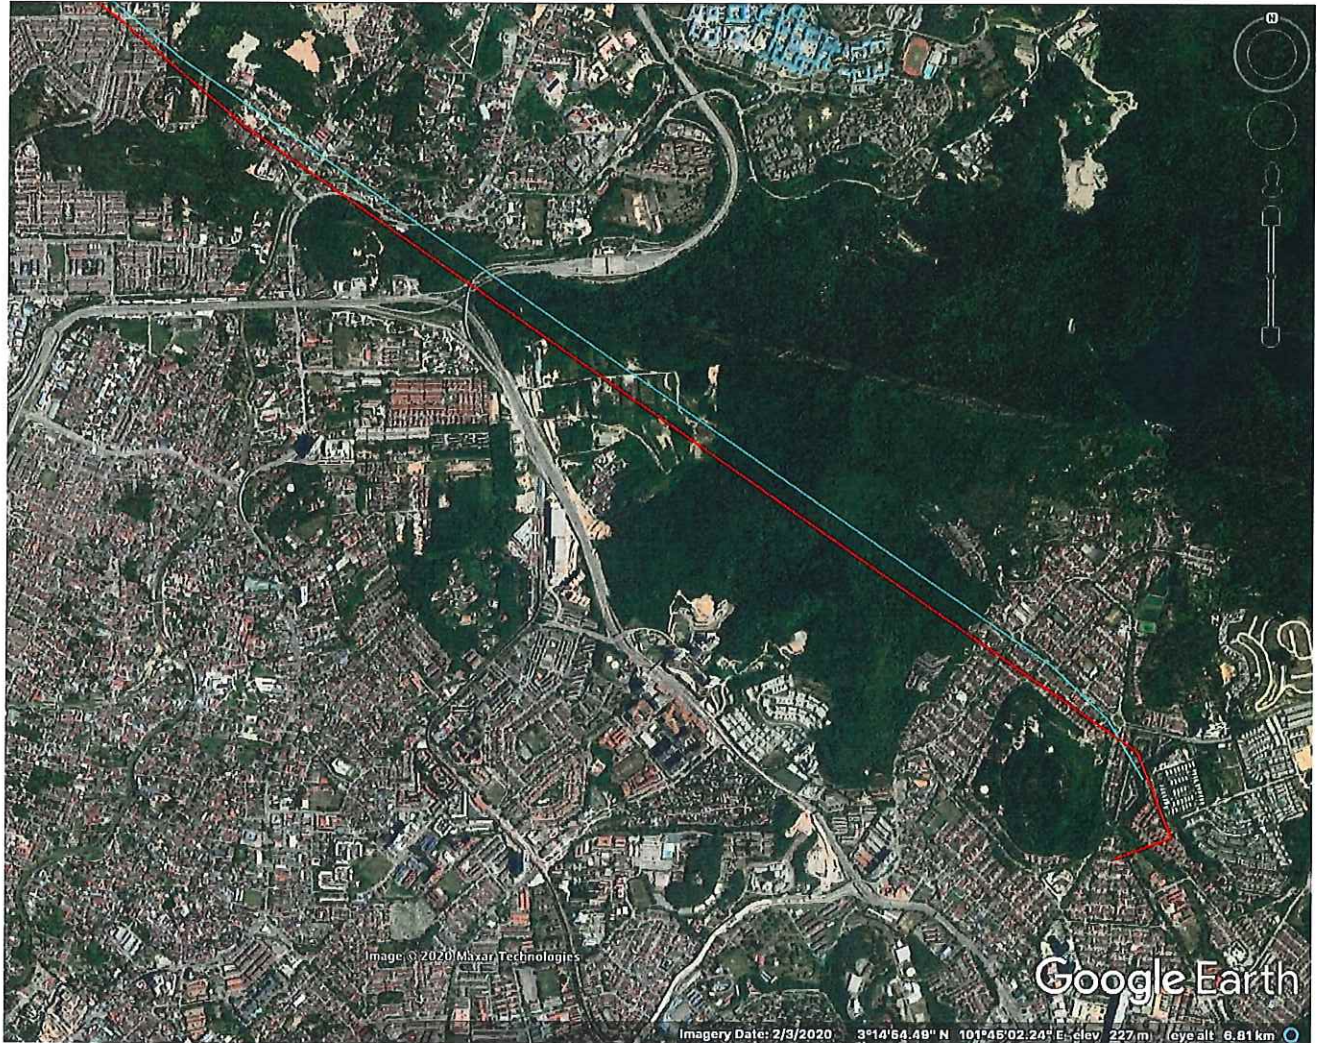
FLIGHT PATH  
(BATU DAM – KLANG GATES)

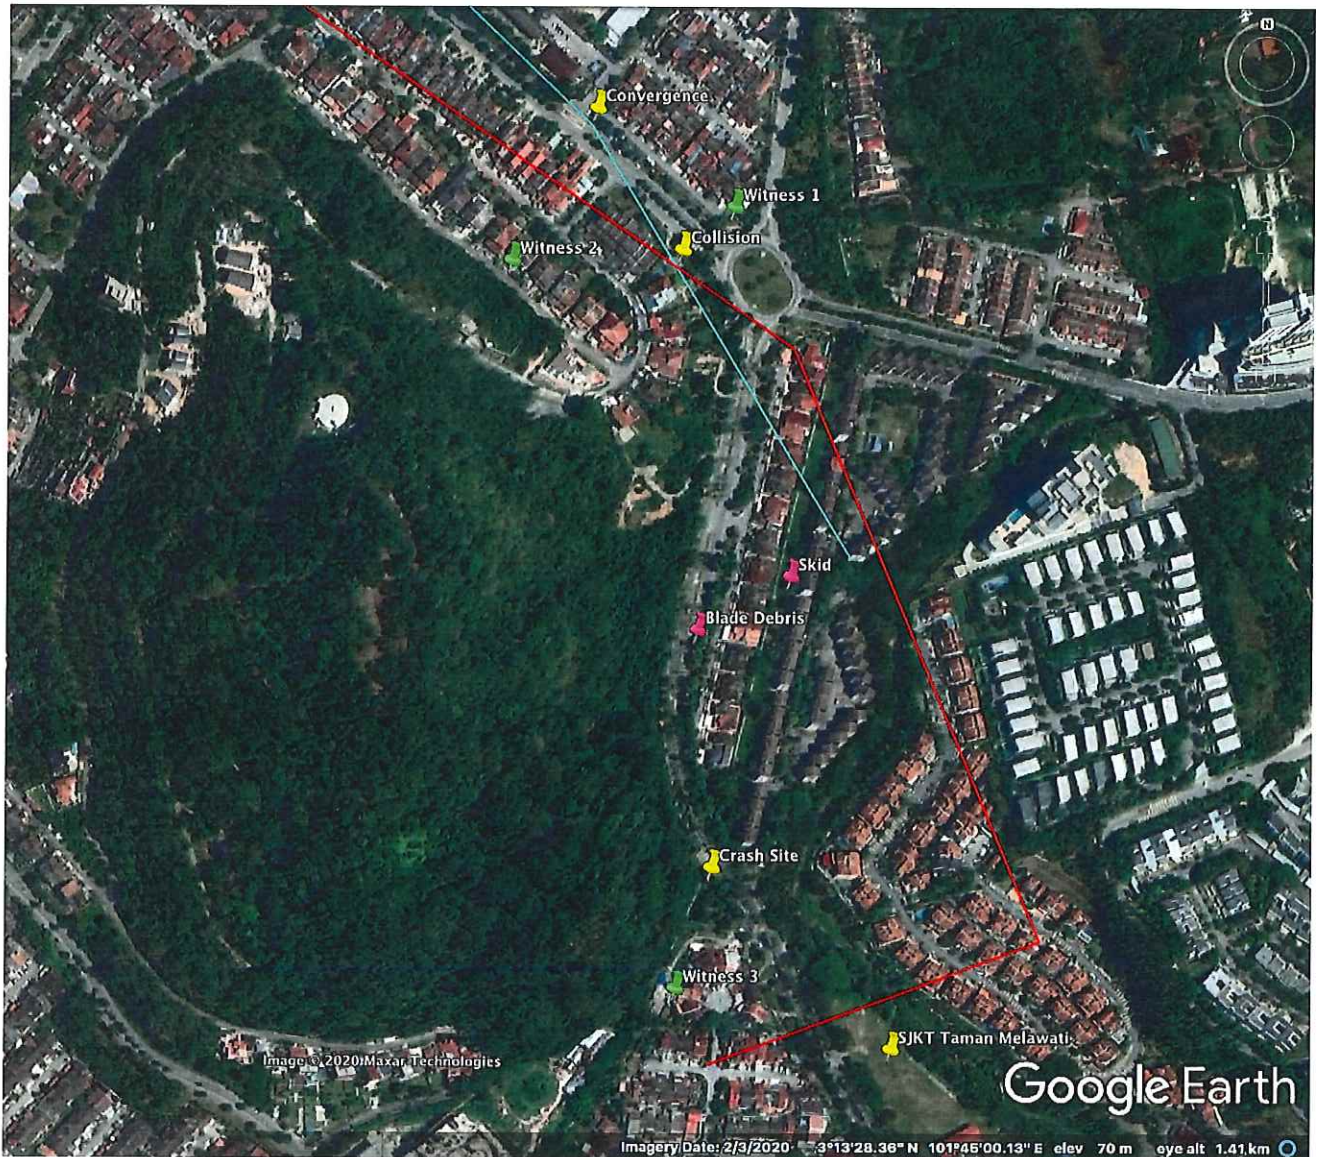
CONVERGENCE AND COLLISION
