**AIRCRAFT ACCIDENT
FINAL REPORT
A 07/18**

**Air Accident Investigation Bureau (AAIB)
Ministry of Transport, Malaysia**

**Accident involving Rotorcraft Helicopter Robinson R66
Registration 9M-RML
at Sultan Abdul Aziz Shah Airport,
Subang, Kuala Lumpur
on the 15th August 2018**

ACCIDENT REPORT NO. : A 07/18

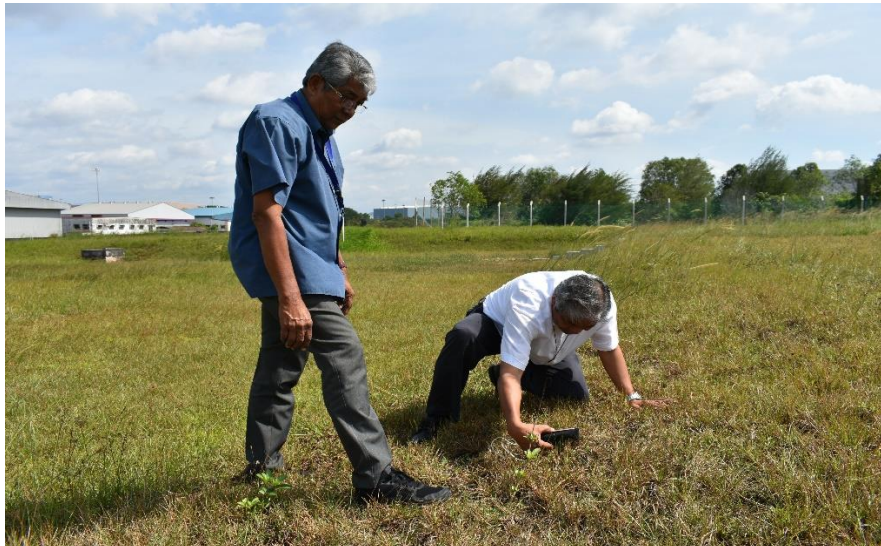
This place was accepted by trainers due to its nature of uneven surface with sloping angles varies from 8° to 12° as per shown below.

Figure 12: Investigator is measuring the slope angle

It should also be emphasized here that the maximum recommended rate of angle for sloping ground exercise is 5° , while the actual angle of slope for the surface used during the occurrence is approximately from 8° to 12° which is on the high side. However, the angle of the slope couldn't be accurately determined by the pilot while flying the helicopter during hover.

3.1.8 The approximate angle of the slope area for the sloping ground exercise is from 8° to 12°, whereby the maximum recommended angle for sloping exercise is 5°.

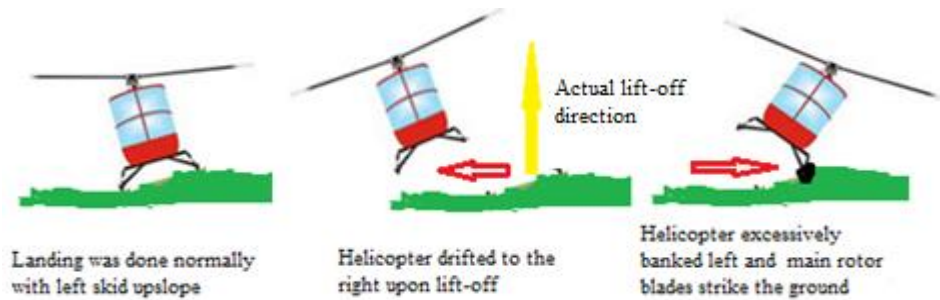
Based on the interview statement given by the PIC, it was a familiarity flight to a PPL pilot with lapsed LPC whom was on the controls at that time following through by the PIC while demonstrating landing and take-off on sloping ground. The landing was done normally with the left skid upslope. When they commenced the take-off with right skid up sloped, the downhill skid needs to be raised without moving the uphill skid. To achieve this, the vertical component of total rotor thrust (VTRT) must be enough to lift on side of the helicopter. Whilst applying sufficient lateral force to the rotor mast to roll the helicopter to a level altitude around the upslope skid, as the right skid break contact with the ground, the helicopter started to drift to the right. The PIC who is also Instructor pilot (occupying LHS), without calling 'I have control' grabs the control and tries to correct the situation. Instead of bringing the helicopter to normal hover, it excessively bank to the left and subsequently

the main rotor blades strike the ground. This was believed due to the startled effect from the PIC.

Diagram 3: Sequence of event during the lift-off until blades strike the ground

The cause of the accident is due to a 'loss of lateral control' during lift-off leading to dynamic roll over.
