AIRCRAFT ACCIDENT FINAL REPORT
A02/19
Air Accident Investigation Bureau (AAIB)
Ministry of Transport, Malaysia

BD100 Challenger Registration 9M-TST
at Sultan Abdul Aziz Shah Airport, Subang, Selangor
on 18 March 2019

ACCIDENT REPORT NO. : A 02/19

OPERATOR	:	BERJAYA AIR
AIRCRAFT TYPE	:	BOMBARDIER BD100-1A10
NATIONALITY	:	MALAYSIA
REGISTRATION	:	9M-TST
PLACE OF OCCURRENCE	:	SULTAN ABDUL AZIZ SHAH AIRPORT, SUBANG, KUALA LUMPUR
DATE AND TIME	:	18 MARCH 2019 AT 0311LT

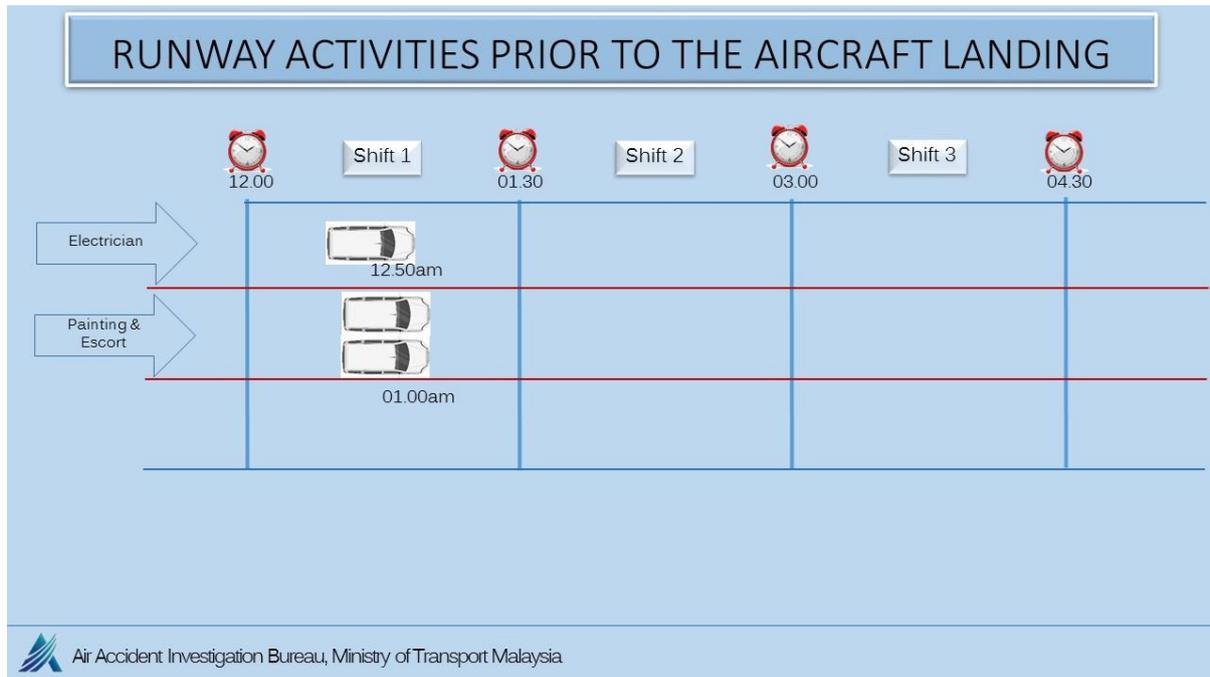
The Duty Air Traffic Controller (named as Shift 1) has allowed a vehicle to enter the threshold area of Runway 15 area at time 0050hrs for lighting maintenance work. All communication between the vehicle and the tower was on walkie talkie.

Subsequently at 0100hrs two vehicles comprising an escort vehicle and a maintenance vehicle carrying three contractors' workers for runway centreline painting work were allowed by Duty Air Traffic Controller to enter the runway via threshold runway 15 to do the painting for runway centreline. All communications between the escorting vehicle and Control tower were through the walkie talkie. The contractor's vehicle does not have any means of communications with control tower.

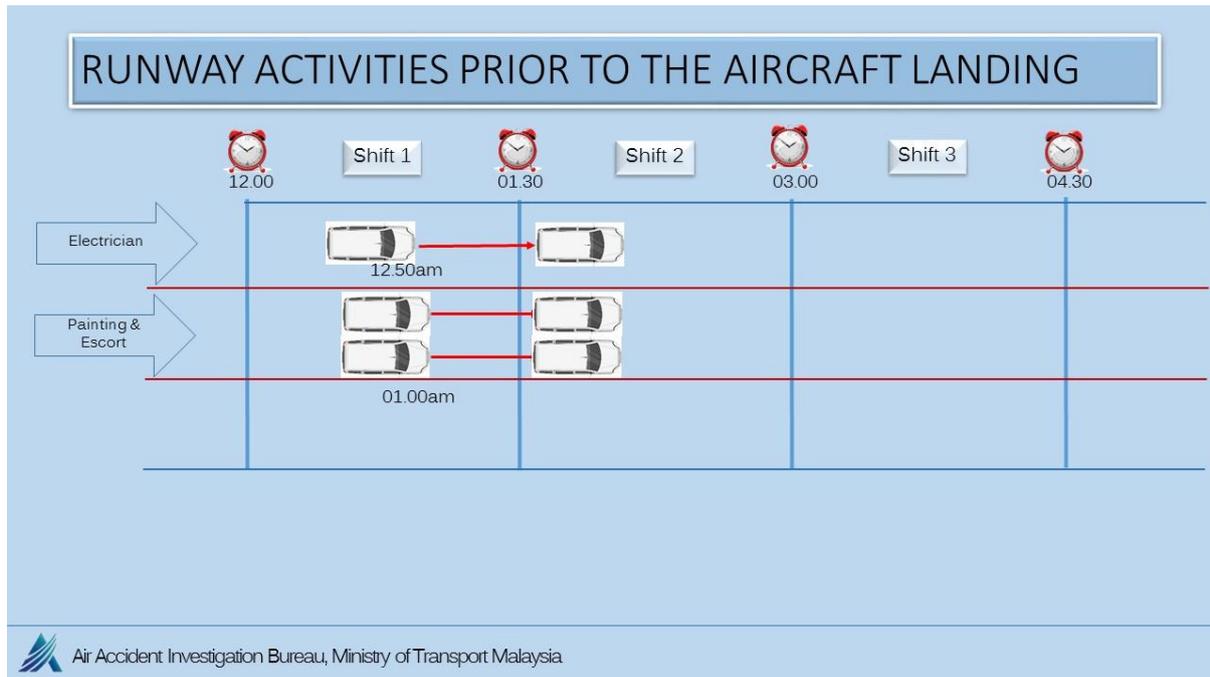
Shift 1 handed over his shift to Controller of Shift 2 at 0130hrs with an information of Work in Progress with 2 separate type of works, lighting with one vehicle and Painting with two vehicles are on the runway.

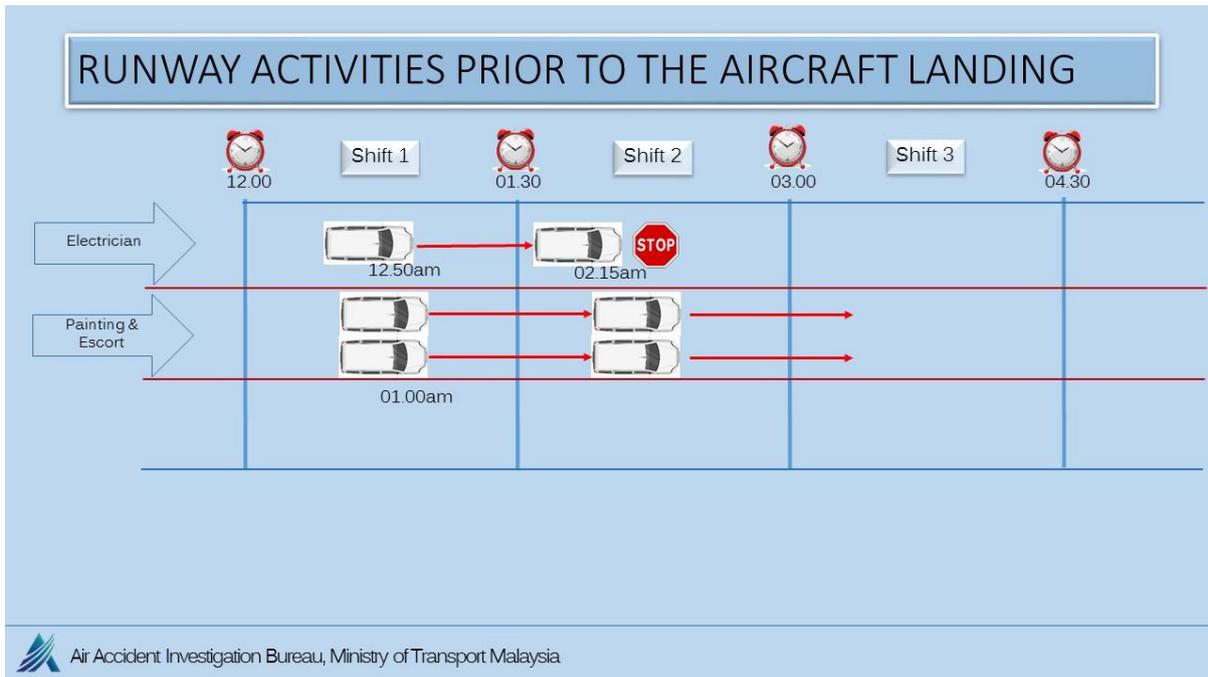
At 0215hrs, tower controller (Shift 2) received a request to vacate the runway from the lighting maintenance vehicle through walkie talkie as their work has been completed. Based on this last communication at time 0215hrs, the Duty Air Traffic Controller (Shift 2) has recorded in the tower logbook that maintenance works on the runway has been completed and **all** vehicles had vacated the runway **despite** there were two other vehicles still on the runway doing painting works.

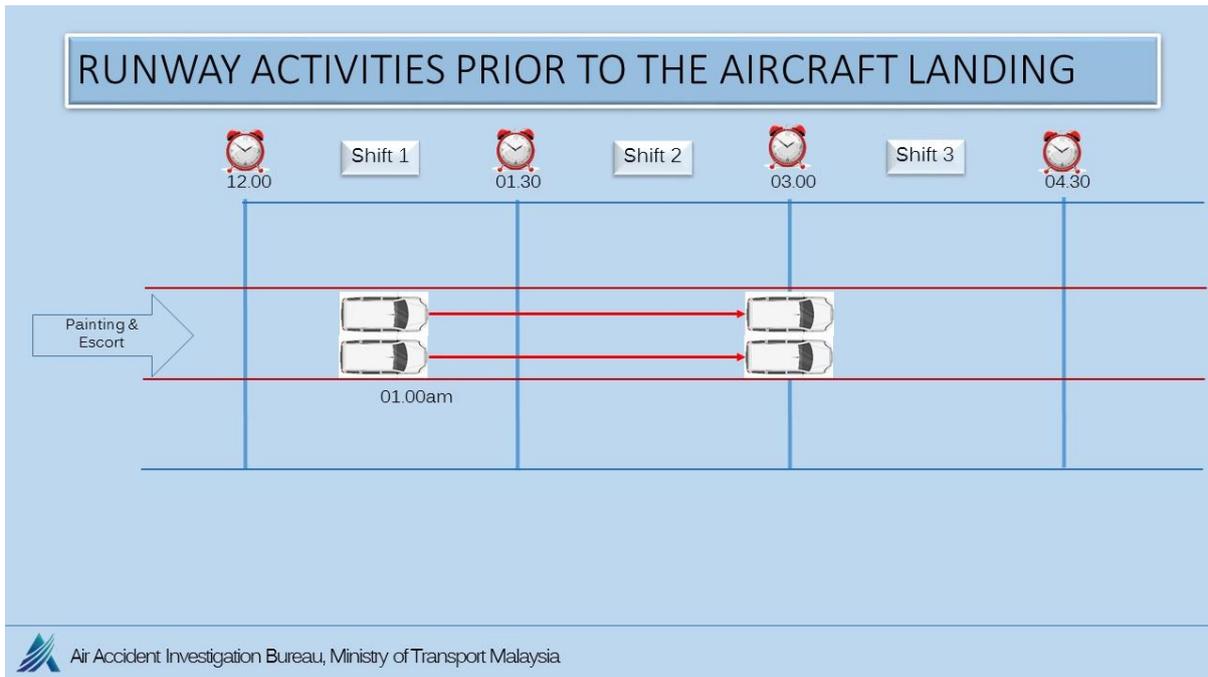
The contractor workers doing the painting works explained that they started painting the runway centreline from threshold Runway 15 and moved towards threshold Runway 33. They were using the contractor's vehicle moving along the centreline and initially the escorting vehicle followed them closely behind. After a while, the workers realised the escorting vehicle was static as far as approximately 120 meters behind with no apparent reason obvious to them. The controller on duty (Shift 2) handed over his shift at 0300hrs to another controller (Shift 3) with the information that **no more work on the runway** (as recorded in the log book). There was also no indication of Work in Progress as a reminder on the flight progress strip bay at the tower console.

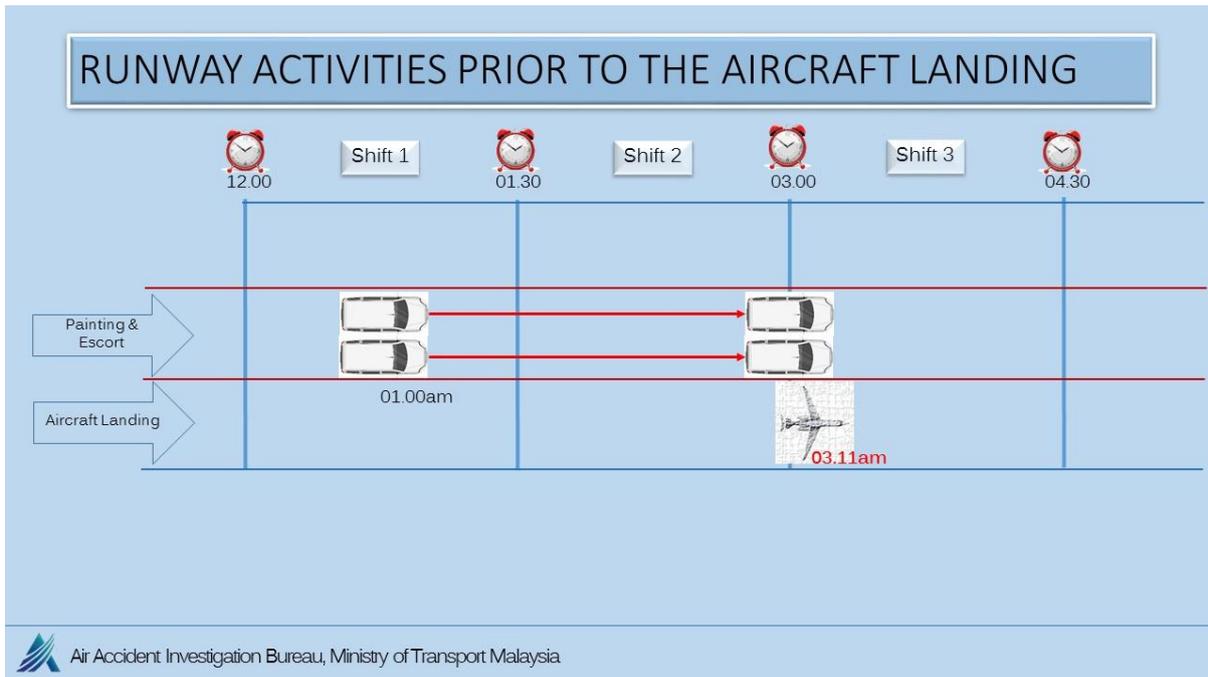
9M-TST reported his position to tower controller (Shift 3) at 9 miles final runway 15 for ILS approach at 0308hrs. After looking out on the runway to check on any abnormal activities or unusual lighting (to indicate vehicles present on the runway), clearance for landing was given to 9M-TST after the controller (Shift 3) was sure that the runway was clear for the aircraft to make a landing.

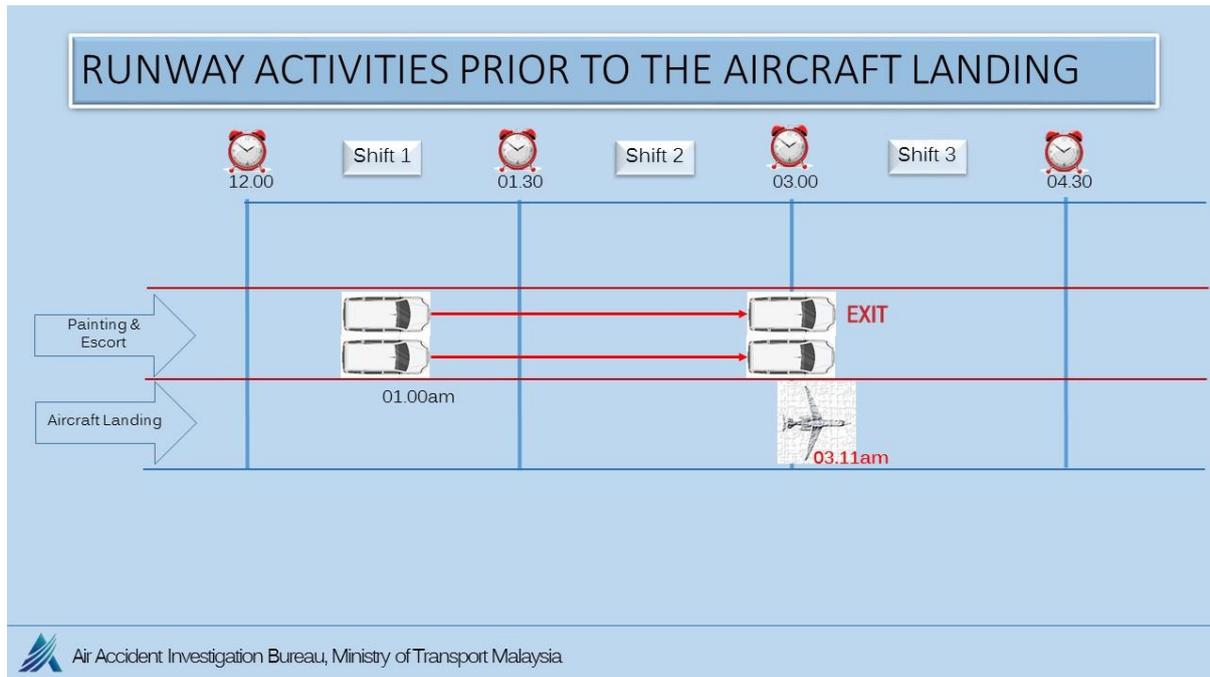
When 9M-TST descended lower and approach closer on its final approach, the leader of the contractor's worker saw the landing light of the aircraft approaching and realised that there was an aircraft coming in for a landing. Fearing of the danger, all three workers boarded their vehicle and drove away from the runway. While making a 180 degrees turn, the driver realised the escorting vehicle was still static at the same last position. Based on witness's statement they flashed the headlight of the vehicle several times to attract the escort vehicle attention. No response was observed from the escort vehicle, and as the aircraft was getting closer to them, the driver drove his vehicle away from the runway and stop at taxiway Foxtrot to give way for the aircraft to land.

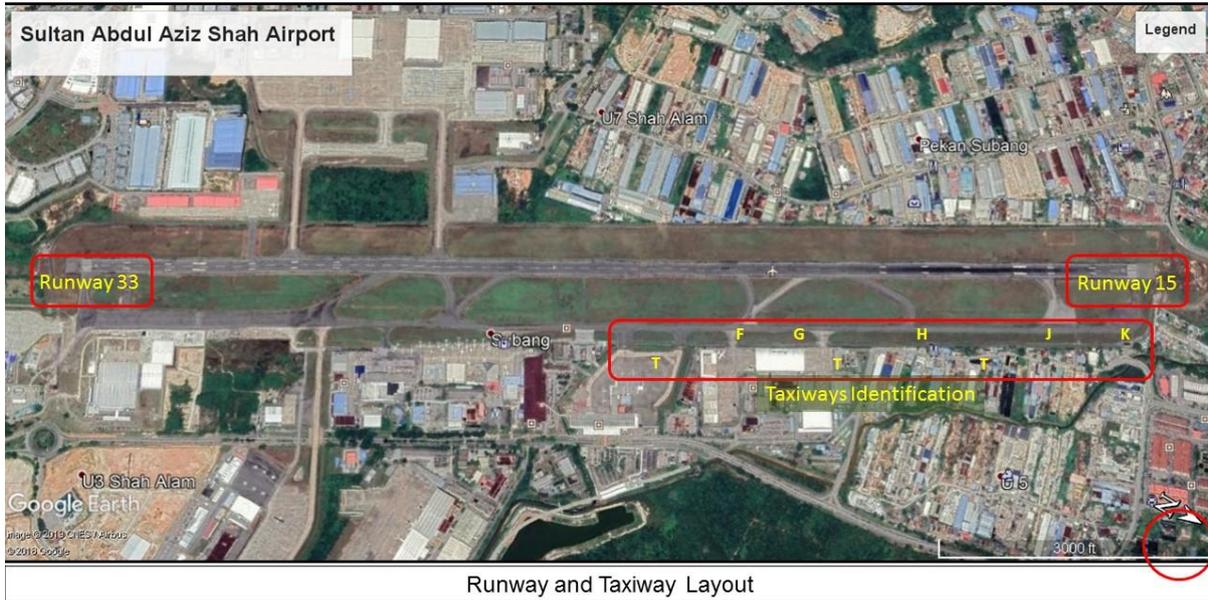
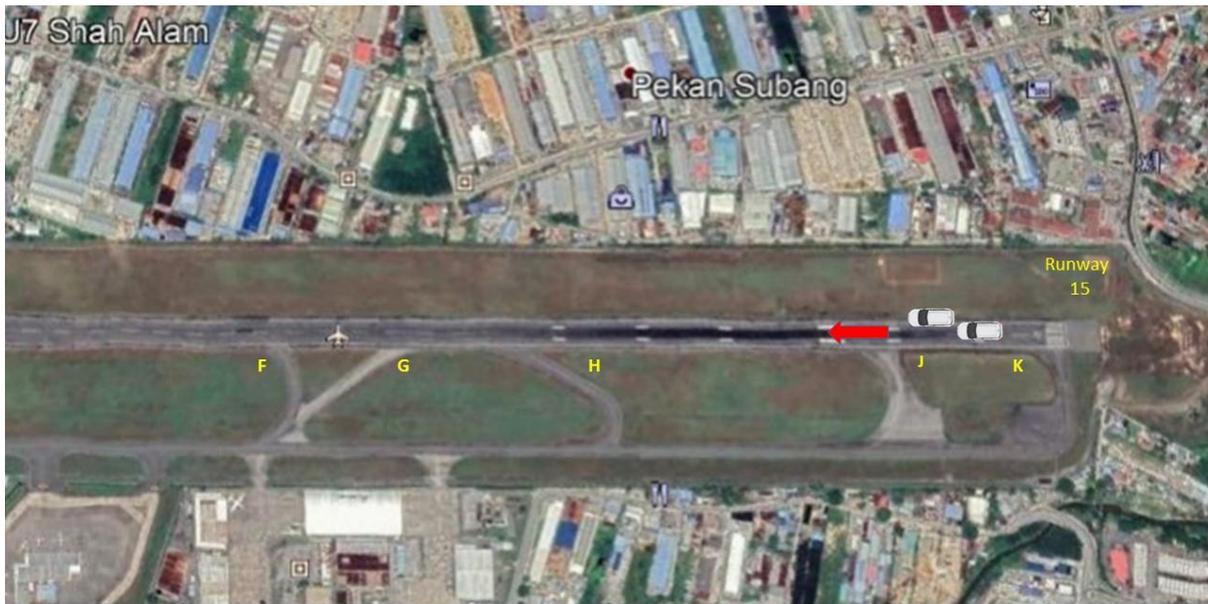
1	Initial Position and movement of vehicles from Threshold Runway 15 (Not to Scale)
---	---

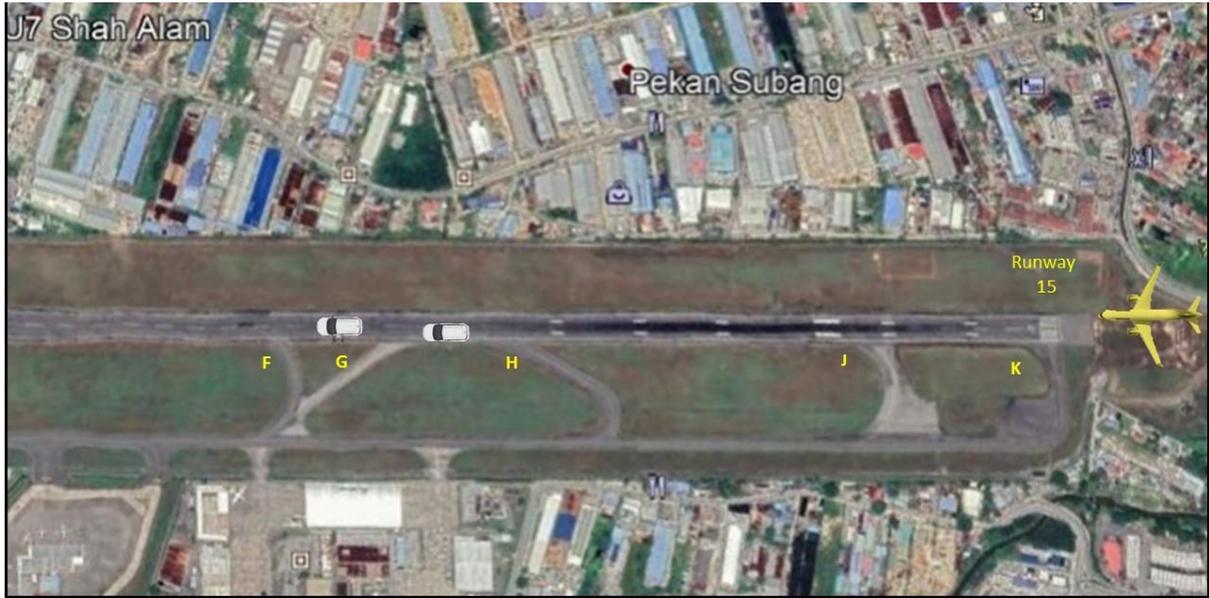
2	Vehicles position when aircraft on short final (Not to scale)
---	---

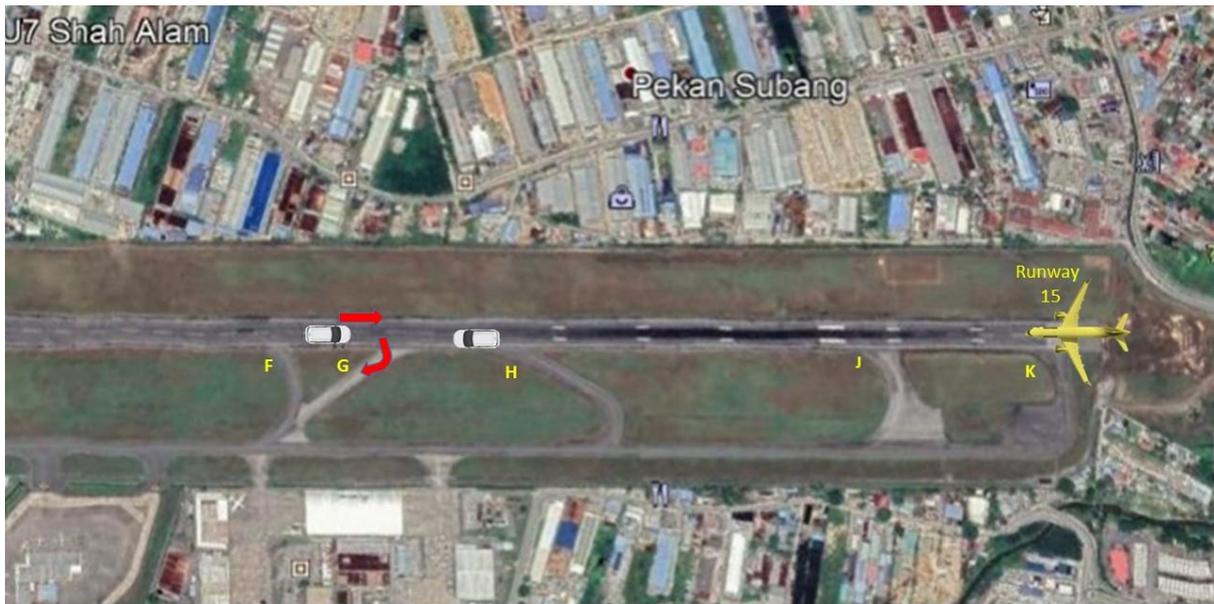
3	Contractor's vehicle making a turn and vacated the runway (Not to Scale)
---	--

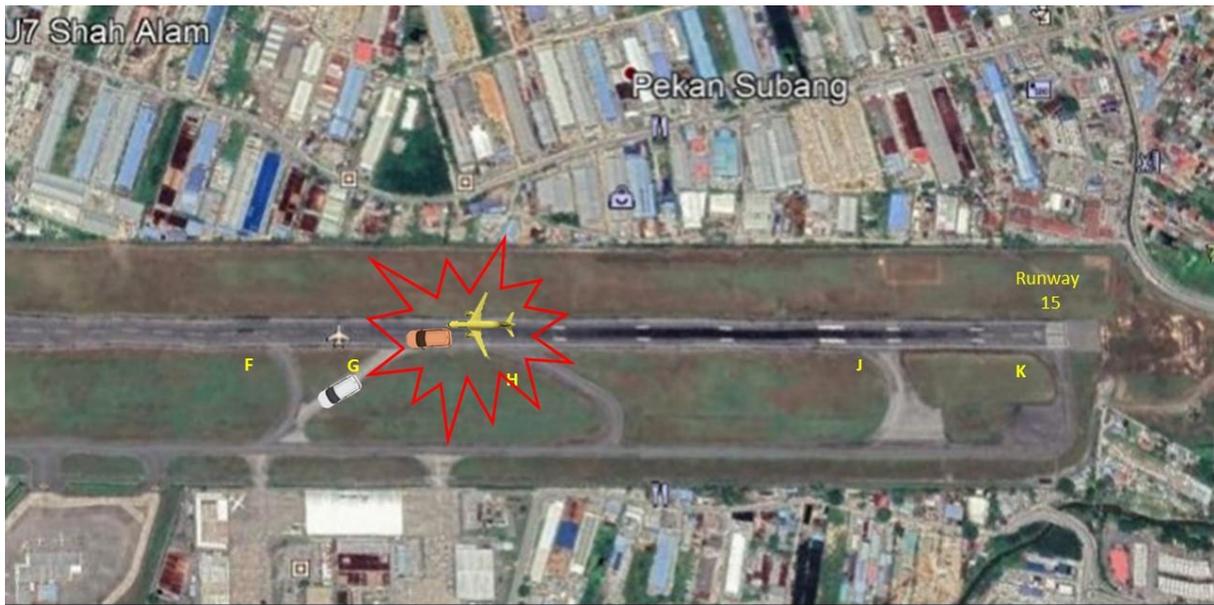
4	The escort vehicle hit by the aircraft (Not to Scale)
---	---
