# AIRCRAFT SERIOUS INCIDENT FINAL REPORT SI 08/20 Air Accident Investigation Bureau (AAIB) Ministry of Transport Malaysia

Serious Incident Involving Fixed Wing Aircraft Beechcraft Bonanza F35 Registration N5045B at km 47.8 Southbound, North South Expressway (PLUS) Near Sedenak, Kulai, Johor. on the 22 November 2020

REPORT NO.	: SI 08/20
OPERATOR	:	PRIVATE
AIRCRAFT TYPE	:	BEECHCRAFT BONANZA F35
NATIONALITY	:	UNITED STATES
REGISTRATION	:	N5045B
PLACE OF OCCURRE	NCE :	KM 47.8 SOUTHBOUND NORTH SOUTH EXPRESSWAY (PLUS) NEAR SEDENAK, KULAI, JOHOR
DATE AND TIME	:	22 NOVEMBER 2020 AT 1105LT

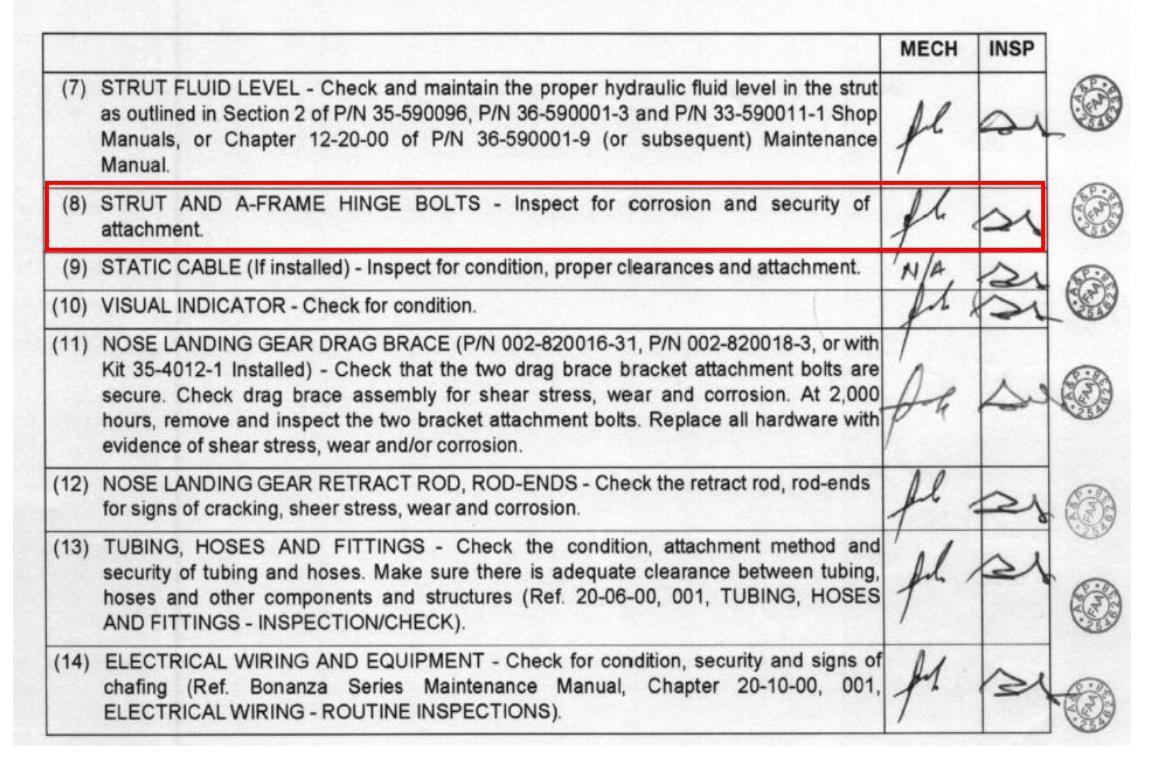
Figure 23: Annual inspection form – Nose Gear Shock Strut Inspection

The annual inspection check calls for the inspection of the nose gear shock strut for corrosion as in Figure 23. It was observed that the aircraft nose gear shock strut shows sign of severe corrosion at various places despite undergoing annual inspection in March 2020 as in Figure 24.

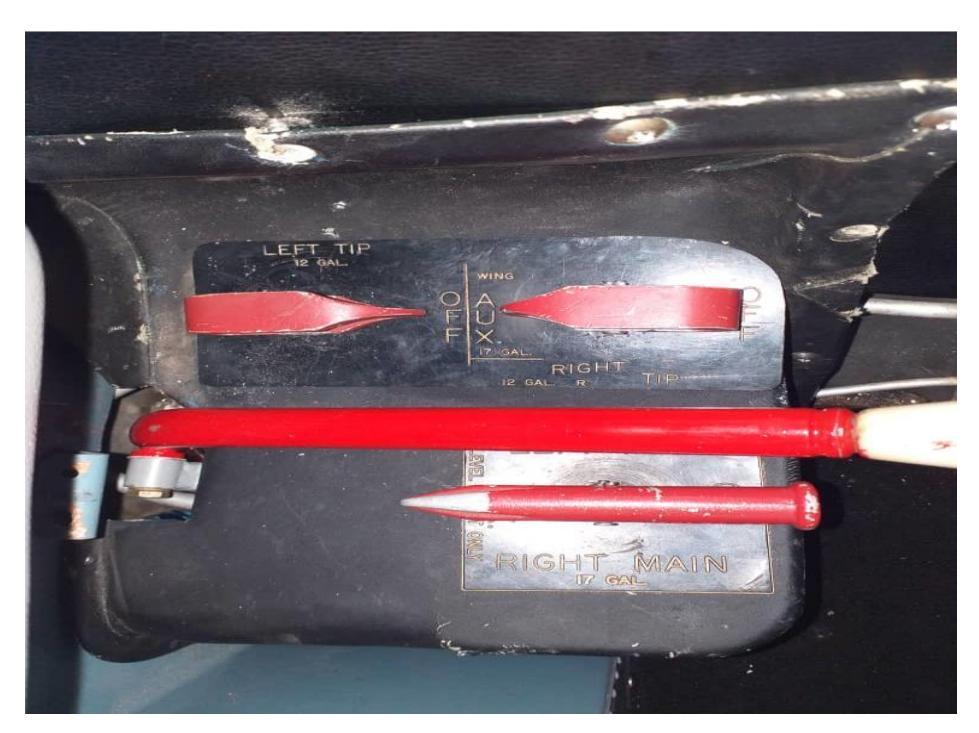
Figure 30: Both AUX tank in use. There is no individual tank selection for auxiliary tank

To use fuel from the auxiliary tanks, two selectors must be pointed to AUX as both the auxiliary tanks are connected to a common port in the fuel selector valve as shown in Figure 30. This is to allow both tanks to feed simultaneously when the selector valve is set to AUX.

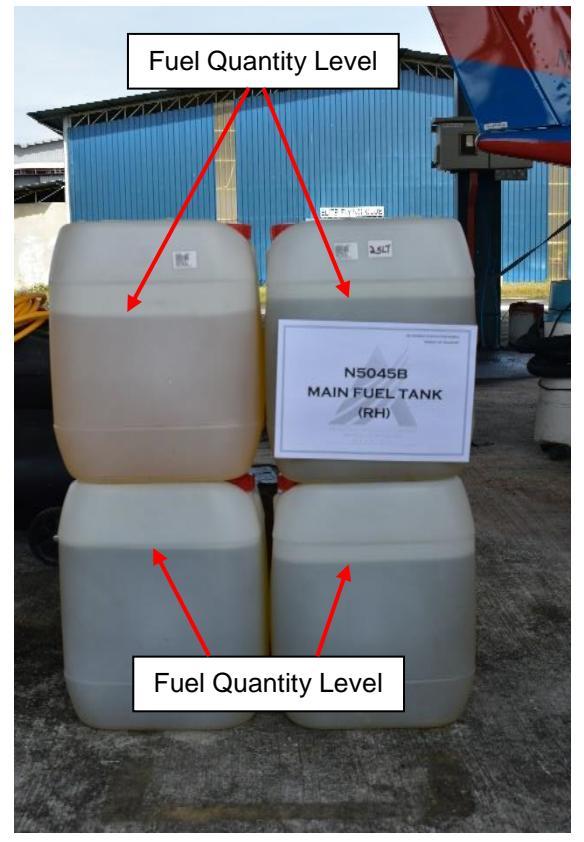
Figure 34: Actual fuel quantity remaining after emergency landing for Left and Right Main Tank

**RIGHT MAIN** Tank – quantity about **17 gallons**

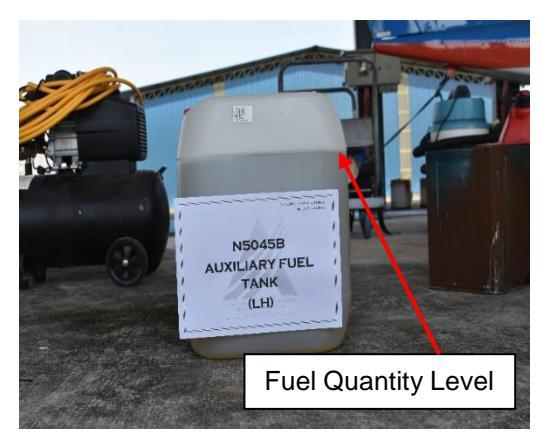
Figure 35: Actual fuel quantity remaining after emergency landing for Left and Right Auxiliary Tank

LEFT AUX TANK – quantity about 4 gallons

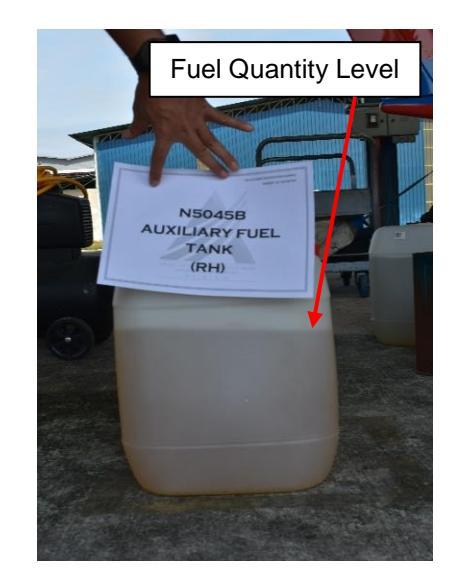
**RIGHT AUX TANK** – quantity about **3 gallons**
