AIRCRAFT SERIOUS INCIDENT FINAL REPORT SI 04/24 Air Accident Investigation Bureau (AAIB) Ministry of Transport, Malaysia

Fixed Wing Aircraft Boeing 737-800, Registration 9M-LCM at Kuching International Airport, Sarawak on 13 February 2024

REPORT NO.: SI 04/24

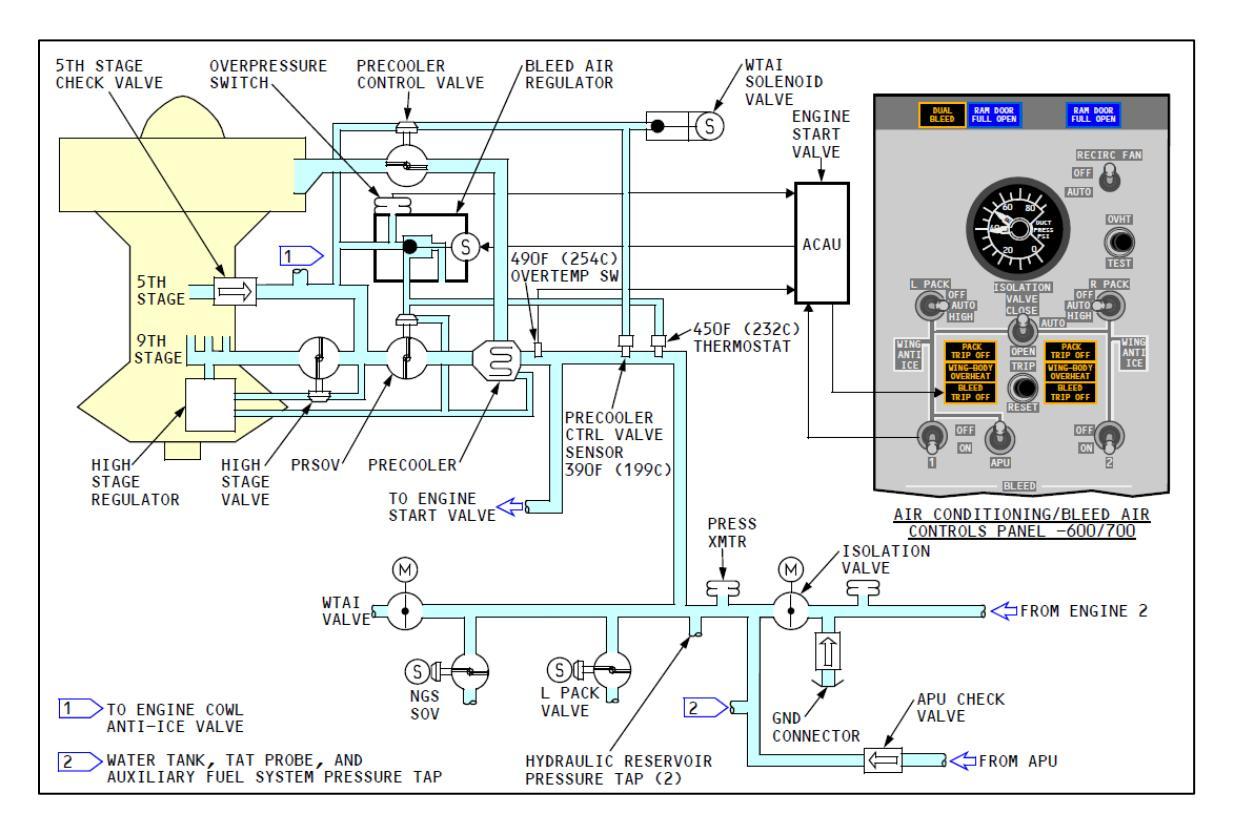
Figure 7: Pneumatic Functional Description

At low engine speed the 5th stage check valve prevents reverse flow. At high engine speed the HSV close and the 5th stage valve open to supply bleed air to the pressure regulating shut off valve (PRSOV). The air conditioning bleed air controls panel has engine bleed switches to control the pressure regulating shut off valve. Also, there are BLEED TRIP OFF light to show over pressure or over temperature condition.

The Bleed Air Regulation (BAR) and PRSOV control the flow of engine bleed air to the pneumatic manifold. The BAR has over pressure switches to prevents over pressure conditions and turn on the BLEED TRIP OFF lights. The 450°F (232°C) thermostats make the PRSOV move toward closed when the temperature gets to 450°F (232°C). The air conditioning accessory unit (ACAU) is an interface between the air conditioning

bleed air controls panel and the PRSOVs. The 490°F (245°C) overheat switches turn on the BLEED TRIP OFF lights and close the PRSOVS. This prevents overheat damage to the pneumatic manifold and user systems.

The bleed trip can occur when the over-temperature switch is triggered, which happens when the bleed air temperature reaches 490°F. As shown in Figure 7, the temperature switch is positioned in the PRSOV pneumatic downstream duct. During the climb phase, the normal configuration of bleed air components operates with the Stage-5 bleed air check valve open, the PRSOV open and regulating (as sensed by the 450°F sensor), the HSV closed, and the PCCV open and regulating depending on the engine supply temperature, as sensed by the 390°F sensor. If there are abnormalities with the HSV (such as it remaining open), it can cause the temperature
