**AIRCRAFT ACCIDENT  
FINAL REPORT**

**A 03/24**

**Fixed-Wing Aircraft Blackshape BK 160TR, Registration I-POOC  
at Kapar, Selangor  
on 13 February 2024**

**FINAL REPORT NO: A 03/24**

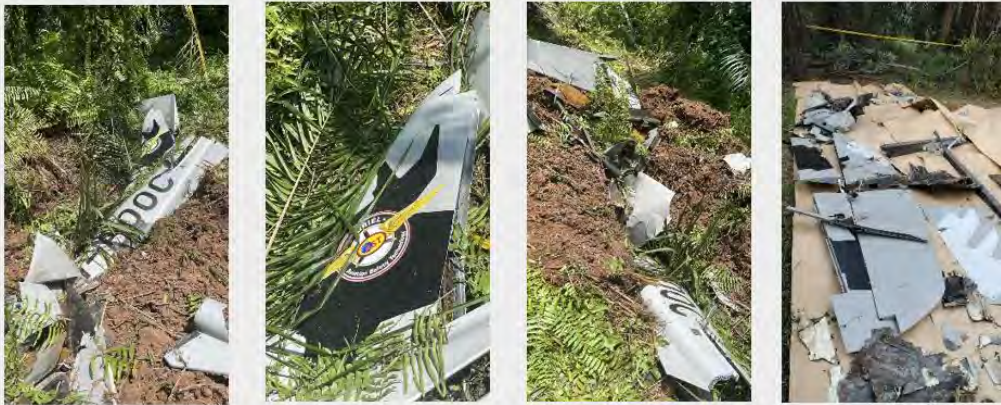
**Site 1. Oil Palm Plantation – Main Wreckage – 3° 07' 56.9"N 101° 20' 18.7"E**

Figures 4 to 7 show the locations of the wreckage and debris. Site 1 marks the location of the main wreckage, including the bodies of the pilot and passenger. Sites 2 to 4 are within an area approximately 250 to 300 metres in diameter, where various aircraft debris were scattered. Before investigators arrived, most of the scattered debris were found by local villagers, who had collected and pooled much of it, particularly at Sites 3 and 4. Site 2, the closest of the three debris sites to the main wreckage, is located about 560 metres east of Site 1.

Figure 4. Site 1

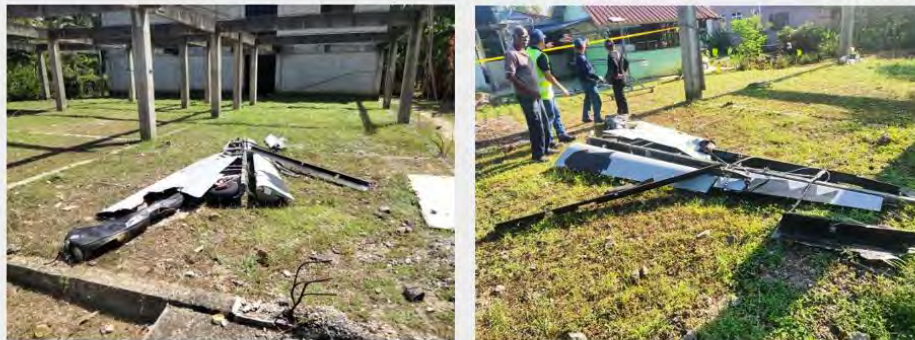
**Site 2. Next to House Kitchen – Right Wing – 3°07'57.8"N 101°20'36.8"E**

Figure 5. Site 2

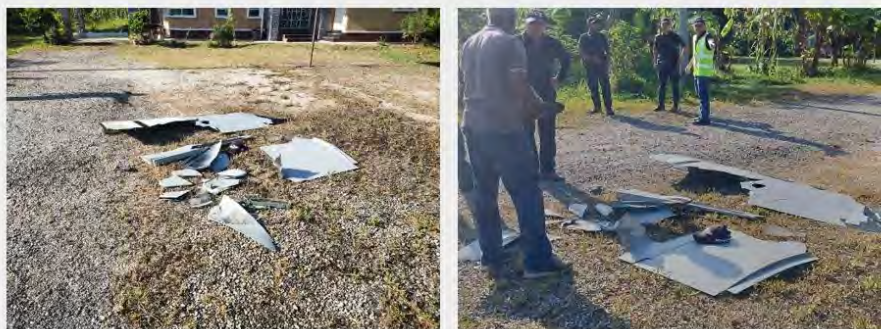
**Site 3. Uninhabited House – Various Debris & Cap – 3°07'56.1"N 101°20'42.1"E**

Figure 6. Site 3

Notably, debris found at or near Site 3 included fragments of the cockpit canopy in various sizes, along with the passenger's baseball cap, suggesting that the canopy had broken up in-flight prior to the aircraft's ground impact at Site 1.

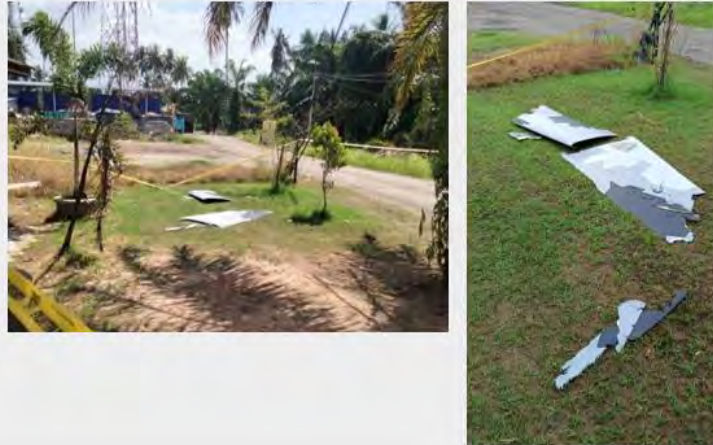
**Site 4.** Front of House – Left Wing Parts – 3°07'53.3"N 101°20'42.7"E

Figure 7. Site 4

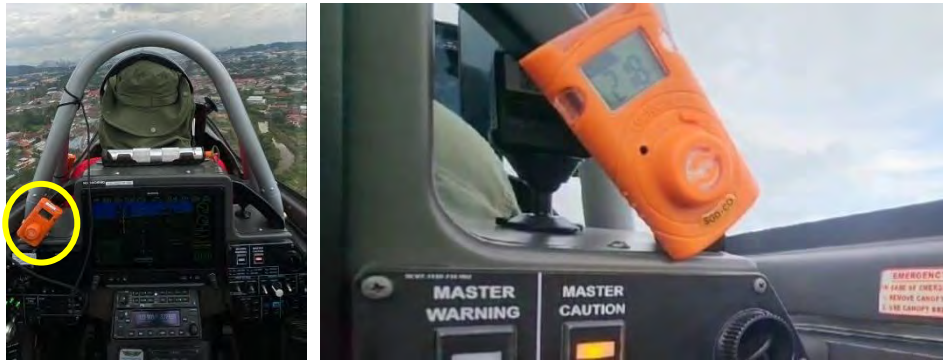
The pilot reported to Blackshape that the aircraft's Master Caution and CO Master Caution alerts on the Garmin G3X flight display occasionally activated during flight. Additionally, the CO indicator strip in the front cockpit was observed to be partially black, suggesting elevated levels of CO in the cockpit.

Figure 15. Jury-Rigged Portable CO Detector

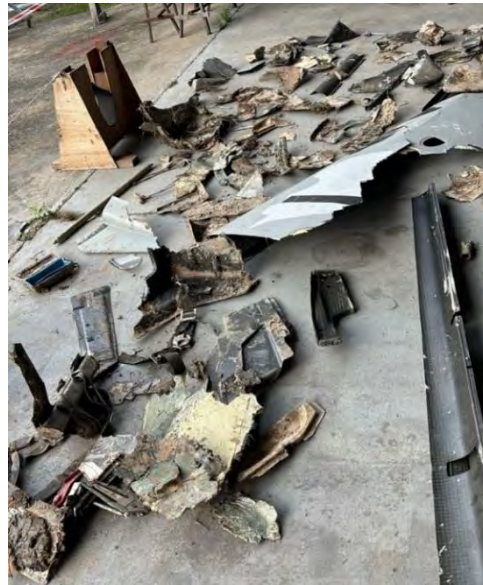
Due to the high-energy impact, the container of the I-POOC aircraft was shattered into pieces, failing to prevent intrusion by external objects and leading to fatal injuries for the occupants.

Figure 25. Container Shattered into Debris  
Survivability Almost Impossible

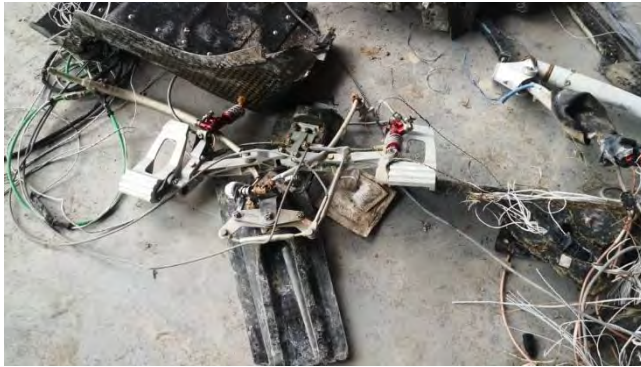
Figure 26. Rear Seat Rudder Pedal  
Relatively Intact

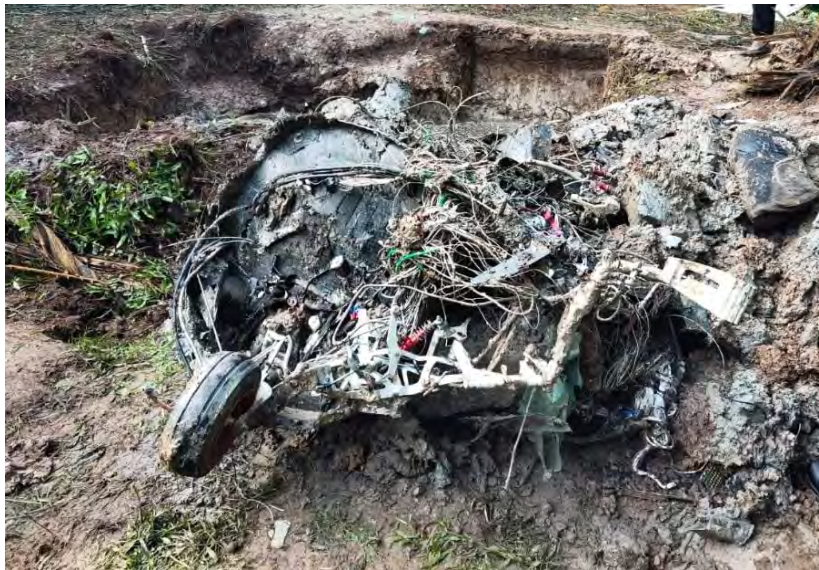
Crumple zones are designed to deform in a controlled manner upon impact, increasing stopping distance and reducing deceleration forces on occupants. In this accident, the landing gear was in a stowed position and did not absorb impact forces. Additionally, the aircraft struck the ground at a 45° downward angle, with only the engine and its housing acting as a crumple zone to extend deceleration time.

Figure 30. Nose Wheel Retracted; Impact Not Absorbed by Landing Gear.

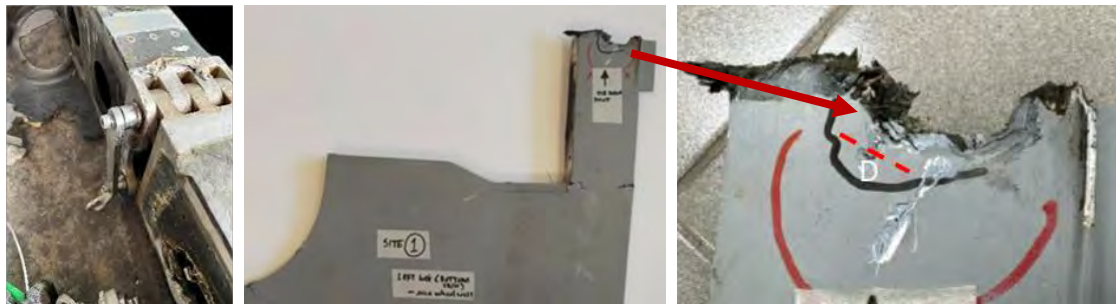
Figure 37. LH Wing – Tie-Down Ring and Man-Made Hole (Fragmented Portion)

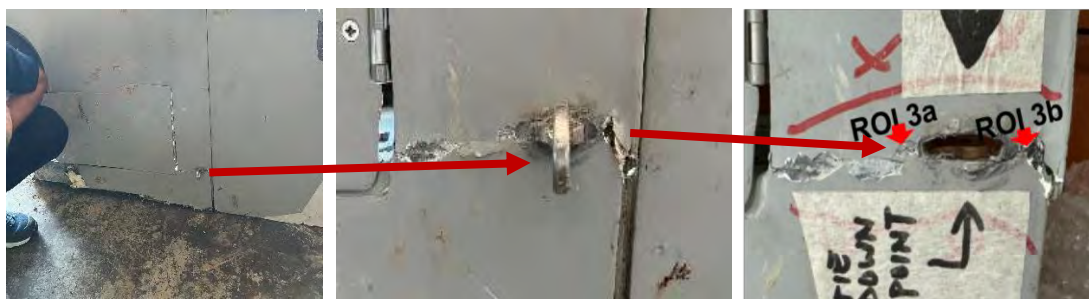
Figure 38. RH Wing – Tie-Down Ring and Man-Made Hole

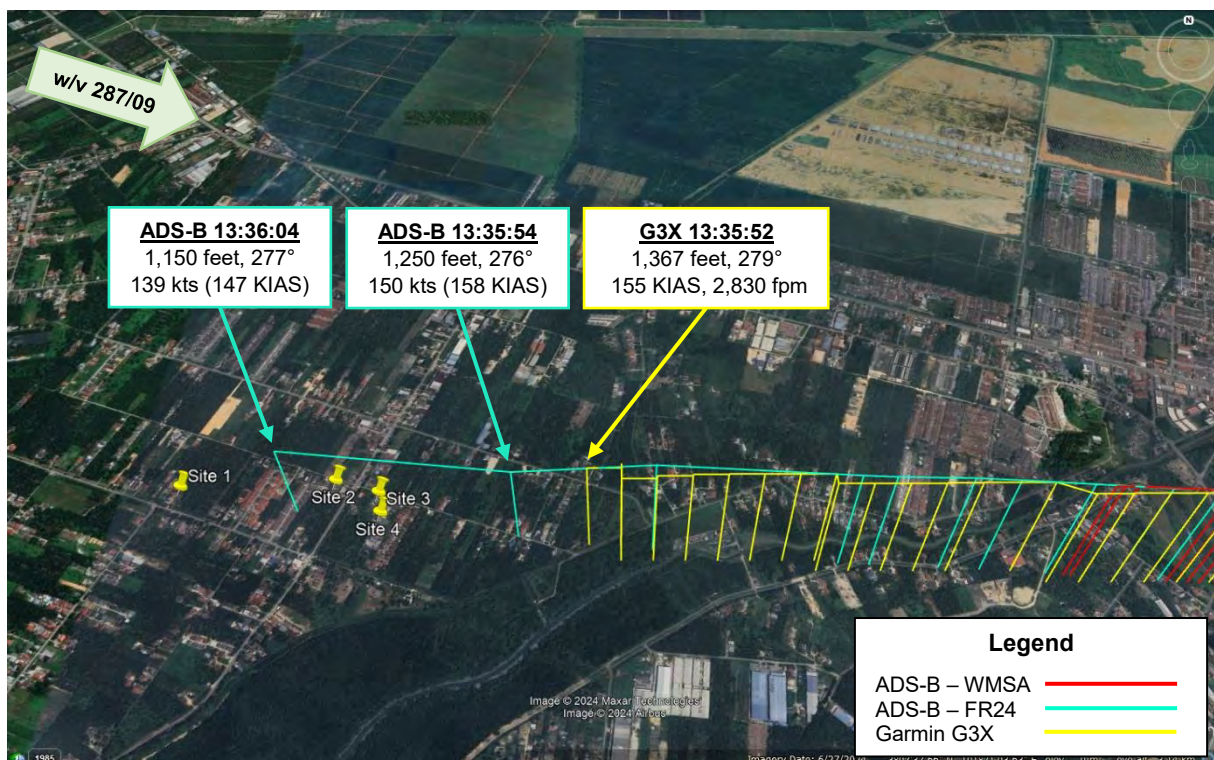
At 13:35:45 LT—around 7:46 minutes into the flight and shortly after the pilot's final ATC radio transmission at 13:35:34 LT—the data show the initiation of a controlled dive manoeuvre, with stable roll and yaw angles and a gradual pitch decrease to approximately -17 degrees, which was then held steady. Roll remained within  $\pm 5$  degrees, indicating wings-level flight, and there was no sign of instability in yaw.

During this descent, the power setting was recorded at approximately 75% maximum continuous power (MCP), beginning from a pressure altitude of 1,650 feet and descending to 1,367 feet. Airspeed increased from 130 KIAS to 155 KIAS, and the controlled parameters of roll, pitch, yaw, and power suggest an intentional, stable descent within the aircraft's operational limits (although the airspeed had reached the  $V_{NO}$  limitation of 155 KIAS). No signs of instability or aerodynamic stall were observed, and the aircraft appeared responsive to control inputs.

Figure 39. Final Phase of ADV429 Flight

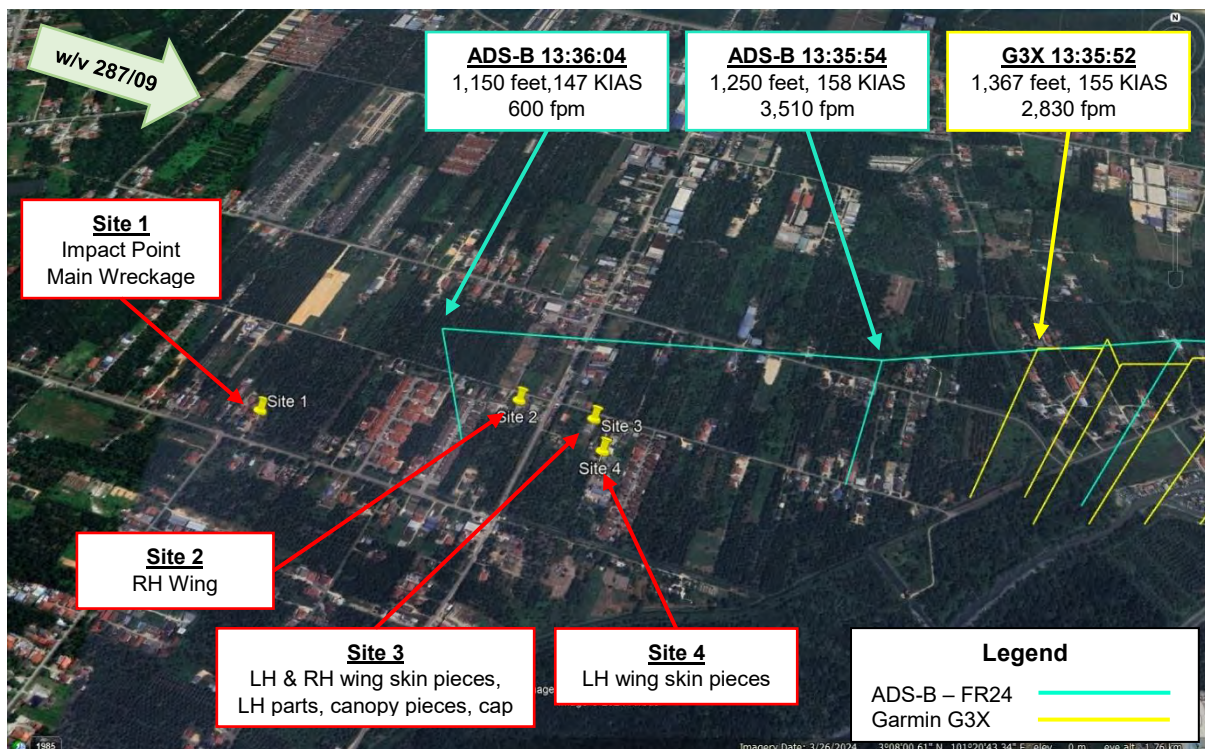
Figure 40. Flight Parameters Changes and Wreckage Distribution

- Wreckage Distribution and Sequence of Events:** The wreckage distribution provides important clues to the sequence of the breakup. Large sections of the LH wing skin were located at Site 4, the farthest wreckage site to the east of the main impact area, indicating that the LH wing skin was likely the first component to detach. Additional smaller fragments, including the LH wing lower skin, RH wing inner upper skin, LH aileron, and LH wing tip, along with cockpit

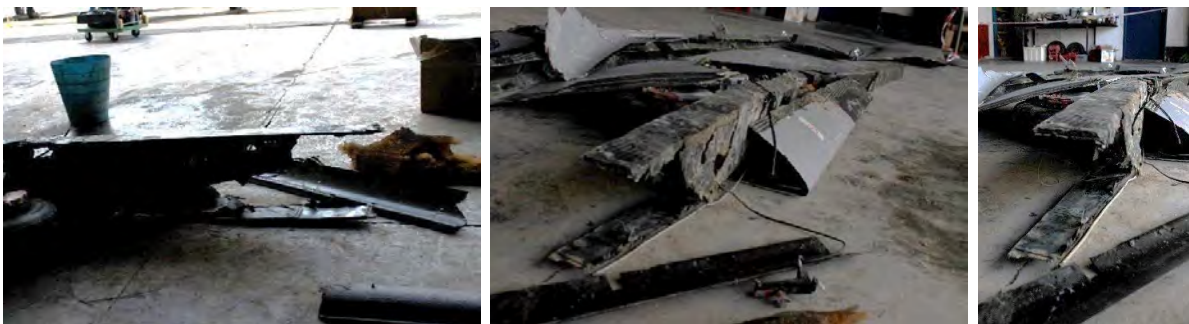
The web of the main spar is totally lost.

Figure 7. Main Spar Fuselage

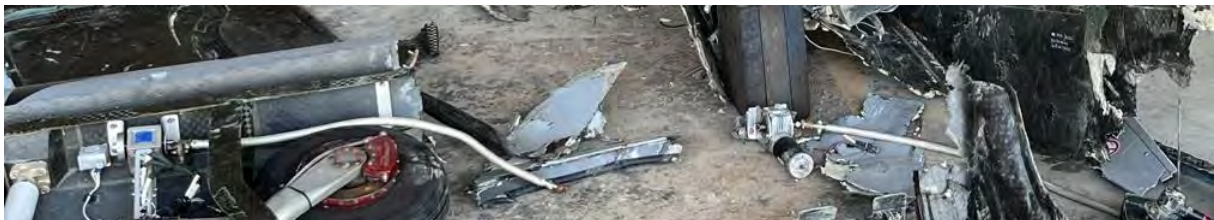
**12.4 Flap Control.** The flap motor is found detached from the rear spar, compatible with high energy impact. The RH connecting rod is disconnected from the gear motor and from the wing flap actuator by the rotating joints. The RH connecting rod is bent, probably due to the in-flight RH wing detachment.

Figure 23. Flap Control System: Flap Motor and Connecting Rods

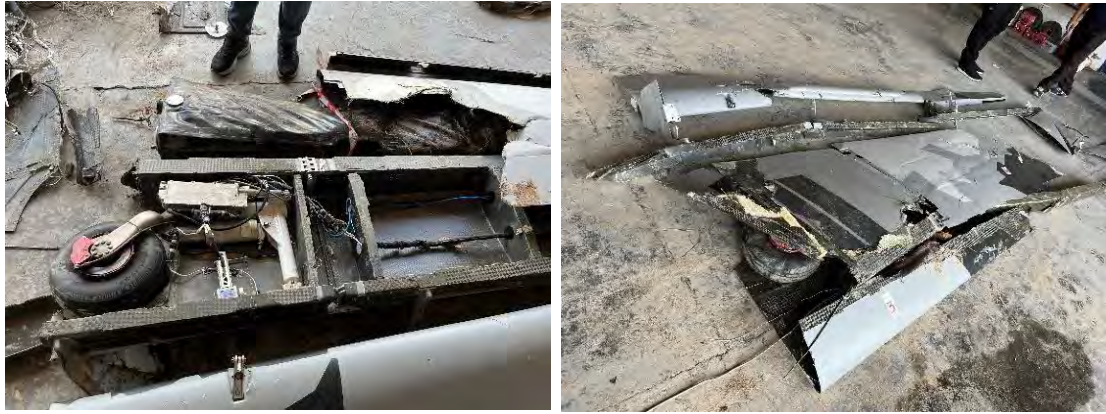
The RH Main Landing Gear (MLG) was found installed in its compartment (RH wing box) apparently in retracted position. The LH MLG was found attached on the LH wing main spar only. The Nose Landing Gear (NLG) was found installed in its position (engine mount), apparently in retracted position.

Figure 24. Main Landing Gear (LH and RH)

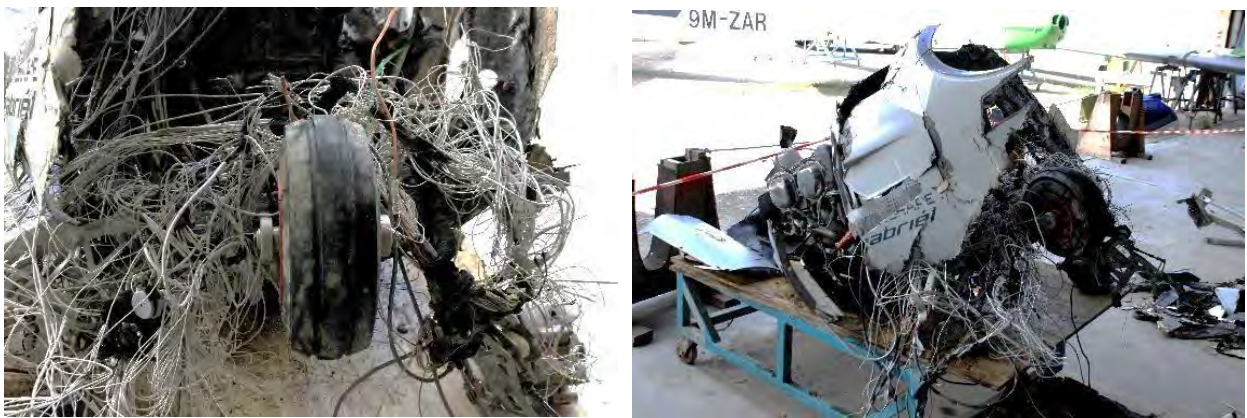
Figure 25. Nose Landing Gear

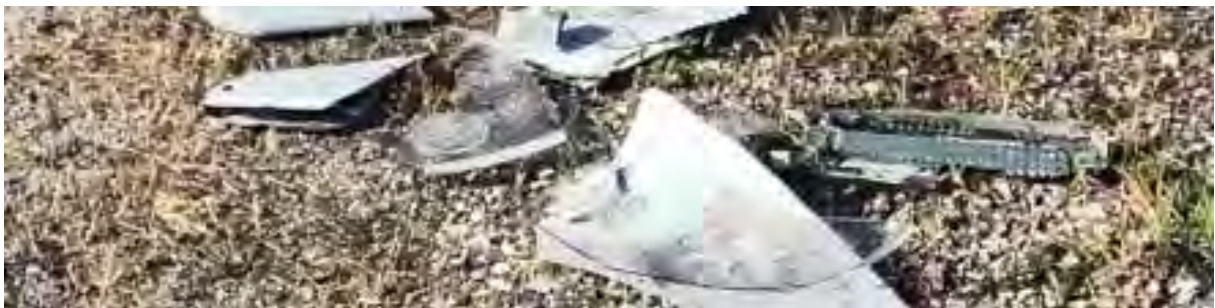
Fragments of the canopy was found at or around Site 3. The front canopy handle was retrieved. The position of the handle was not closed. However, the opening system was broken.

Figure 26. Fragments of Canopy Found at or Around Site 3

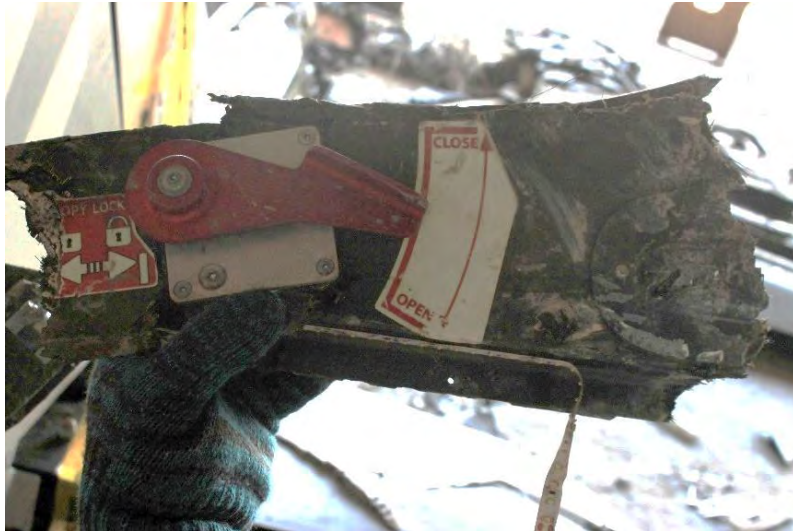
Figure 27. Front Canopy Opening Handle

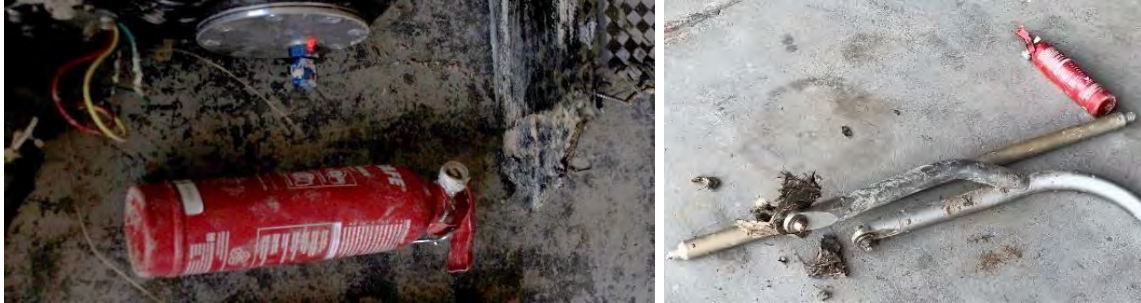
A fire extinguisher was found together with the wreckage. It was not part of the approved configuration. There is no provision of a storage place in the cabin for the fire extinguisher.

Figure 29. Fire Extinguisher

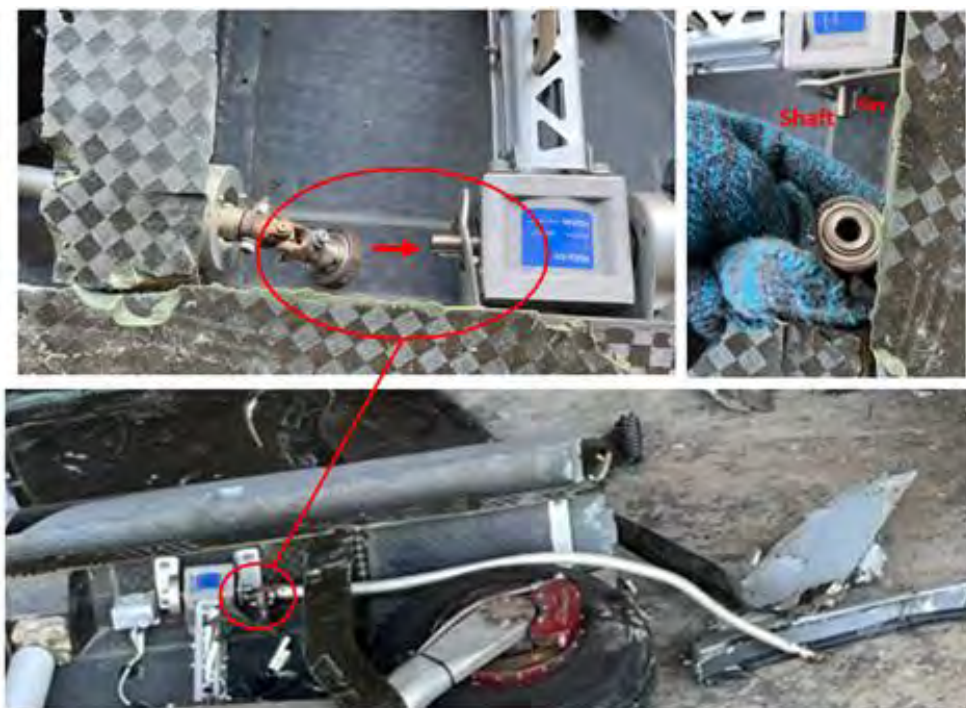
An additional wreckage assessment was conducted on the RH flap connecting rod to evaluate the bending of the right wing. The RH flap rod joint was re-connected onto the shaft of the flap actuator (wing side), as depicted in Figure 30 below. The shaft has a key that ensures a precise positioning within the joint. Assessing the bending of this flap rod indicates that the direction of wing bending was up.

Figure 30. RH flap connecting rod joint re-connected to flap actuator shaft

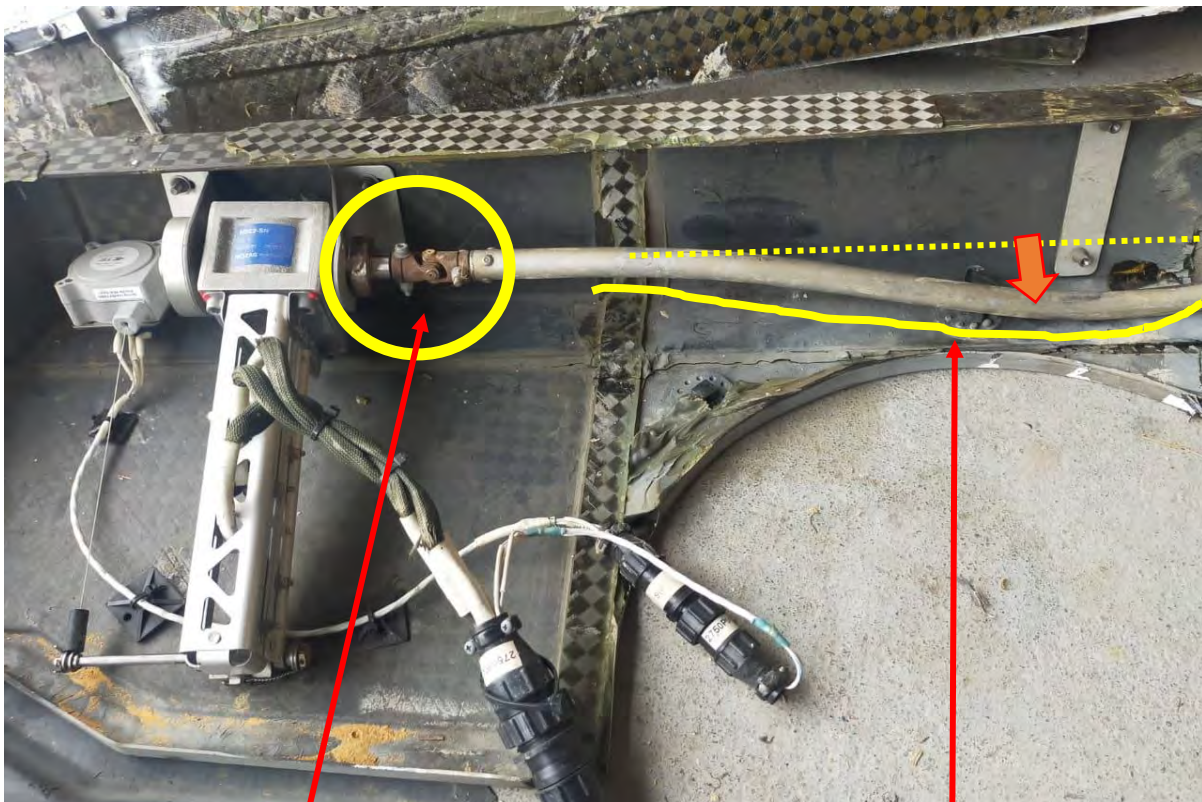
The RH flap connecting rod reconnected to the shaft of the flap actuator (wing side)

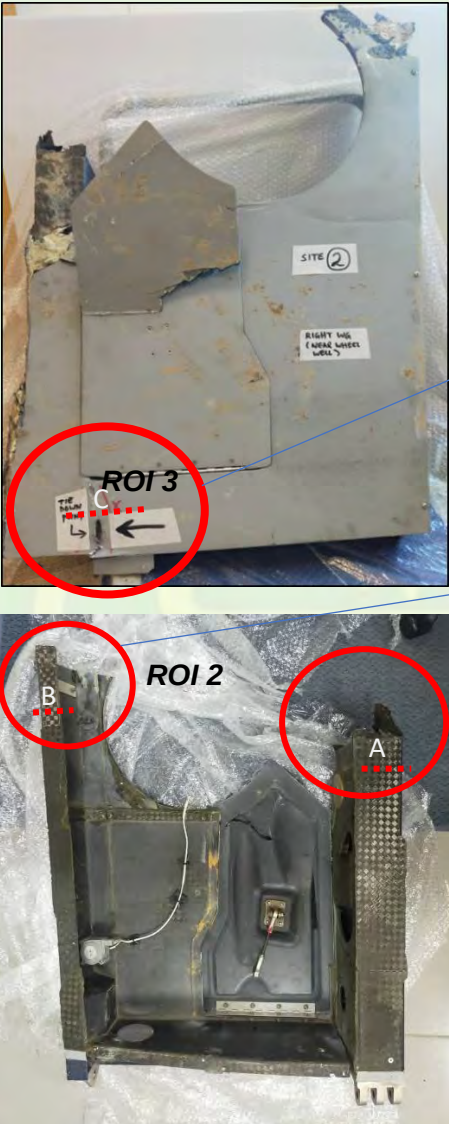
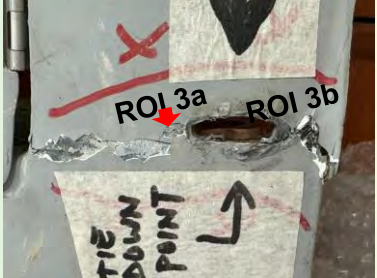
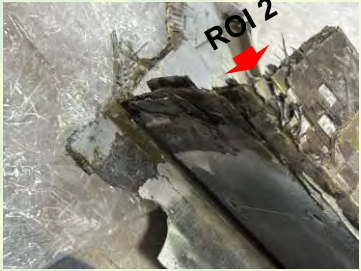
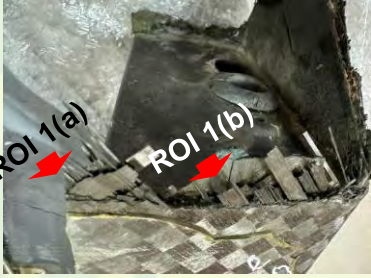
| No. | Photograph & ID No. | Wreckage Location (Site No.) | Descriptions of Parts/Debris/Materials, (location on the aircraft) & Quantity |
|---|---|---|---|
| 4 | ID No: <b>BSKU/IPOOC/004(S2)</b><br><br> | Site 2 | Right wing - near to the wheel well.<br>(Qty: 1 piece)<br><br><br><br><br><br> |

The mode of failure was analysed using Scanning Electron Microscopy (SEM) analysis at 500x and 5000x magnification factors. The SEM image was taken at 15kV voltage at the region of interests (ROIs) indicated on Site 2; Sample ID: BSKU/IPOOC/004(S2) - Right wing - near to the wheel well.

The test was conducted in accordance with Agreed Test Method 021 - Microsection Analysis for Porosity Content. The entire cross-section thickness in ROI1 indicated on Site 2; Sample ID: BSKU/IPOOC/004(S2) - Right wing - near to the wheel well, were cold mounted in an epoxy resin and polished with fine grit media to produce a uniform mirror surface finish, until no visible scratch or artefacts from the cutting or polishing operations were seen when viewed at 50x magnification (minimum) under a compound microscope.

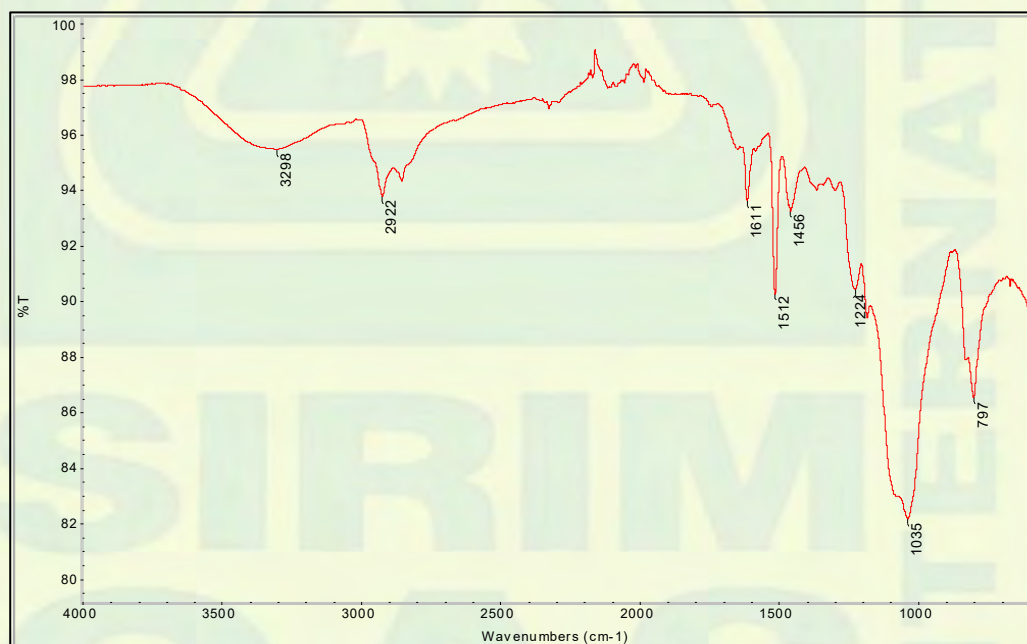
Figure 1. FTIR Spectrum of the resin sample collected from Site 1; Sample ID: BSKU/IPOOC/003(S1) - Left wing - near to the wheel well

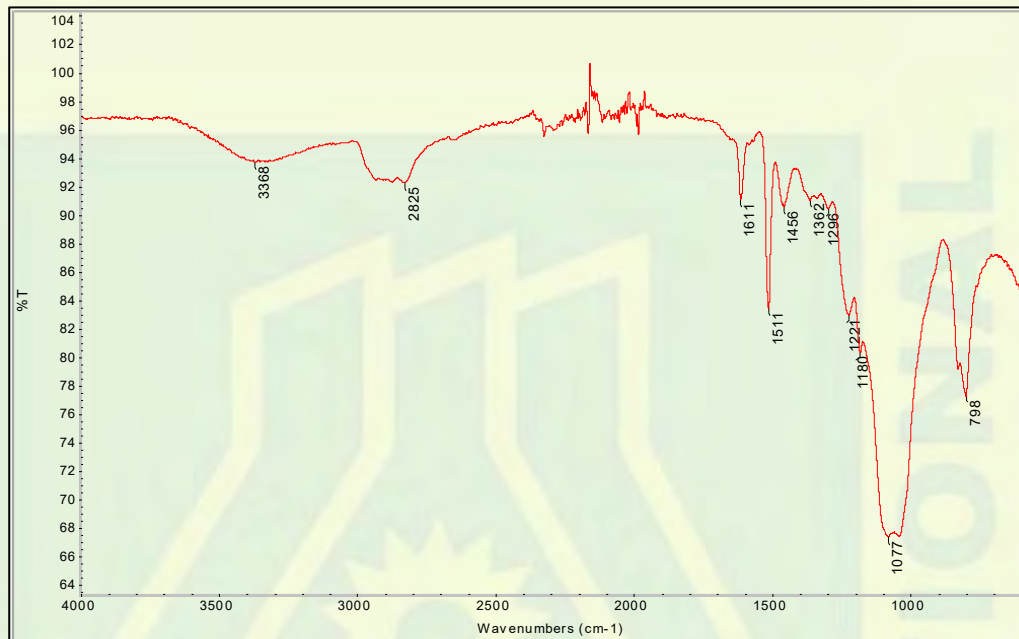
Figure 2. FTIR spectrum of the resin material collected from Site 2; Sample ID: BSKU/IPOOC/004(S2)  
- Right wing - near to the wheel well

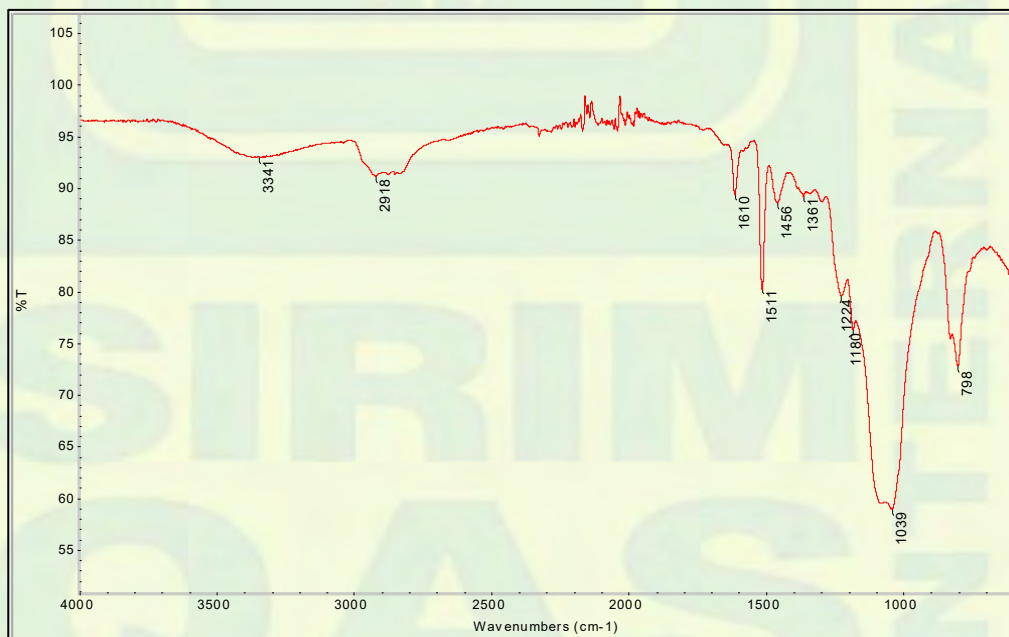
Figure 3. FTIR spectrum of the resin material collected from Site 3; Sample ID: BSKU/IPOOC/002(S3)  
- Right wing (upper skin) - near to the fuselage

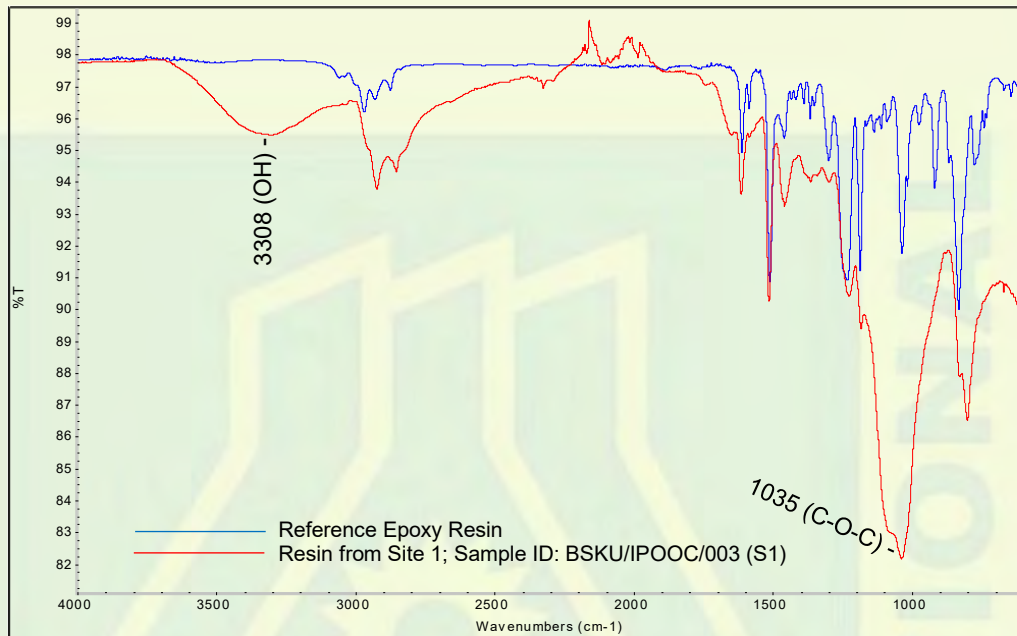
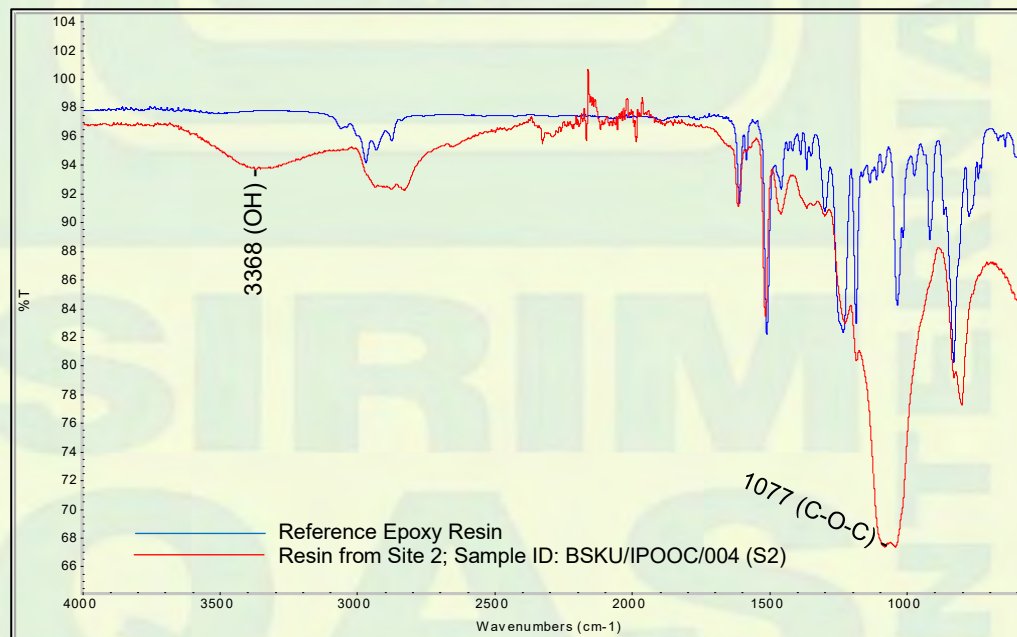
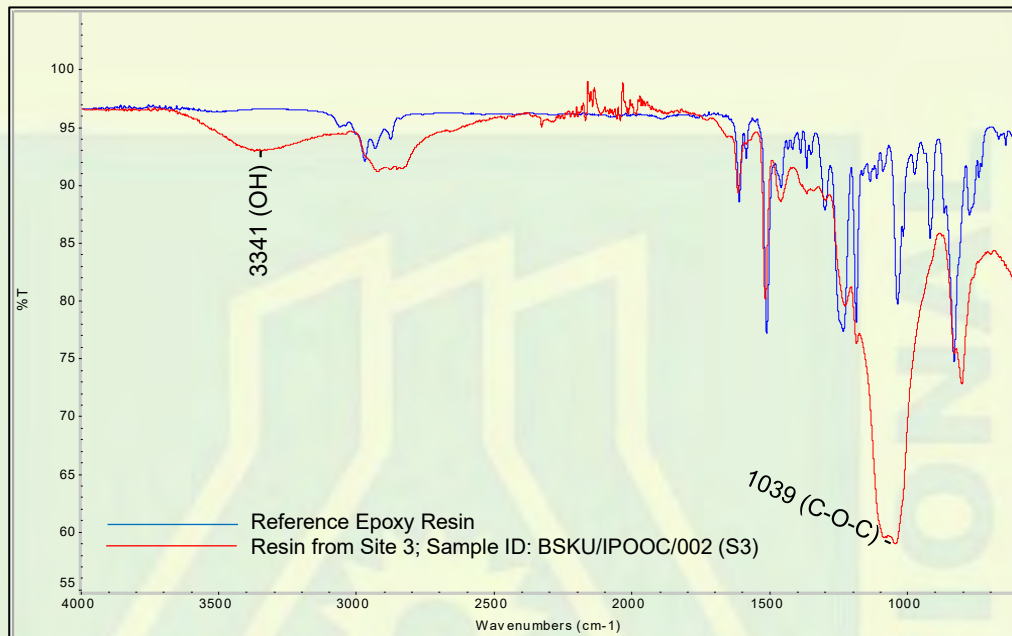
Figure 4. Overlaid FTIR spectra of the resin material collected from Site 1; Sample ID: BSKU/IPOOC/003(S1) - Left wing - near to the wheel well, with Reference Epoxy Resin

Figure 5. Overlaid FTIR spectra of the resin material collected from Site 2; Sample ID: BSKU/IPOOC/004(S2) - Right wing - near to the wheel well, with Reference Epoxy Resin

Figure 6. Overlaid FTIR spectra of the resin material collected from Site 3; Sample ID: BSKU/IPOOC/002(S3) - Right wing (upper skin) - near to the fuselage, with Reference Epoxy Resin

The overlaid FTIR spectra indicates that the FTIR spectrum of both tested samples are relatively similar to that of the reference epoxy resin except at the absorption peak at approximately  $(3308 - 3368) \text{ cm}^{-1}$  and  $(1035 - 1077) \text{ cm}^{-1}$ . Explanation regarding these additional peaks are as follows:

- Peaks at about  $3308 \text{ cm}^{-1}$ ,  $3341 \text{ cm}^{-1}$  and  $3368 \text{ cm}^{-1}$ : These peaks are often associated with O-H stretching vibrations, which can indicate the presence of hydroxyl groups. Hydroxyl groups can be formed as a result of material hydrolysis, especially in the case of water absorption or chemical breakdown involving water. In epoxy resins, this peak may suggest moisture uptake or possible hydrolytic degradation.
- Peaks at  $1035 \text{ cm}^{-1}$ ,  $1039 \text{ cm}^{-1}$  and  $1077 \text{ cm}^{-1}$ : These peaks are commonly attributed to the C-O-C stretching vibrations of ether groups, which are part of the epoxy structure. It could also be indicative of aliphatic ether linkages, which are typical in many epoxy-based materials. This peak does not specifically suggest degradation but rather the inherent chemical bonds in the cured resin.

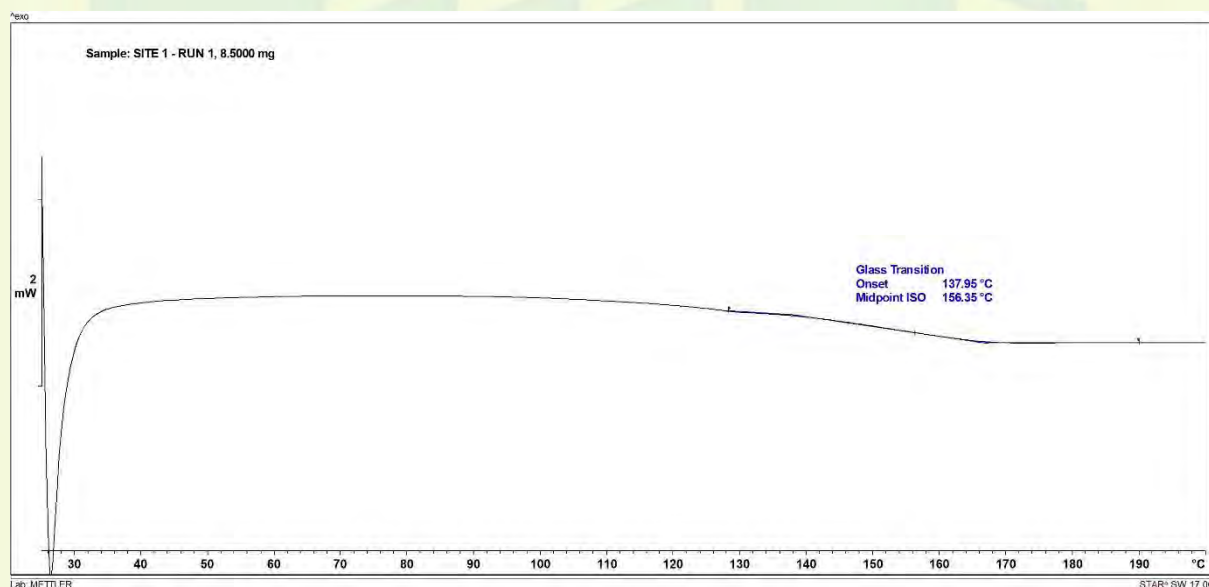
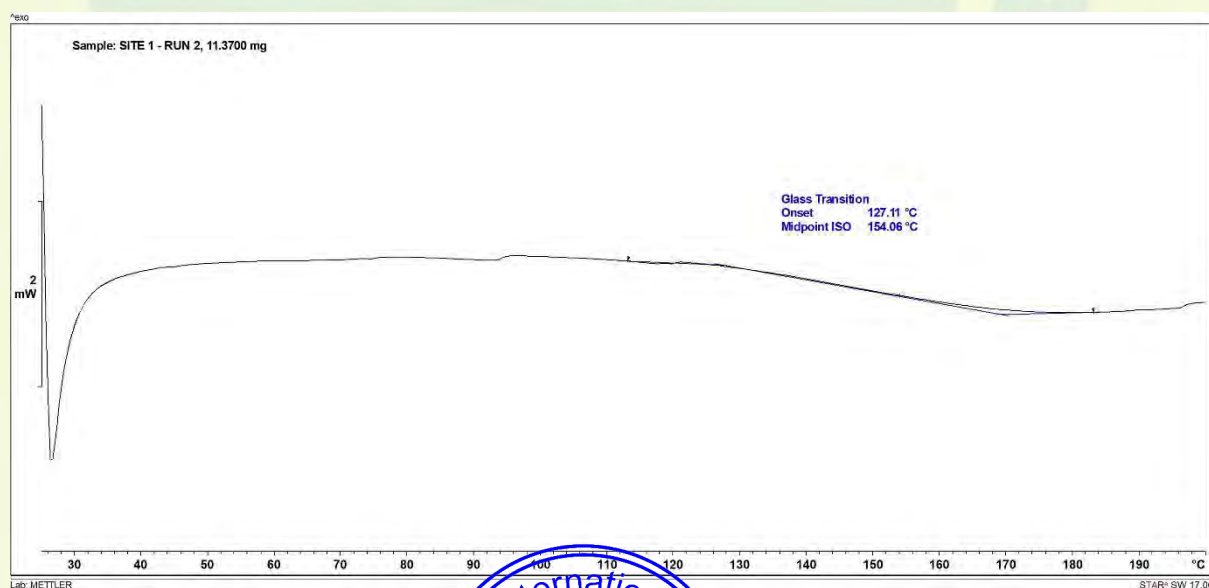
Figure 7. DSC Curve of The Resin Sample Taken from Site 1; Sample ID: BSKU/IPOOC/003(S1) - Left wing - near to the wheel well - Run #1

Figure 8. DSC Curve of The Resin Sample Taken from Site 1; Sample ID: BSKU/IPOOC/003(S1) - Left wing - near to the wheel well - Run #2

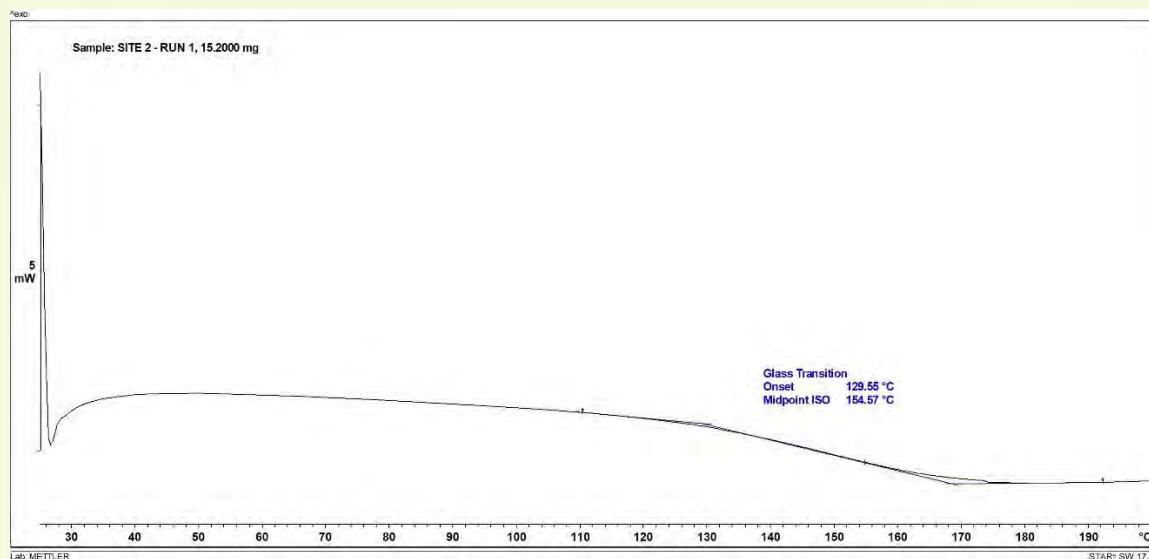
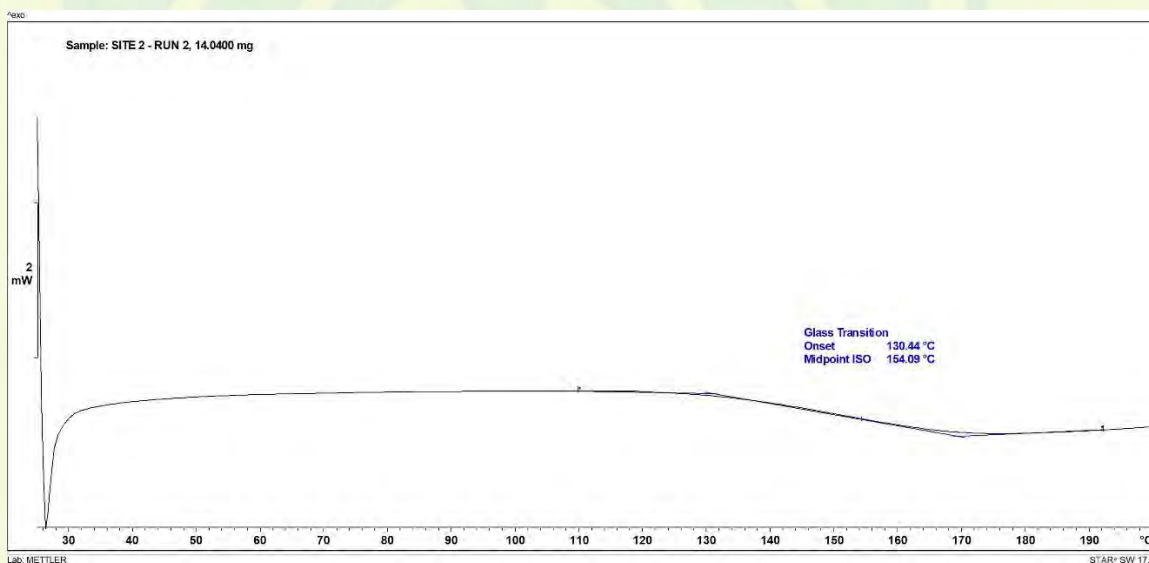
Figure 9. DSC Curve of The Resin Sample Taken from Site 2; Sample ID: BSKU/IPOOC/004(S2)  
- Right wing - near to the wheel well - Run #1

Figure 10. DSC Curve of The Resin Sample Taken from Site 2; Sample ID: BSKU/IPOOC/004(S2)  
- Right wing - near to the wheel well - Run #2

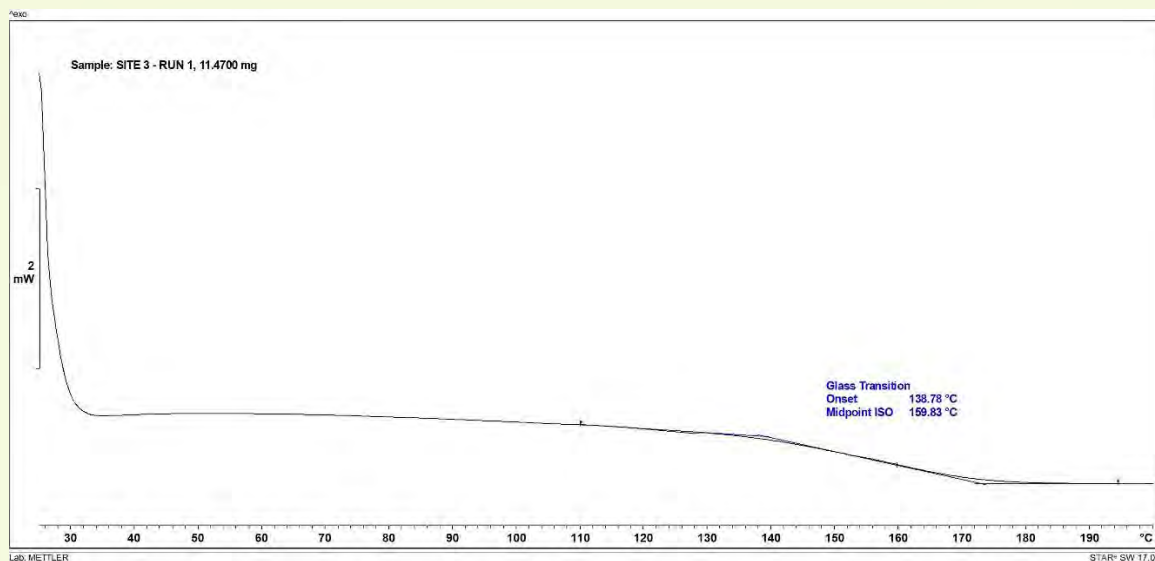
Figure 11. DSC Curve of The Resin Sample Taken from Site 3; Sample ID: BSKU/IPOOC/002(S3) - Right wing (upper skin) - near to the fuselage - Run #1

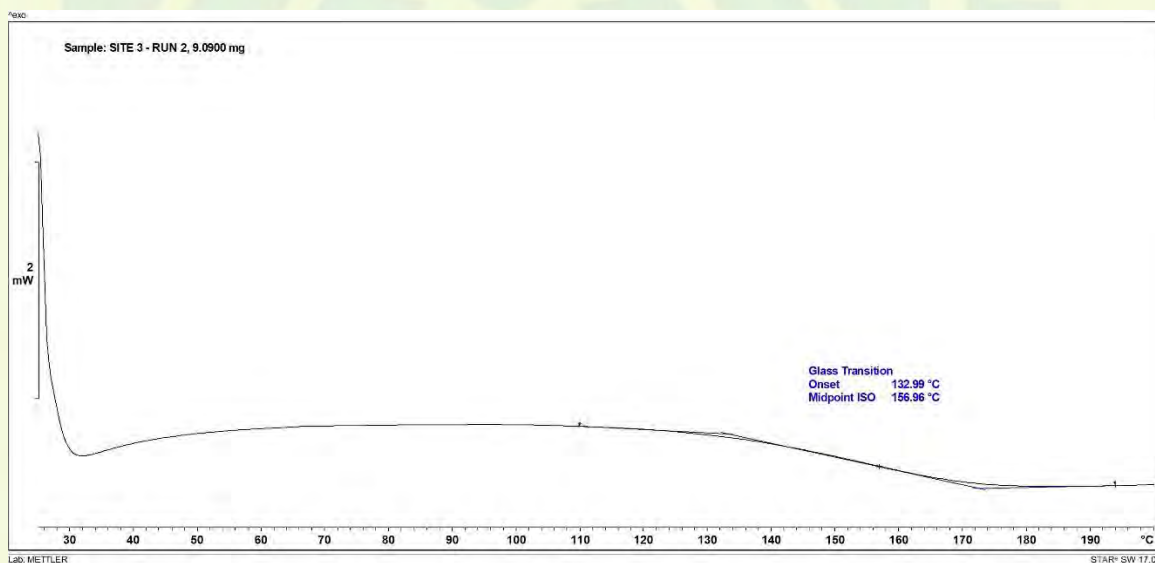
Figure 12. DSC Curve of The Resin Sample Taken from Site 3; Sample ID: BSKU/IPOOC/002(S3) - Right wing (upper skin) - near to the fuselage - Run #2

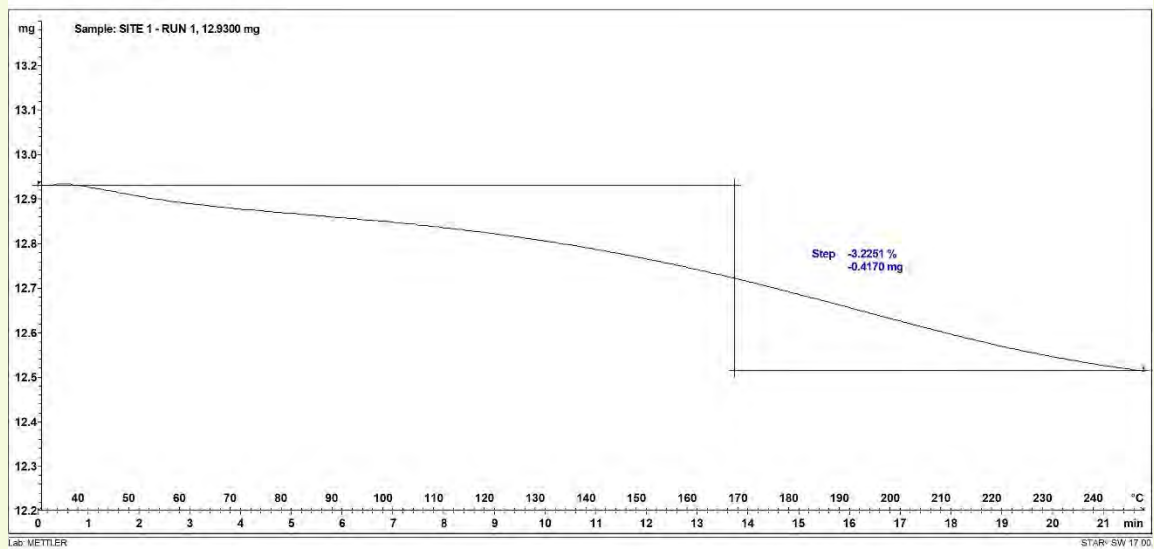
Figure 13. TGA Thermogram of Sample Taken from Site 1; Sample ID: BSKU/IPOOC/003(S1)  
- Left wing - near to the wheel well - Run #1

Result from Table 2 indicates that the CFRP composite samples taken at Site 1, Site 2 and Site 3 contain about (1 to 4) % moisture. This result support the presence of the hydroxyl (OH) functional group observed from the FTIR analysis.

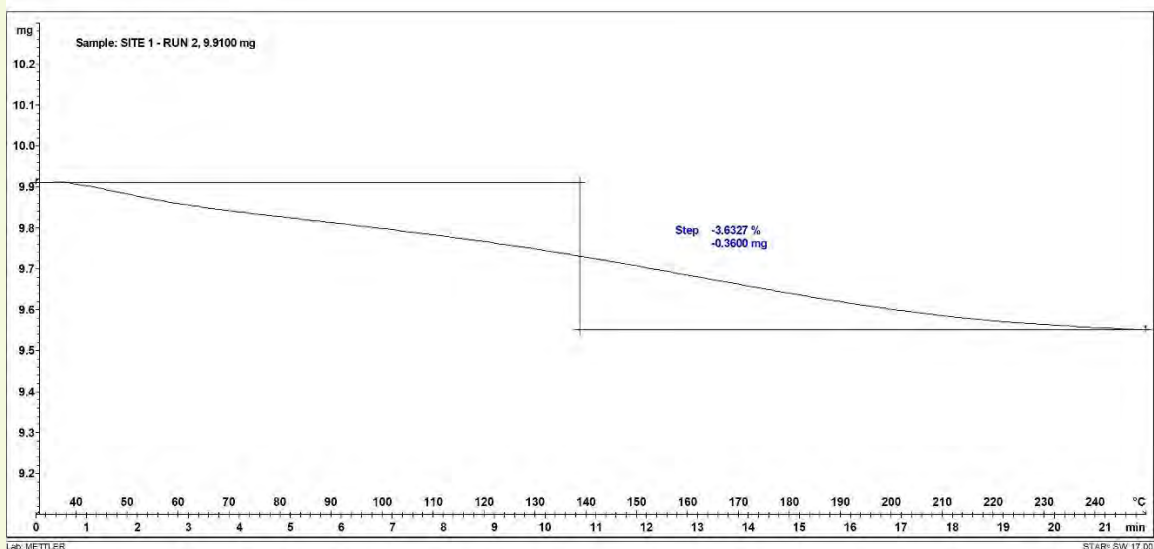
Figure 14. TGA Thermogram of Sample Taken from Site 1; Sample ID: BSKU/IPOOC/003(S1)  
- Left wing - near to the wheel well - Run #2
