**AIRCRAFT ACCIDENT  
FINAL REPORT**

**A 03/24**

**Fixed-Wing Aircraft Blackshape BK 160TR, Registration I-POOC  
at Kapar, Selangor  
on 13 February 2024**

**FINAL REPORT NO: A 03/24**

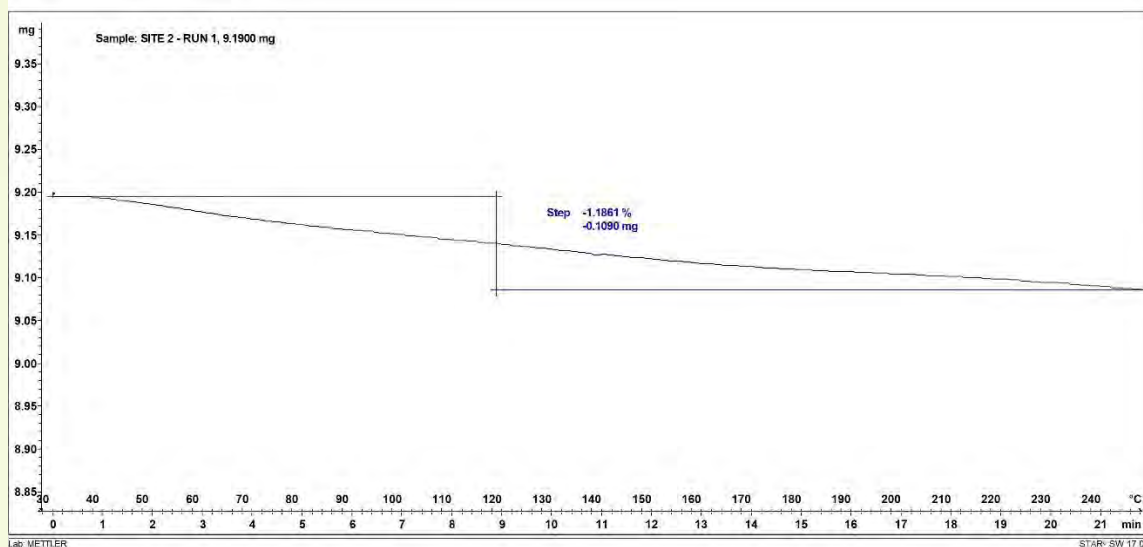
Figure 15. TGA Thermogram of Sample Taken from Site 2; Sample ID: BSKU/IPOOC/004(S2)  
- Right wing - near to the wheel well - Run #1

Result from Table 2 indicates that the CFRP composite samples taken at Site 1, Site 2 and Site 3 contain about (1 to 4) % moisture. This result support the presence of the hydroxyl (OH) functional group observed from the FTIR analysis.

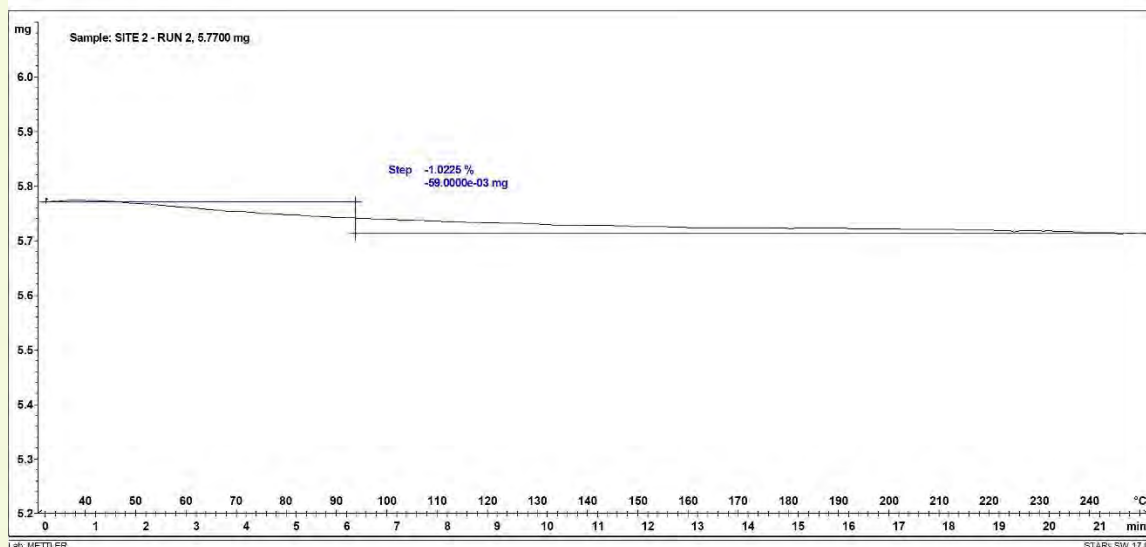
Figure 16. TGA Thermogram of Sample Taken from Site 2; Sample ID: BSKU/IPOOC/004(S2)  
- Right wing - near to the wheel well - Run #2

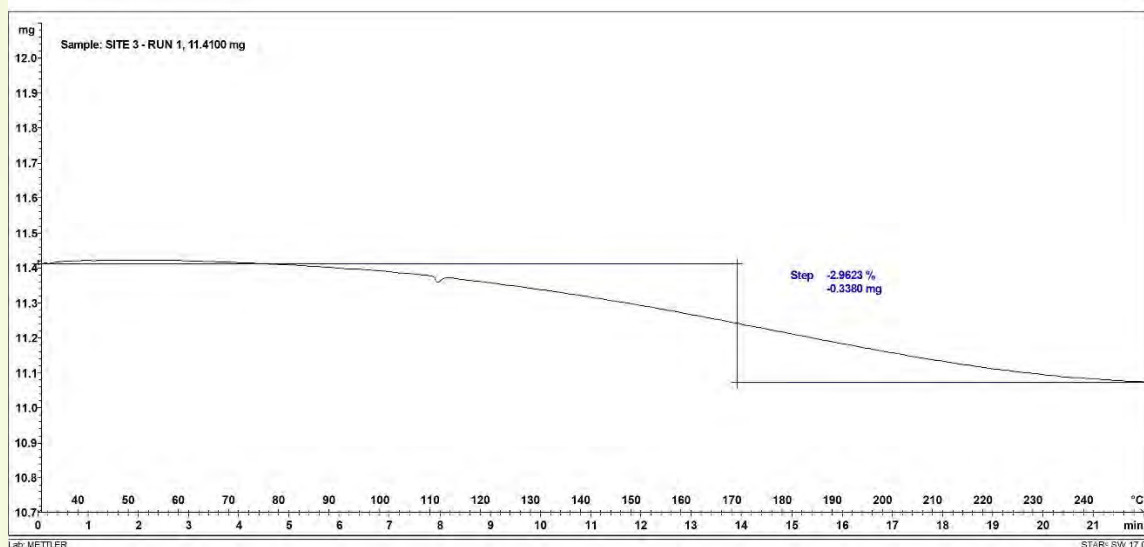
Figure 17. TGA Thermogram of Sample Taken from Site 3; Sample ID: BSKU/IPOOC/002(S3)  
- Right wing (upper skin) - near to the fuselage - Run #1

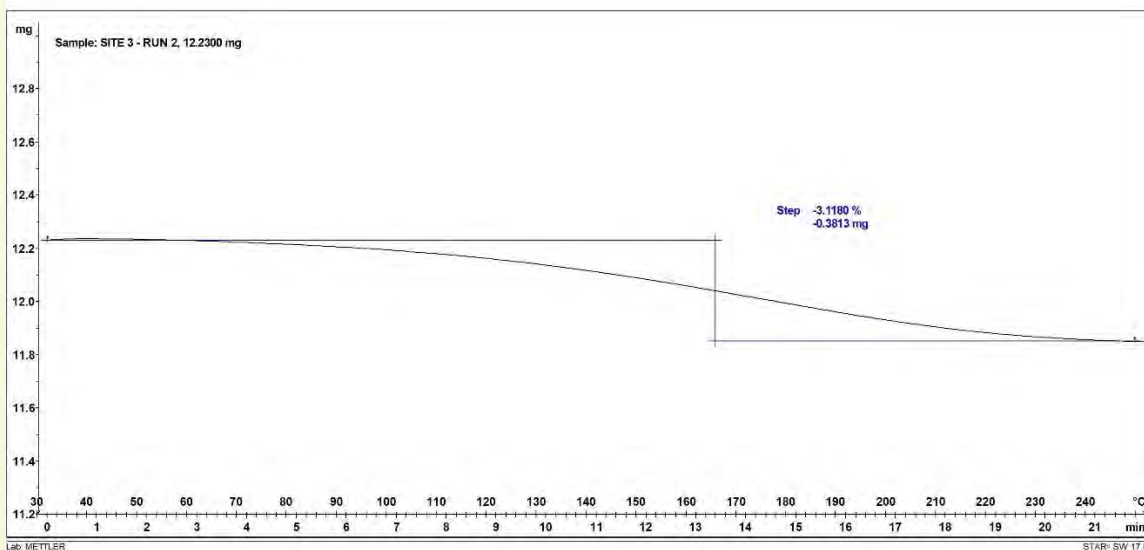
Figure 18. TGA Thermogram of Sample Taken from Site 3; Sample ID: BSKU/IPOOC/002(S3)  
- Right wing (upper skin) - near to the fuselage - Run #2

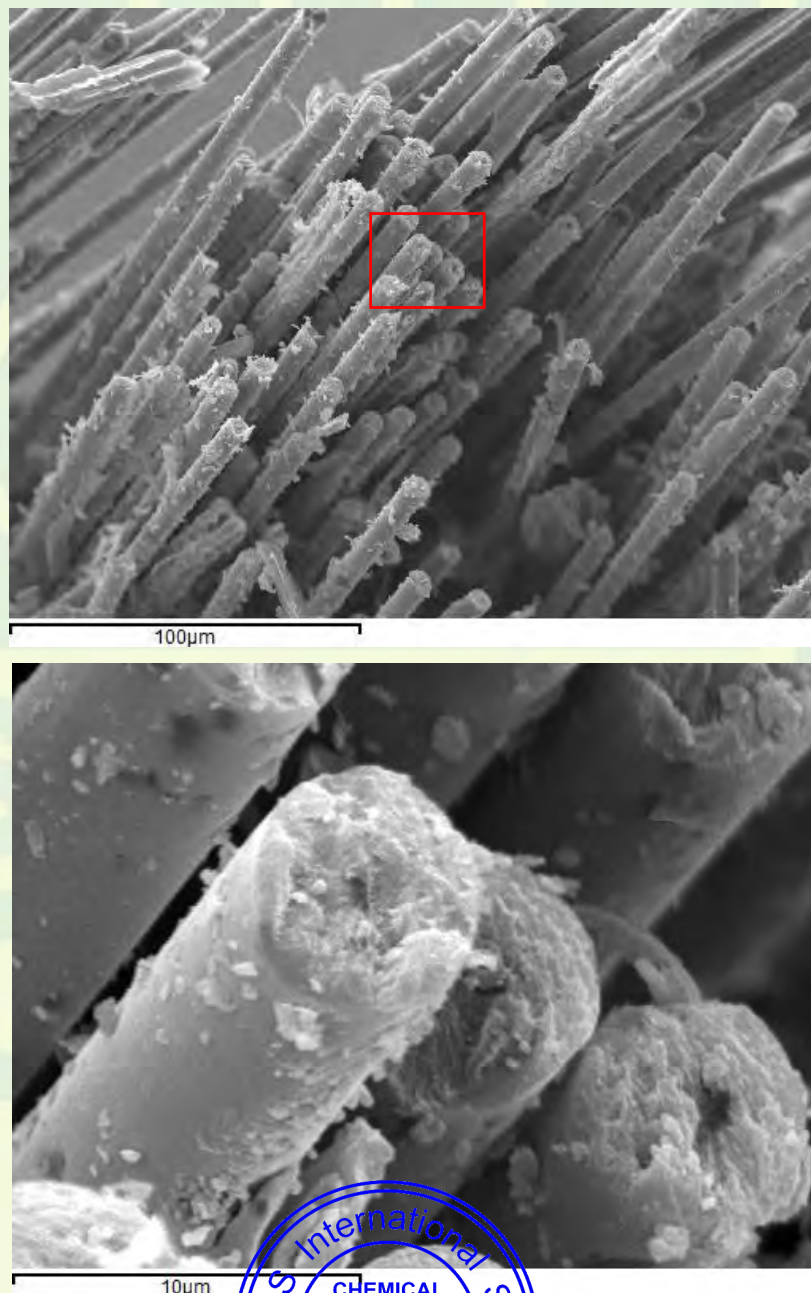
The SEM images of cracked surfaces found at the ROIs in Site 2; Sample ID: BSKU/IPOOC/004(S2) - Right wing - near to the wheel well, are shown in Figures 19 to 23.

Figure 19. SEM Images at ROI (a) Magnification: 500x (Top) and 5,000x (Bottom)

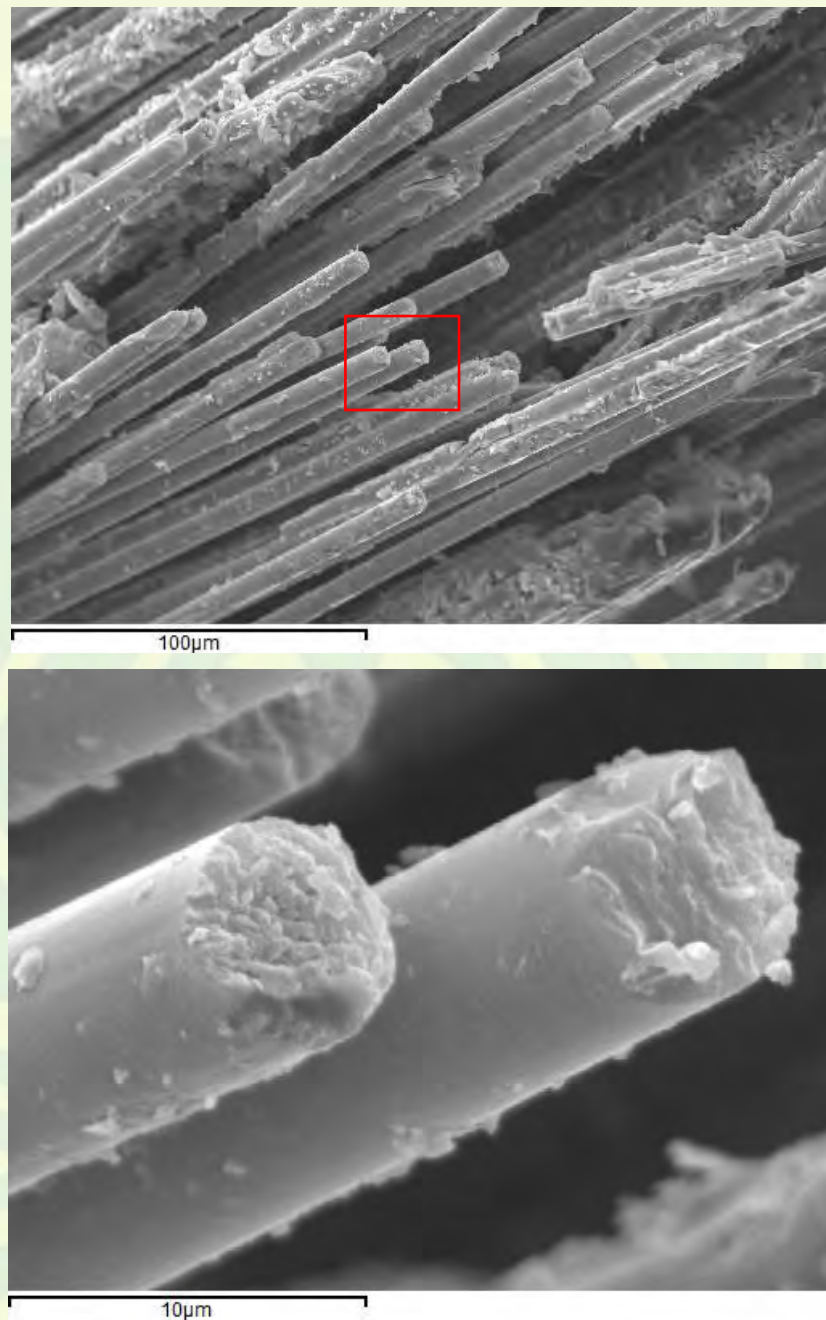
Figure 20. SEM Image at ROI 1(b) – Magnification: 500x (Top) and 5,000x (Bottom)

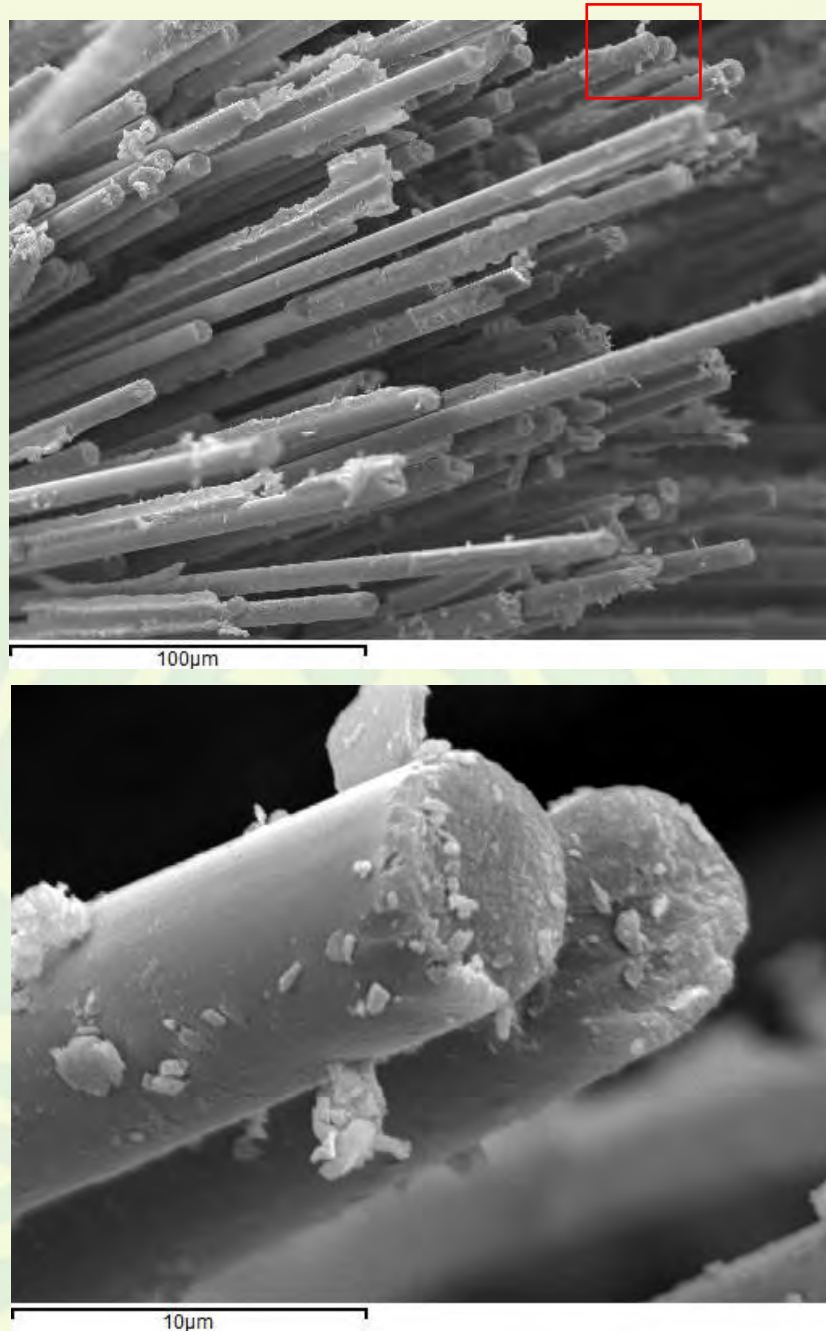
Figure 21. SEM Image at ROI 2 – Magnification: 500x (Top) and 5,000x (Bottom)

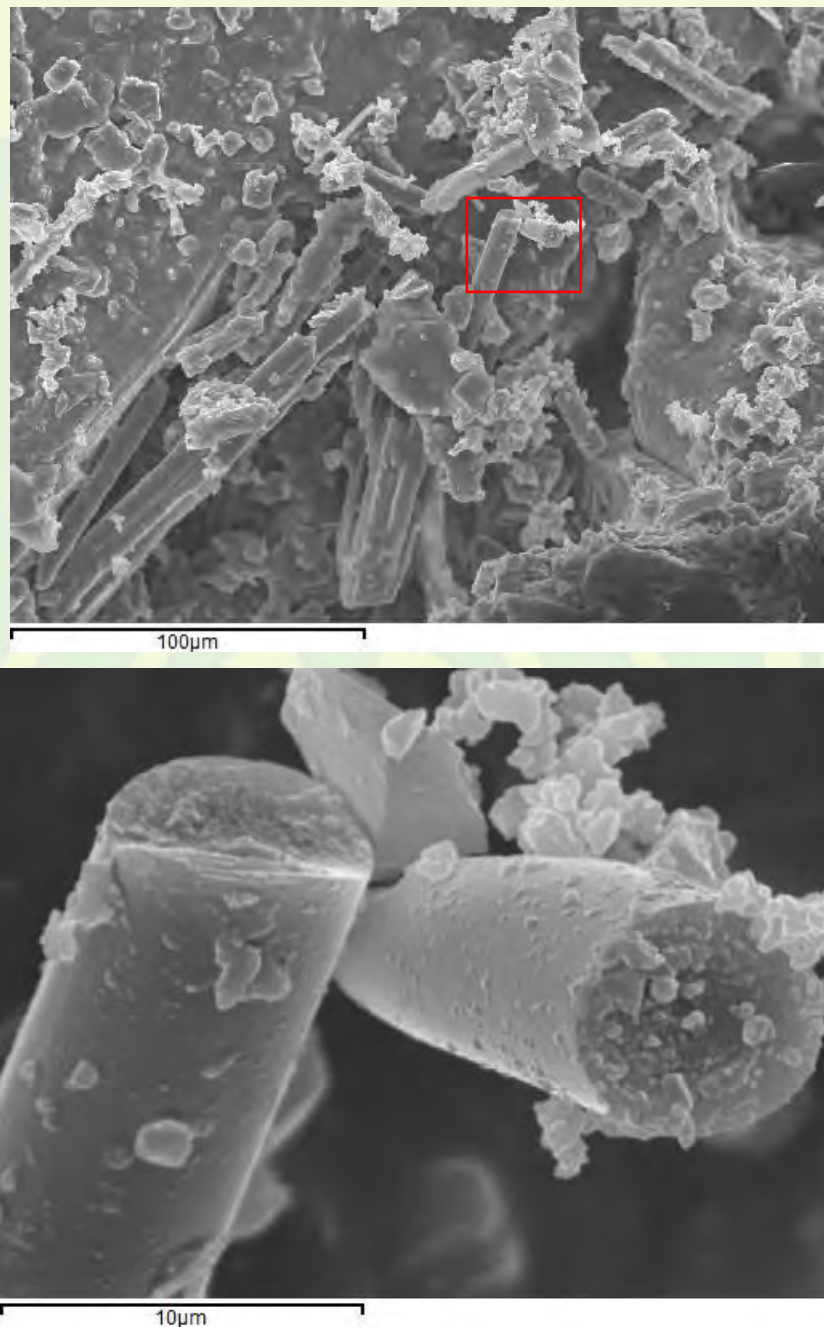
Figure 22. SEM Image at ROI 3(a) – Magnification: 500x (Top) and 5,000x (Bottom)

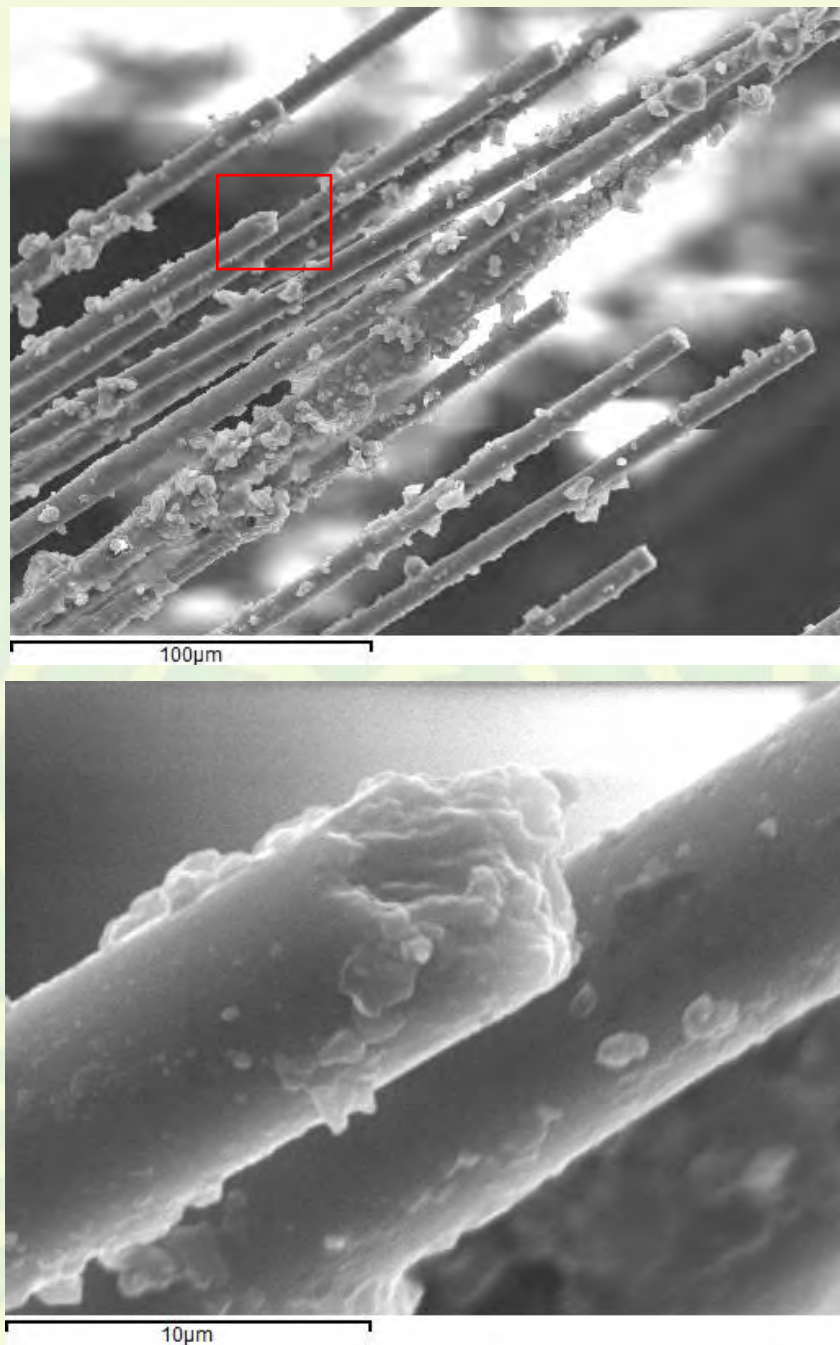
Figure 23. SEM Image at ROI 3(b) – Magnification: 500x (Top) and 5,000x (Bottom)

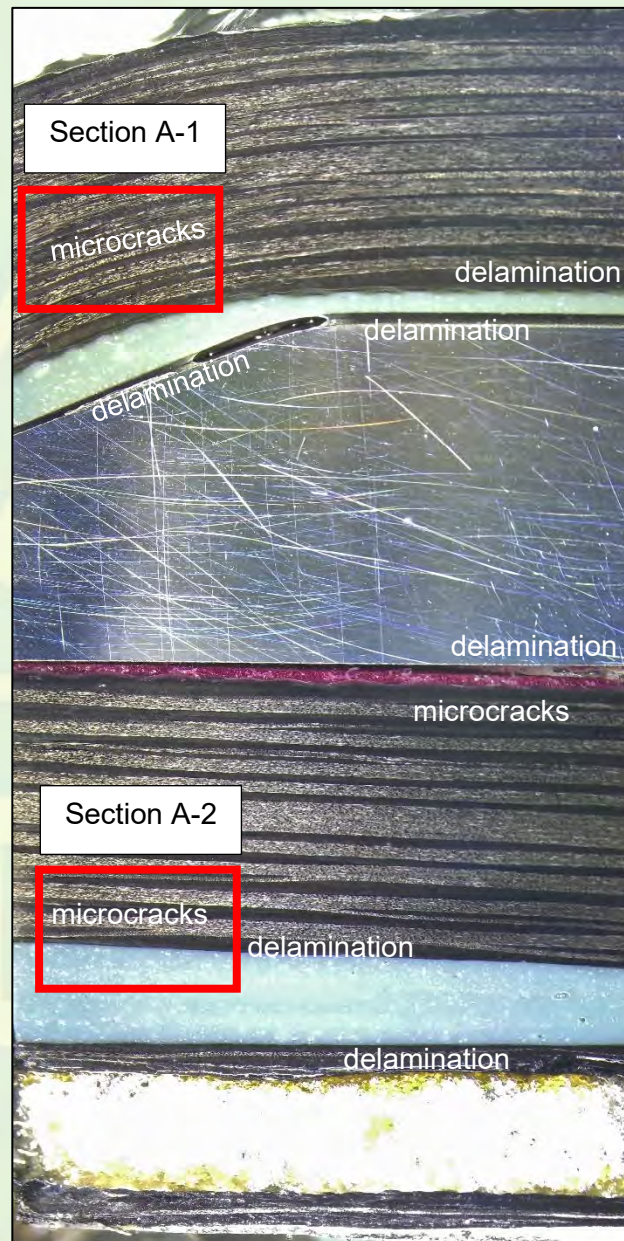
Figure 24. Cross Sectioned Image at Cut Section A – Using Stereo Microscope; Magnification: 10x

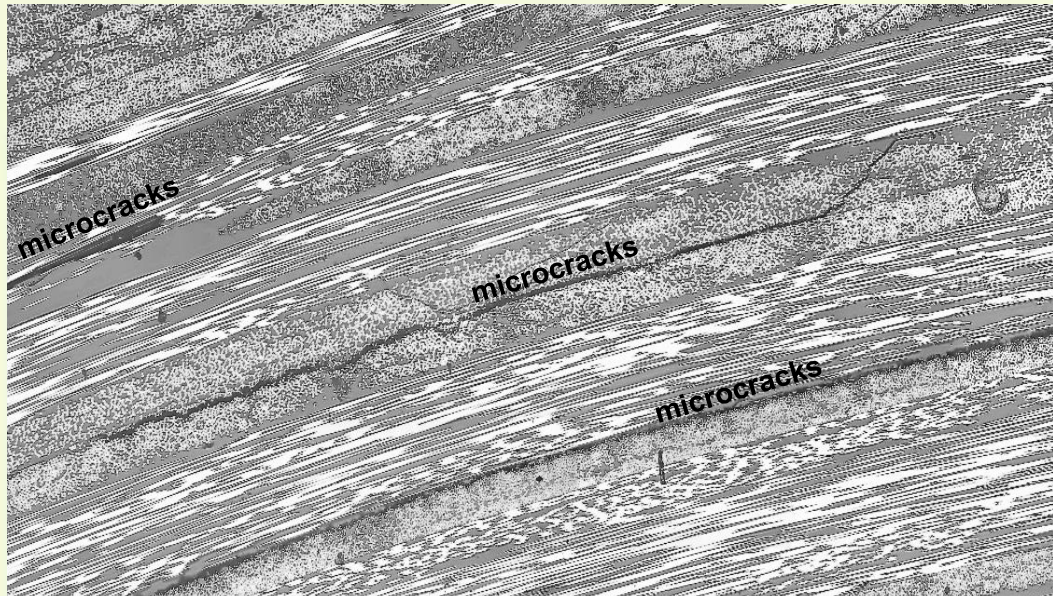
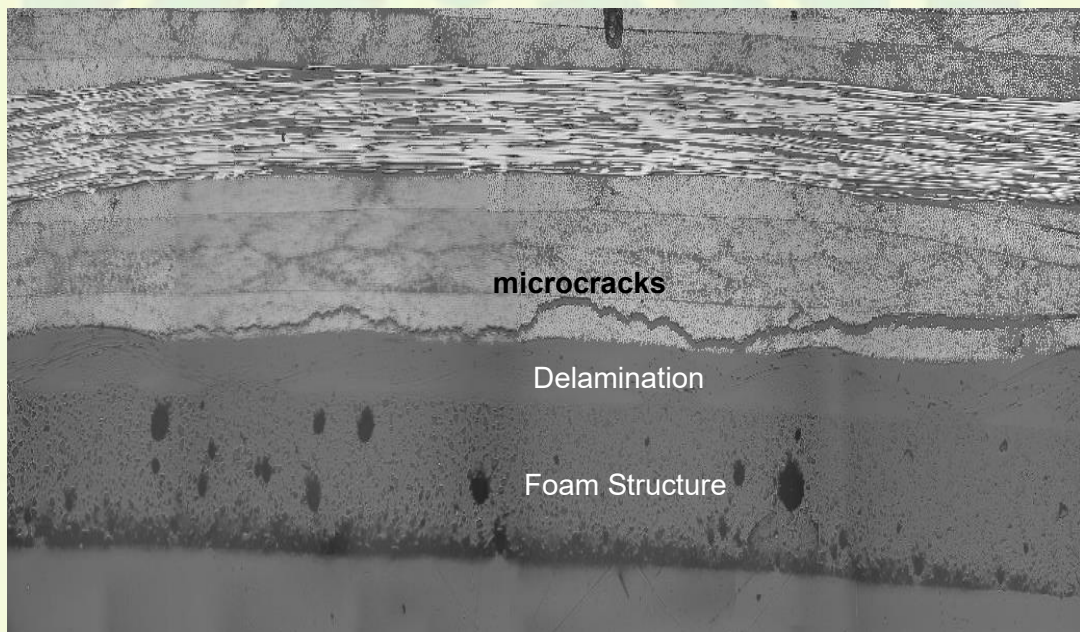
Figure 25. Cross Sectioned Image at Cut Section A – Using Compound Microscope; Magnification: 50x

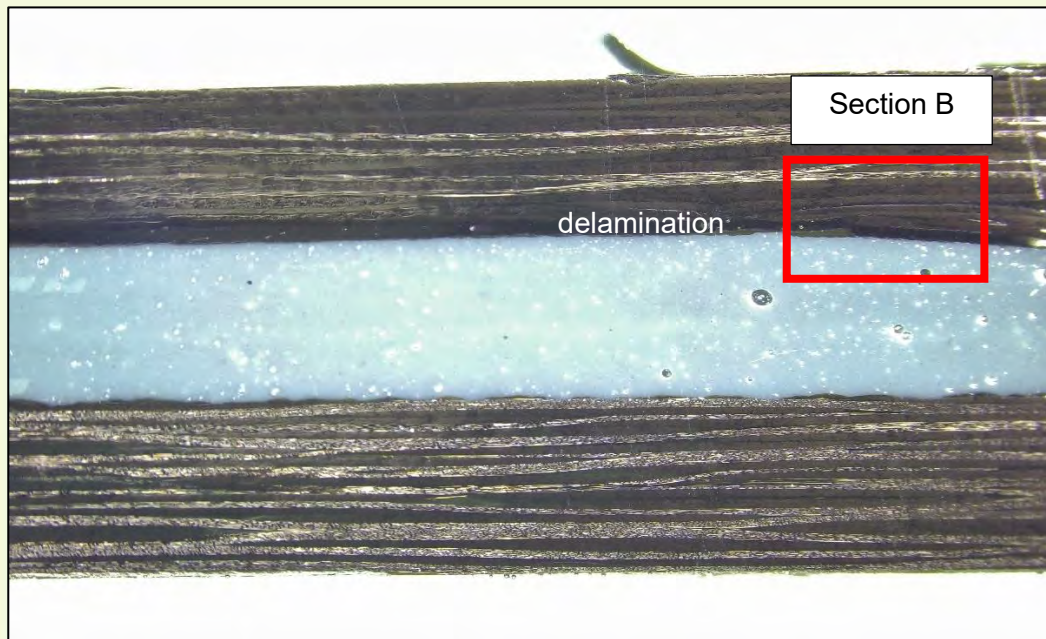
Figure 26. Cross Sectioned Image at Section B – Using Stereo Microscope; Magnification: 10x

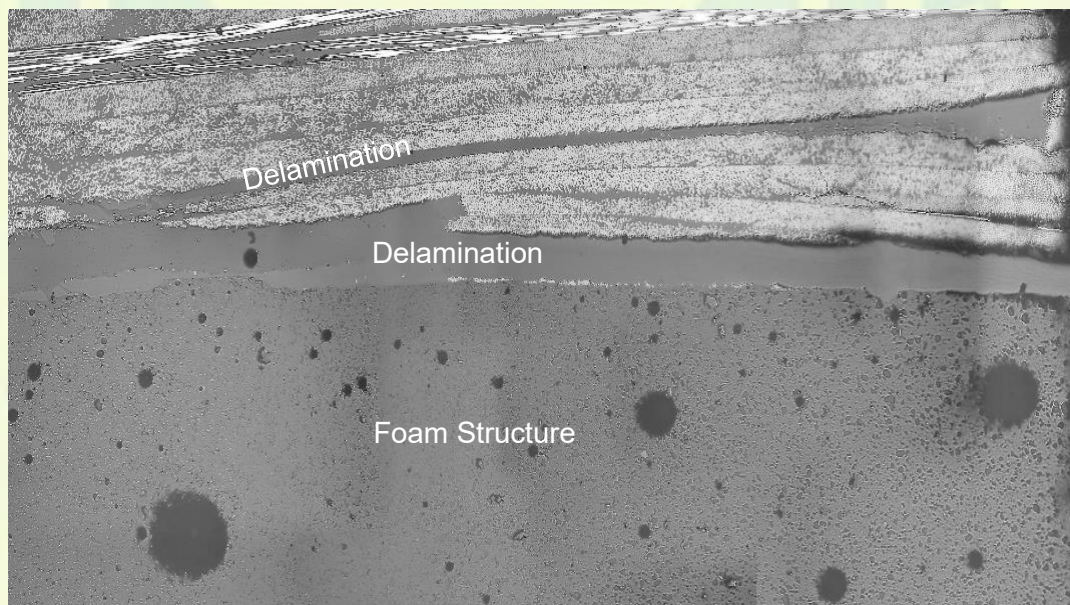
Figure 27. Cross Sectioned Image at Section B – Using Compound Microscope; Magnification: 50x

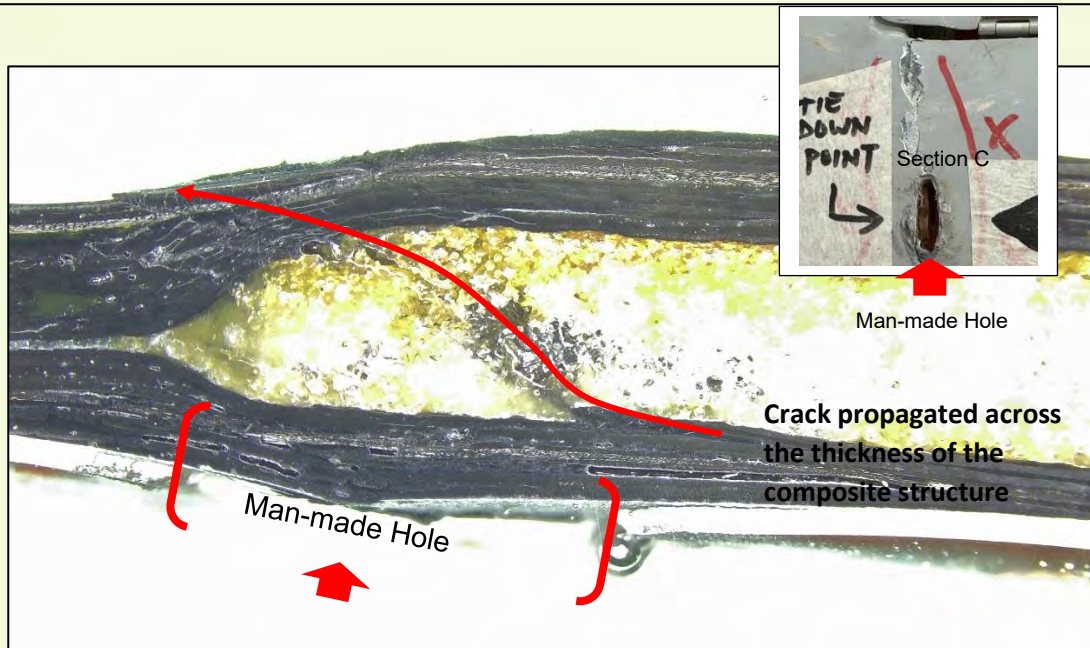
Figure 28. Cross Sectioned Image at Section C – Using Stereo Microscope; Magnification: 10x

The surface morphology shown in Figure 28 to 31 present more significant signs of damage than the previous one. The key observations that can be made from these images are as follows:

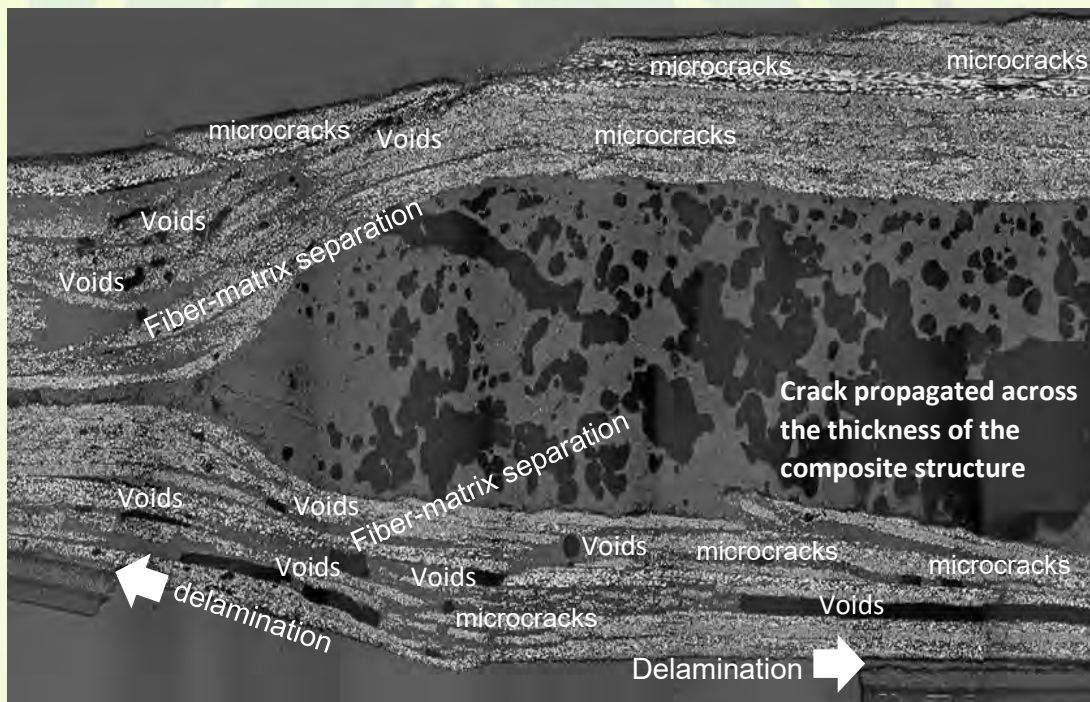
Figure 29. Cross Sectioned Image at Section C – Using Compound Microscope; Magnification: 50x

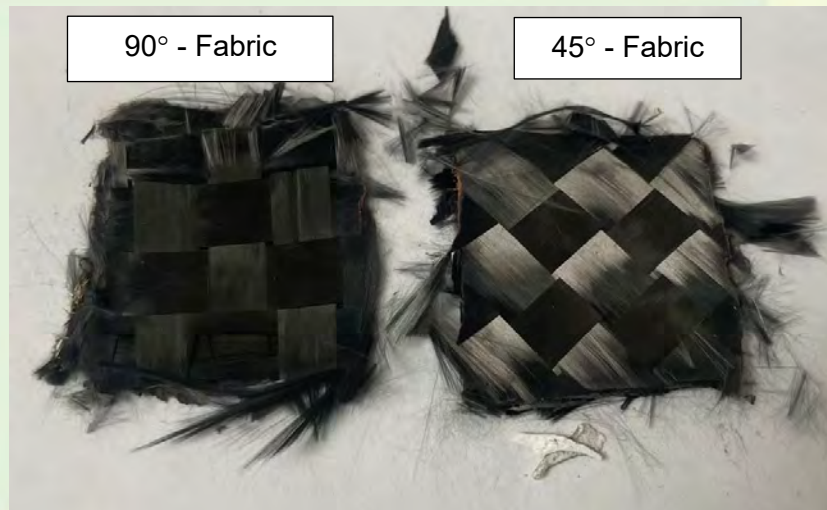
It was also observed from the analysis that the CFRP composite material comprises of alternating carbon fibre fabric plies with  $90^\circ$  and  $45^\circ$  orientation. Photograph of the ply orientation is given in Figure 32.

Figure 32. Orientation of Carbon Fibre Fabric

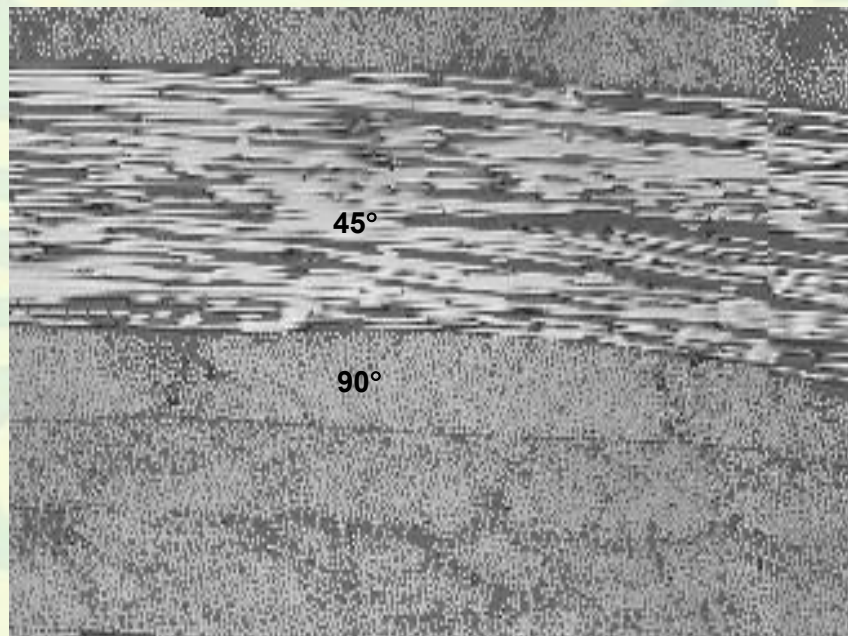
Figure 33. Laminate Cross-Section Indicating the Ply-Wise Variation in Fibre Orientation

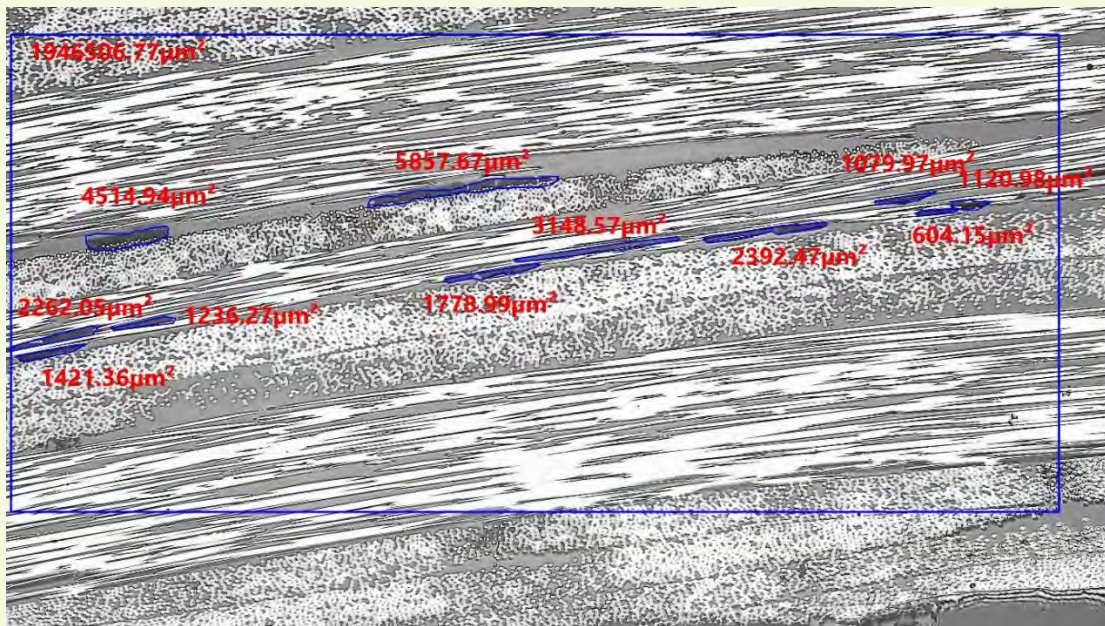
Figure 34. Area Used for the Calculation of Void Content

For the area marked in blue rectangle the calculated void content is approximately 1.2% and the ply/laminate thickness for the 90° fibre orientation is approximately 114 µm (0.114 mm)

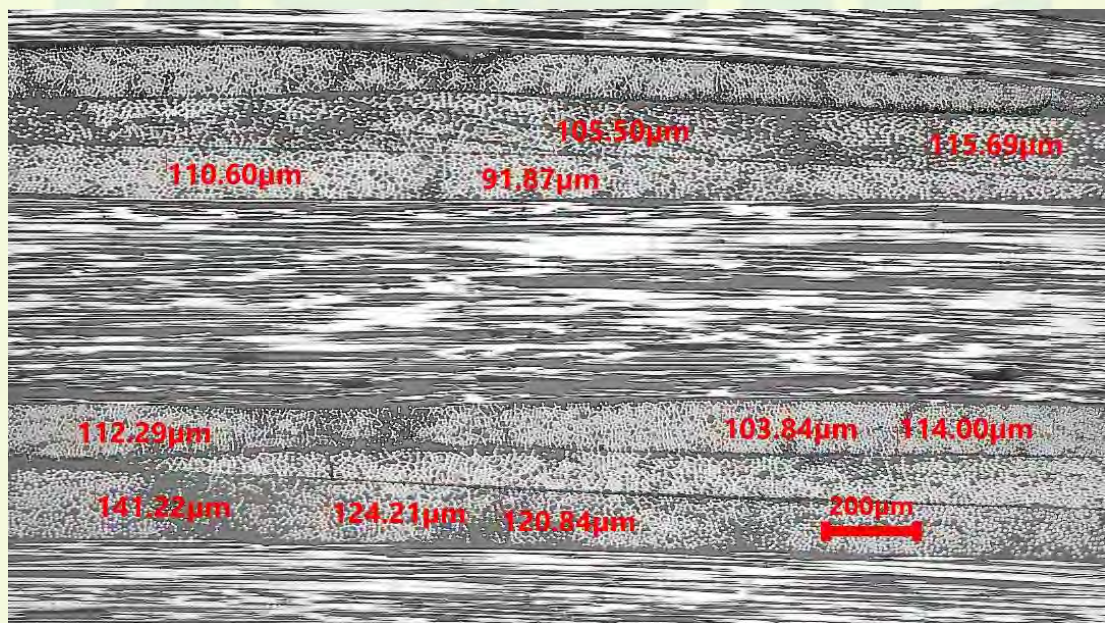
Figure 35. Image for Ply/Laminate Thickness Evaluation

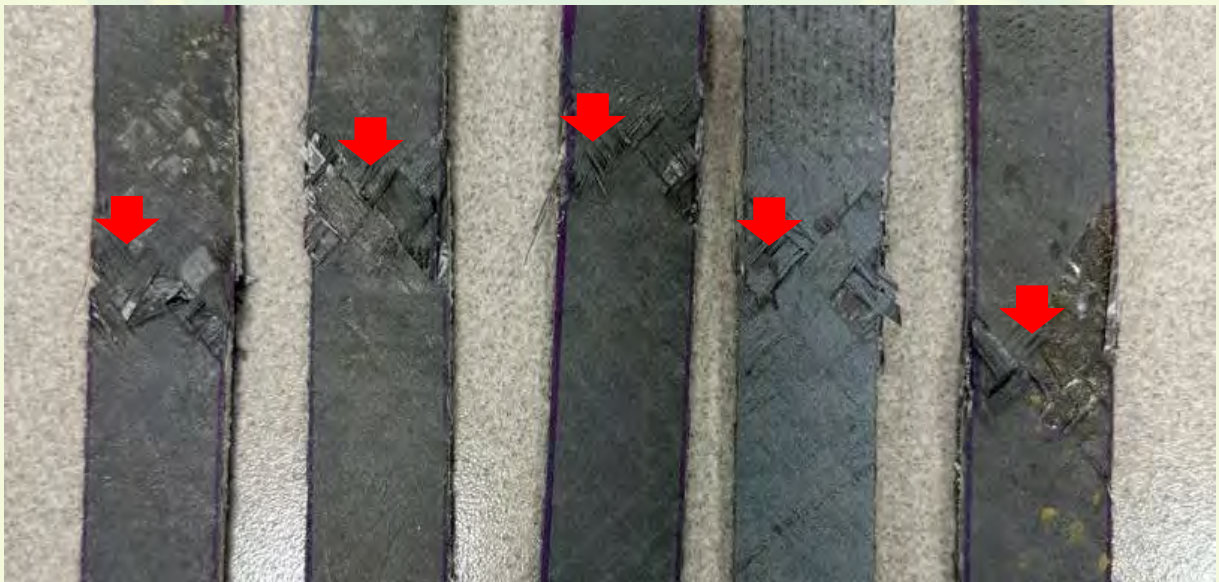
Figure 36. Photograph of Test Specimens after Tensile Properties Testing – Failure Type: Fiber Pullout (Red Arrows) Due to Tensile Loads

The mode of failure observed in Figure 36 is similar to that observed on the component found at Site 2; Sample ID: BSKU/IPOOC/004(S2) - Right wing - near to the wheel well. For comparison purposes, photograph taken at ROI 1 indicating fibre pullout on the sample (see Table 2) are shown in Figure 37.

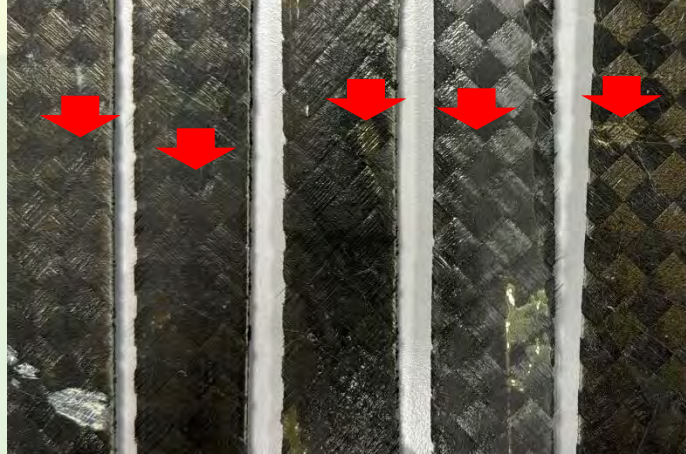
These observations suggest that the samples might have suffered from some form of damage, either from hydrolysis or delamination or both, which would explain their reduced compressive properties.

Figure 38. Photograph of Test Specimens after Compressive Properties Testing – Red Arrows Indicating Fibre Deformation

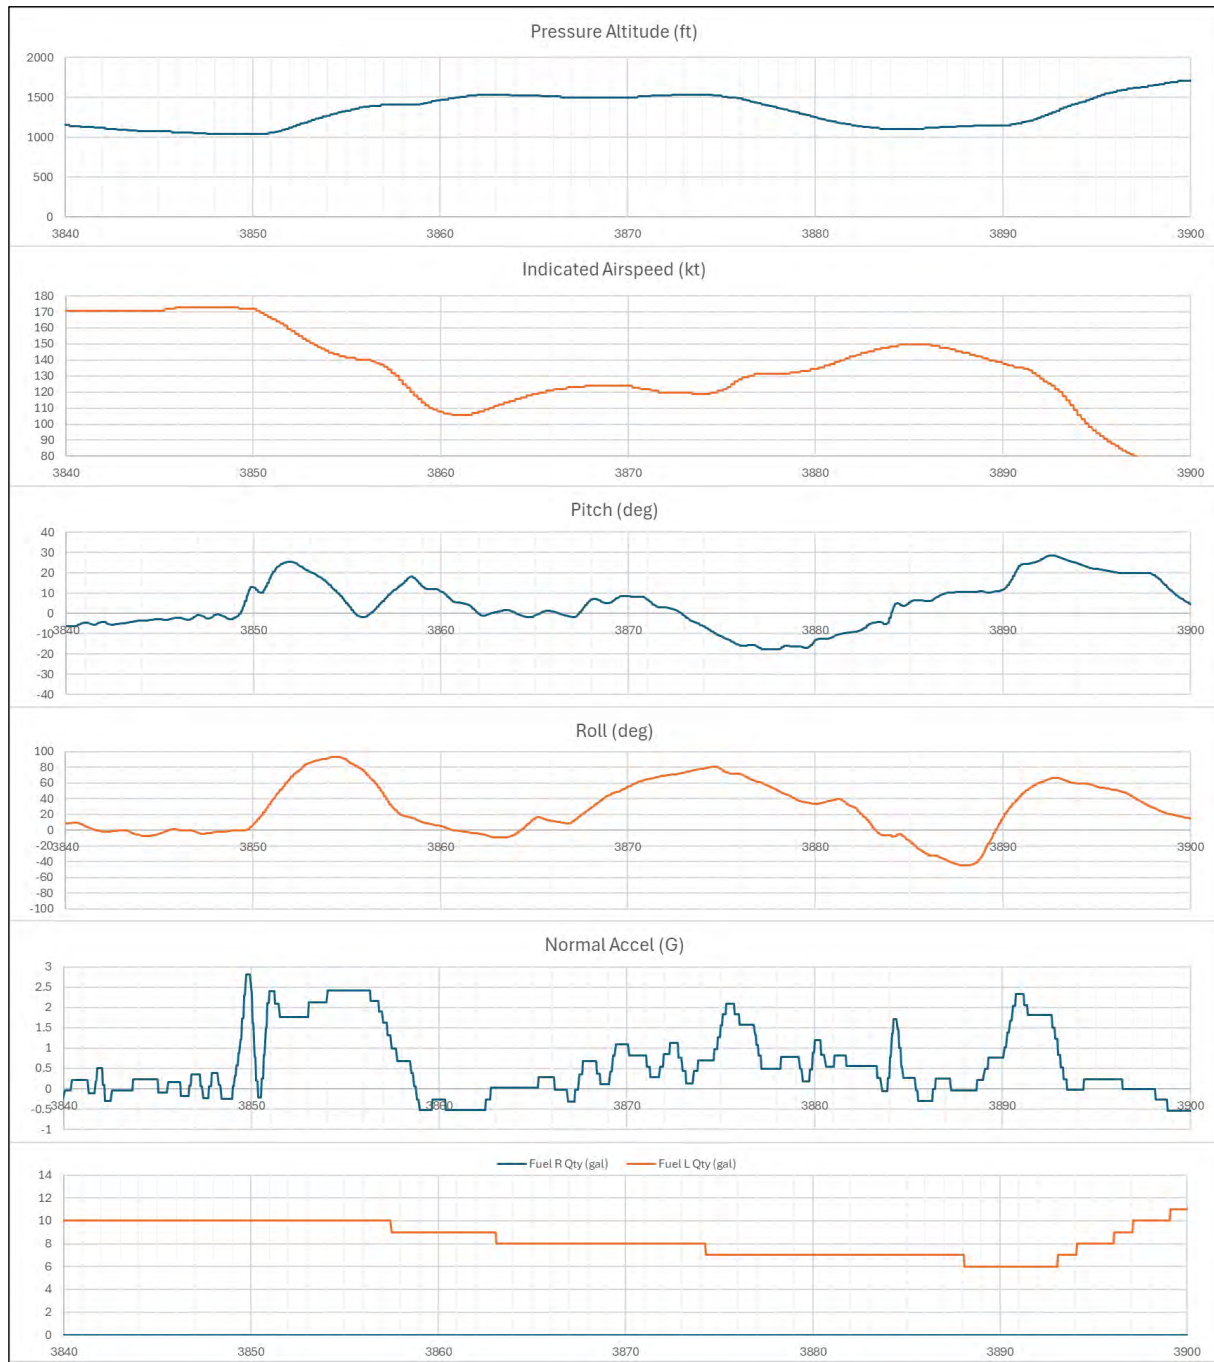
Figure 1

### 1. Flight No 43 enroute to Chiang Mai Air Sports airfield on 08/12/2023.

**Manoeuvres:** Pull-up at 172 KIAS,  $n = 3.8$  g, then roll to 90°, under high load factor.

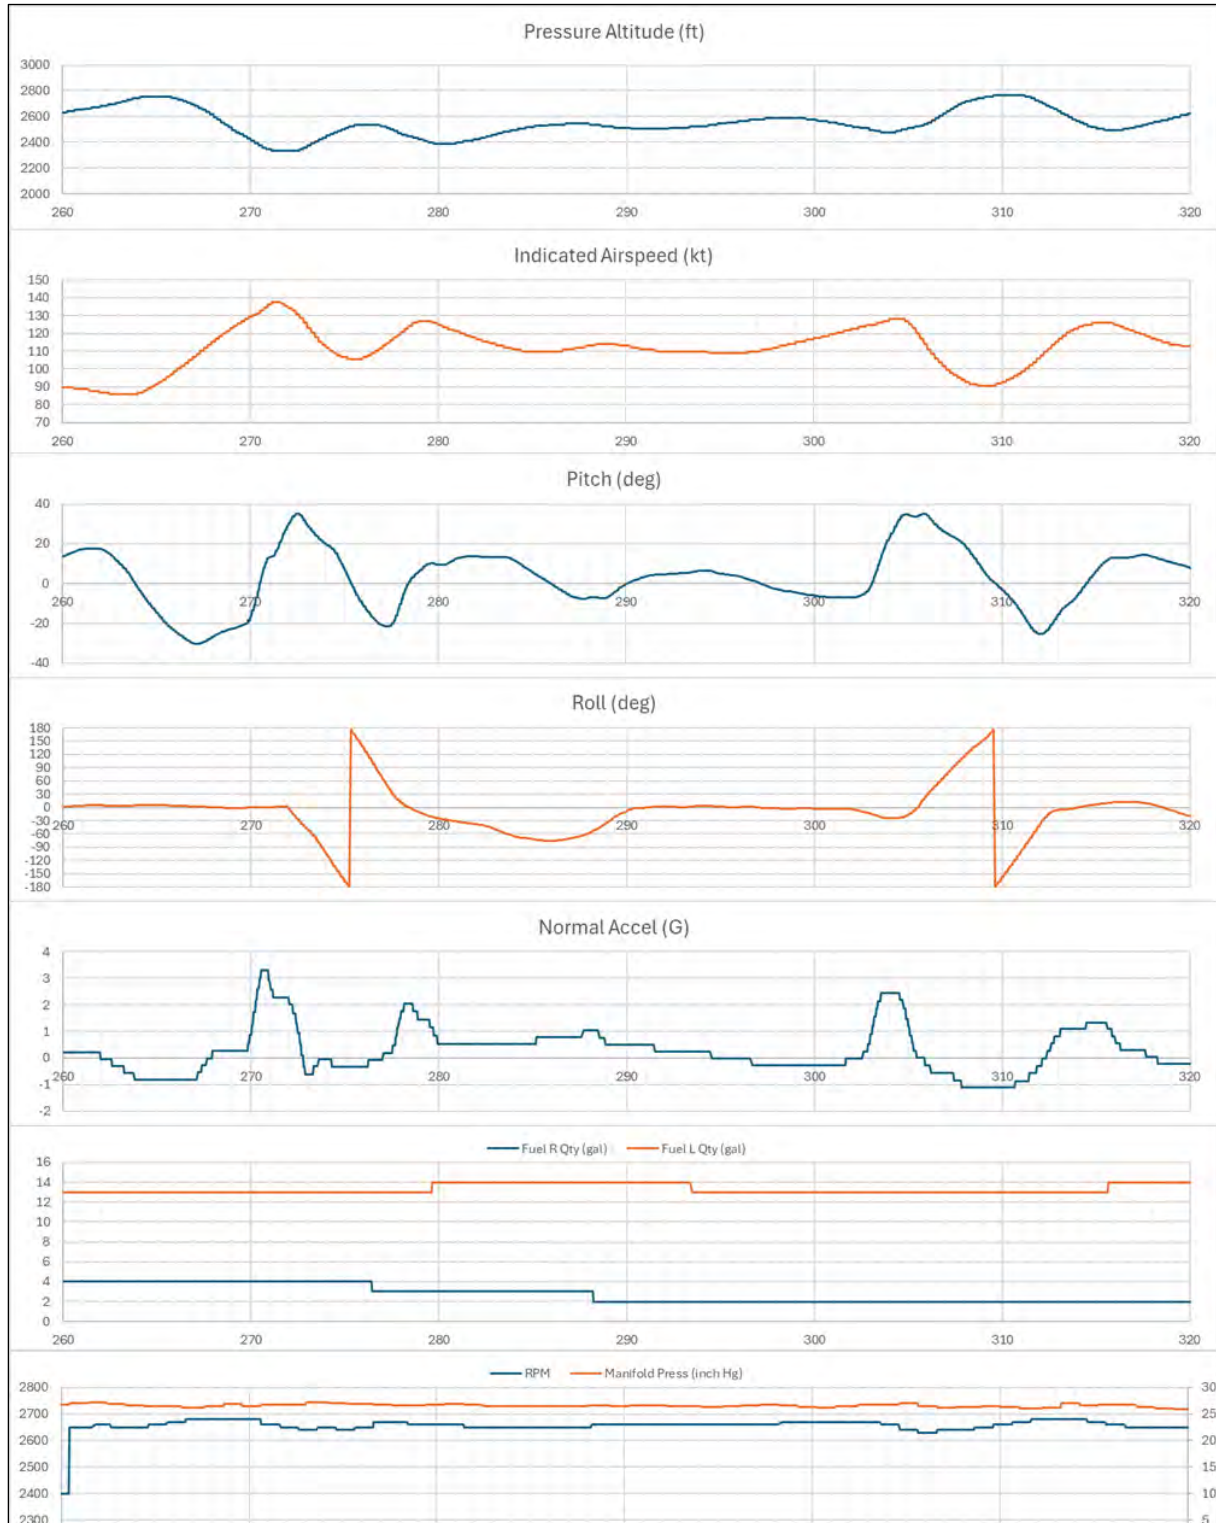
Figure 2

### 2. Flight No 45 at Chiang Mai Air Sports airfield on 09/12/2023.

**Manoeuvres:** Dive from 85 to 137 KIAS, then pull-up to  $n = 4.3$  g plus aileron roll (full aileron with  $n=3.3$ ). This maneuver was repeated several times in different flights, at speeds below 140 KIAS. Two 360° rolls in this segment (left roll, then right roll).

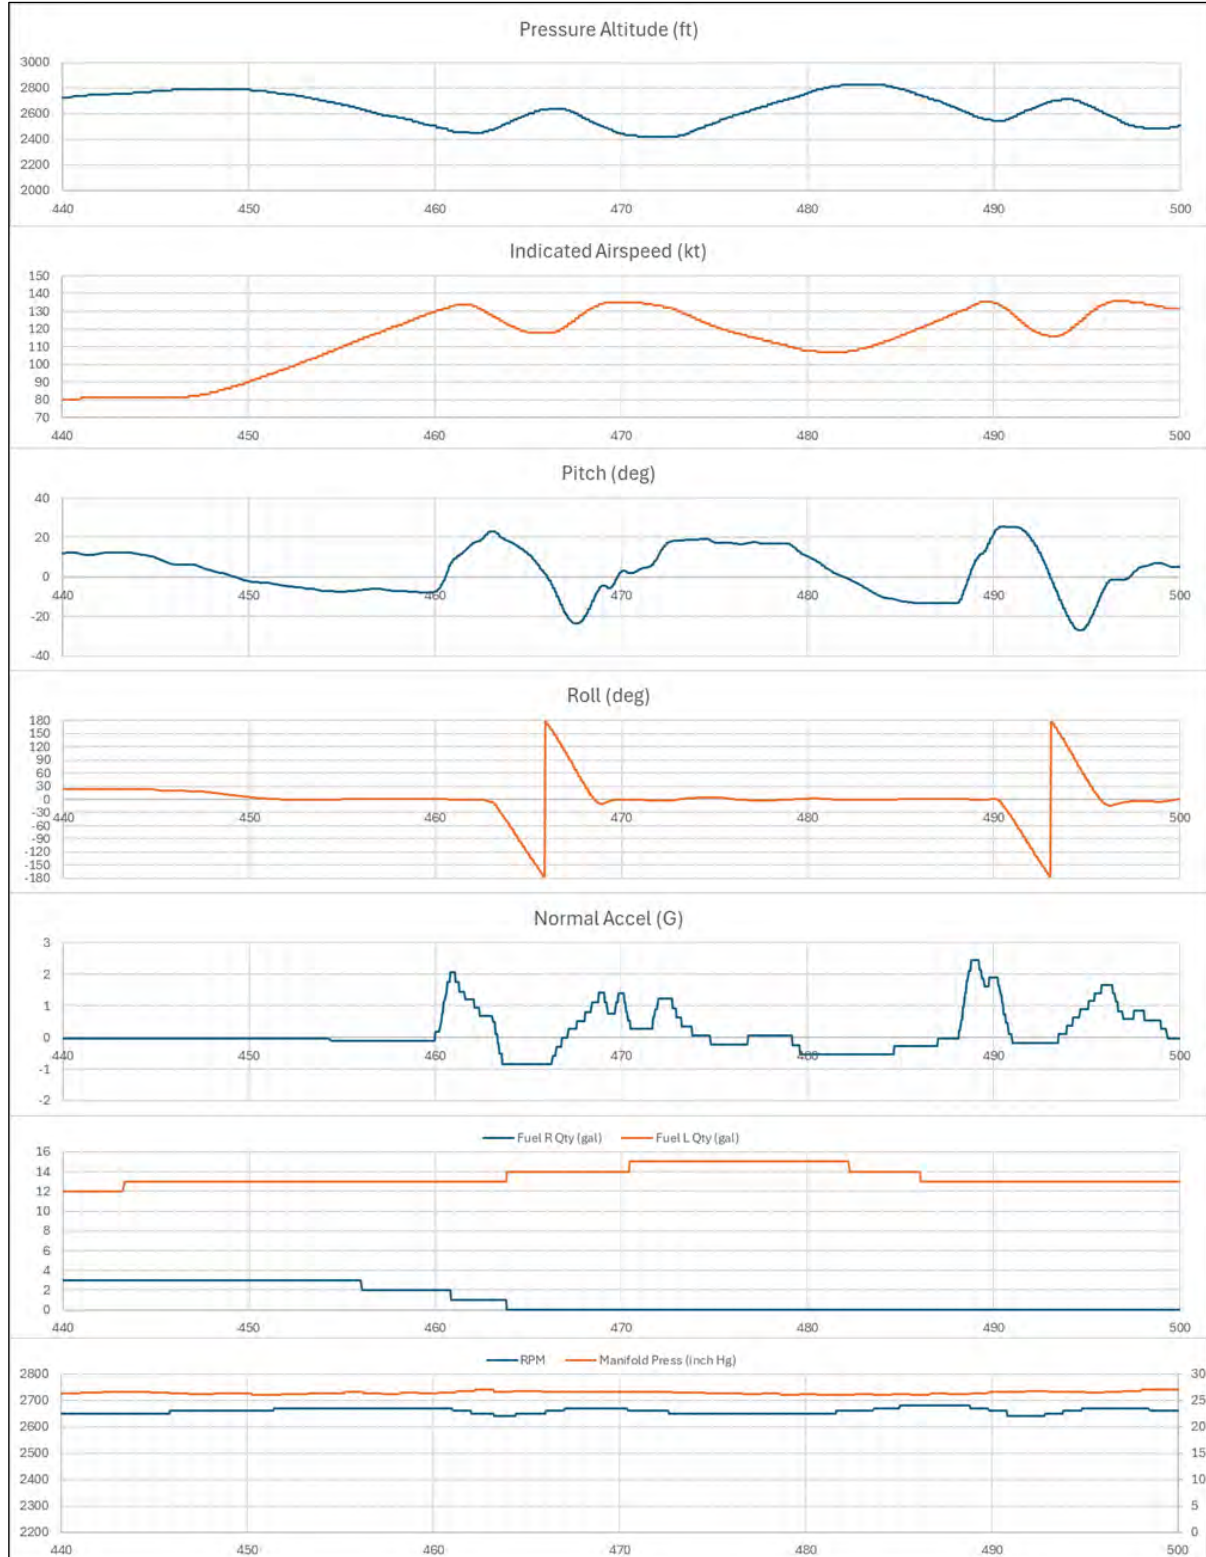
Figure 3

### 3. Flight No 45 at Chiang Mai Air Sports airfield on 09/12/2023.

**Manoeuvres:** Dive from 80 to 132 KIAS, then pull-up to  $n = 3.1$  g plus aileron roll. Two  $360^\circ$  rolls in this segment (both, left roll).
