**AIRCRAFT ACCIDENT  
FINAL REPORT**

**A 03/24**

**Fixed-Wing Aircraft Blackshape BK 160TR, Registration I-POOC  
at Kapar, Selangor  
on 13 February 2024**

**FINAL REPORT NO: A 03/24**

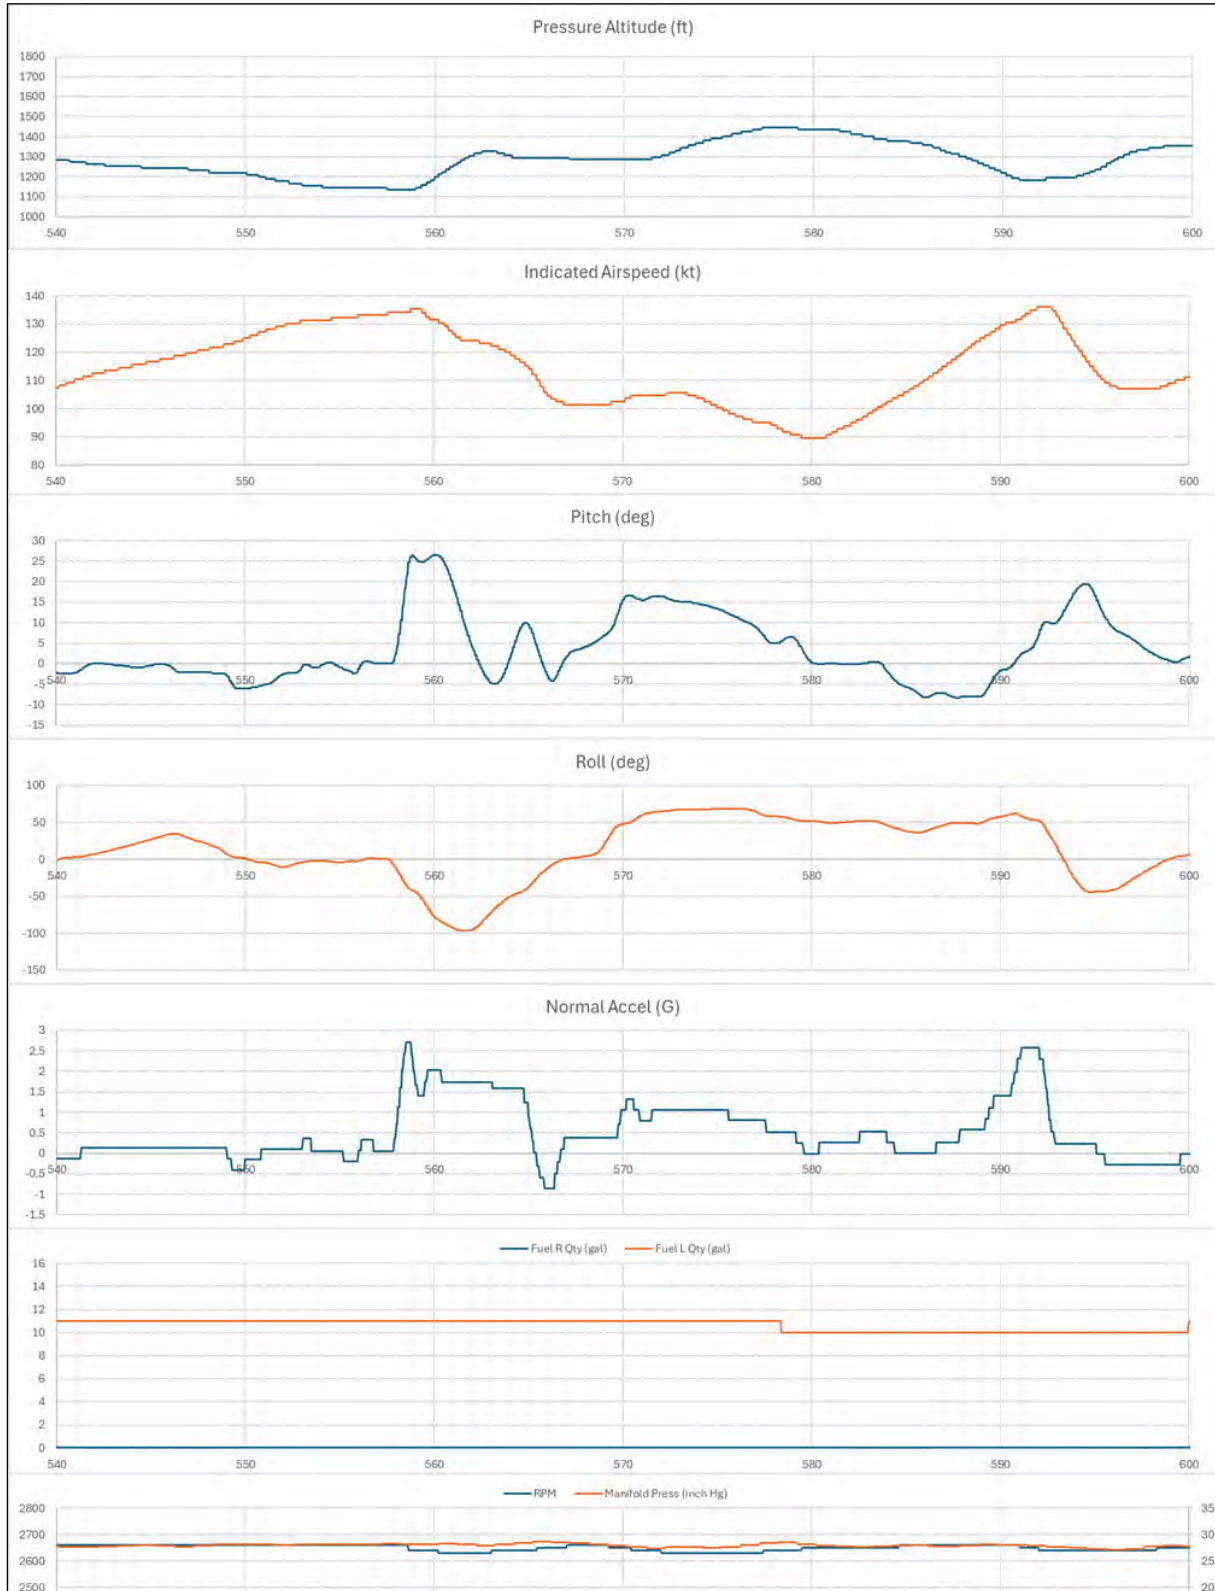
Figure 4

### 4. Flight No 45 at Chiang Mai Air Sports airfield on 09/12/2023.

**Manoeuvres:** Dive from 107 to 135 KIAS, then pull-up to  $n = 3.7$  g, then roll to  $90^\circ$  under high load factor.

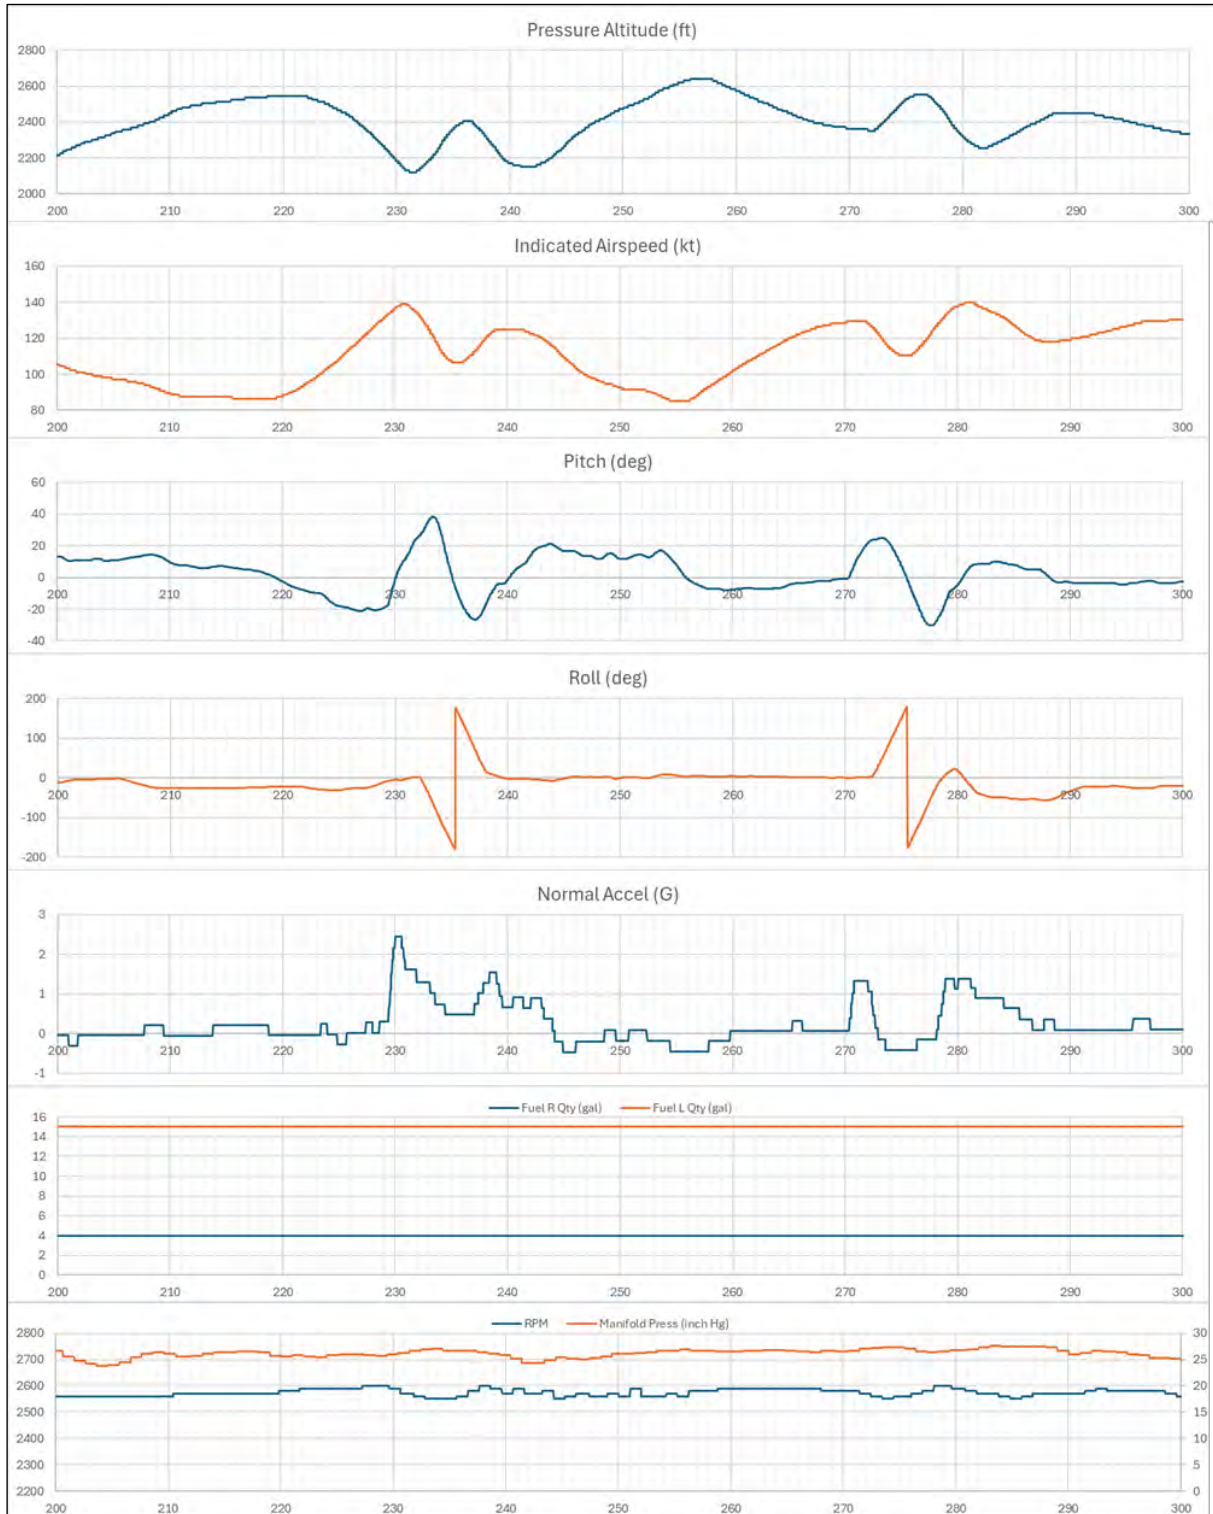
Figure 5

### 5. Flight No 46 at Chiang Mai Air Sports airfield on 10/12/2023.

**Manoeuvres:** Dive from 85 to 138 KIAS, then pull-up to  $n = 3.5$  g plus aileron roll. Two 360° rolls in this segment (left roll, then right roll).

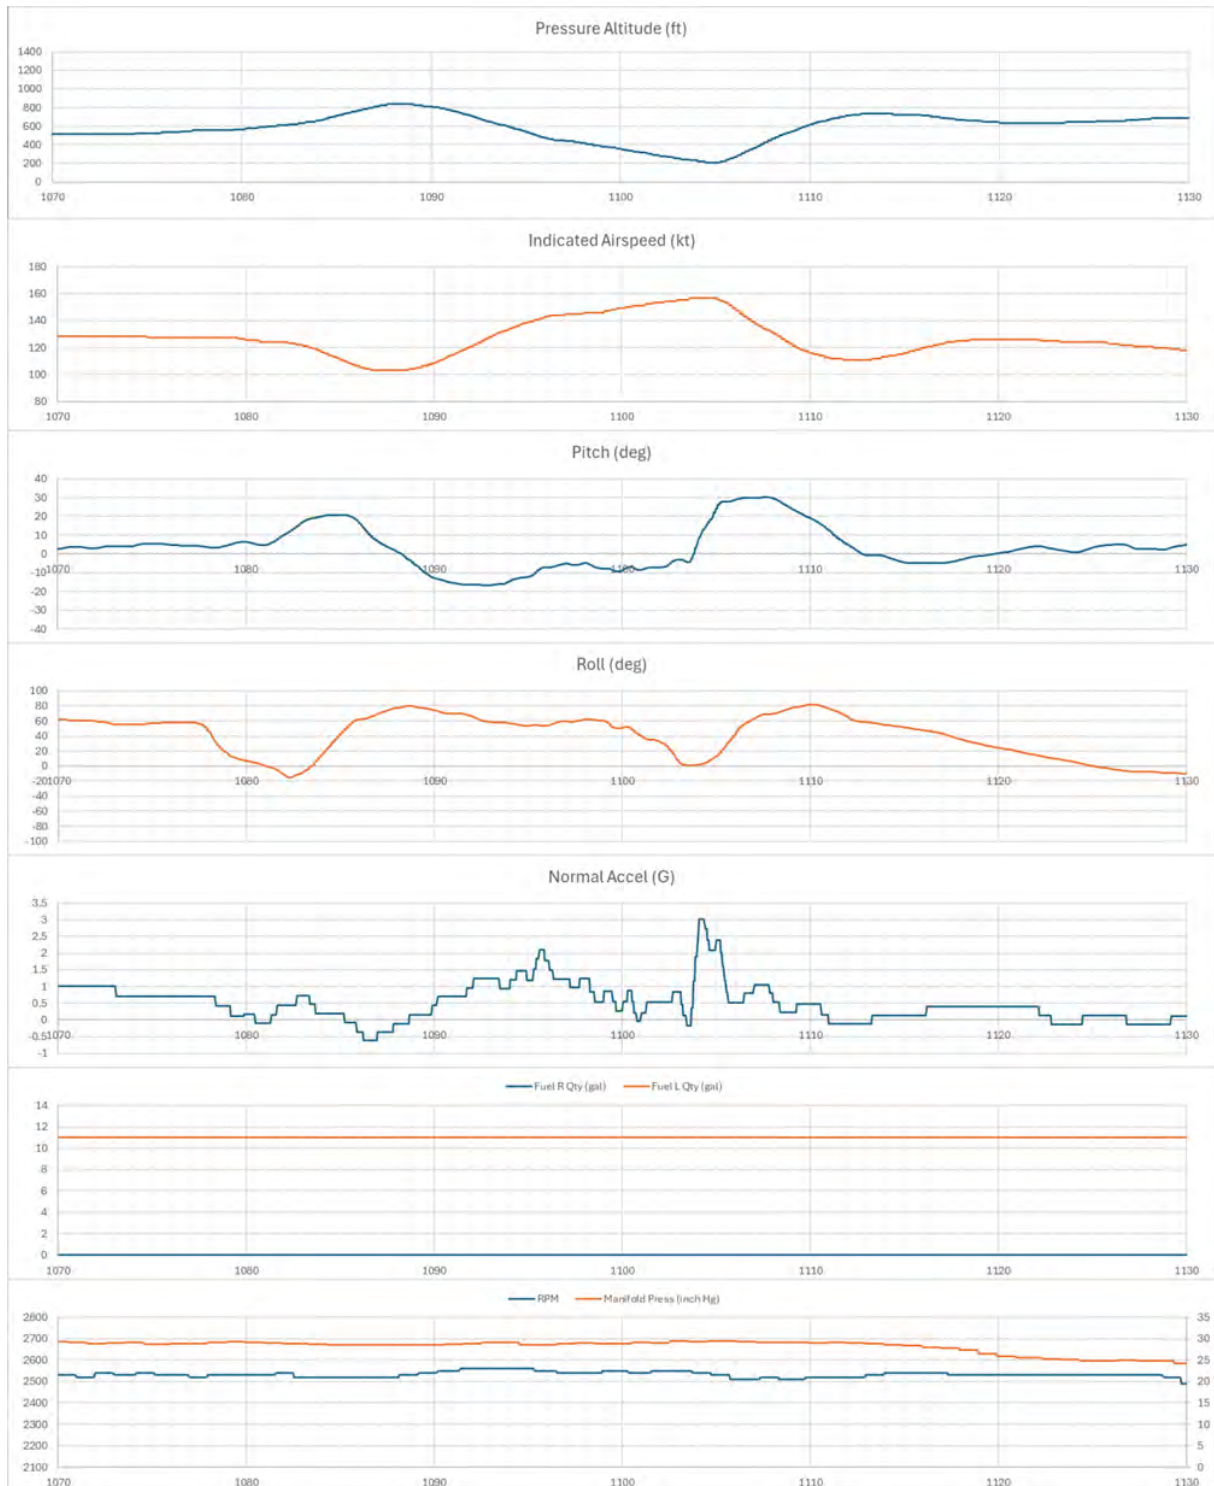
Figure 6

### 6. Flight No 50 at Phuket Airpark on 11/12/2023.

**Manoeuvres:** Dive from 103 to 157 KIAS, then pull-up to  $n = 4.0$  g.

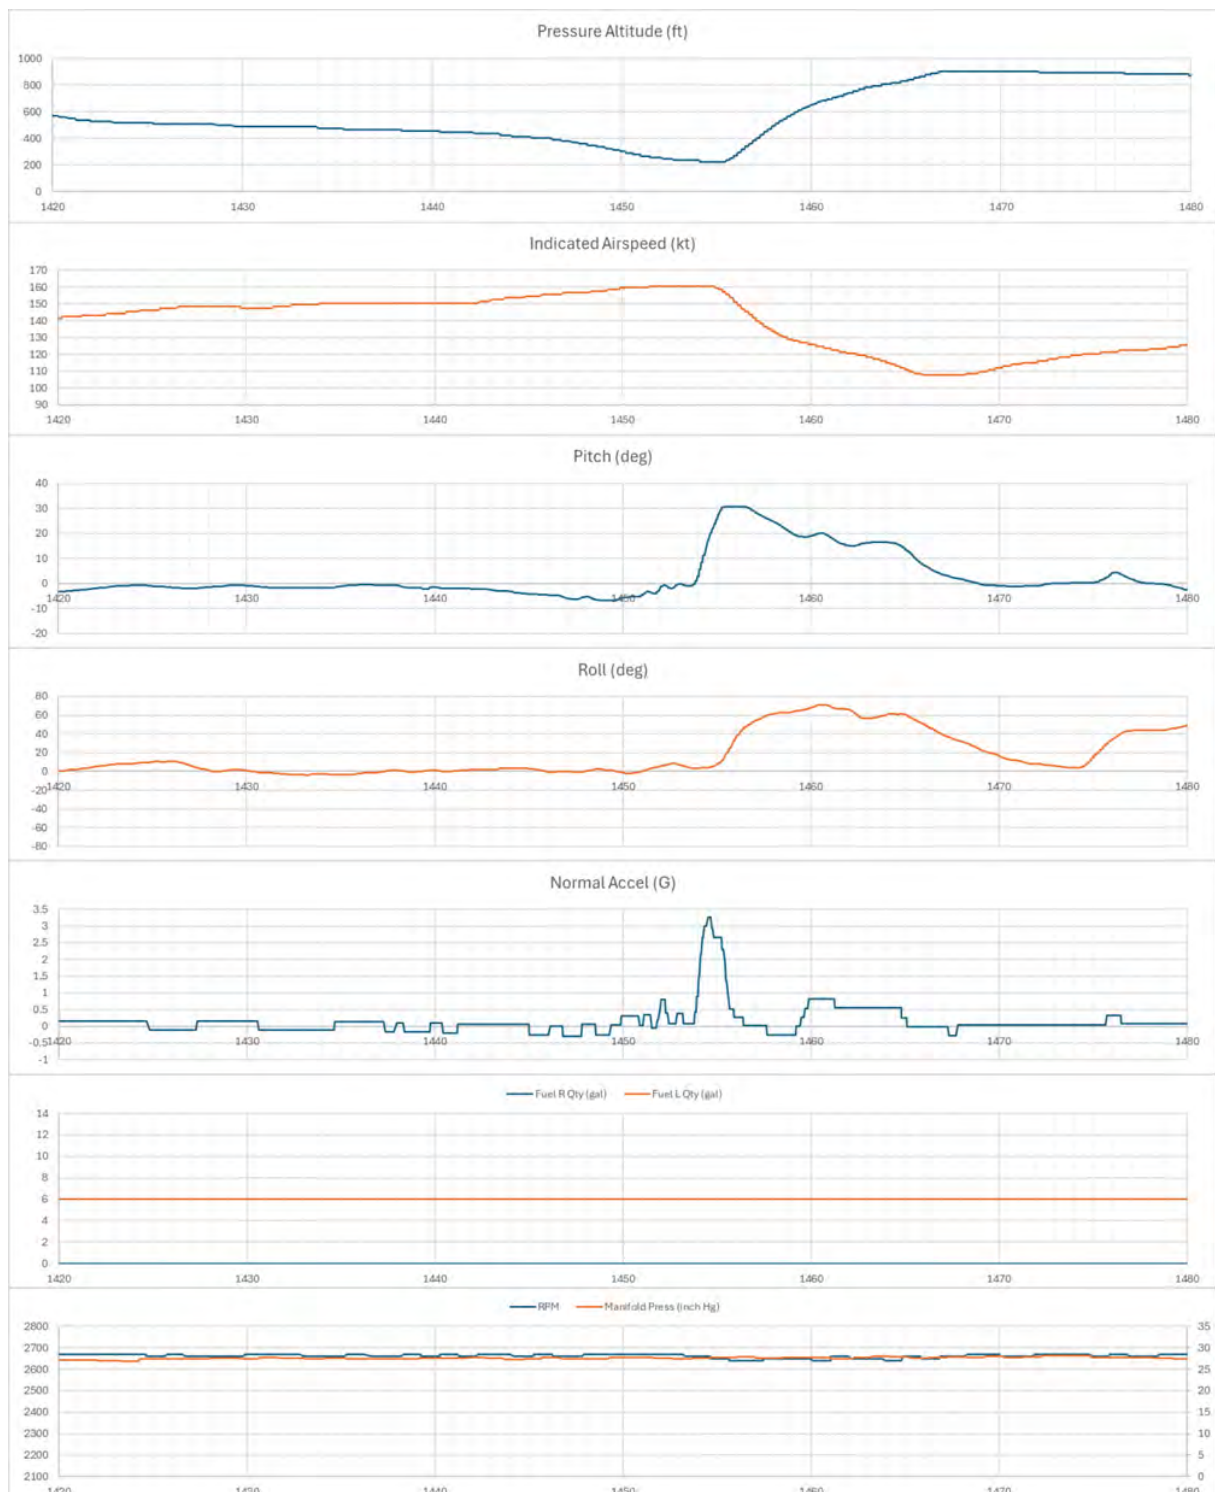
Figure 7

### 7. Flight No 51 at Phuket Airpark on 11/12/2023.

**Manoeuvres:** Pull-up at 161 KIAS,  $n = 4.3$  g.

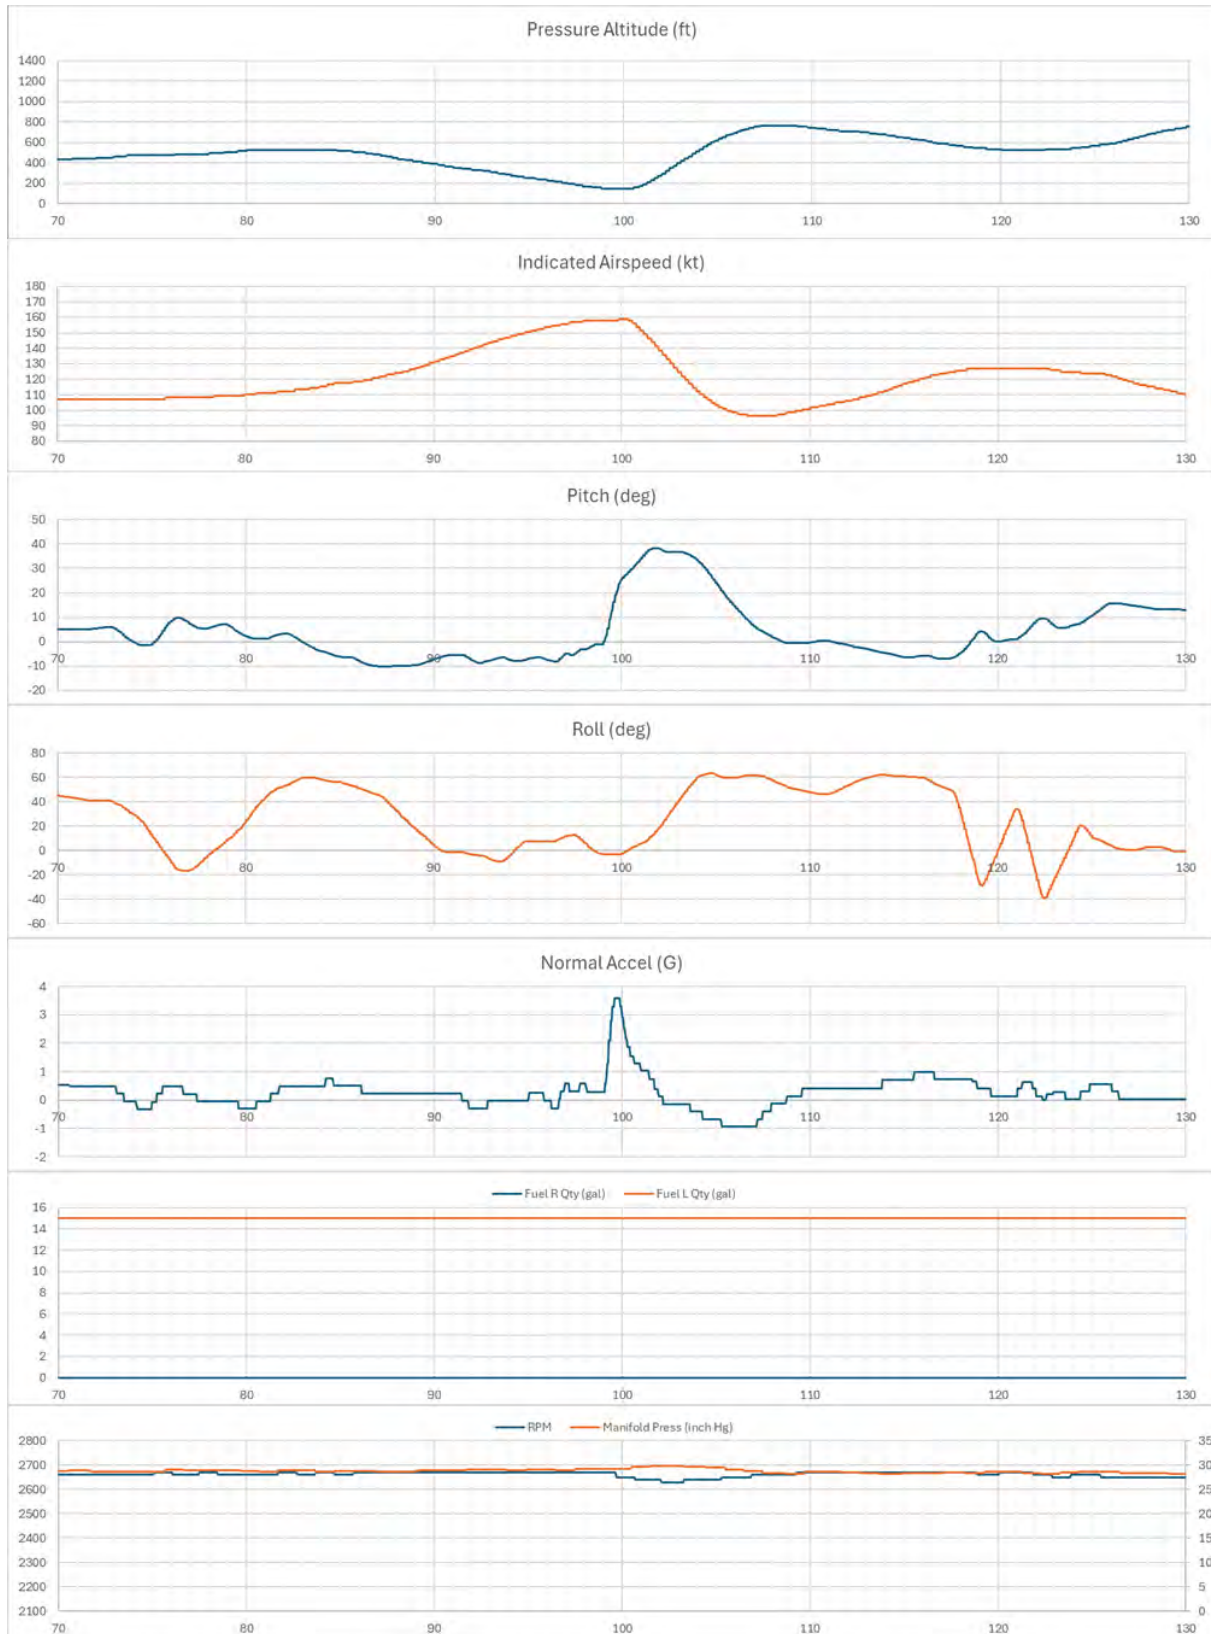
Figure 8

### 8. Flight No 52 enroute from Phuket Airpark to VTSS on 13/12/2023.

**Manoeuvres:** Dive from 115 to 158 KIAS, then pull-up to  $n = 4.6$  g.

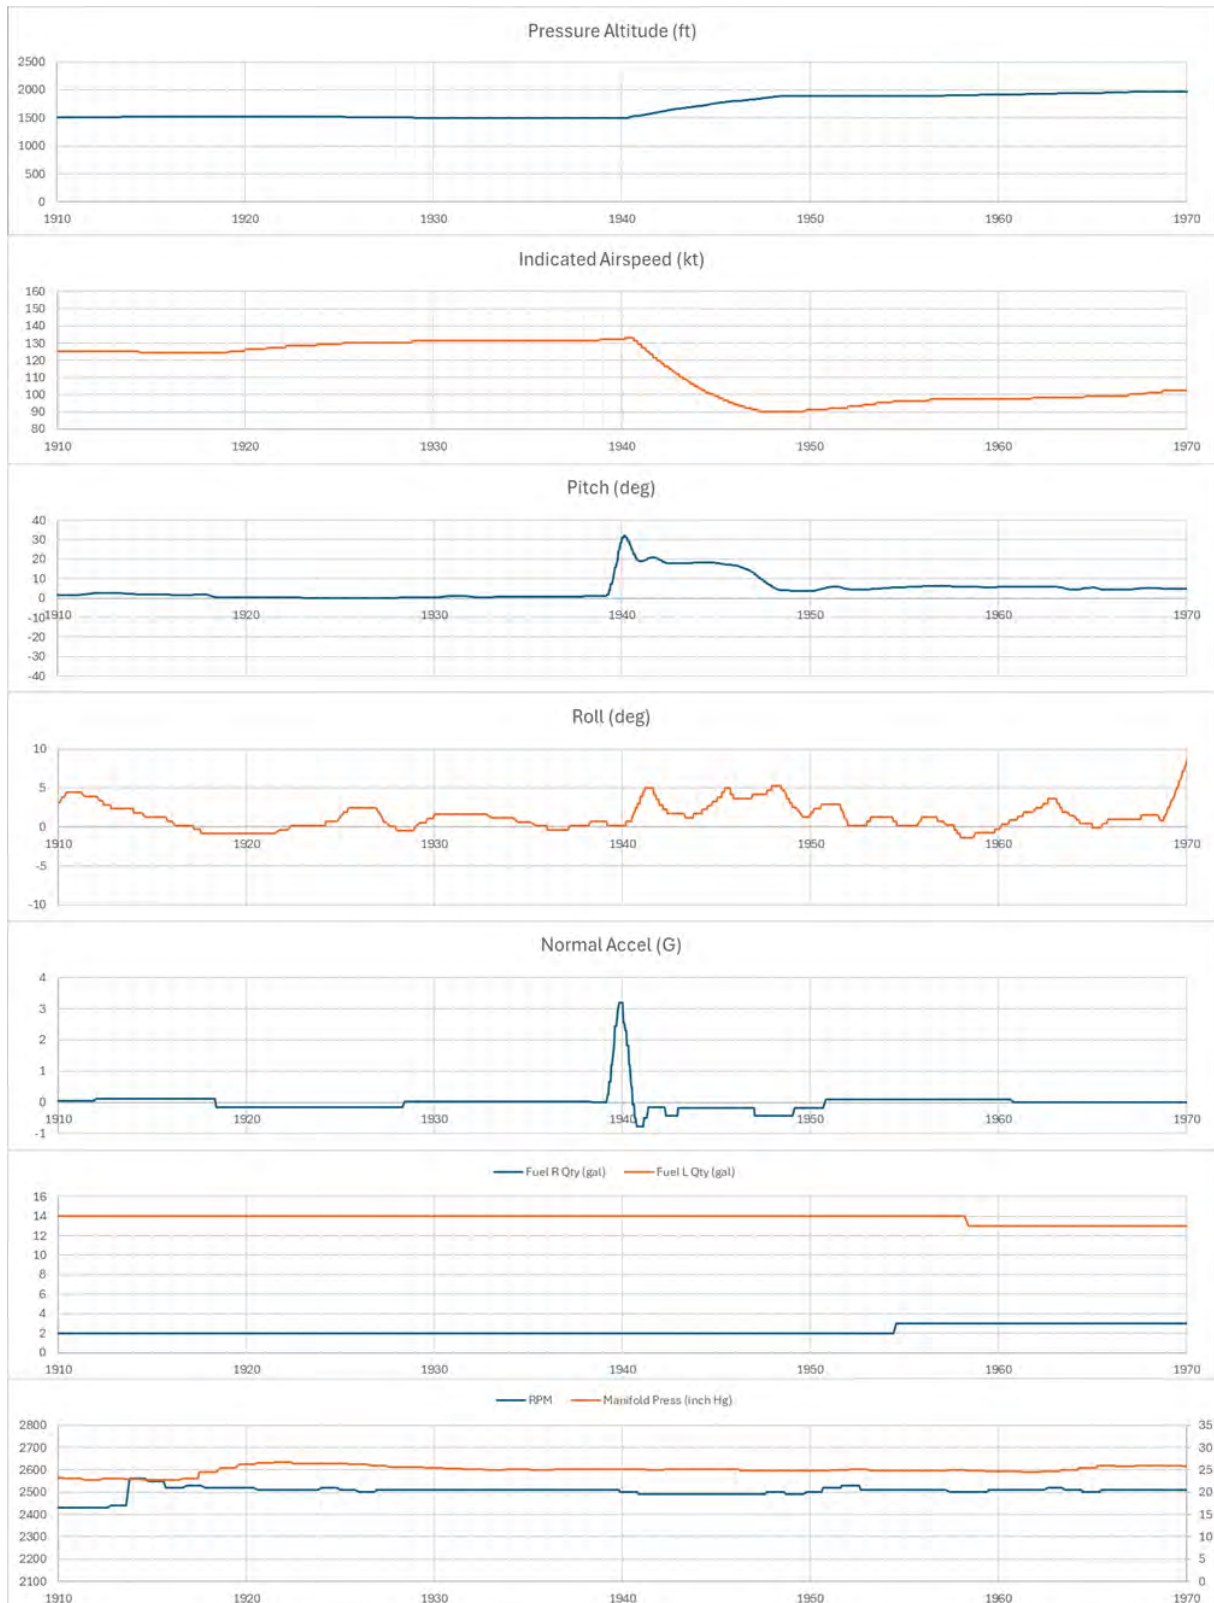
Figure 9

### 9. Flight No 54 in local area near WMSA on 24/12/2023.

**Manoeuvres:** Pull-up at 132 KIAS,  $n = 4.2$  g.

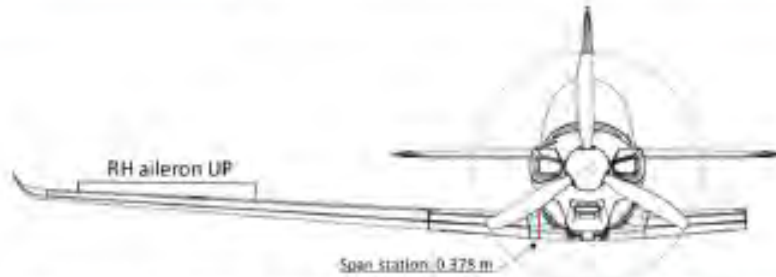
In Figure 4-9 is shown a schematic representation of the RH wing condition and its span corresponding to the break-up location for which the load is calculated:

<sup>2</sup> It is supposed that the pull-up brought the RH wing to the maximum angle of attack (maximum lift coefficient), while the LH wing was stalled due to the loss of the skin.

**Figure 4-9 Schematic representation of the RH wing condition and its span corresponding to the break-up location for which the load is calculated**
