AIRCRAFT ACCIDENT

FINAL REPORT

A 06/24

Accident Involving Fixed Wing Aircraft Cessna 172N,

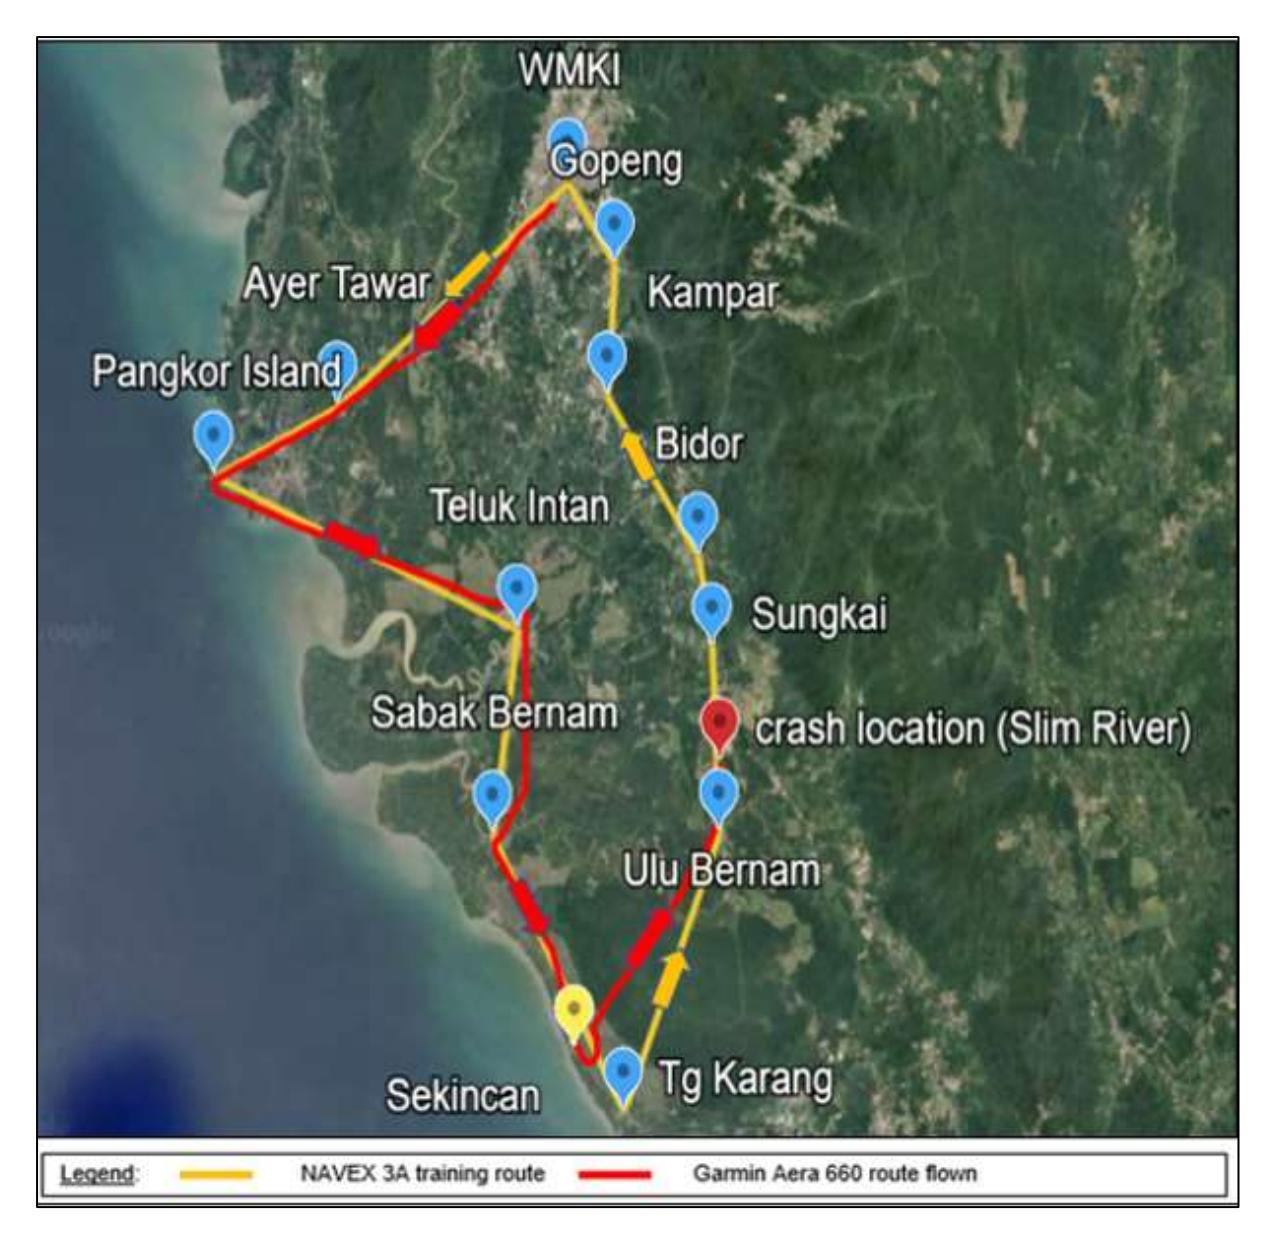
Figure 2: Planned route vs. flown route, and crash location³

In the Sekinchan area, the TP deviated from the planned route, heading north toward the waypoints Ulu Bernam and Sungkai to return to WMKI, as illustrated in Figure 2.

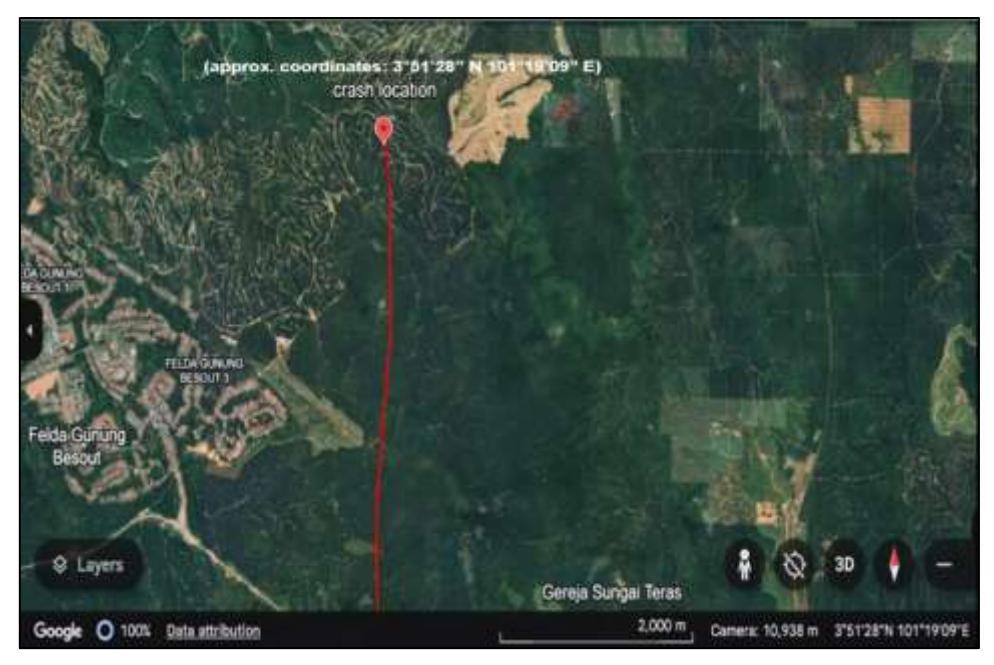
Figure 5: Crash location⁹

The aircraft suffered significant damage after striking trees and crashing into the ground. The crash location coordinates are shown in Figure 5. Figure 6 illustrates the aircraft's trajectory before the crash, while Figure 7 depicts its post-accident condition.

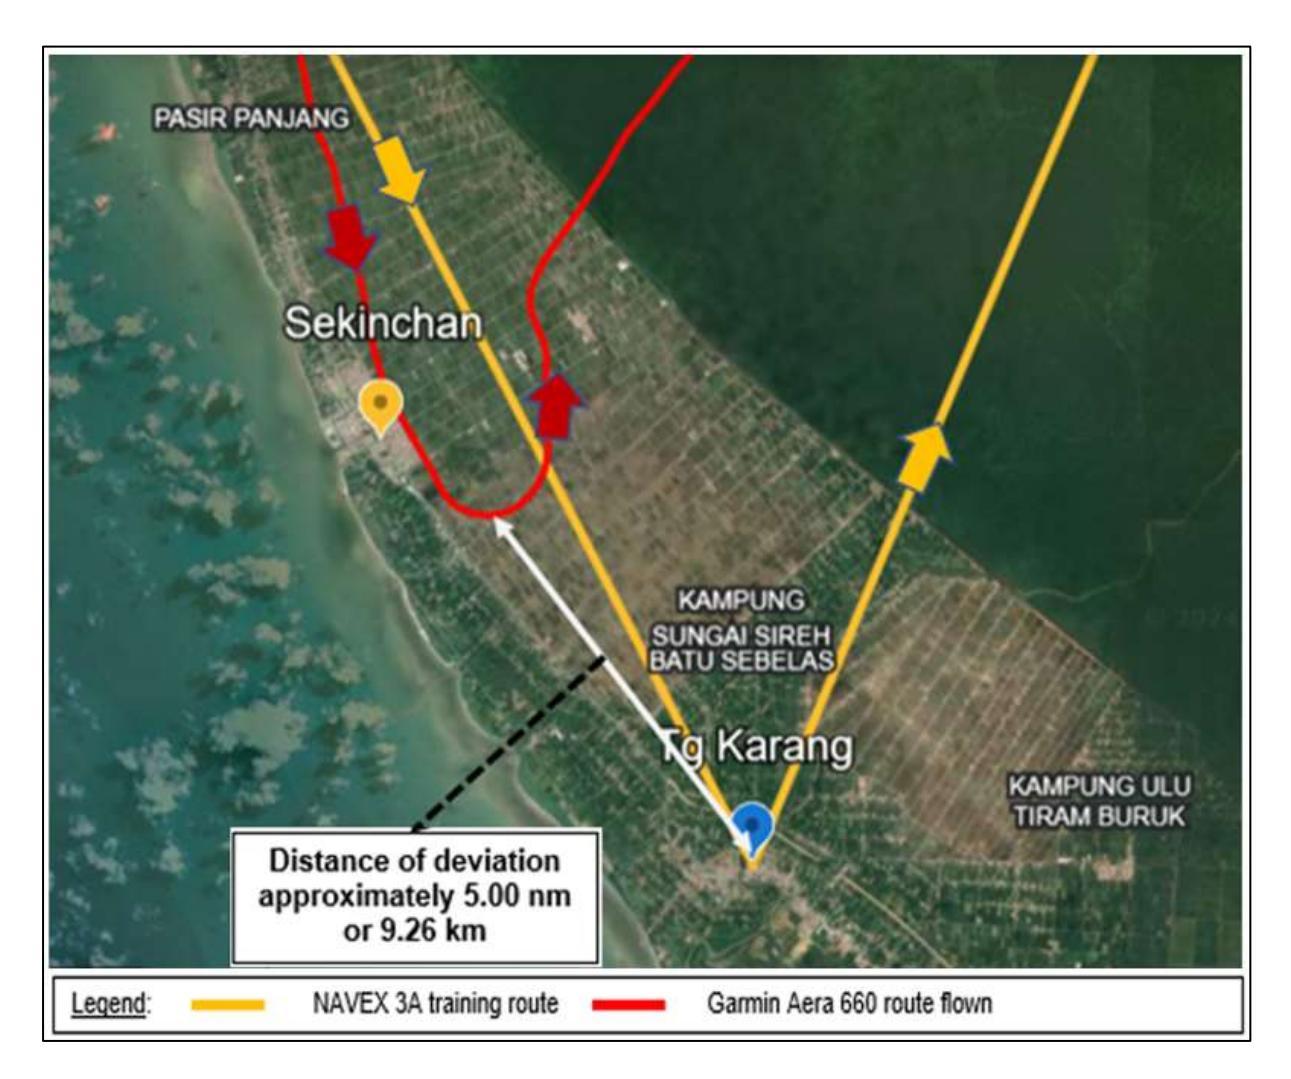
Figure 13: Distance from the aircraft's turnback point to the last waypoint - Tanjung Karang¹⁰

At approximately 0900 LT, while passing over Sabak Bernam, the TP observed adverse weather ahead, preventing the flight from proceeding to its final southern waypoint, Tanjung Karang. Data from the Garmin Aera 660 shows that the flight deviated in the Sekinchan area, turning back northward at a distance of approximately 5.00 nm (9.26 km) from Tanjung Karang. The flight then proceeded to the next waypoint, Ulu Bernam, on its return route to WMKI, as shown in Figure 13.

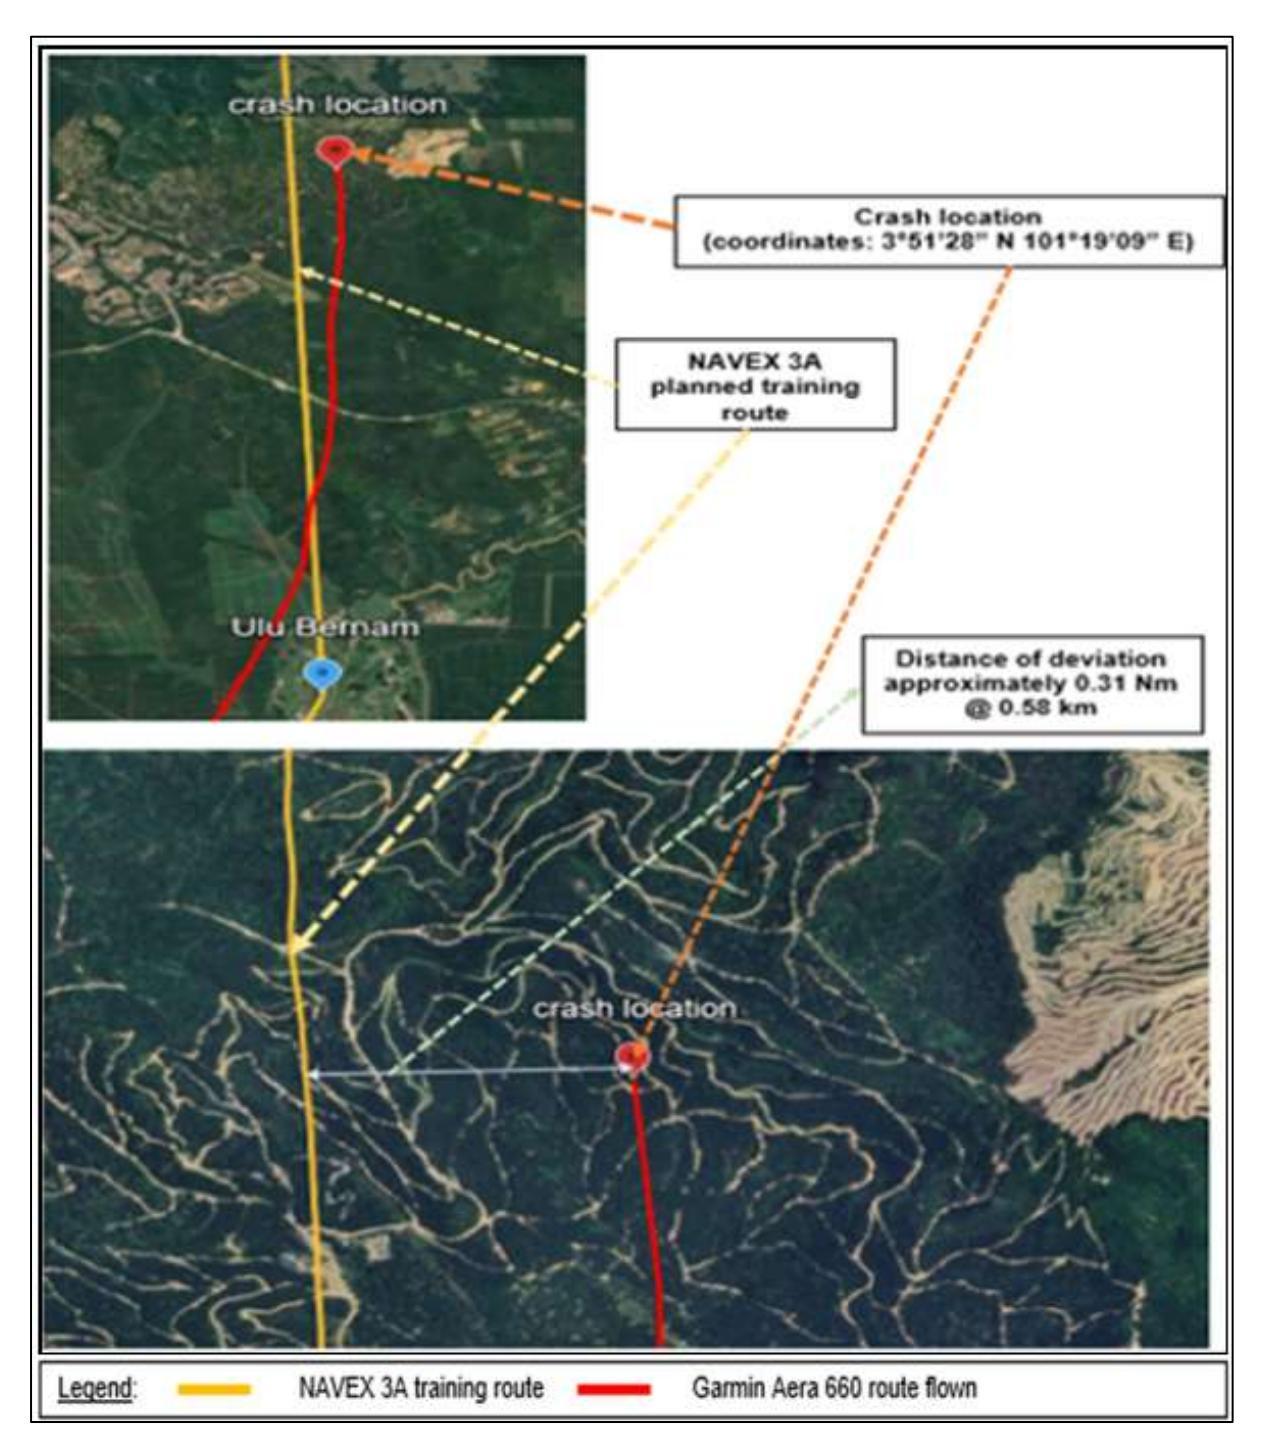
Figure 14: Crash location vs planned training route and distance of deviation¹¹

With reference to the crash location, Garmin data showed that the flight had slightly deviated to the right of the planned route, most likely to avoid the weather. The deviation from the planned route was approximately 0.31 nm (0.58 km). The data

indicates that the flight was attempting to return and was on track northward to WMKI, as shown in Figure 14.

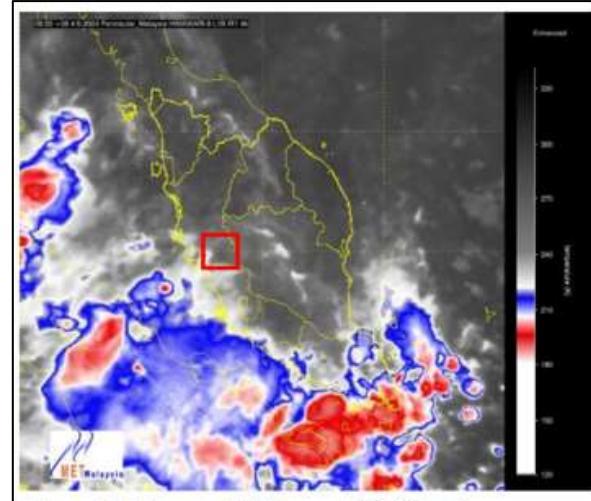
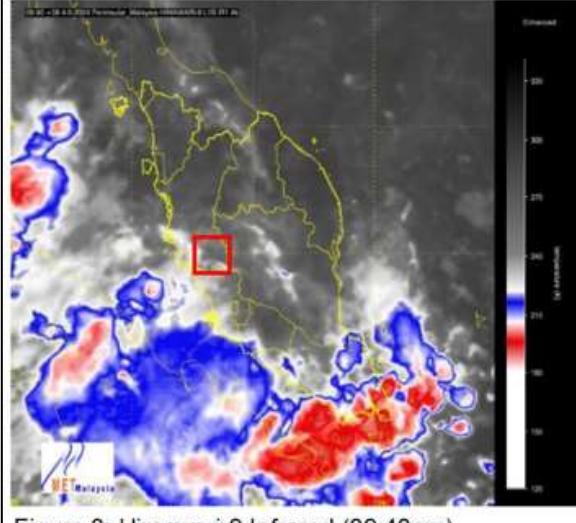
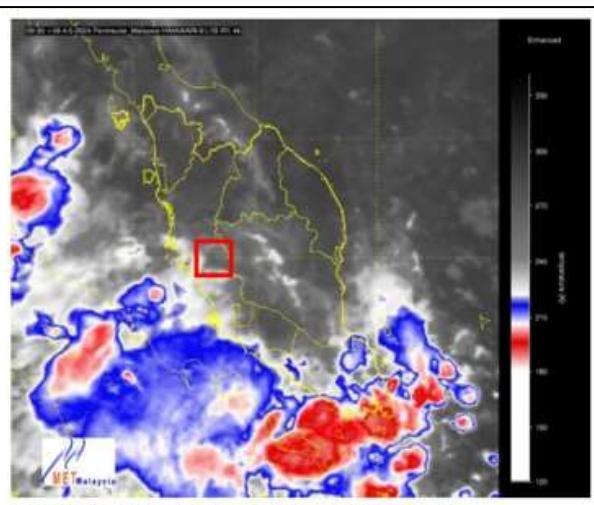
Figure 23A: Weather Satellite imagery by MET Malaysia

As shown in Figures 23A, 23B, and 23C, weather satellite images¹⁵ from Himawari-9 indicate the presence of medium clouds and high clouds between 0920 and 0940 LT within a 10 nm radius of Sungkai (highlighted in the 'red box'). For reference, the distance between Sungkai and the crash site (Slim River) is approximately 8.0 nm, and Slim River falls within the 'red box'. The images show no 'convective cloud'. However, the Surface Weather Observation Report by MET Malaysia confirmed the presence of humid conditions, low clouds, and fog between 0900 LT and 1000 LT within a 10 nm radius of the Sungkai area. A detailed weather analysis and a report are provided in Appendix D.

- i. Satellite Himawari-9 Infrared Band (Band 13) Images (Figures 1, 2, and 3) show the light grey colour shade that indicate medium to high cloud existence between 9.20 and 9.40 a.m. LT in the indicated area.
- ii. Comparison with other satellite images (Visible Band and Cloud Type Product) is required to clarify this cloud.
