## **AIRCRAFT SERIOUS INCIDENT**

**SI 08/24**

**Air Accident Investigation Bureau (AAIB)**

**Fixed Wing Aircraft Boeing 737-800, Registration 9M-MXQ  
at Yangon International Airport, Myanmar  
on 19 July 2024**

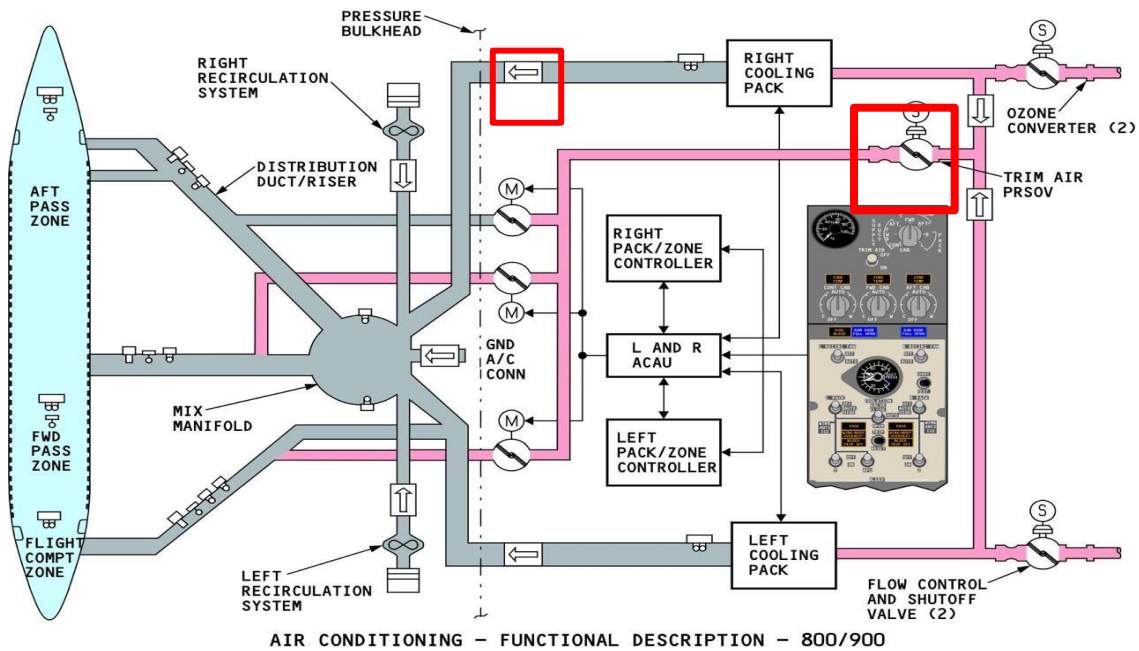
Figure 8: RH Flexible Pressure Sleeve Functional Description

The ruptured pressure sleeve was located between the Air Cycle Machine (ACM) and the High-Pressure Water Separator (HPWS). Because the pressure sleeve is situated upstream within the cooling system, its failure caused cooled air to leak from the right-hand (RH) cooling pack, resulting in the loss of positive air supply to the system. This confirmed the information provided by the cabin crew, who reported that the forward cabin area was hot
