AIRCRAFT ACCIDENT

FINAL REPORT

A 01/25

Rotary Wing Helicopter Bell 206L4, Registration PK-ZUV

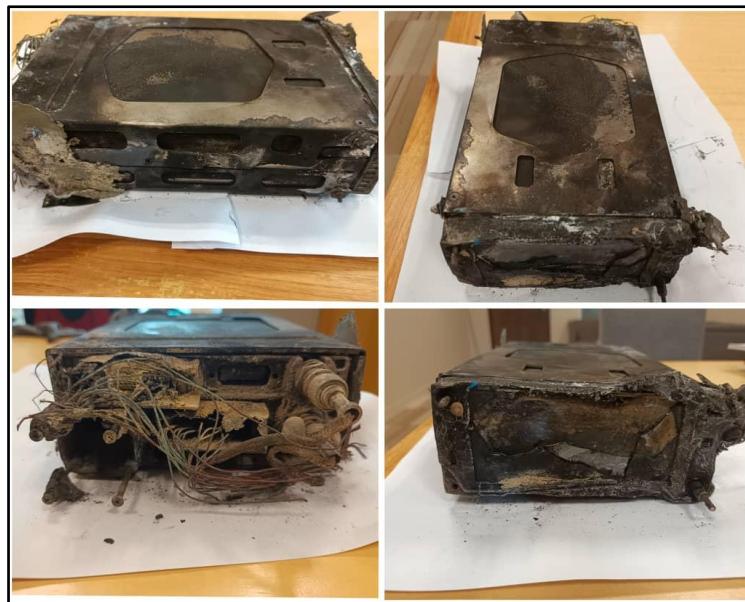
Figure 4: PK-ZUV Garmin GTN 6xx series unit

The helicopter was not equipped with a Flight Data Recorder (FDR) or a Cockpit Voice Recorder (CVR). However, it was found that the helicopter was installed with a Garmin GTN 6xx series unit (refer to Figure 4), which includes a memory card that may contain stored data.

Picture 4: The memory card shows signs of burning and damage, making data extraction impossible.
