AIRCRAFT ACCIDENT

PRELIMINARY REPORT

A 10/25

Fixed Wing Aircraft PIPER PA28-181 Archer III, Registration 9M-SKR

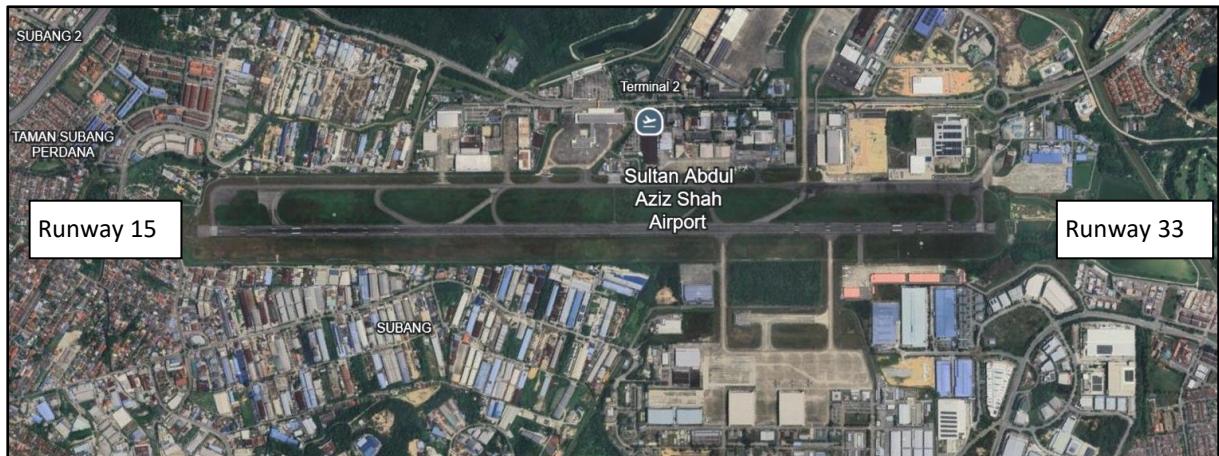
Figure 4: Sultan Abdul Aziz Shah Airport, Subang (WMSA)

Sultan Abdul Aziz Shah Airport Subang (WMSA), located at Latitude 03°07'52"N and Longitude 101°32'53"E, has an elevation of 89 feet and provides a Landing Distance Available (LDA) of 3,780 feet. Runways 15 and 33 were in use for landing operations at the time of the event, and no abnormalities were reported with respect to runway surface condition (refer to Figure 4).
