## AIRCRAFT SERIOUS INCIDENT

### PRELIMINARY REPORT

SI 11/25

**Fixed-Wing Aircraft Boeing 737-800,  
Registration 9M-MXU, at Sultan Ahmad Shah Airport, Kuantan, Pahang  
on 27 November 2025**

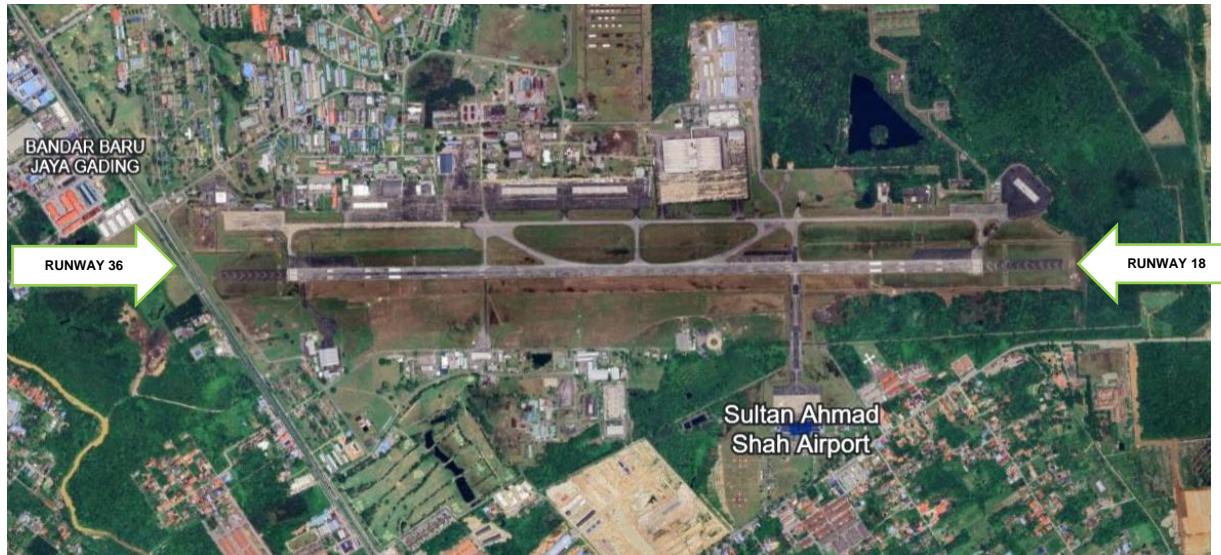
Figure 5: Sultan Ahmad Shah Airport (WMKD)

Kuantan Airport (ICAO: WMKD) also known as Sultan Ahmad Shah Airport is a joint-user military operated airfield. Malaysia Airports Holdings Berhad (MAHB) are responsible towards the operation of civil aircraft on the civil taxiway and aprons. The aerodrome is located approximately 15 km southwest of Kuantan, Pahang and is equipped with a tarmac runway 18/36 measuring about 2,804 metres in length and 46 metres in width. The runway is supported by standard markings and lighting for day and night operations with Taxiway H serving as the taxiway linking the runway to the civil apron. Navigation and approach aids available at the aerodrome include an ILS for Runway 36 VOR/DME and PAPI supporting both IFR and VFR operations. ATC services—comprising Aerodrome Control, Approach Control and Ground Control—are provided by RMAF, with civil operators confined with ground handling of civil aircraft into Sultan Ahmad Shah Airport.
