## **AIRCRAFT ACCIDENT REPORT A 02/18**

**Air Accident Investigation Bureau  
Ministry of Transport, Malaysia**

**Final Report on the Accident Involving  
Fixed Wing Aircraft M-18A Dromader Registration VH-FOS  
In Keratong, Pahang, Malaysia  
On The 25<sup>th</sup> February 2018**

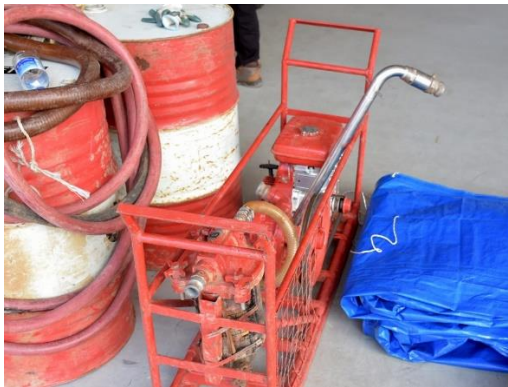
**Picture 10**  
Fuel Pump

The motorised pump was in a working condition. The filter was checked and no trace of water found.

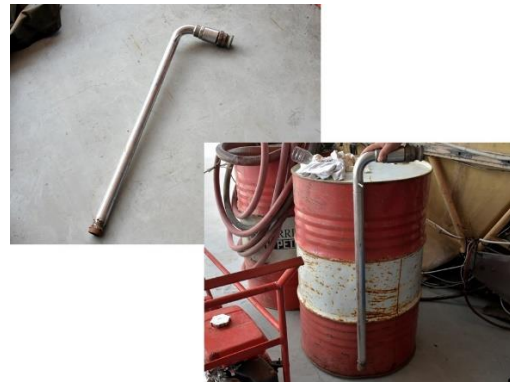
**Picture 11**  
Pipe used connected to the hose

The stainless pipe used (dipped into the fuel drum) has been modified with a stopper bars on the side as to ensure the pipe did not goes all the way to the bottom of the drum. This is the procedure use by the ground handler as to ensure some of the fuel at the bottom will be left in the drum as a precautionary to ensure if there is a water contamination, it will remain in the drum.

The hose is made up of a few hoses joint together using the hose clamp. This hose found to be dry with no sign of water during the inspection.

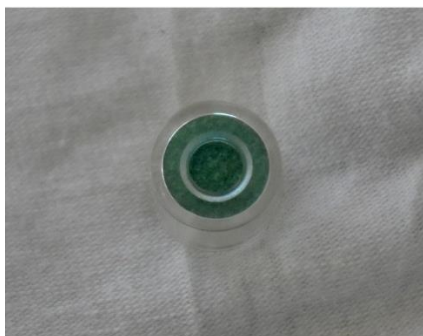
**Picture 18**  
Water Detector capsule

The standard Water Detector Capsules which is available in the market used by SAS ground handler in detecting water contamination. However as explained by the ground handler, the method employed to check water contamination is not as recommended by the manufacturer of the capsules.

The actual sampling process require the capsule to be attach to a syringe (without a needle) and then dip in the fuel sample. Using the syringe, fuel will be extracted through the capsule. If there is any water contaminating the fuel, the colour of the table will immediately change.
