**SERIOUS INCIDENT REPORT NUMBER SI 01/2017
(FINAL REPORT)**

**SERIOUS INCIDENT INVOLVING MALAYSIA AIRLINES MH2718
BOEING B737-800 REGISTRATION 9M-MXX
AT SIBU AIRPORT, SARAWAK
8 APRIL 2017**

**BIRO SIASATAN KEMALANGAN UDARA
MINISTRY OF TRANSPORT
MALAYSIA**

SERIOUS INCIDENT REPORT NO.: SI 01/2017

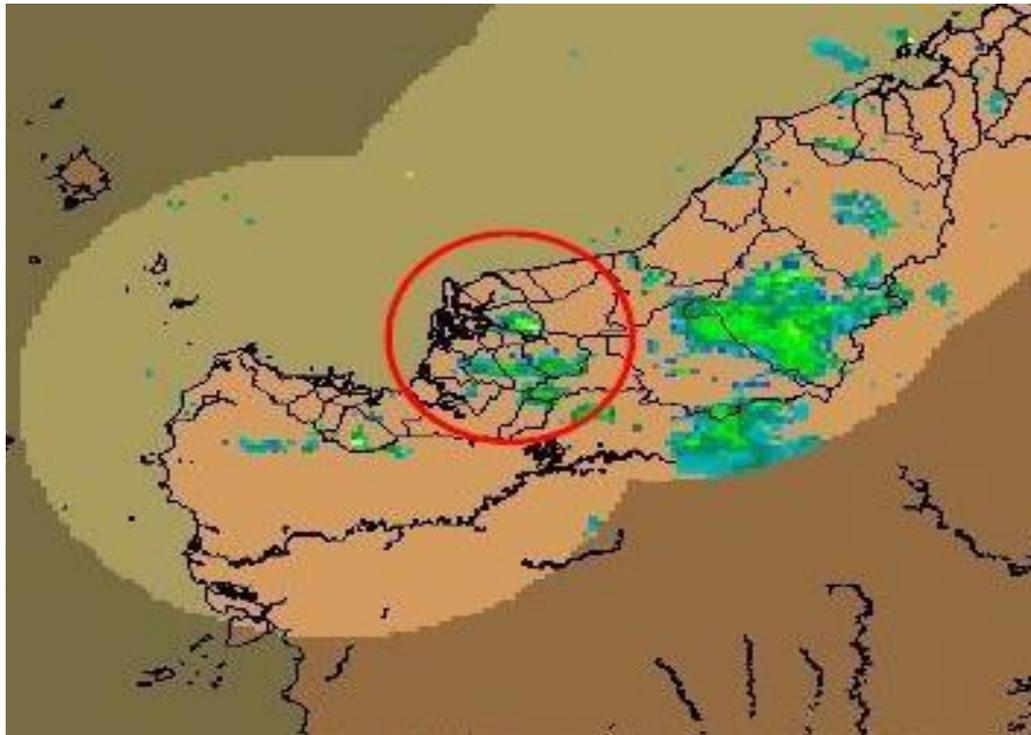
1.7.4 During the investigation, the data from the RVR readout was obtained from the Meteorological Department. This data shows the sporadic visibility pattern (associated with changing rain intensity) ranging from 450 m to 10 km throughout the period in question. The RVR data during this period is shown in Appendix P.

Figure 2: Weather radar image of cloud cover over Sibiu at 2210 LT. (Source: Kuching Meteorological Department)

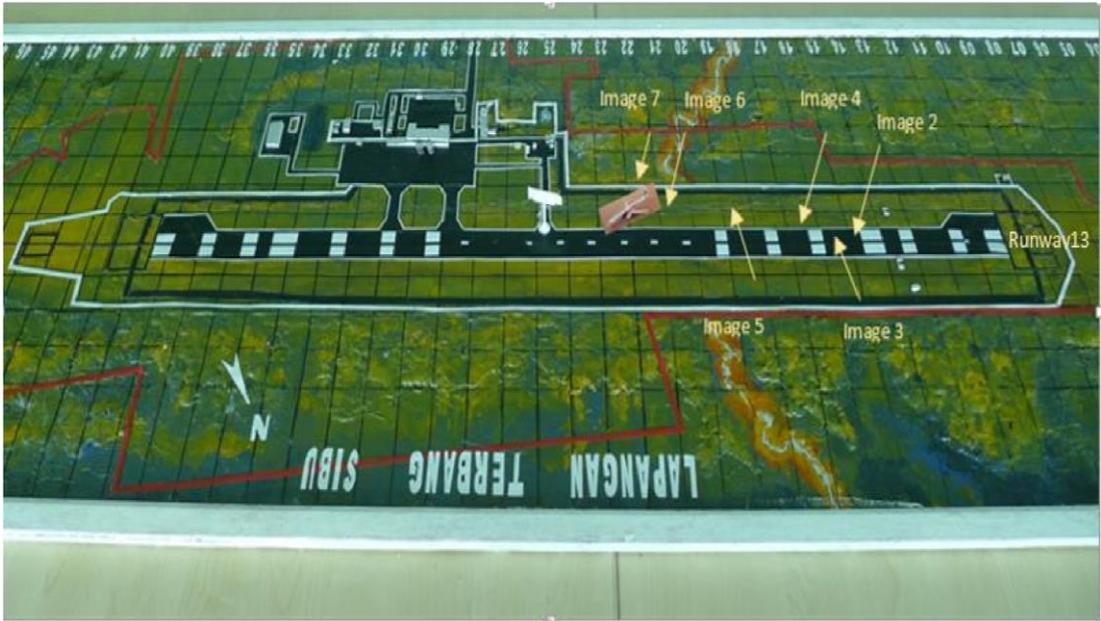
Figure 3: Layout of Sibuan Airport Runway 13/31 with reference to the images 2 to 7

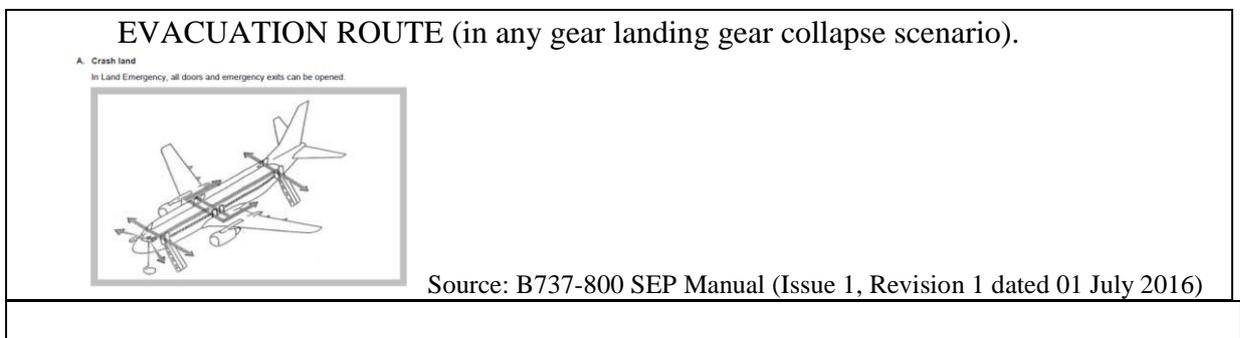
Figure 20: SEP on Evacuation Using All Available Exits

2.2.12.13 Nevertheless, the procedures for evacuation following a crash land required evacuation from all primary 4 main doors (Door 1 L, Door 1 R, Door Door 2 L and Door 2 R). The over-wing window emergency exits were supposed to be opened by the passengers seated near the over-wing exits, as shown in the diagram below.

2.2.12.14 The evacuation process using only the 2 forward doors was completed in a timely manner due to the swift action by the cabin crew and relatively lesser number of passengers in the cabin.

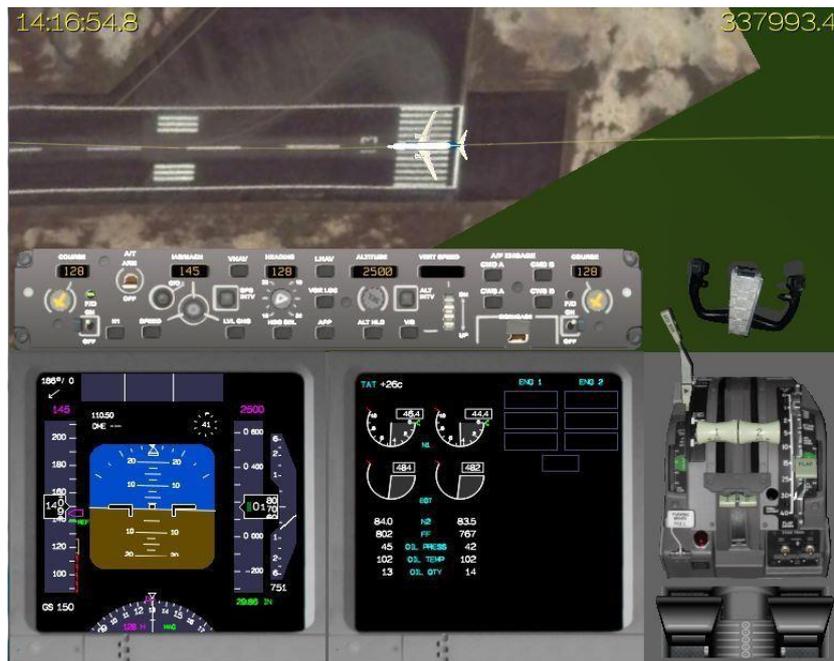
Photograph 1: Aircraft appears to be on the centreline when flying over the Threshold Runway 13 at 42ft RA. No deviation was evident at this juncture.

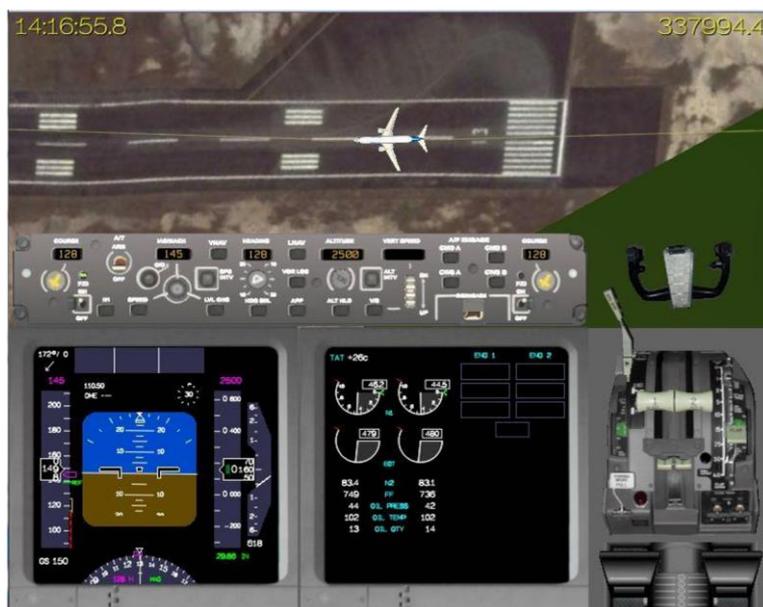
Photograph 2: Aircraft was still seen flying over the centreline of Runway 13 at 30ft RA.

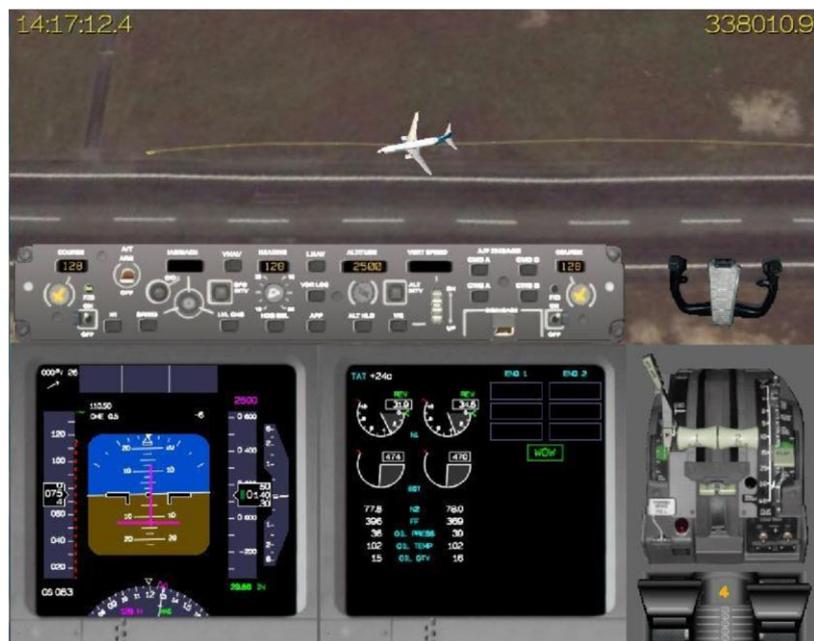
Photograph 10: Position of aircraft at 10 seconds after touchdown.
