Australian Government
Australian Transport Safety Bureau

Data entry and navigational issues involving Airbus A330-343X 9M-XXM

Sydney Airport, New South Wales | 10 March 2015

ATSB Transport Safety Report
Aviation Occurrence Investigation
AO-2015-029
Final – 7 September 2016

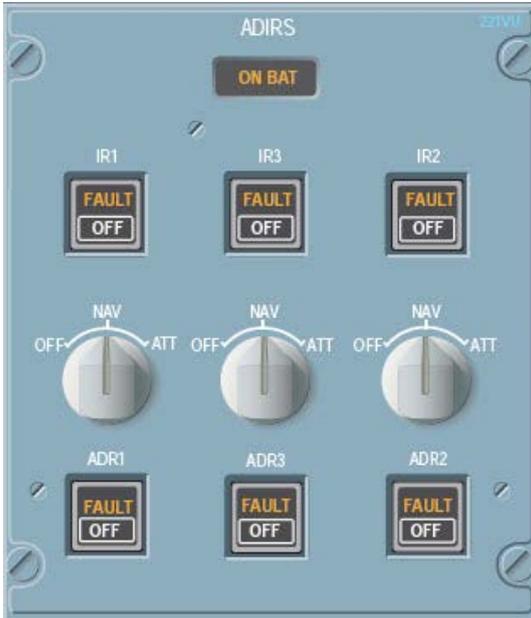
Figure 9: ADIRS control panel containing rotary switches as well as individual IR and ADR FAULT lights and OFF push-buttons.

The FO informed the captain that, in order to attempt to reset the system, it was intended to cycle the three air data and inertial reference unit (ADIRU) rotary switches on the overhead panel from NAV to OFF (Figure 4), and that this would likely cause the autopilot to drop out. The ADIRU rotary switches influence both the ADR and inertial reference parts of the respective ADIRU, and have a greater combined effect on aircraft systems compared with the individual ADR and/or inertial reference push-buttons available on the same overhead panel (Figure 4) (see the section titled *Context*).

During interview the captain and FO stated that the captain's response was simply 'Yes'. The FO recalled initially holding their hand in the vicinity of the rotary switches awaiting confirmation from the captain to cycle them to OFF. Both crew recalled that ATC instructions then disrupted the normal process of confirmation before actioning critical flight deck switches. Once the ATC instruction was acknowledged and complied with, the FO turned ADIRU 1 and 3 OFF without clarifying the captain's confirmation for the action. In response, several flight guidance and navigation systems degraded and the autopilot disengaged. The captain instructed the FO to stop actioning the switches, with ADIRU 2 remaining in the NAV position.

ADIRU can be deactivated by pressing the OFF push-button below the fault light. The ADR part of the ADIRU operates in the same manner (Figure 9).

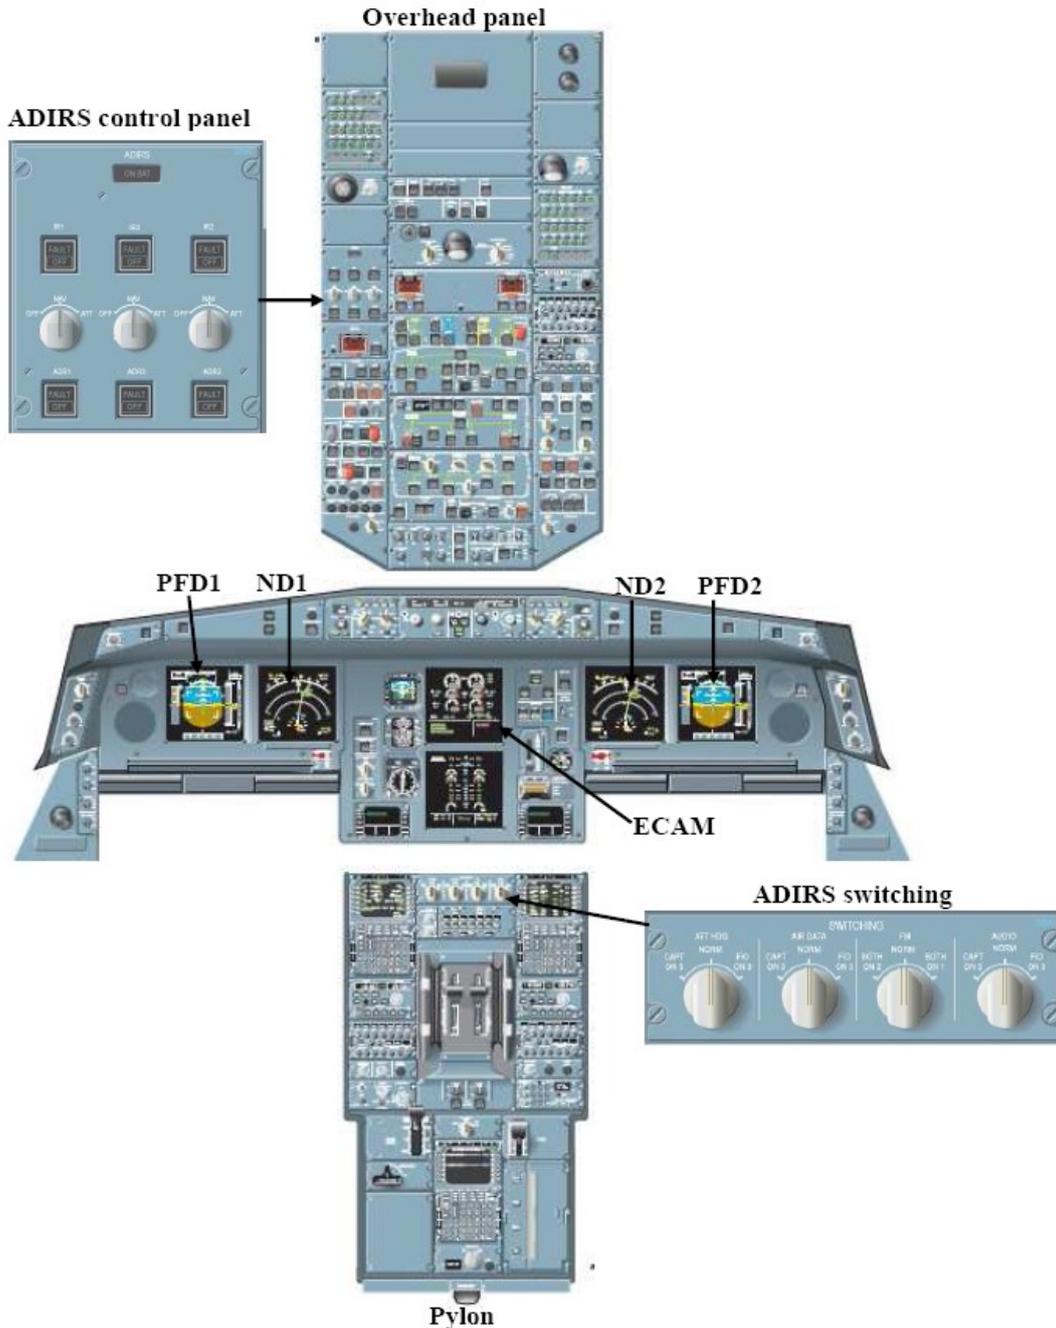
Figure 10: Overhead panel showing the ADIRS control panel (at inset) and relative cockpit position of a number of displays and controls

The ADIRS control panel is located on the flight deck's overhead panel (Figure 10)

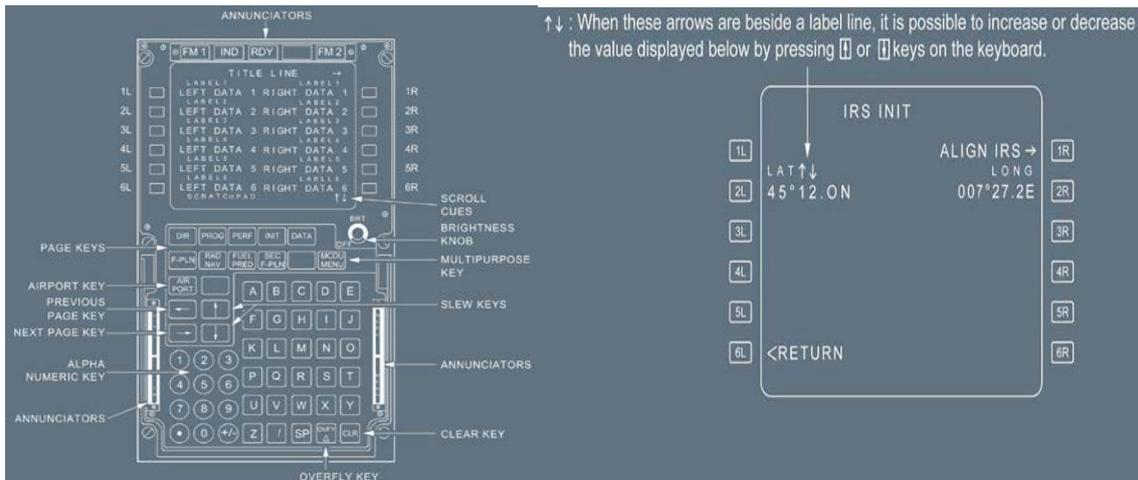
Figure 11: Slew key indicators on the MCDU

The slew keys mentioned in the FCTM were two up and down keys on the MCDU that allow the pilot to incrementally adjust a value displayed on the MCDU screen, without having to retype the entire value. In the case of the ADIRS initialisation, these slew keys enabled the pilot to adjust the latitude and longitude of the initialisation position from the ARP to the gate coordinates without having to retype the entire coordinates. (Figure 11)

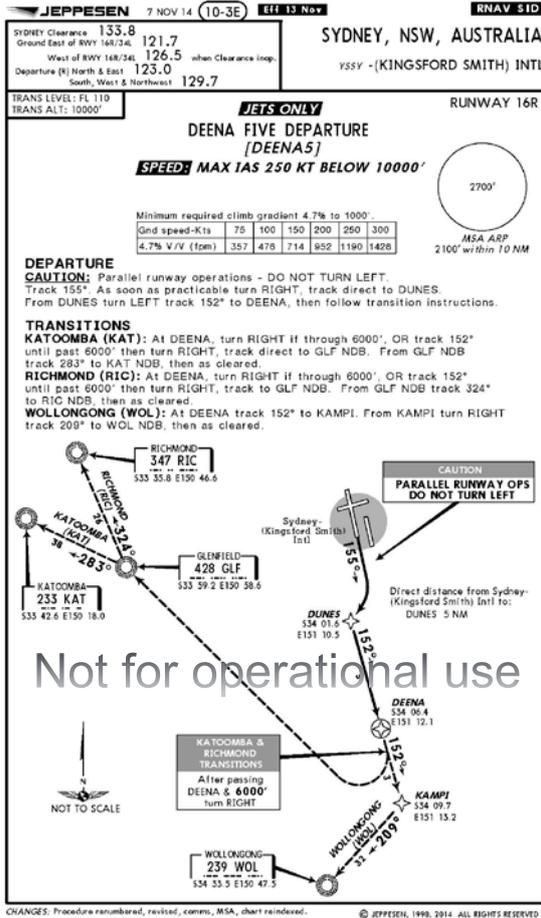
Appendix A – Standard instrument departure

A few seconds later, ATC observed the aircraft turning left, contrary to the SID, and tracking towards the flight path for the active parallel runway, runway 16L. In response, ATC contacted the crew and requested confirmation that they were tracking via the SID and would be maintaining a heading of 155° before turning right. At the same time ATC held another aircraft in the line-up position for departure from runway 16L (Figure 2).

DEENA 5 standard instrument departure depicting the right turn requirement and caution regarding the parallel runway.
