SAFETY INVESTIGATION REPORT

**Malaysia Airlines Boeing B777-200ER (9M-MRO)
08 March 2014**

The Malaysian ICAO Annex 13 Safety Investigation Team for MH370

Issued on 02 July 2018
MH370/01/2018

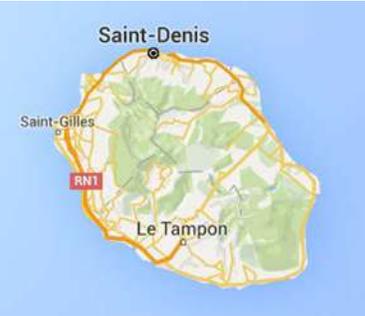
<p data-bbox="792 663 999 699">Right Flaperon</p>

<p data-bbox="1240 663 1547 730">Saint-Denis, Réunion Island</p>	<ul style="list-style-type: none"> • <i>Confirmed</i> by French Judicial Authority belonging to MH370 on 03 September 2015 • Refer to <i>Appendix 1.12A-1</i> and <i>Appendix 1.12A-2</i>
Item 2	27 December 2015

The examination of the flaperon at DGA/TA revealed the following damages:

- a) the inboard and outboard hinge fittings were fractured in two places; at the level of the leading edge and on the lower surface of the flaperon;
- b) the fracture surfaces on the hinge fittings were highly corroded;
- c) the ribs at the edge of the flaperon showed, in their metallic area, holes due to corrosion;
- d) the leading edge showed dents and cracks;
- e) the trailing edge was generally broken;
- f) the lower and upper surface panels showed localised dents and the upper surface had a large crack; and

g) the mounting attachment zones on each side of the flaperon were damaged or broken off.

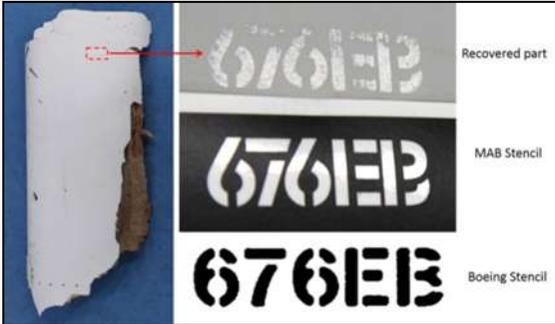
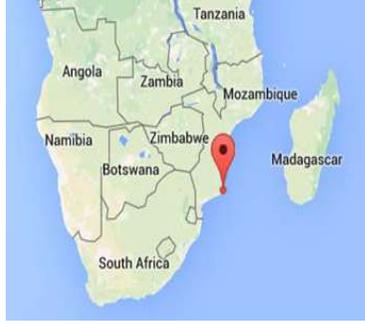
<p data-bbox="618 1126 1173 1161">Right Wing No. 7 Flap Support Fairing</p>

<p data-bbox="1272 1126 1541 1193">Daghatane Beach, Mozambique</p>	<ul style="list-style-type: none"> • Examination showed that part is <i>almost certain</i> from MH370 • Refer to <i>Appendix 1.12B</i>

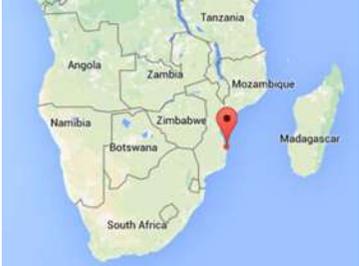
<p data-bbox="667 719 1128 751">Right Horizontal Stabiliser Panel</p>

<p data-bbox="1223 679 1570 746">Valankulo, Paluma Sandbank, Mozambique</p>	<ul style="list-style-type: none"> • Examination showed that part is <i>almost certain</i> from MH370 • Refer to <i>Appendix 1.12B</i>
Item 4	22 March 2016

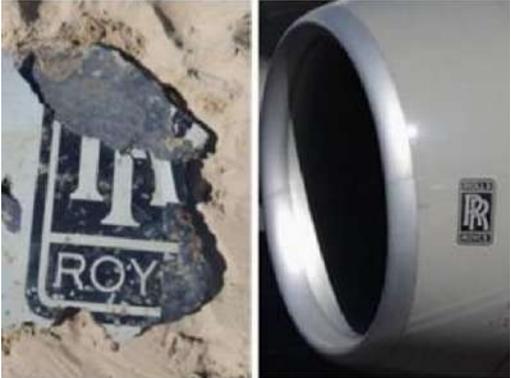
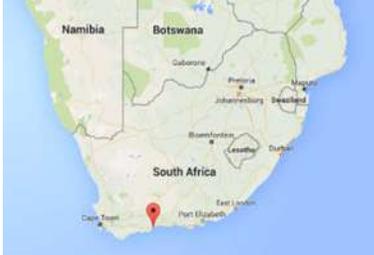
<p data-bbox="763 1233 1032 1265">Engine Nose Cowl</p>

<p data-bbox="1211 1110 1576 1142">Mossel Bay, South Africa</p>	<ul style="list-style-type: none"> • Examination showed that part is <i>almost certain</i> from MH370 • Refer to <i>Appendix 1.12C</i>

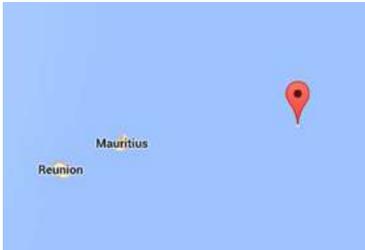
<p>Source: Malaysian MOT / ATSD</p> <p>Door R1 Stowage Closet</p>

<p>Rodrigues, Mauritius</p>	<ul style="list-style-type: none"> • Examination showed that part is <i>almost certain</i> from MH370 • Refer to <i>Appendix 1.12C</i>
Item 6	24 April 2016

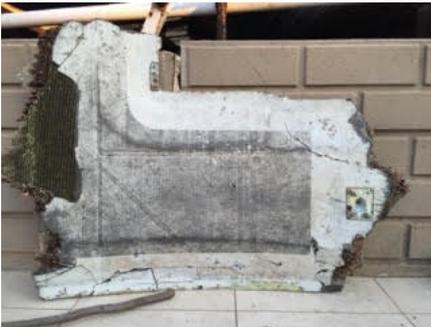
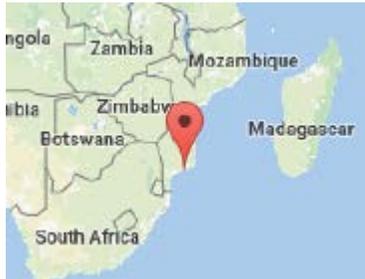
<p>Right Hand Engine Fan Cowling</p>

<p>South of Chidenguele, Mozambique</p>	<ul style="list-style-type: none"> • Examination showed that part is <i>almost certain</i> from MH370 • Refer to <i>Appendix 1.12D</i>

Item No. 6 was found on 24 April 2016, south of Chidenguele, Mozambique. The item was brought back to Malaysia for identification and further examination by the Team. The possible location of the debris on a MAS B777 aircraft was determined. The hinge bracket, number of fasteners and fasteners' pitch on the part were consistent with those on the right engine fan cowl on the aircraft. The mount found on the part was also consistent with the mount of the fan cowl "Hold-Open Stay Rod" in regards to its location, shape and size of the mounting bracket. The words "HOIST POINT" were still visible and in the correct location. The fonts used for the words on the part matched those on the fan cowl of the aircraft. The part was brought near to the right fan cowl and was found to physically resemble it in terms of shape, size, colour and features.

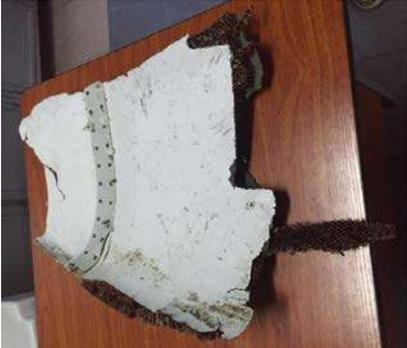
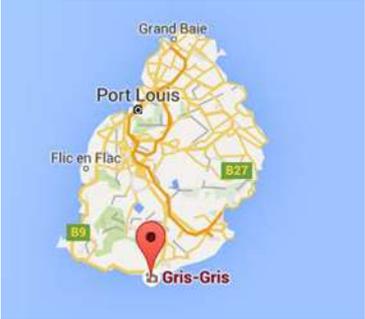
<p data-bbox="636 1189 1160 1224">No. 1 Flap Support Fairing Tail Cone</p>

<p data-bbox="1279 1160 1514 1228">Gris Gris Beach, Mauritius</p>	<ul style="list-style-type: none"> • Examination showed that part is <i>highly likely</i> from MH370 • Refer to <i>Appendix 1.12F</i>

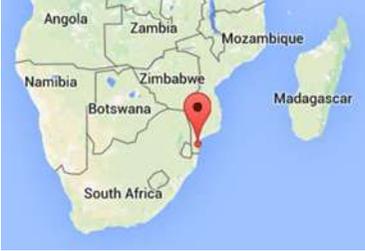
<p data-bbox="629 719 1059 751">Left Wing Trailing Edge Panel</p>

<p data-bbox="1193 671 1487 740">Macenta Peninsular, Mozambique</p>	<ul style="list-style-type: none"> <li data-bbox="1608 424 1989 536">• Examination showed that part is <i>highly likely</i> from MH370 <li data-bbox="1608 587 1984 624">• Refer to <i>Appendix 1.12G</i>
Item 10	10 May 2016

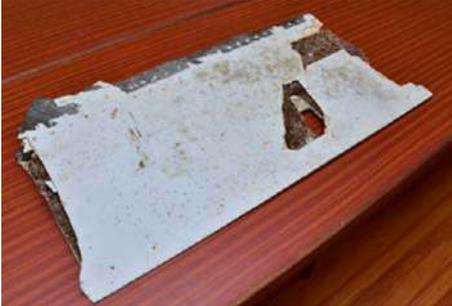
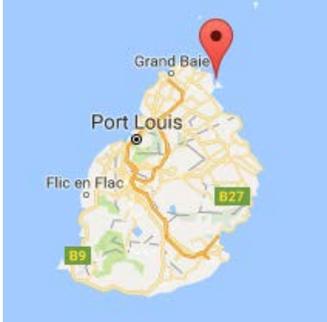
<p data-bbox="707 1182 976 1214">Left Outboard Flap</p>

<p data-bbox="1189 1198 1525 1230">Ilot Bernache, Mauritius</p>	<ul style="list-style-type: none"> <li data-bbox="1608 879 2011 943">• This part is <i>confirmed</i> from MH370 <li data-bbox="1608 991 1984 1023">• Refer to <i>Appendix 1.12H</i>

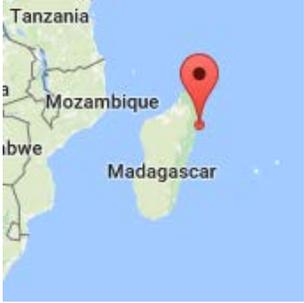
<p data-bbox="741 727 1055 799">Seat Back Trim Panel encasing IFE Monitor</p>

<p data-bbox="1256 719 1534 831">Riake beach, Nosy Boraha Island, Madagascar</p>	<ul data-bbox="1603 424 1989 624" style="list-style-type: none"> • Examination showed that part is <i>highly likely</i> from MH370 • Refer to <i>Appendix 1.12I</i>
Item 12	06 June 2016

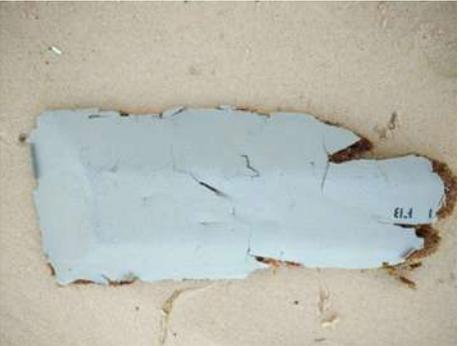
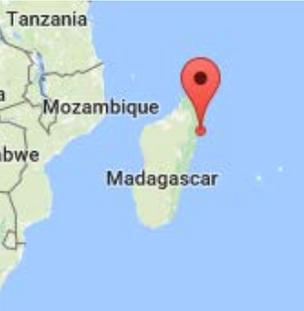
<p data-bbox="696 1246 1111 1318">Bottom panel on the Wing or Horizontal Stabilizer</p>

<p data-bbox="1256 1206 1534 1318">Riake beach, Nosy Boraha Island, Madagascar</p>	<ul data-bbox="1603 903 1989 1062" style="list-style-type: none"> • Examination showed that part is <i>likely</i> from MH370 • Refer to <i>Appendix 1.12J</i>

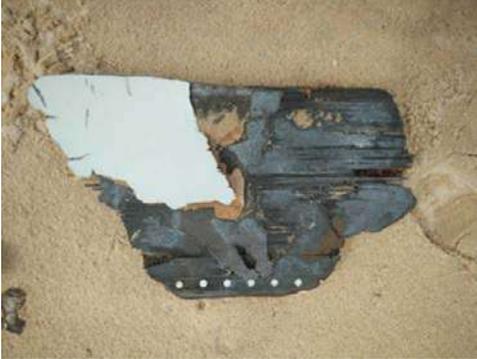
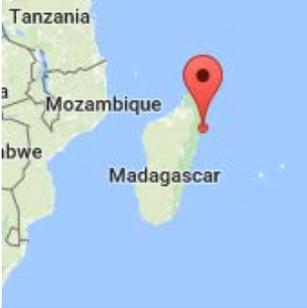
<p data-bbox="781 778 1021 810">Unidentified part</p>

<p data-bbox="1256 727 1532 834">Riake beach, Nosy Boraha Island, Madagascar</p>	<ul style="list-style-type: none"> • Not identifiable • Refer to <i>Appendix 1.12K</i>
Item 14	12 June 2016

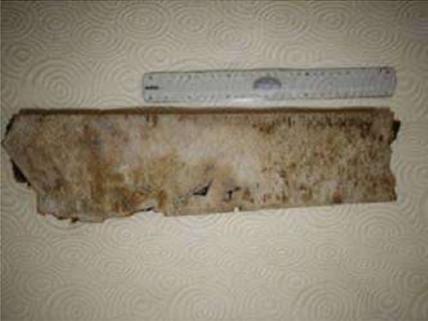
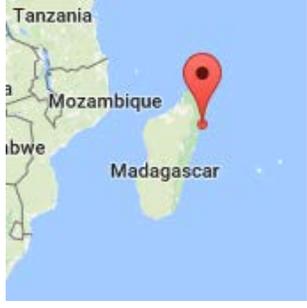
<p data-bbox="781 1230 1021 1262">Unidentified part</p>

<p data-bbox="1256 1206 1532 1313">Riake beach, Nosy Boraha Island, Madagascar</p>	<ul style="list-style-type: none"> • Not identifiable • Refer to <i>Appendix 1.12L</i>

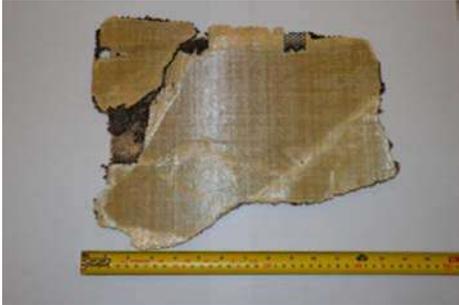
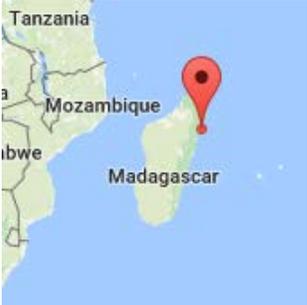
<p data-bbox="779 722 1019 756">Unidentified part</p>

<p data-bbox="1272 727 1516 799">Antsiraka beach, Madagascar</p>	<ul style="list-style-type: none"> • Not identifiable • Refer to <i>Appendix 1.12M</i>
Item 18	12 June 2016

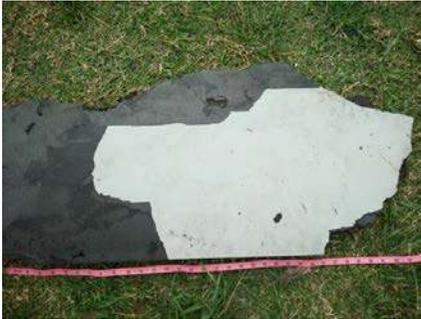
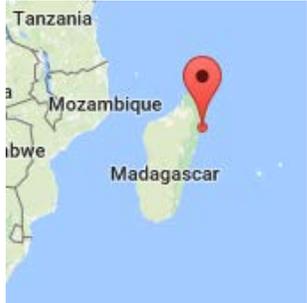
<p data-bbox="613 1217 1182 1251">Right Forward Nose Landing Gear Door</p>

<p data-bbox="1272 1203 1516 1275">Antsiraka beach, Madagascar</p>	<ul style="list-style-type: none"> • Examination showed that part is <i>highly likely</i> from MH370 • Refer to <i>Appendix 1.12N</i>

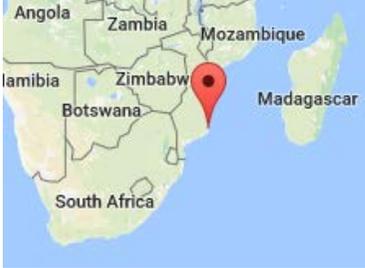
<p data-bbox="685 1206 1108 1238">Right Vertical Stabilizer Panel</p>

<p data-bbox="1261 1169 1527 1241">Linga Linga beach Mozambique</p>	<ul style="list-style-type: none"> • Examination showed that part is <i>almost certain</i> from MH370 • Refer to <i>Appendix 1.12R</i>

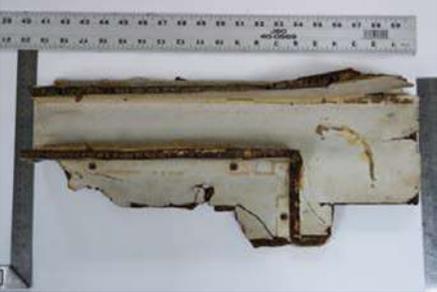
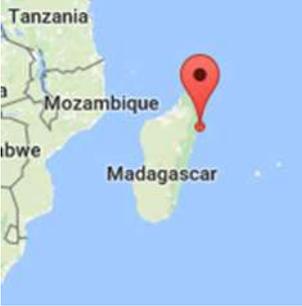
<p data-bbox="770 715 1010 743">Unidentified Part</p>

<p data-bbox="1261 727 1532 831">Riake beach, Nosy Boraha Island, Madagascar</p>	<ul style="list-style-type: none"> • Not identifiable • Refer to <i>Appendix 1.12S</i>
Item 24	February 2016

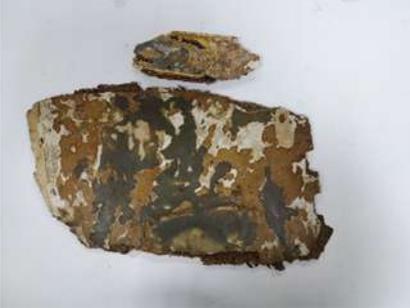
<p data-bbox="779 1249 1023 1278">Unidentified Part</p>

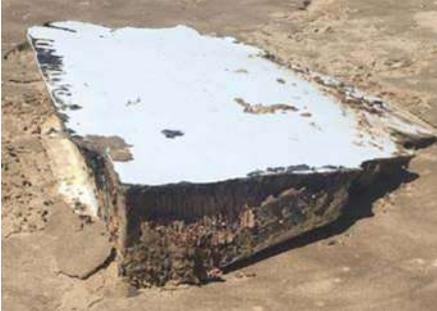
<p data-bbox="804 1246 994 1278">Right Aileron</p>

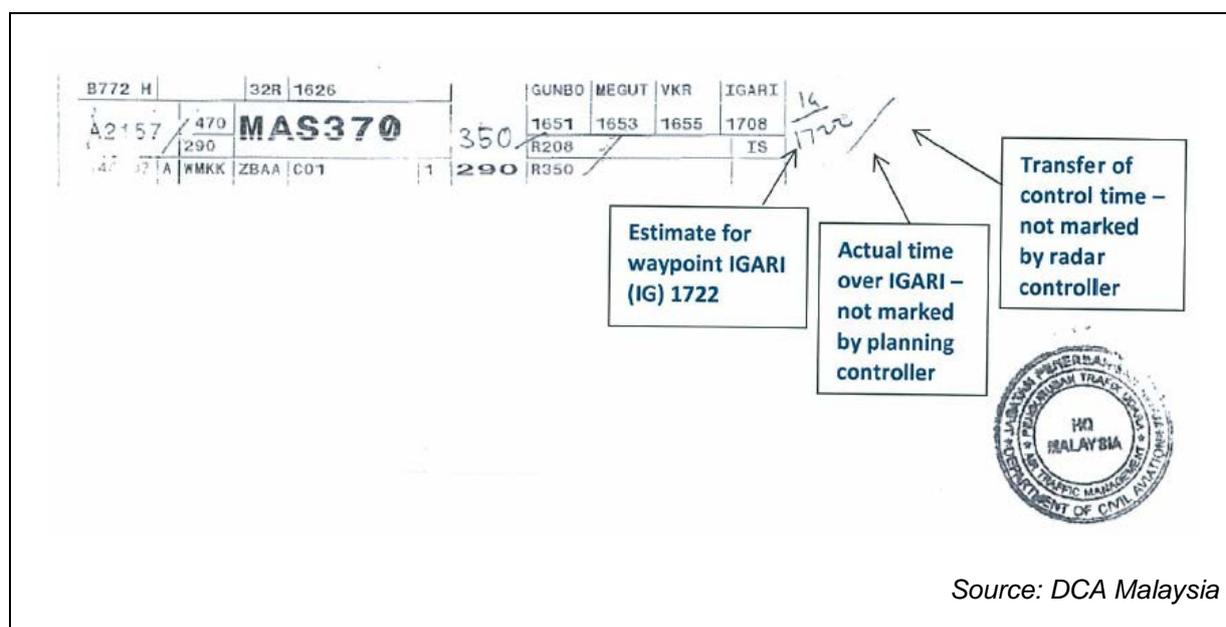
Figure 2.2G - Flight Progress Strip on MH370 from KL ACC

i) Two markings have been left out on the flight progress strip (FPS), *Figure 2.2G*, (below) of MH370:

- (1) The actual time (1721) when MH370 passed over IGARI - FPS' Estimate IG (abbreviation for IGARI) 1722, and
- (2) The transfer of control time (1719) on the FPS.

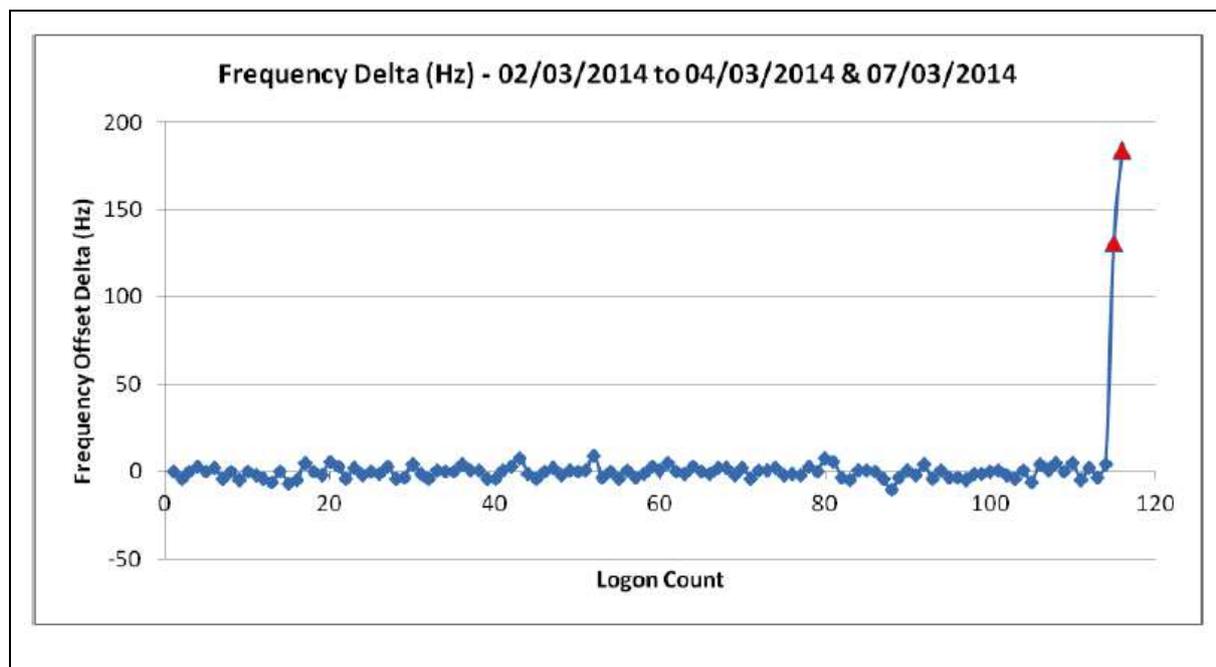
Figure 2.5A – Delta Frequencies between Pairs of Log-On Request and Log-On Acknowledge

- 1) During each of the two in-flight Log-Ons that occurred during flight MH370, the GES recorded abnormal frequency offsets for the SATCOM transmissions. This is in contrast with the 'normal' Log-On behaviour.

- 2) *Table 1.9D* in *Section 1.9.5* shows the frequencies of these Log-On bursts, as measured at the GES, plus differences from assumed reference frequencies. The table also shows the very high delta frequencies between the respective Log-On Request and Log-On Acknowledge bursts.
- 3) The following graph (*Figure 2.5A*) shows the delta frequencies between pairs of Log-On Request and Log-On Acknowledge bursts for over one hundred Log-Ons of the SATCOM on-board 9M-MRO, up to and including the two during flight MH370. In every case prior to MH370 the delta frequencies were fairly small. Only the last two pairs of transmissions (the 1825 and 0019 Log-Ons) show significant deltas. Note that for ease of display, only the magnitude is shown for the two MH370 Log-On frequency deltas.

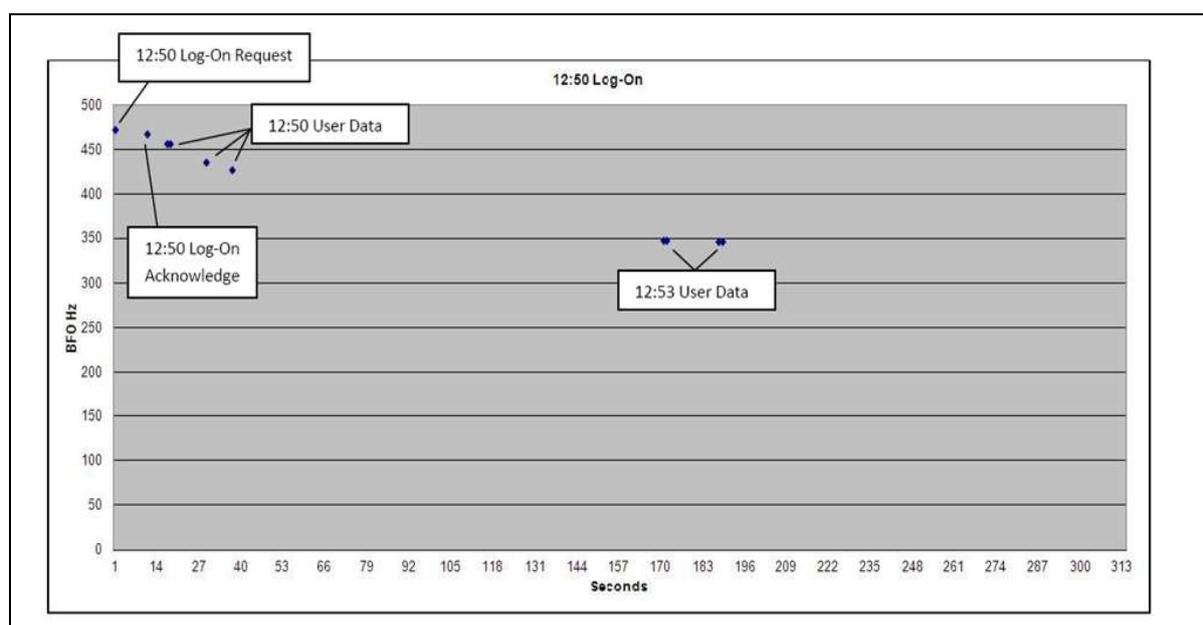
Figure 2.5B - SATCOM Log-On Frequency Offsets at 1250, 07 March 2014

- 6) These frequency offsets can be seen in the plot (*Figure 2.5B*) below, for a 9M-MRO SATCOM Log-On (believed to have taken place after a lengthy power down), at 1250 on 07 March, whilst the aircraft was on the ground at Kuala Lumpur, prior to the departure of MH370. The frequency has stabilised to a value of around 350Hz, within three minutes of the Log-On Request.

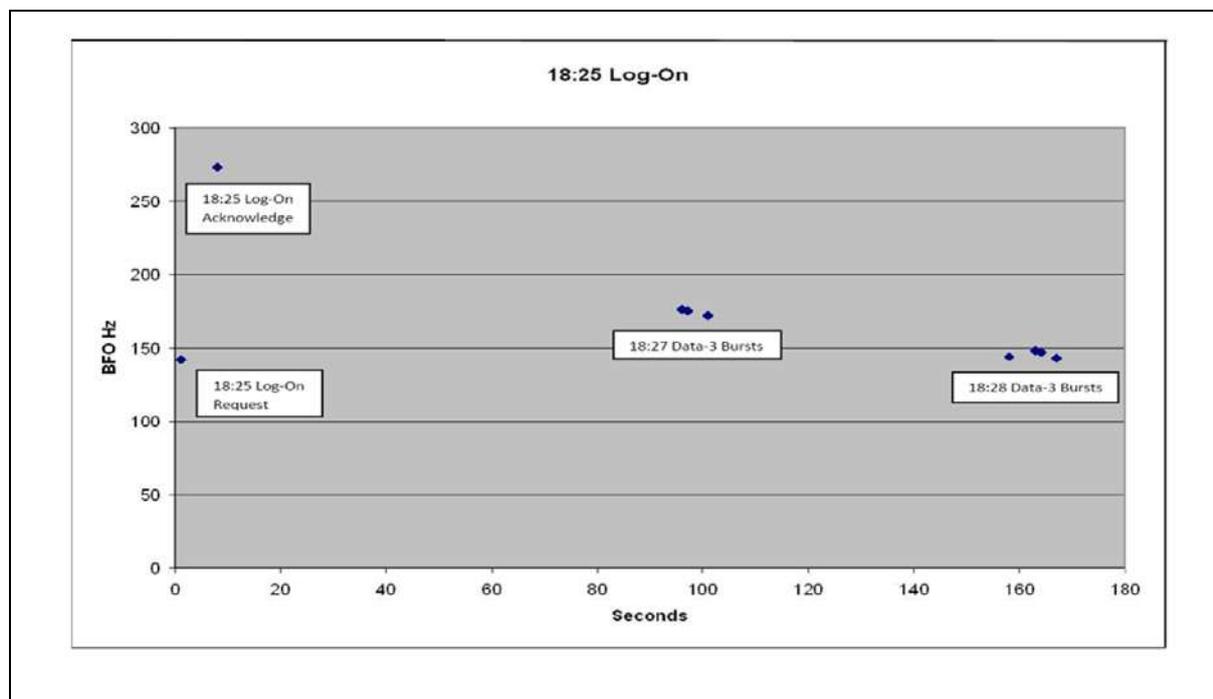
Figure 2.5C - SATCOM Log-On Frequency Offsets at 1825, 07 March 2014

- 7) These frequency offsets can also be seen in the plot (*Figure 2.5C*) below for the MH370 1825 Log-On. As with the 1250 Log-On, the frequency has stabilised within three minutes of the Log-On Request, this time at around 150Hz.

- 8) The 1825 Log-On Acknowledge and the subsequent Data-3 transmissions exhibit a frequency offset, which decays to the steady state value. This frequency decay endorses the belief that the SATCOM had been powered down prior to the 1825 Log-On.

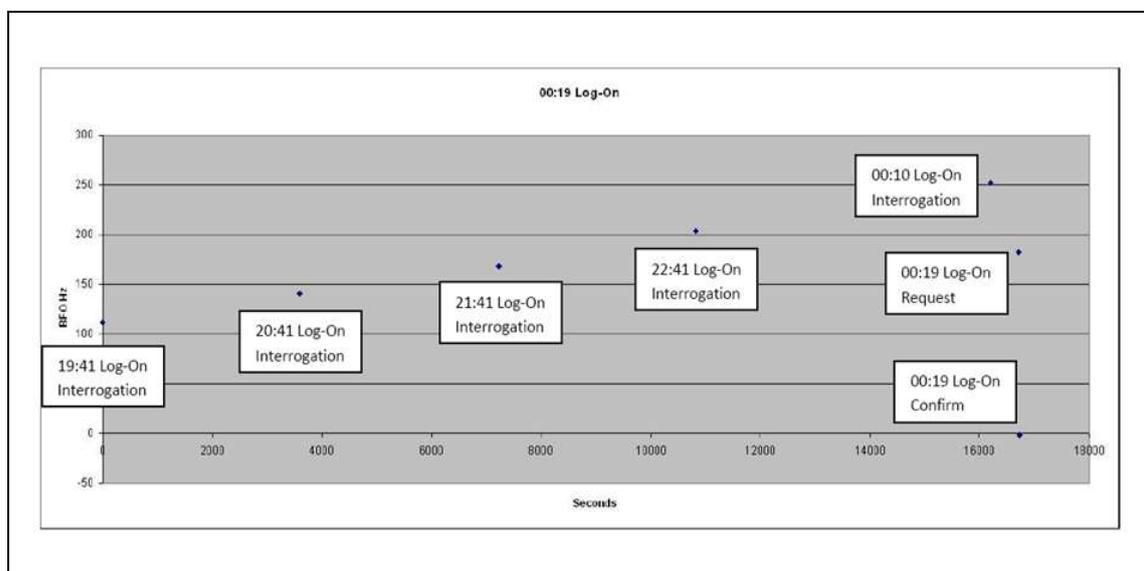
Figure 2.5D - Log-On Interrogation Transmissions

11) The plot (*Figure 2.5D*) below shows a series of MH370 Log-On Interrogation transmissions, which steadily rise in frequency (due to the satellite ephemeris). However, the 0019 Log-On Request and Log-On Acknowledge transmissions diverge from the steady state slope.

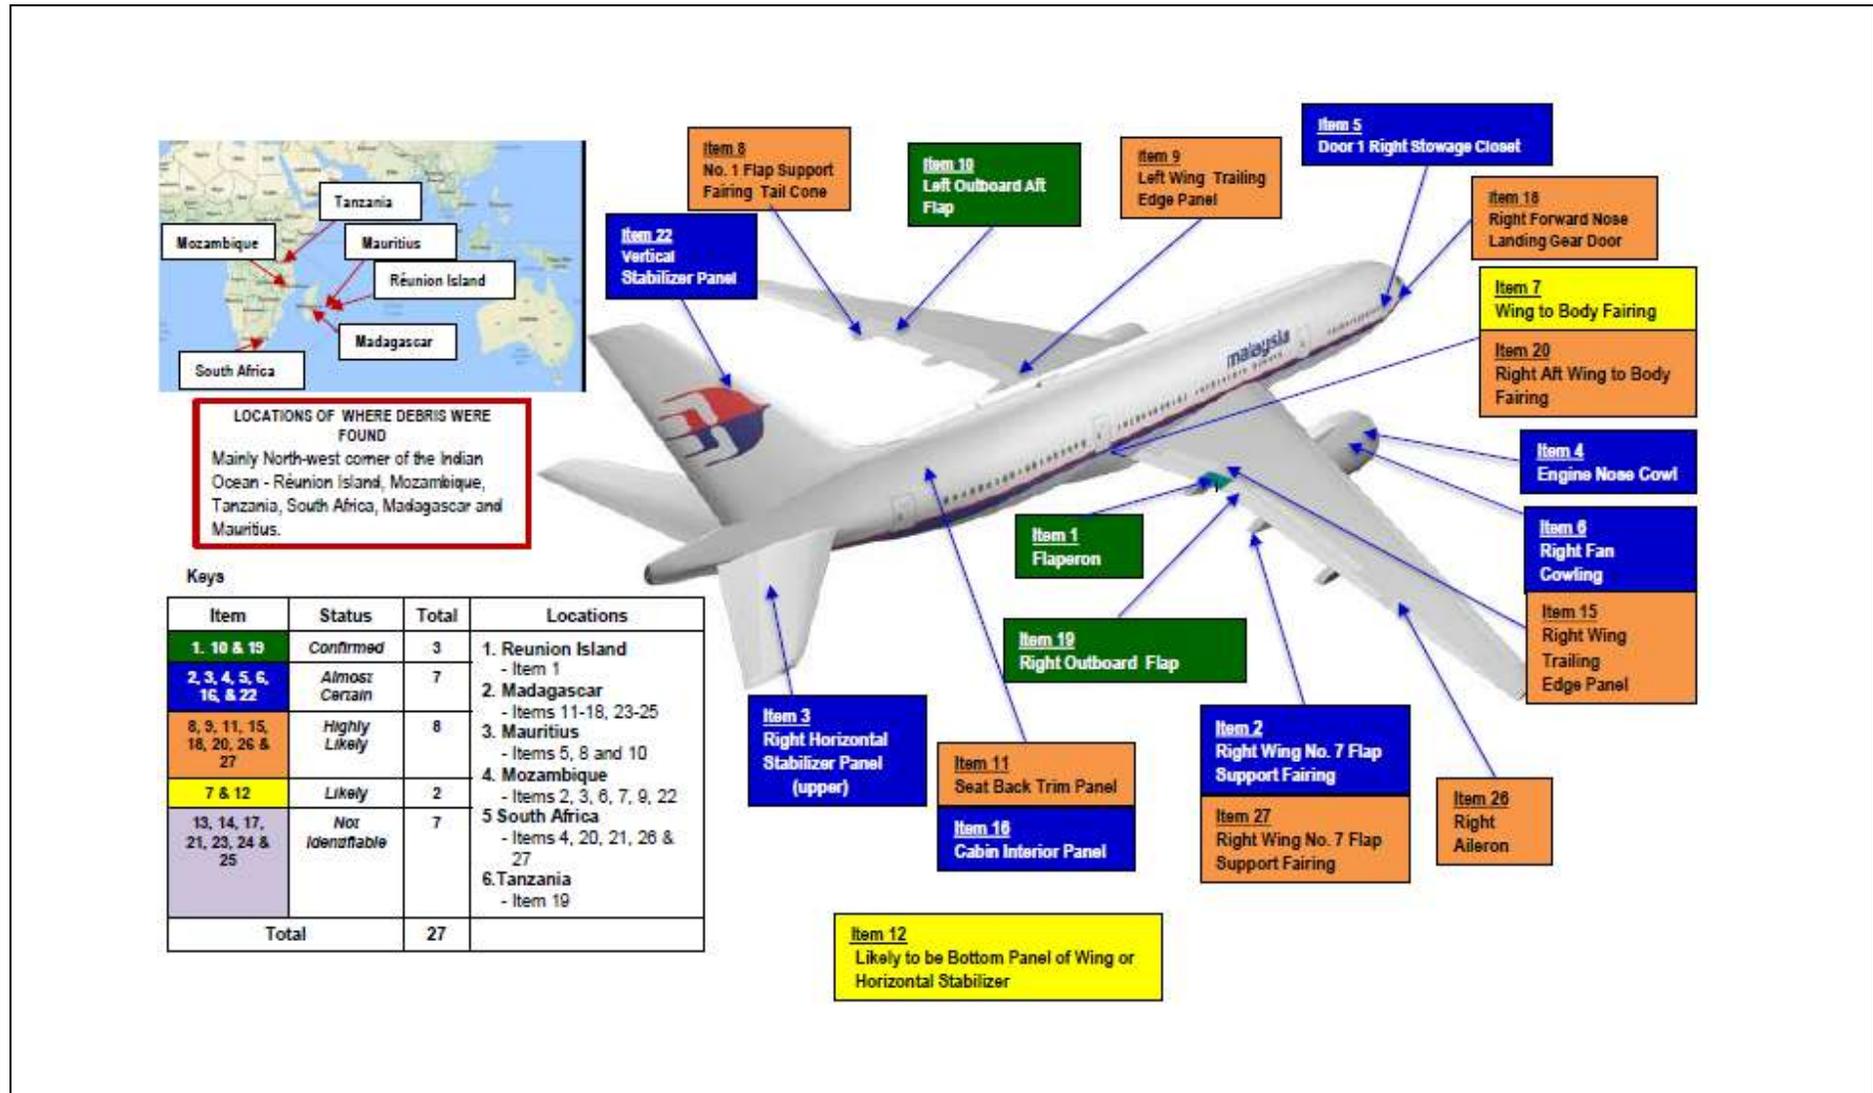
Figure 2.6A - Location of Parts and Debris Found with respect to Aircraft

Figure 2.6A (below) shows the locations of the debris with respect to the aircraft.

Item 4 (part of the Engine Nose Cowl) is depicted to be from the right engine. There were no significant differentiators on the cowling segment to assist in determining whether the item of debris was from the left or right side of the aircraft, or the inboard or outboard side the cowling. Similarly, although Item 6 (part of the RH fan cowl) is depicted to be from the right engine in *Figure 2.6A*, there is a possibility that it could also be from the left engine. As for Item 7 - Wing body fairing - this too could be from either side of the aircraft.

Based on the identification of the parts and debris found, it shows that most of those parts and debris were from the right hand side of the aircraft.

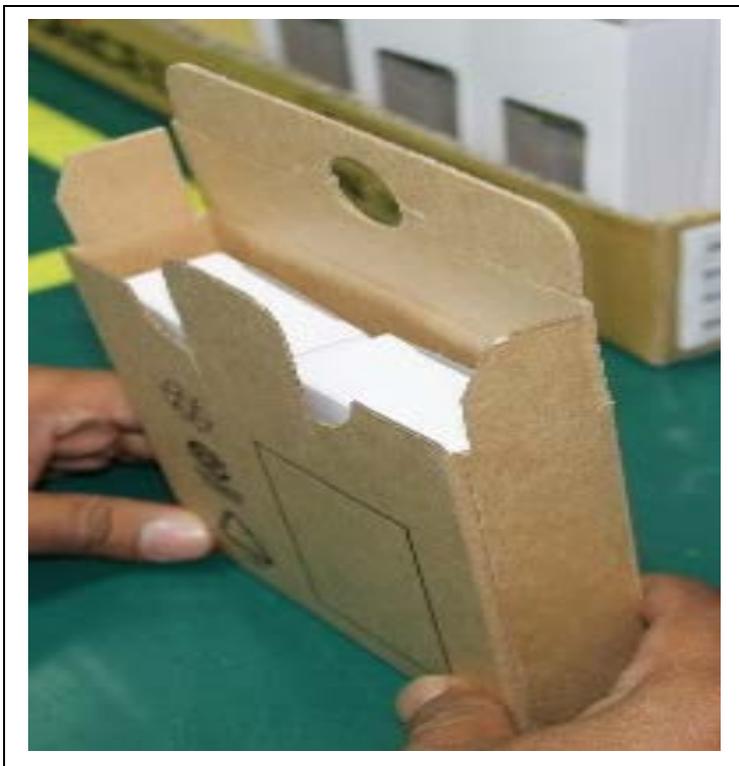
Figure 2.8A - 2 Batteries in window white box and placed in a brown box

The tests were carried out with batteries (window white box in brown box (*Figure 2.8A*, [below]) dropped at a height of 120.92 cm (48 inches) on to a wooden platform. It was found that the batteries had no observable physical damage and functioned normally.

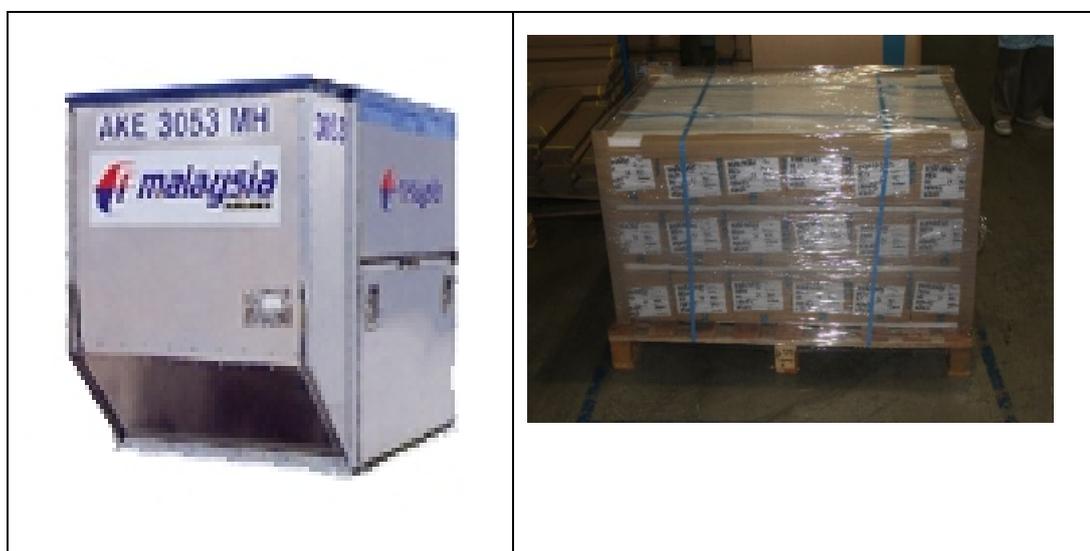
In one of the cargo compartments on MH370 the Motorola Solutions batteries and mangosteens were placed next to each other (No. 1 and 'A'). Even though they were placed next to each other in the aircraft (*Figure 2.8B* [below]), the mangosteens were packed in plastic crates and placed in Unit Load Device (ULD) containers. The consignment was also wrapped in a plastic sheet to make it water-proof to a certain extent.

Figure 2.8B - Sample ULD and Batteries placed next to each other

There were concerns that the mangosteen extracts could have got into contact with the batteries and produced hazardous fumes or in a worst case scenario caused a short circuit and/or fire. These tests were carried out and the results are as follows:

- i) This was highly improbable on board MH370 with a comparatively short flight duration and under controlled conditions.
- ii) After carrying out the tests, STRIDE was convinced that the two items tested could not be the cause in the disappearance of MH370. The Team concurs with STRIDE's findings.
