DEBRIS EXAMINATION REPORT

SAFETY INVESTIGATION FOR MH370

**Malaysia Airlines MH370 Boeing B777-200ER (9M-MRO)
08 March 2014**

Identification of Debris (Item 27 in the “Summary of Possible MH370 Debris Recovered”) recovered from Mpame Beach, South Africa on 27 January 2017

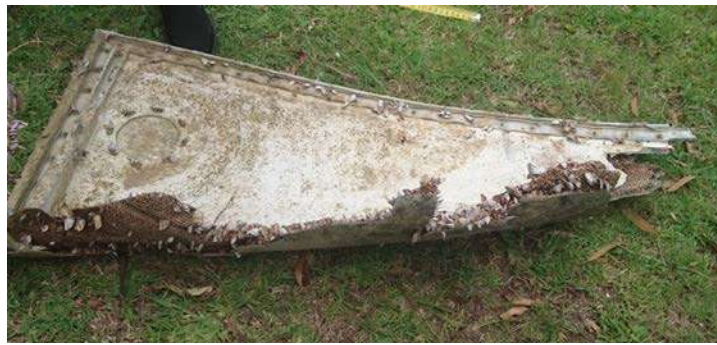
This item was recovered from Mpame beach, South Africa on 27 January 2017. It is identified as Item No. 27 from the items recovered; refer to the *“Summary of Possible MH370 Debris Recovered”*.

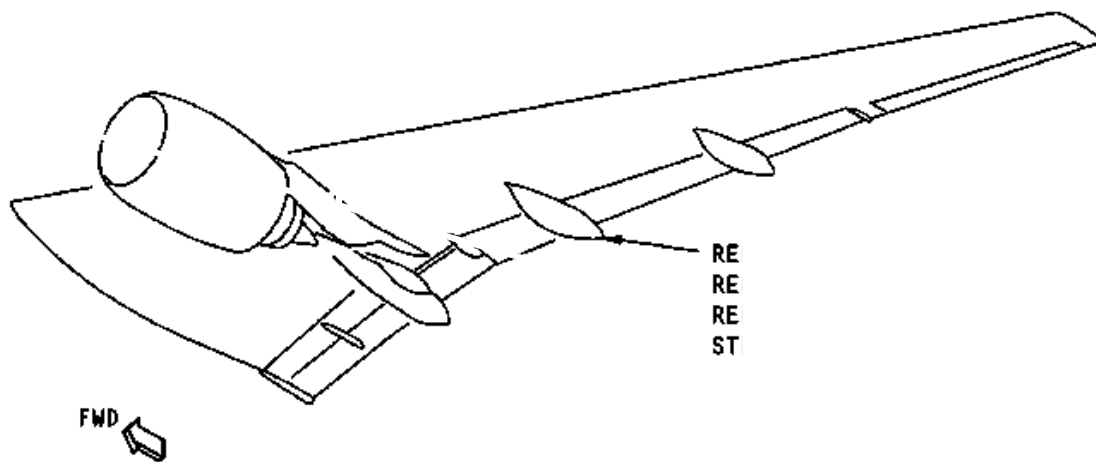
NUMBER 2 FAIRING IS SHOWN, NUMBER 7 FAIRING IS OPPOSITE

The diagrams below from the B777 Structural Repair Manual (SRM) show the location of the No. 2 flap support fairing and the complete assembly. The No. 7 fairing is in a similar location on the opposite wing.

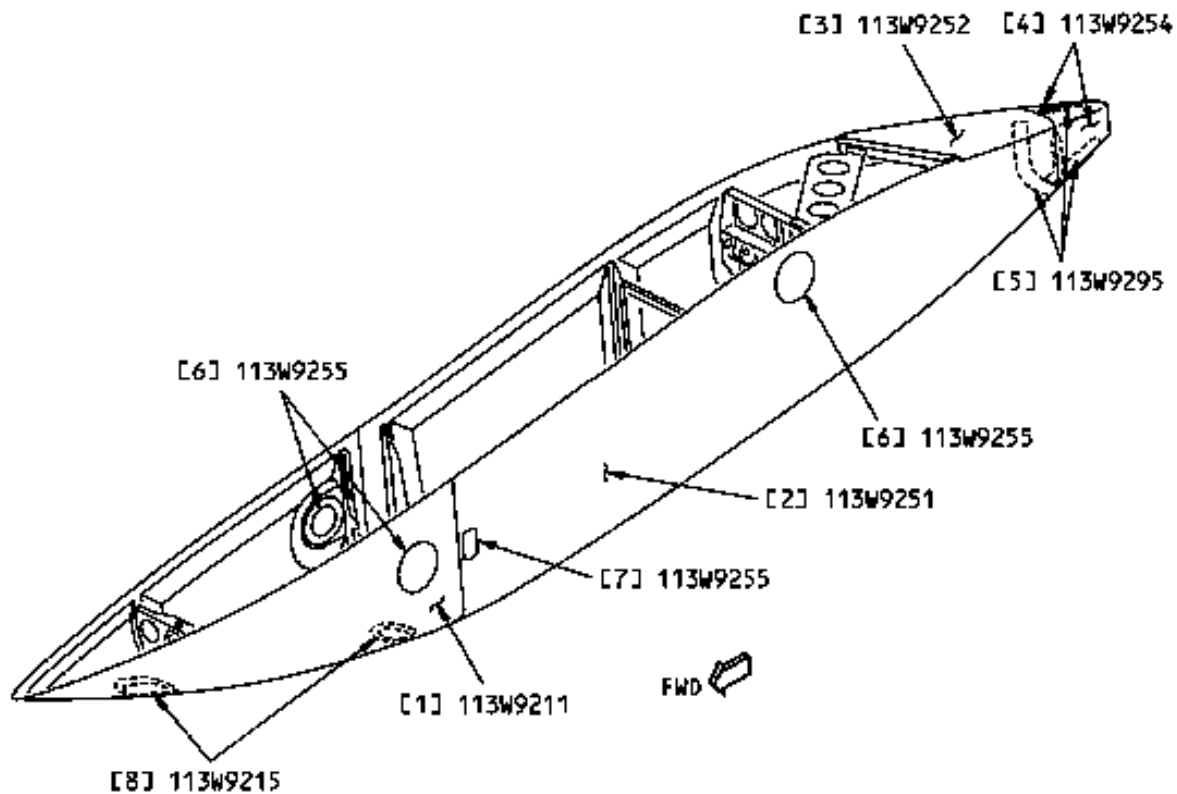
NUMBER 2 FAIRING IS SHOWN, NUMBER 7 FAIRING IS OPPOSITE

The following diagram shows the complete No. 2 flap fairing, No. 7 is opposite.
