Australian Transport Safety Bureau

MH370 – Search and debris examination update

Outboard flap failure analysis

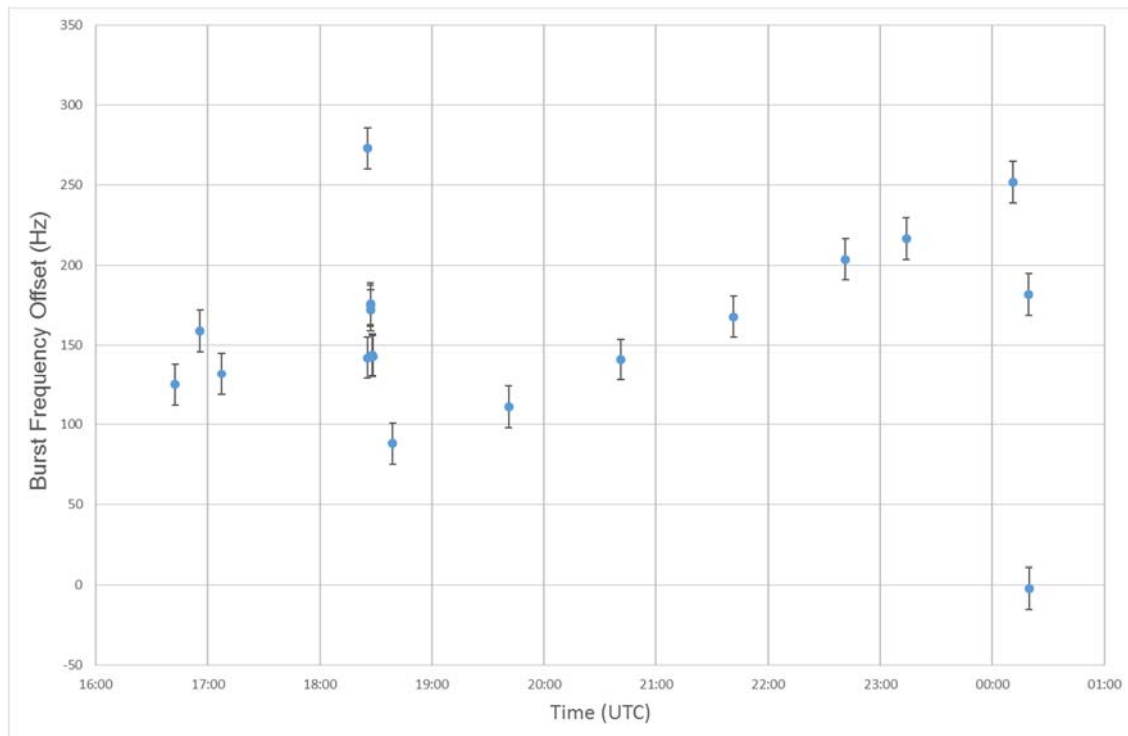
Figure 1: Recorded BFO values throughout the flight

This graph illustrates the measured BFO recordings throughout the flight with the appropriate error bars on the measurements. After 18:39 the BFO values follow an approximately linear trend until the final two values at 00:19.

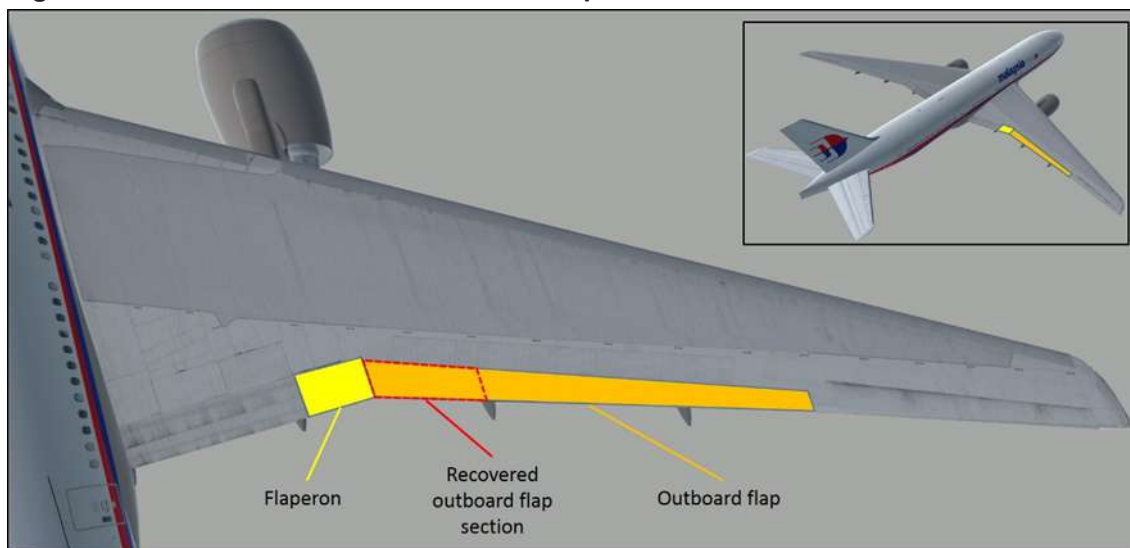
Figure 12: Location of recovered outboard flap section

The recovered right, outboard wing flap section (Figures 12, 13 and 14) was examined for any evidence of interaction with mechanisms, supports and surrounding components that may indicate the state of flap operation at the time of fracture and separation from the wing. The purpose of the examination was to inform the end-of-flight scenarios being considered by the search team. The most significant items of evidence in relation to this are documented below.
