AIRCRAFT ACCIDENT FINAL REPORT

A 03/15P

Air Accident Investigation Bureau (AAIB)

**Helicopter Dauphine AS 365 N3, Registration 9M-IGB
40 nautical miles south east of Subang Airport, Kuala Lumpur
on 04 April 2015**

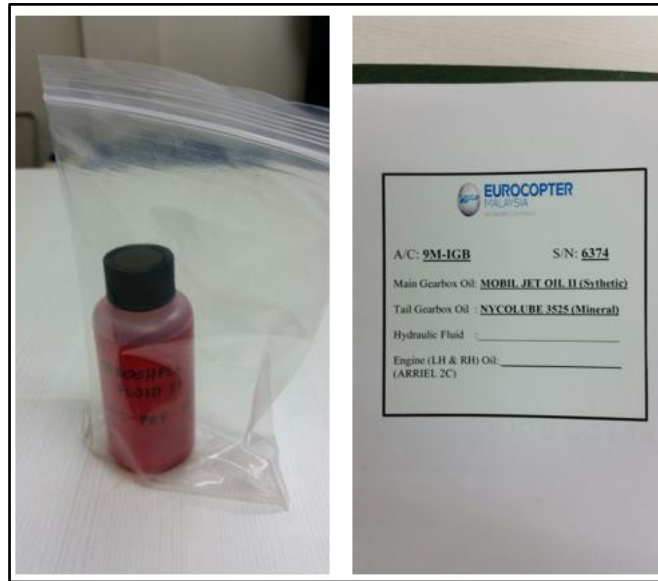
Figure 14

Test result from the Chemistry Department of Malaysia shows that the sample taken at the SK Ladang Kota Bahagia is consistent with the Mobil Jet Oil II (Synthetic) of the AS365N3 helicopter hydraulic fluid specifications.

The hydraulic fluid may indicate evidence of some leakage from the helicopter hydraulic system at the field where the aircraft landed.

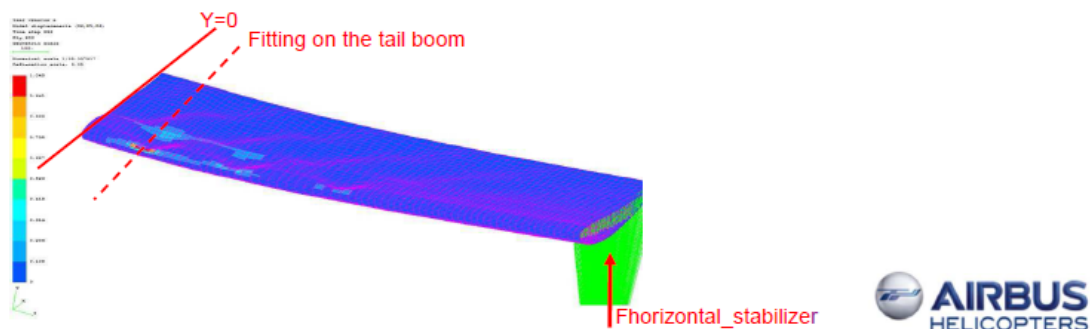
Figure 28

Horizontal stabilizer Resistance

- The horizontal stabilizer begins to damage for a vertical load at its extremity of 160daN.
(\ll Fleft_mlg = 1874 daN when outboard tail fin contacts the ground)
- Under $F_z=160\text{daN}$ the horizontal stabilizer bent of 45mm.
(\ll 237mm when the Left landing gear is in the soil of 40cm)

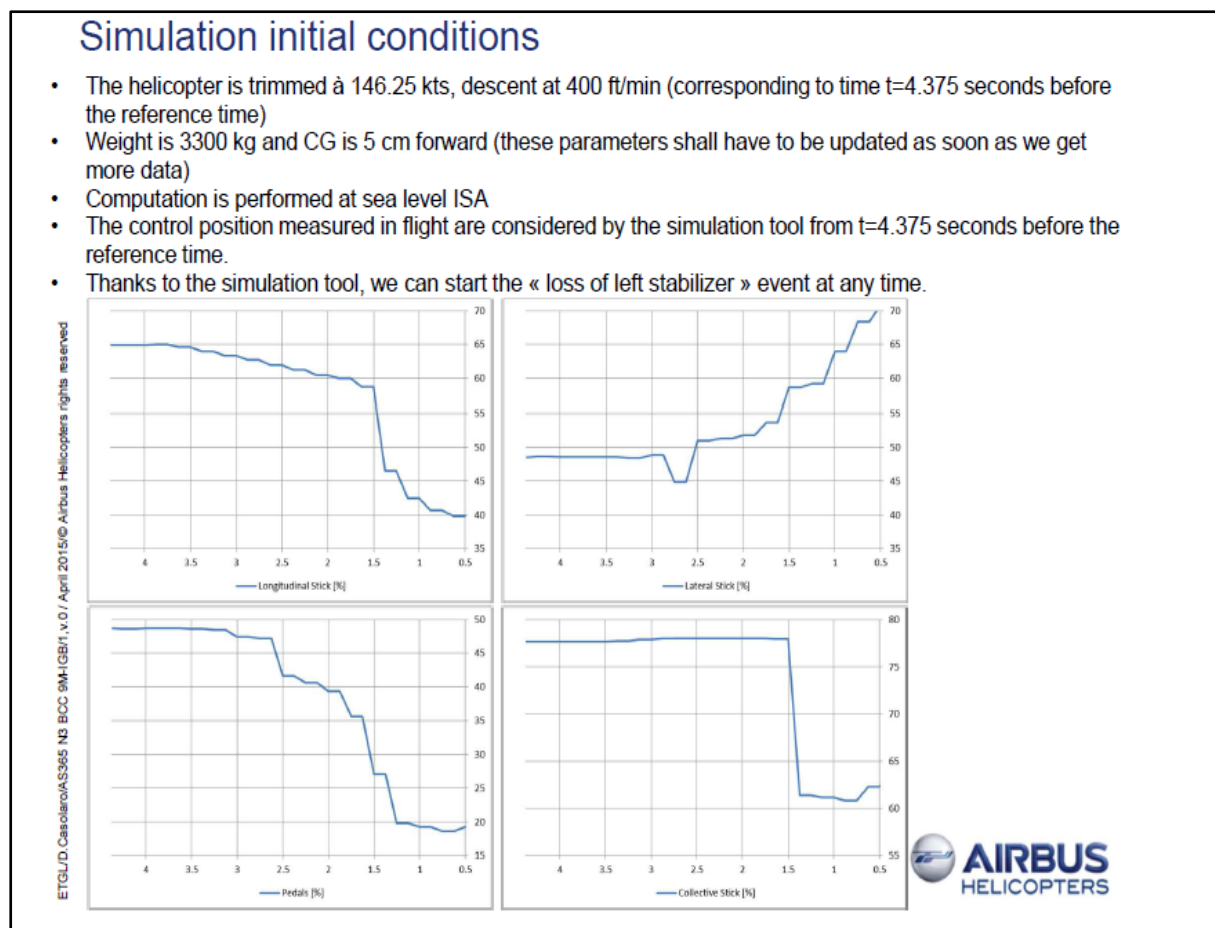
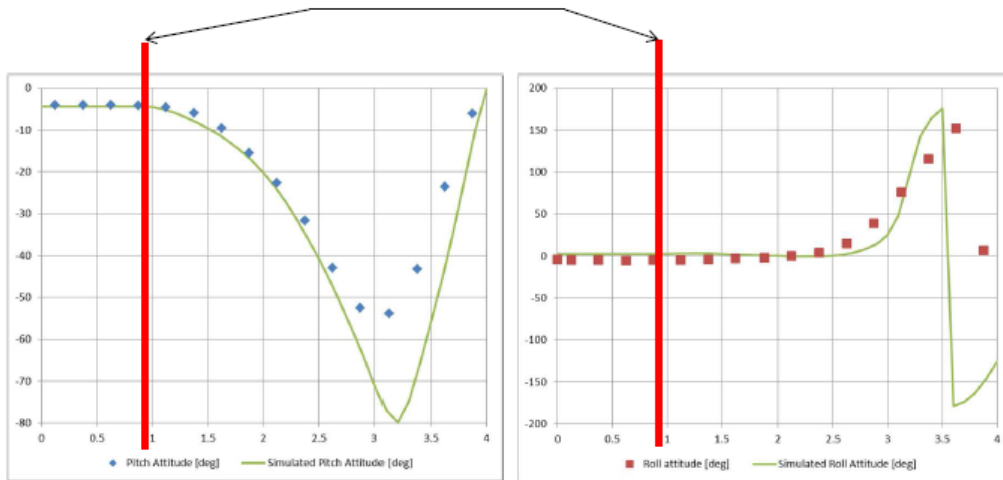
Figure 31

Simulation results – Pitch and Roll

Suspected Loss of the left horizontal stabilizer

Nota: Once the vertical load factor $-1g$ is reached the simulation can differ from the real flight as the aircraft is completely outside of the certified flight envelope

The observed result of the simulation is consistent with the FDR
