**AIRCRAFT ACCIDENT
FINAL REPORT
SI 11/17**

**Accident Involving Airbus A320-216
Registration 9M-AHM
at Subang Airport/Sultan Abdul Aziz Shah, Kuala Lumpur
on 30th November 2017**

REPORT NO.: SI 11/17

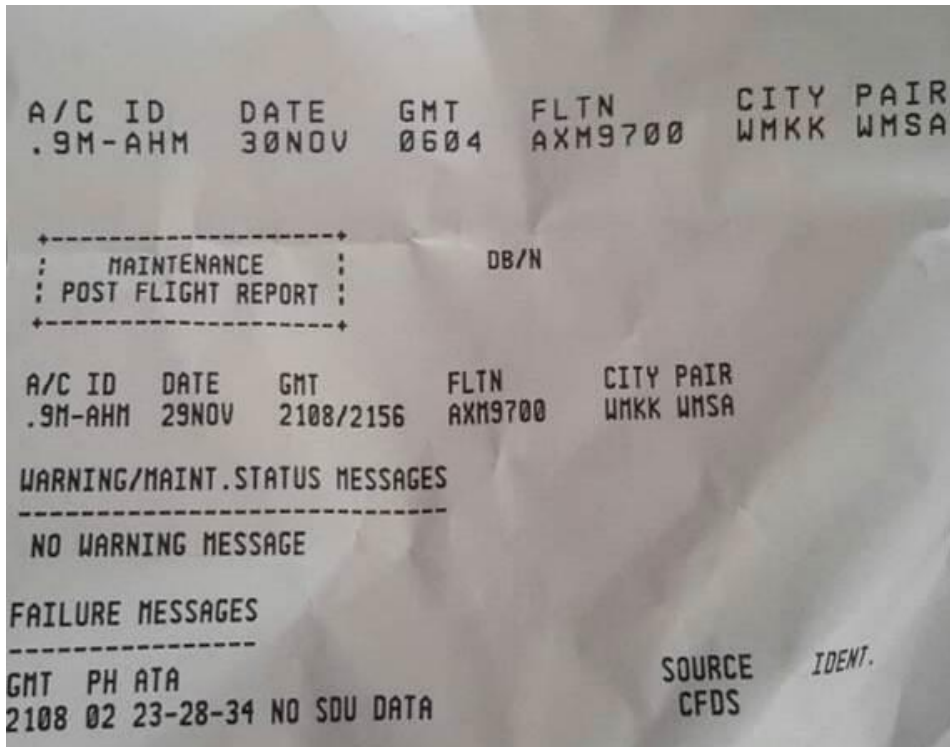
Figure 16: PFR printout after the flight

Based on the report from the operator for the previous one year, no outstanding defects were found. There are also no significant recurring defects. Analysis of the Post Flight Report (PFR) for this flight indicated no significant faults or failures of aircraft systems at the time preceding, during and after the incident (see figure 16).

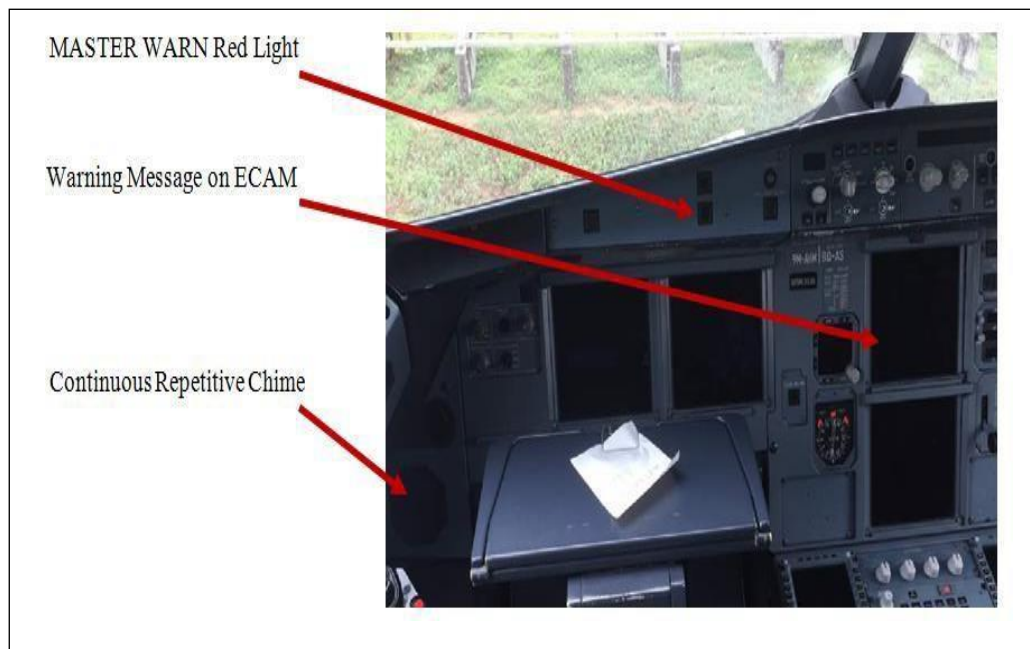
Figure 23: "TO Config Warning" indications in the flight deck

If the warning is triggered, the flight crew will be alerted with a Continuous Repetitive Chime (CRC) in the cockpit accompanied by a “MASTER WARN” flashing red light on both the CAPT and FO side of the glare shield. A red Warning Message indicating the system which is not in the correct TO Config will also be displayed on the E/WD (see figure 23).

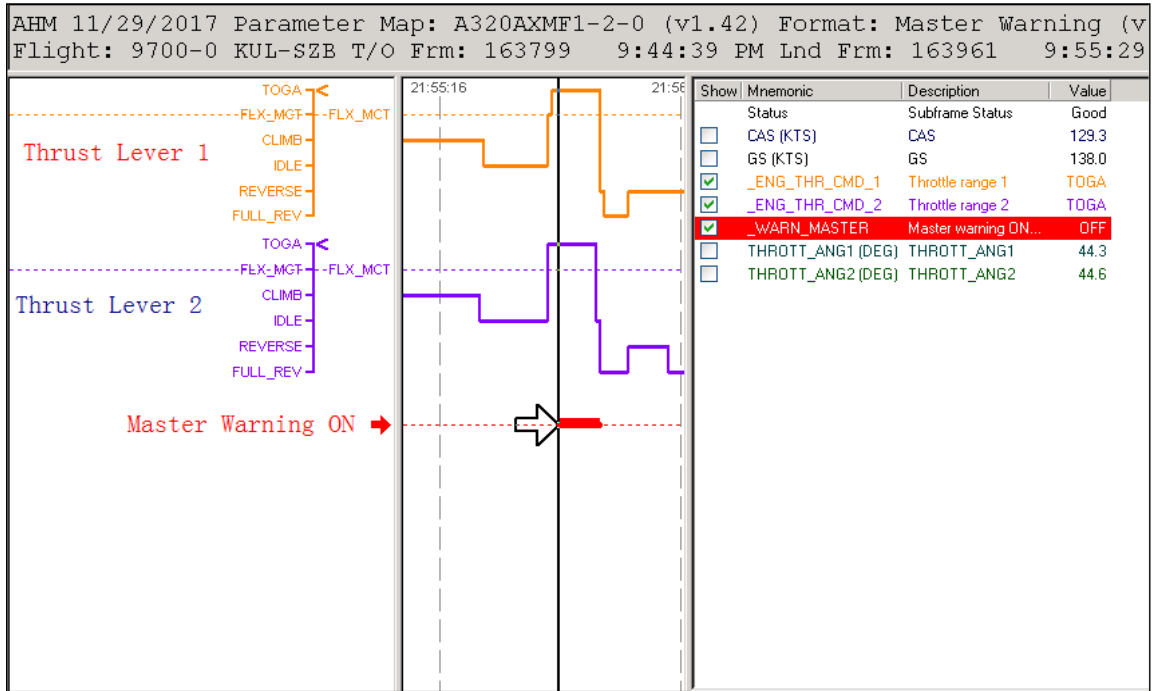
Figure 24: FDR (A Master Warning event was recorded on the FDR at 21:55:46 UTC, approximately 2 seconds after both thrust levers were set at above CLB detent)

Flight data shows that a Master Warning event was recorded on the FDR at 05:55:46 LT, approximately 2 seconds after both thrust levers were above CLB detent (see figure 24 and 25). It was extinguished at 05:55:55 LT, after 11 seconds and it was simultaneous with the initiation of the rejected take-off.

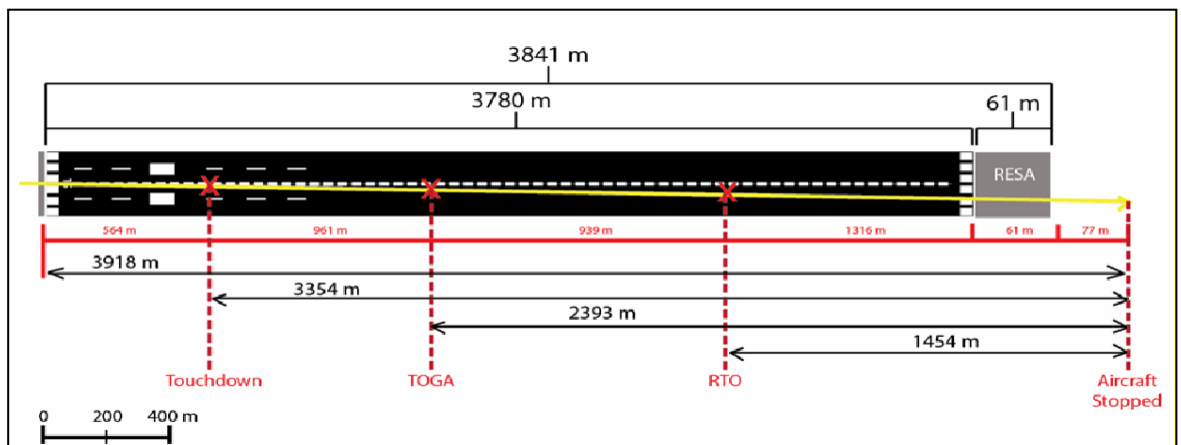
Figure 55: Distances Travelled by Aircraft from Threshold to Aircraft Stopped

In accordance to ICAO Annex 13, the investigation team had requested assistance from the Manufacturer for more accurate analyses of the distances, especially the actual braking and stopping distance which are very complex due to changing aerodynamics, propulsion and rolling friction forces. The result of these analyses shall be complemented to this report if deemed necessary, at a later date.

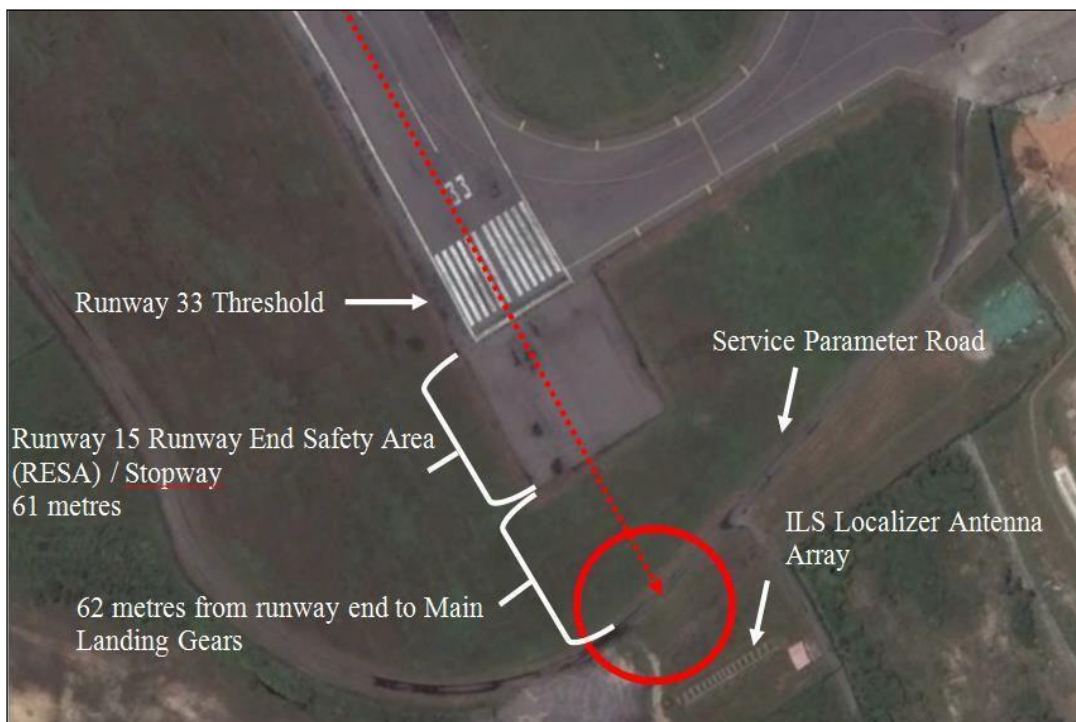
Figure 57: Zoom in of impact area at the end of runway 15

Impact Area Coordinates (WGS84)	N 3° 6' 53.27" E 101° 33' 30.55"
Type of Surface	Grass and Soil (unpaved)
Measured Distance from Runway	62 meters

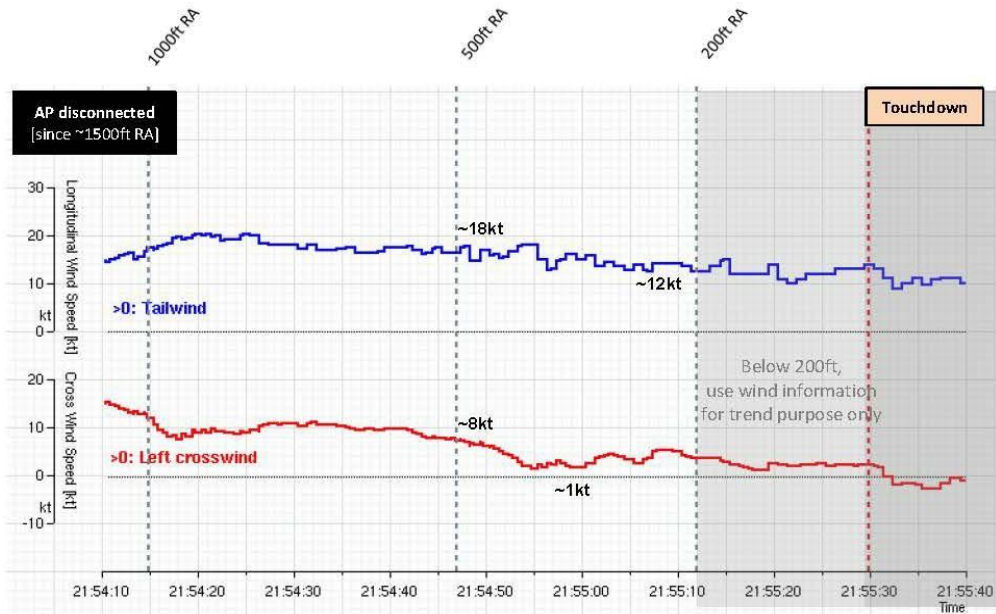
Figure 5 – Wind evolution computed by the ADIRU

In short final approach, the wind information computed by the Air Data Inertial Reference Unit (ADIRU) and recorded by the FDR was as follows:
