AIRCRAFT ACCIDENT FINAL REPORT
A 07/17
Air Accidents Investigation Bureau (AAIB)
Ministry of Transport

Accident Involving a Cessna C-152
Registration 9M-FBS
at Sultan Abdul Aziz Shah Airport (WMSA), Selangor, Malaysia
on the 8 July 2017

ACCIDENT REPORT NO. : A 07/17

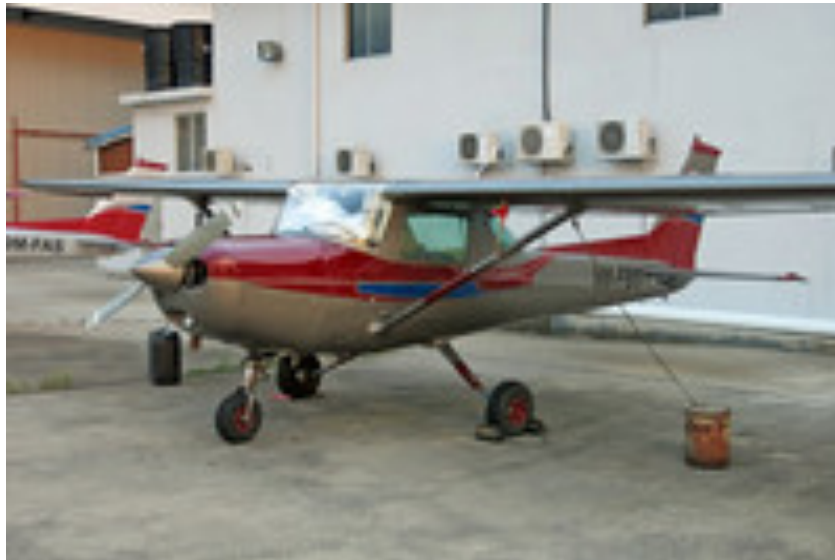
An assessment of damage to the aircraft revealed that the nose-wheel gear assembly had been substantially damaged along with damages to the propeller and engine cowling.
