## **Accident Investigation Coordinating Committee**

### **Report 2018/01**

Final Report on the Serious Incident to  
Airbus, A330-300 (9M-XXC), A350-900 (A7-ALL)  
Velana International Airport, Maldives  
7 July 2018

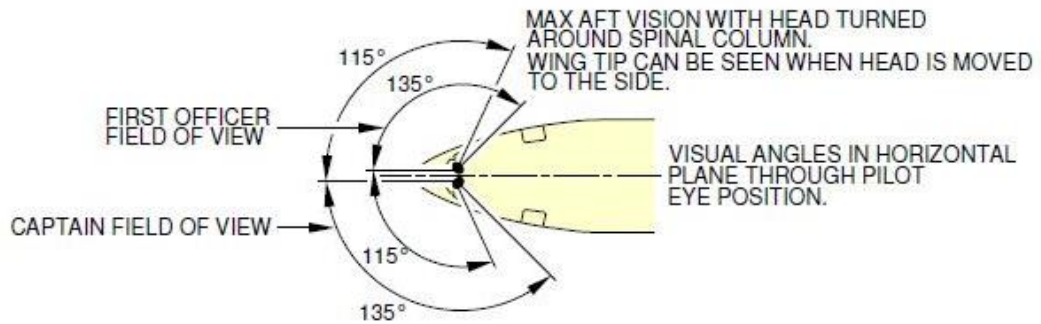
Figure 1 – A330-300 visibility from cockpit in static position

On the A330-300 aircraft, the visual angle in the horizontal plane through the co-pilot's normal eye position and looking towards the wingtip is 115°. If the pilot moves his head to the side, the visual angle in the horizontal plane increases to 135°, and the wing tip becomes visible, as summarised in Figure 1.

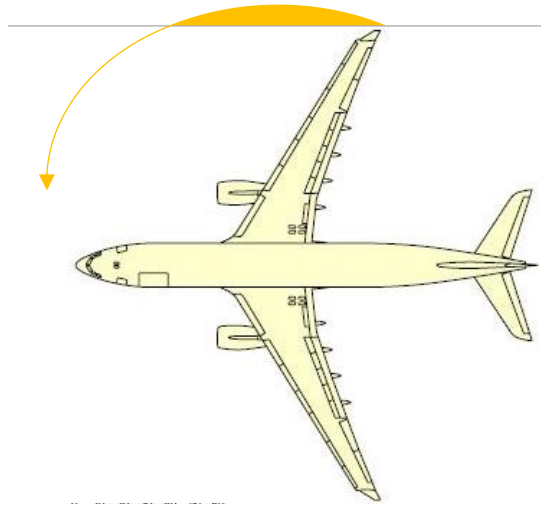
Figure 3 – Swept wing growth

The A330 aircraft, like most modern large transport aircraft have swept wings that are subject to a phenomenon known as ‘swept wing growth’ or ‘wing creep’. This occurs during a turn when the wing tip describes an arc greater than the normal wingspan due to the geometry of the aircraft and the arrangement of the landing gear<sup>1</sup>.

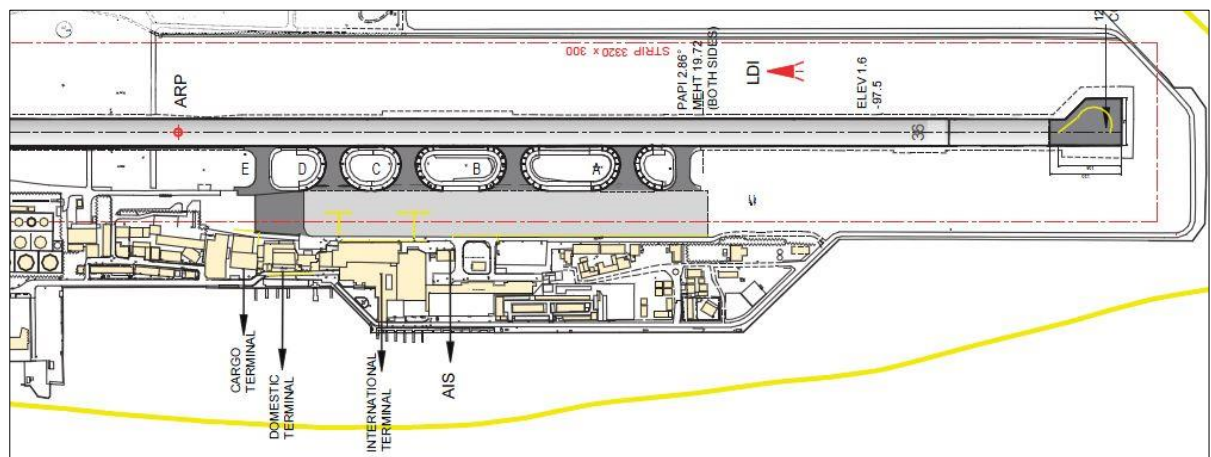
Figure 4: VIA international apron and associated Taxi-ways.

The international apron is a concrete apron with a PCN of 55, accessible via Taxi-ways A to E. Taxi-way C is 23 m wide with a PCN of 57. See Fig 4 for the layout of the runway, taxi-way, apron etc.
