**AIRCRAFT ACCIDENT FINAL REPORT**  
**A 03/21**  
**Air Accidents Investigation Bureau (AAIB)**  
**Ministry of Transport**

**Accident Involving an Airbus Helicopters H125**  
**Registration 9M-LEO**  
**at Sultan Abdul Aziz Shah Airport (WMSA), Malaysia**  
**on the 24 March 2021**

**ACCIDENT REPORT NO. : A 03/21**

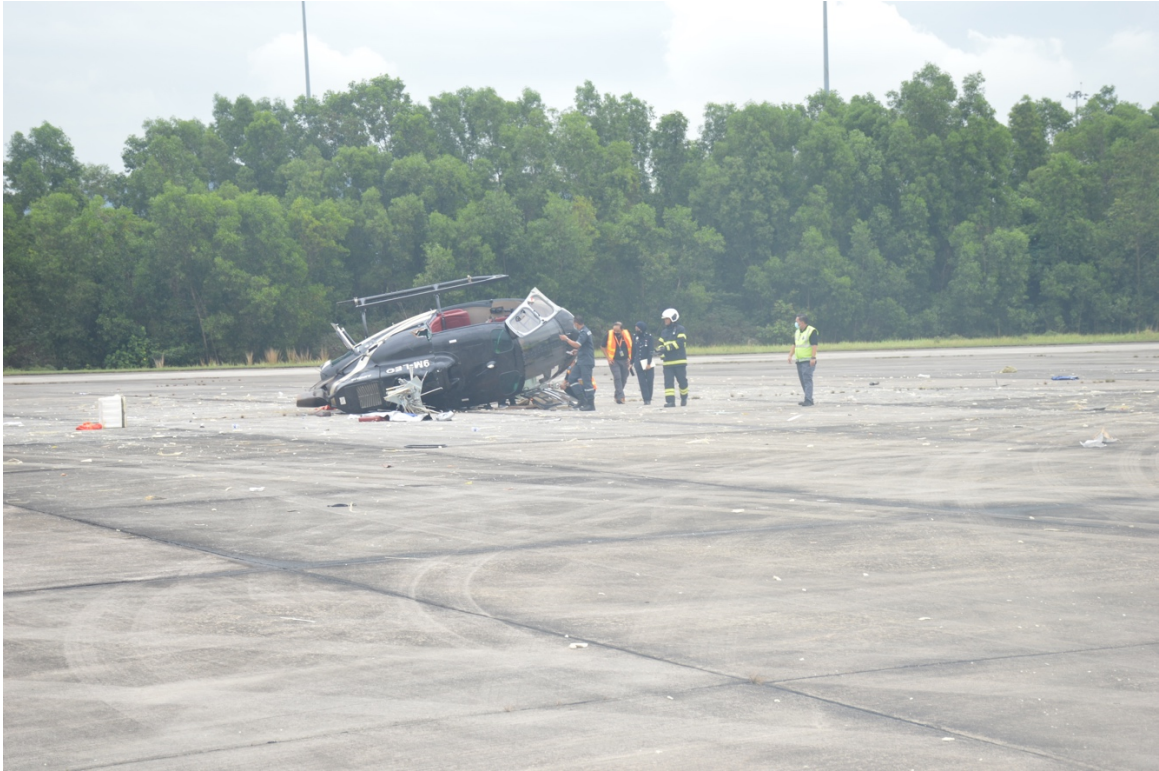
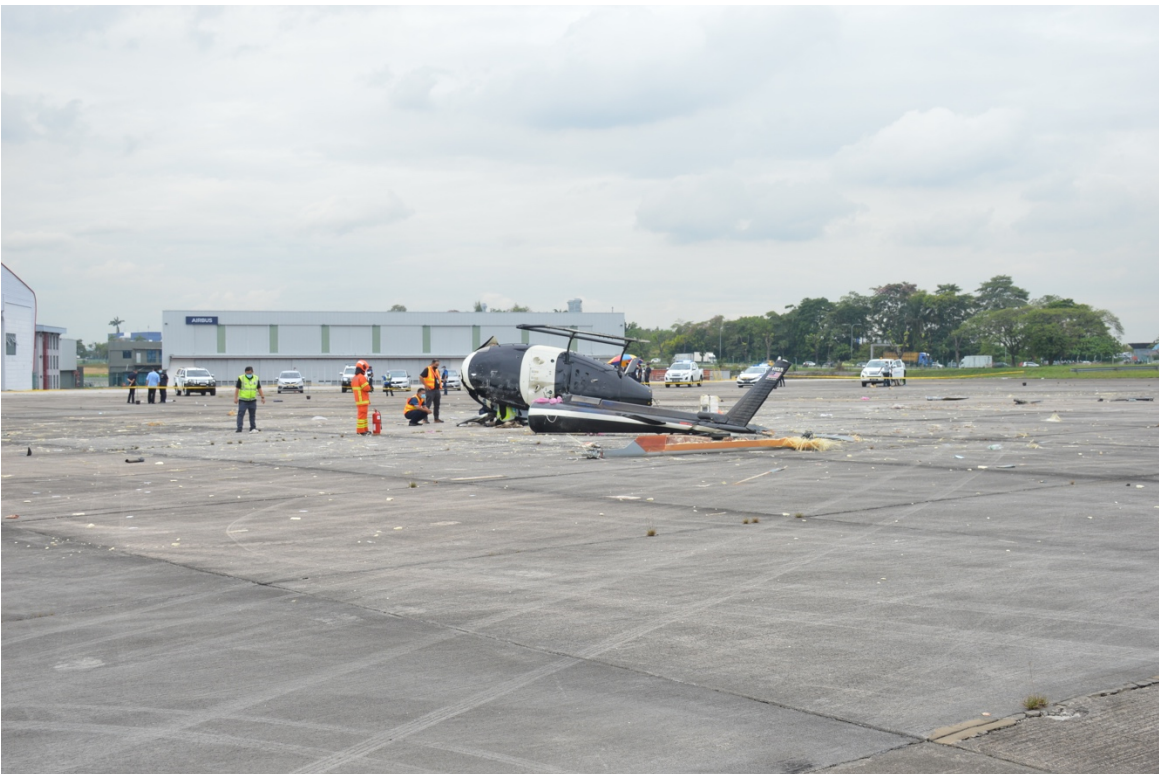
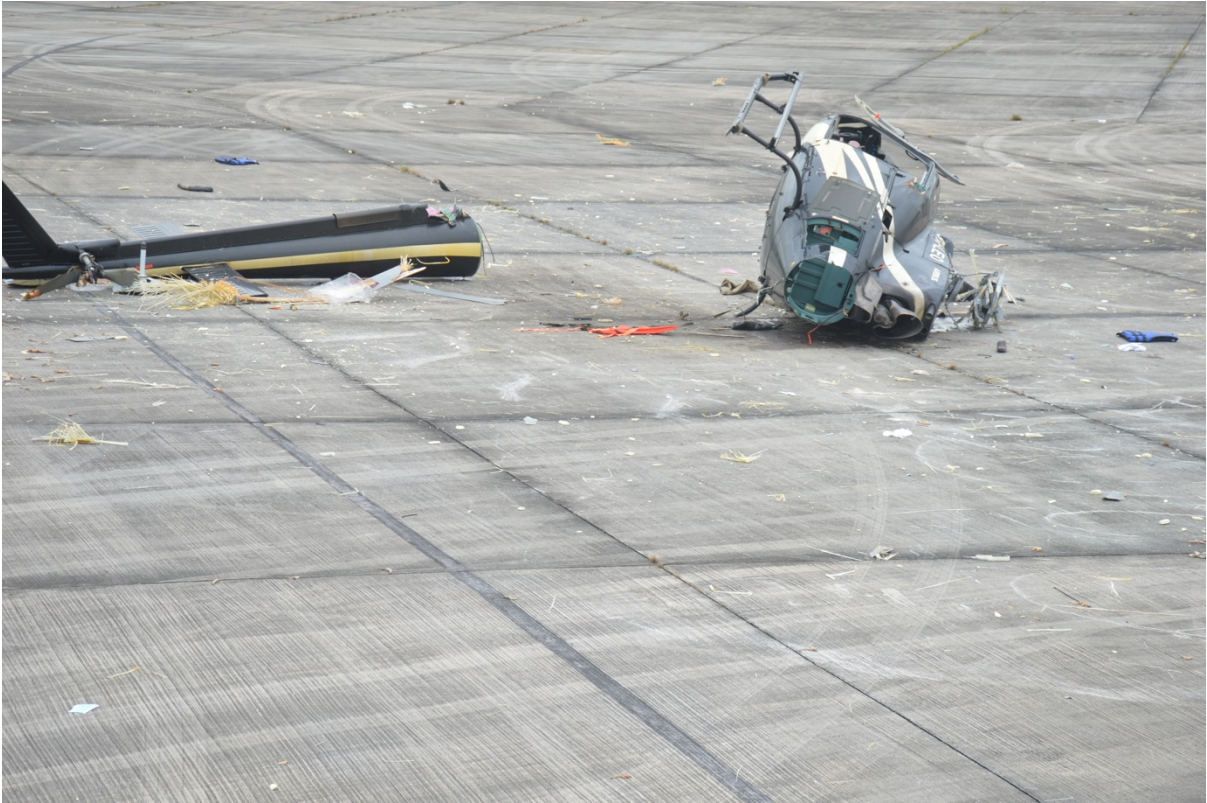
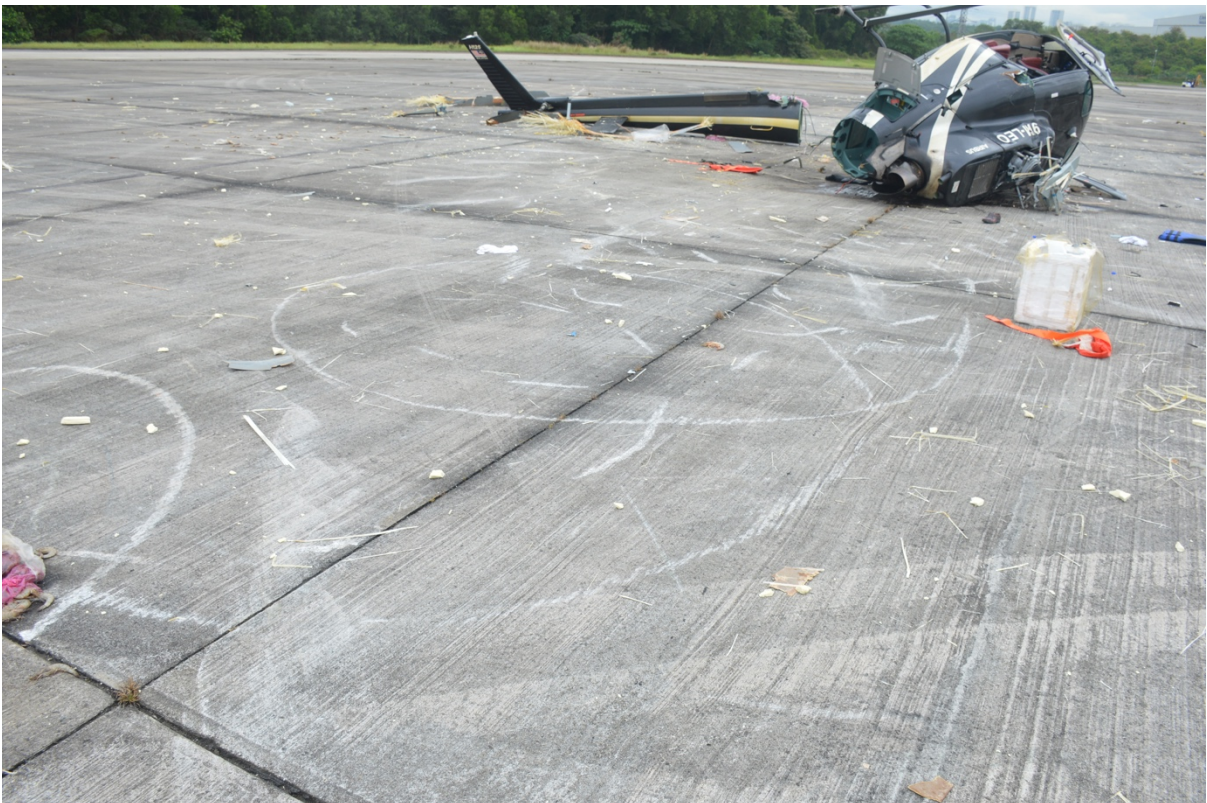
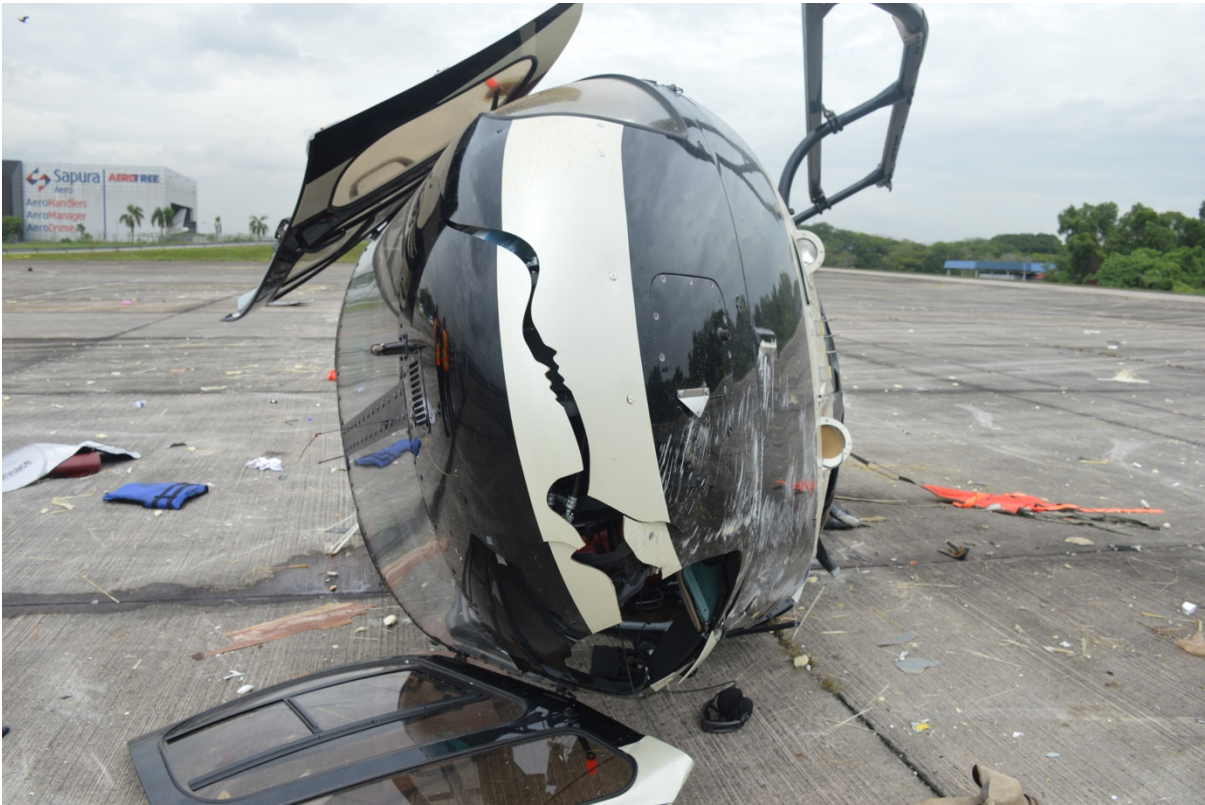
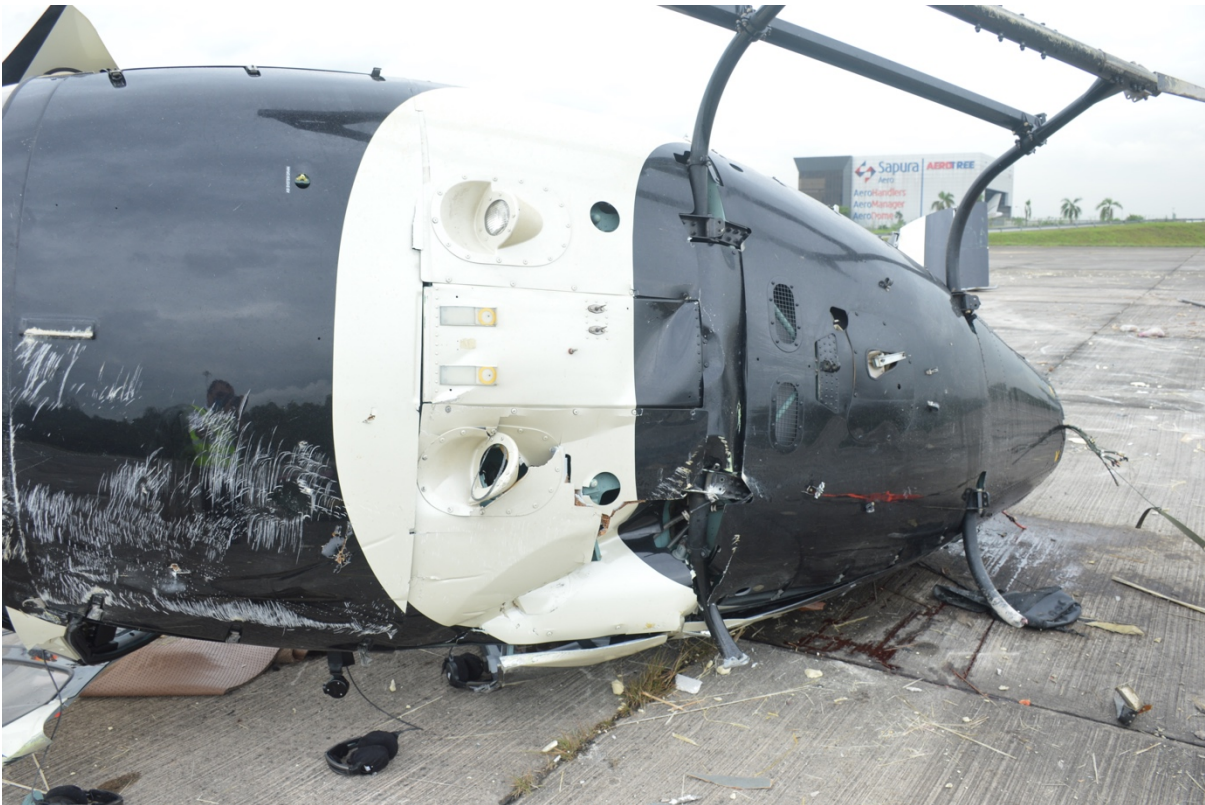
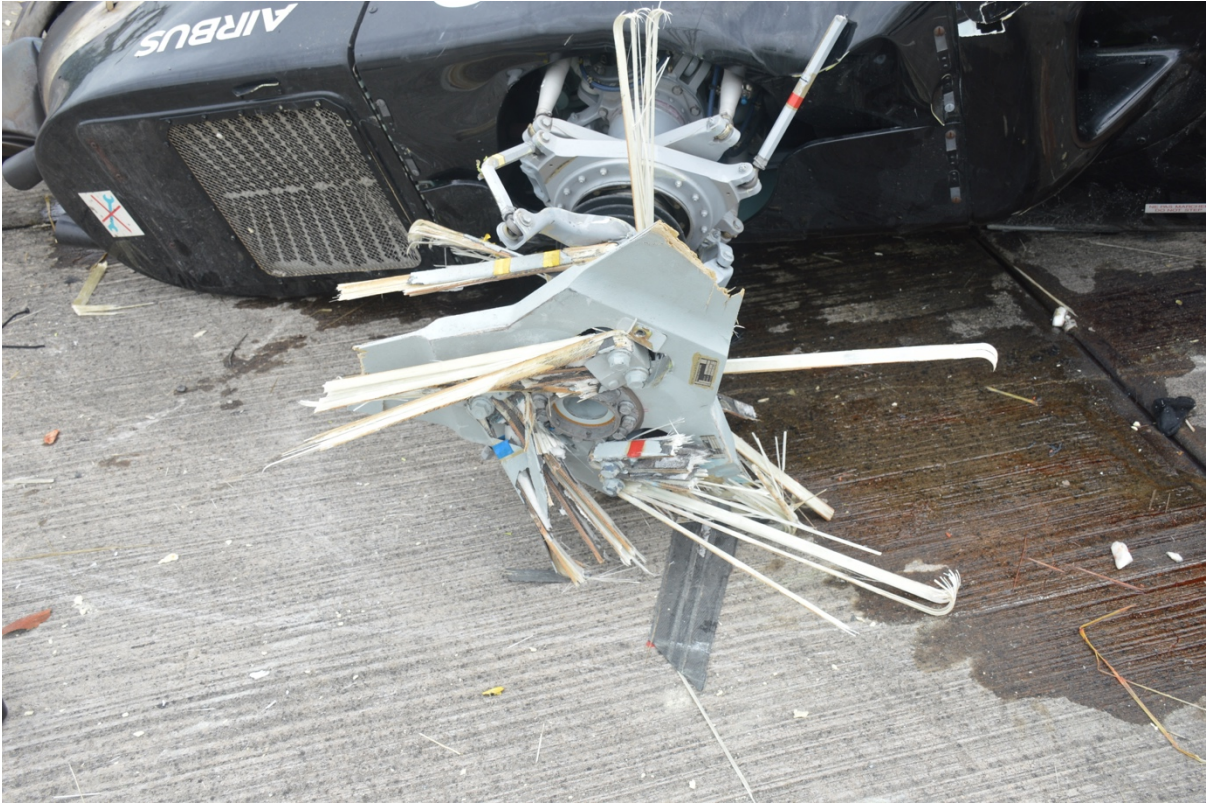
DAMAGE ASSESSMENT (IMAGES ON-SITE)

For images of damage to the aircraft on-site please refer to **APPENDIX C**. The aircraft was deemed as a total write-off.

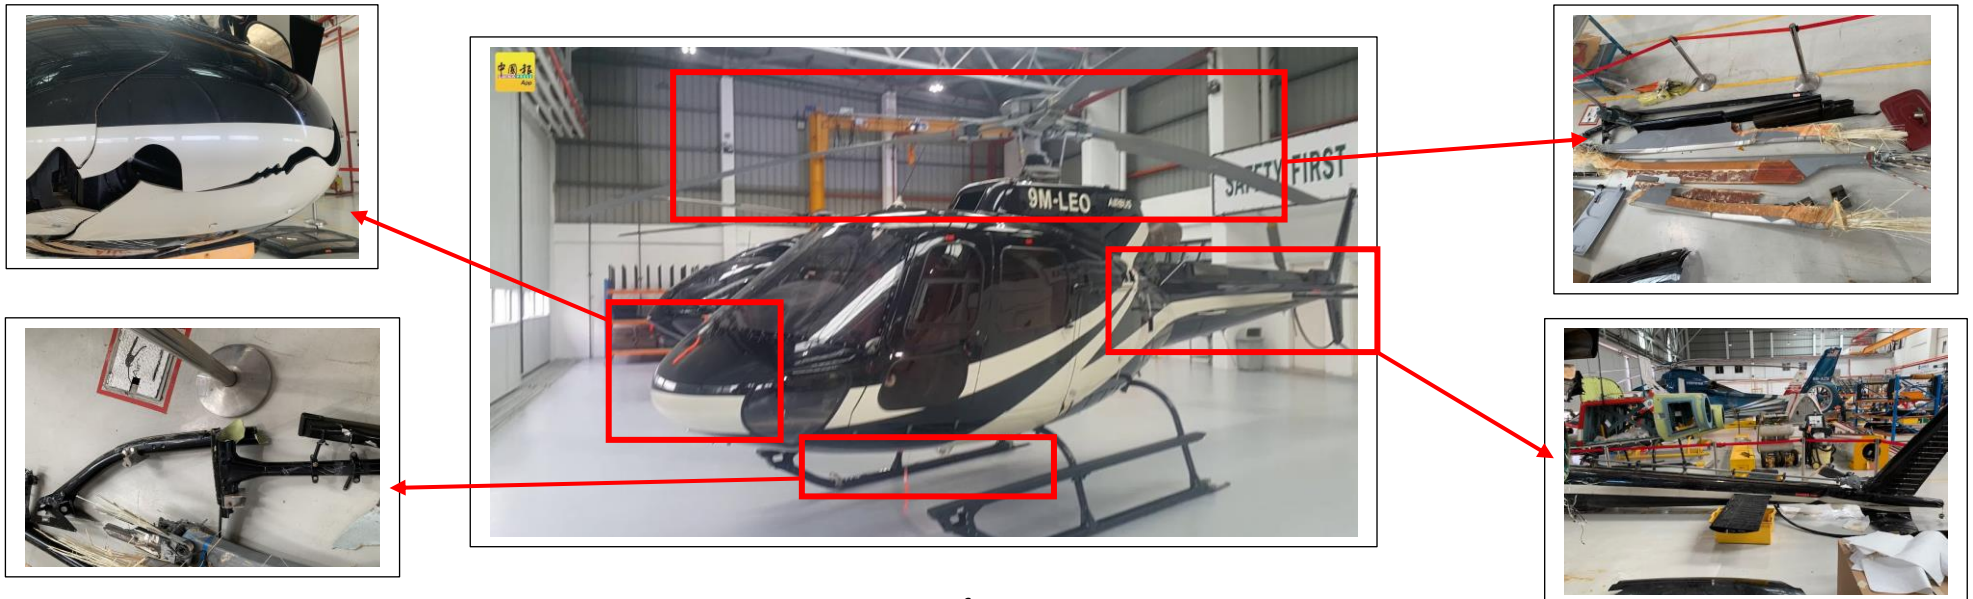
The 3 Main Rotor Blades are seriously damaged (leading and trailing edges) and exhibit impact damages.

**Figure 2. Damage on all the 3 Main Rotor Blades**

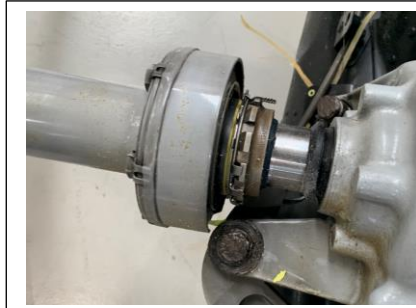
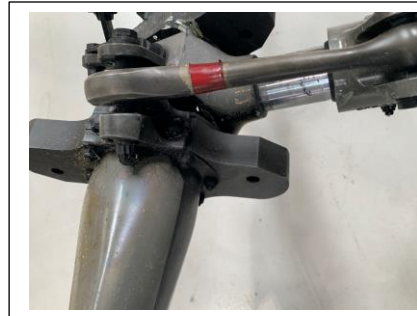
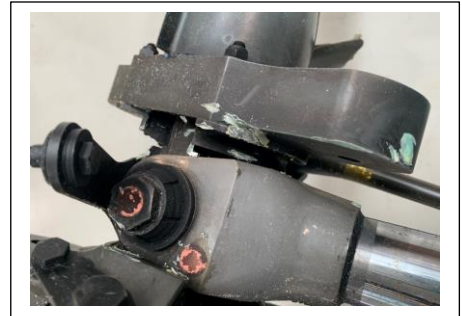
*Figure 8 - Pitch Change Spider, Pitch Link Elastomer, Tail Rotor Hub not damage and all attachments are intact.*

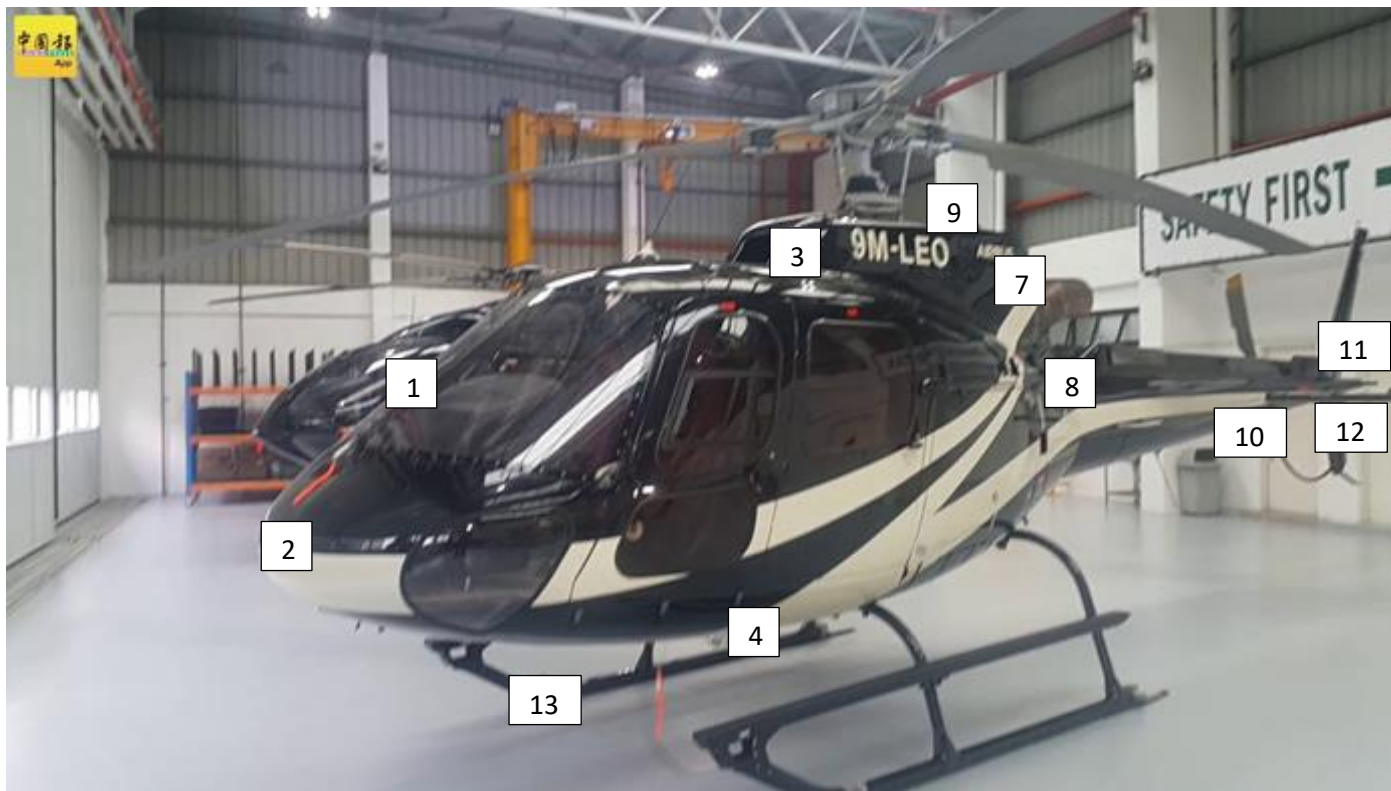
No	Damage Description	Picture
1	RH Windshield crack and punctured.

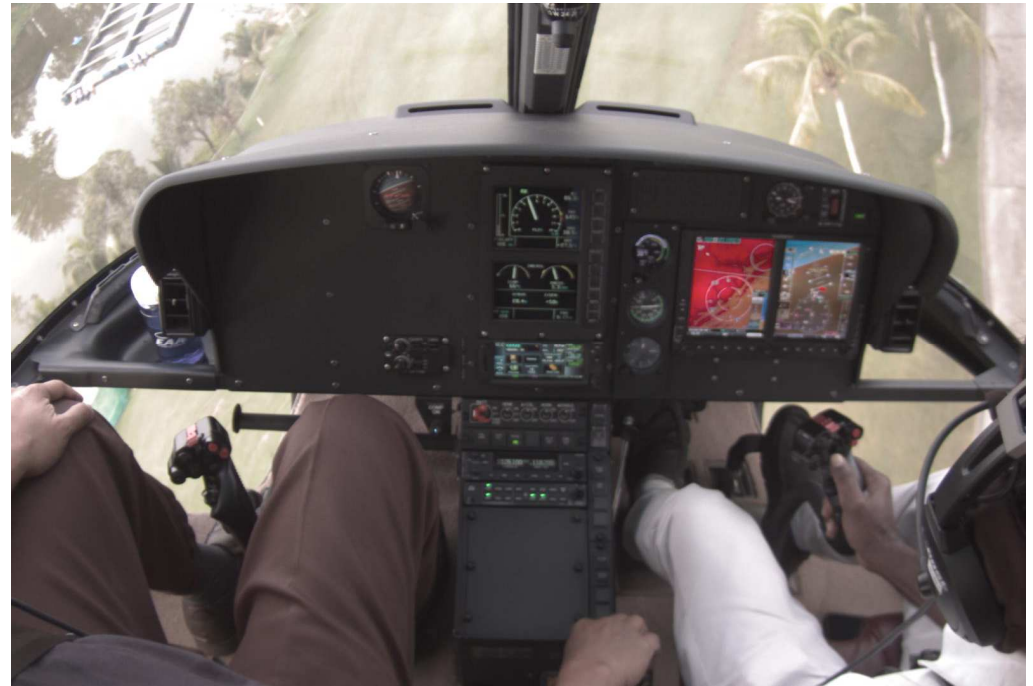
- Manoeuvre close to the ground

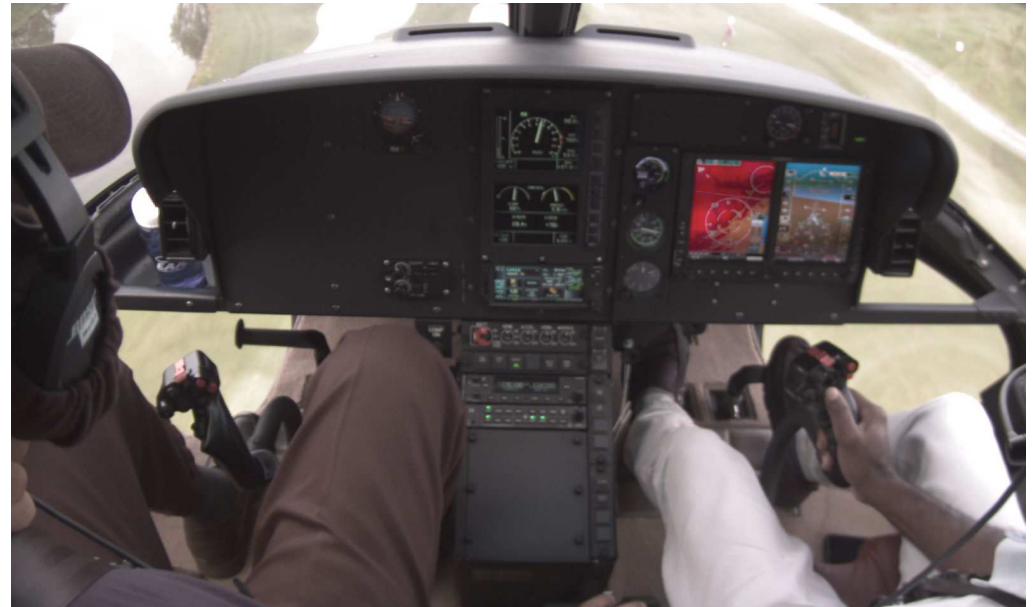
- Manoeuvre close to the ground with a bank angle increase

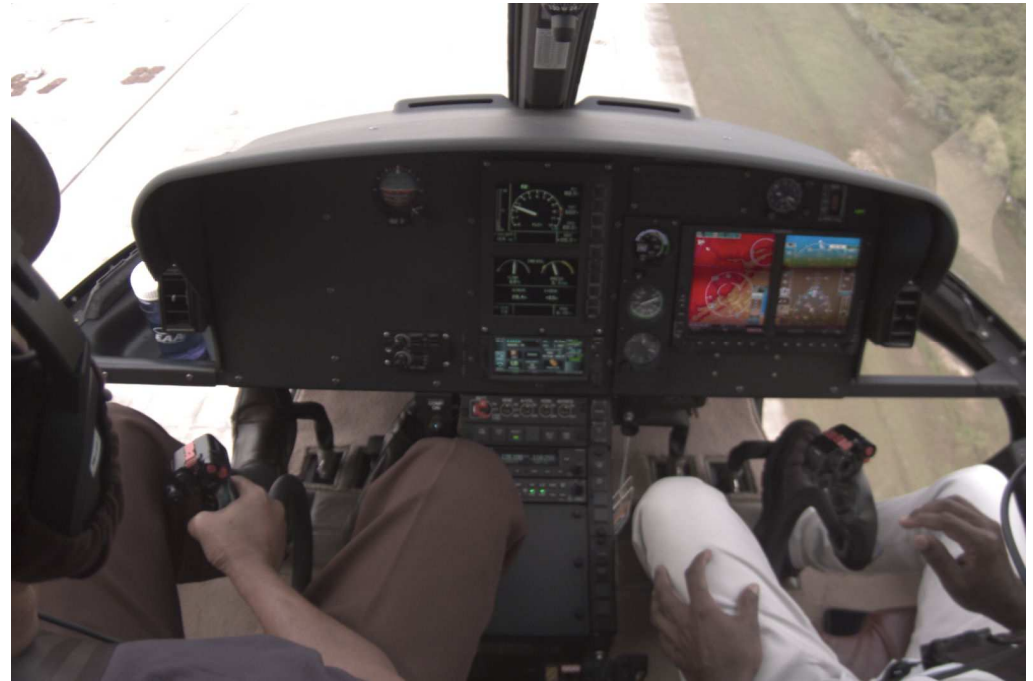
- IAS approx. 40kt heading 280°
- Low FLI

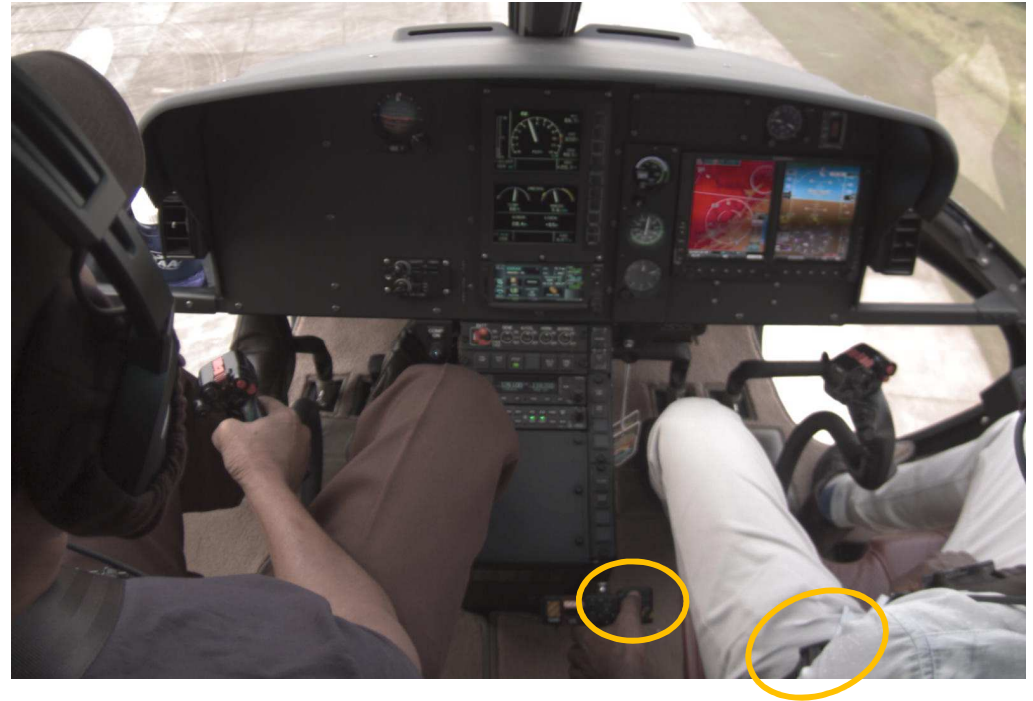
- Low speed heading 280°
- FLI increase
- RH pilot switches on the light (switch on the collective lever)
- RH pilot seat belt fastened

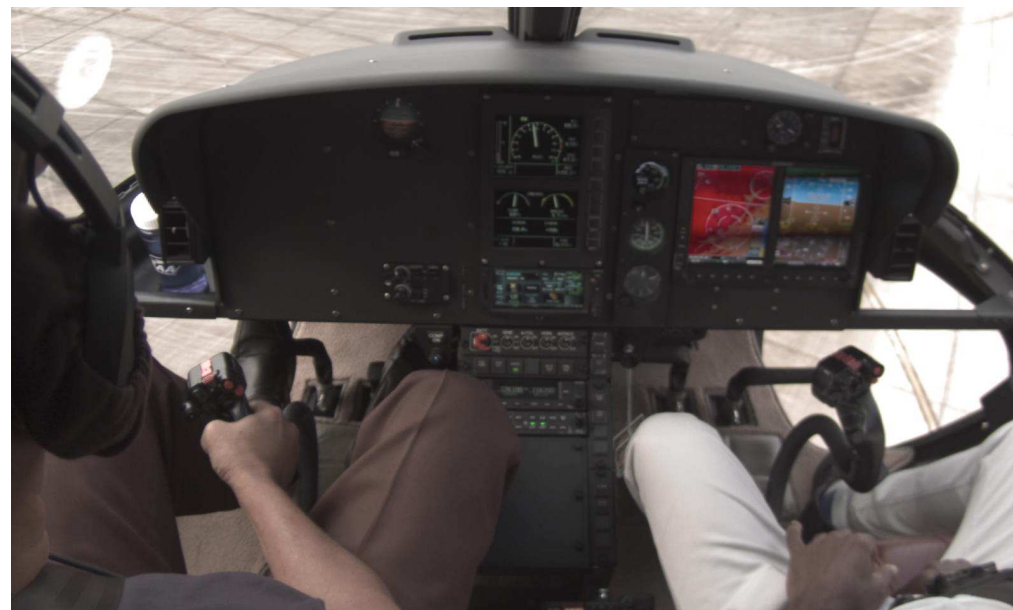
- Low speed
- FLI increase

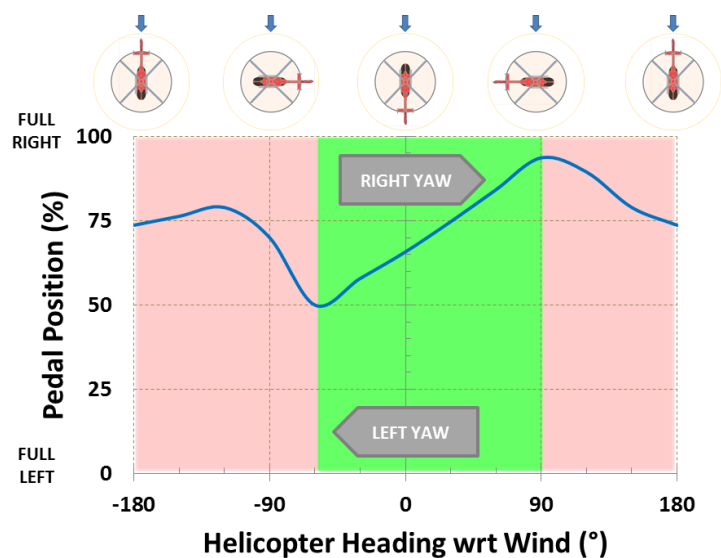
**Figure 1: Example of hover pedal curve**

An example is provided in **Figure 1**. The well-known critical azimuth, which gives the smallest pedal margin, corresponds in this Figure to about  $+90^\circ$  heading (wind coming from the left hand side with respect to the helicopter).

Where a headwind is present (green area in **Figure 1**) the helicopter is stable in yaw. If a gust alters the heading of the helicopter, from  $0^\circ$  to  $-10^\circ$  for example, the pedal position is now above the curve (the heading was brought to  $-10^\circ$  with the pedal position that existed at  $0^\circ$ ). The helicopter yaws right until it crosses the trim curve, which happens at the initial  $0^\circ$  heading. Shifted away from the trim position, it comes back to it.

On the opposite side of Figure 1 the red area represents an area of a yaw instability. When the helicopter is shifted from its trim position, it moves further away until a stable headwind condition is found. This tailwind instability is well known by helicopter pilots who are aware that yaw must be very carefully controlled when the wind approaches from behind (tailwind).

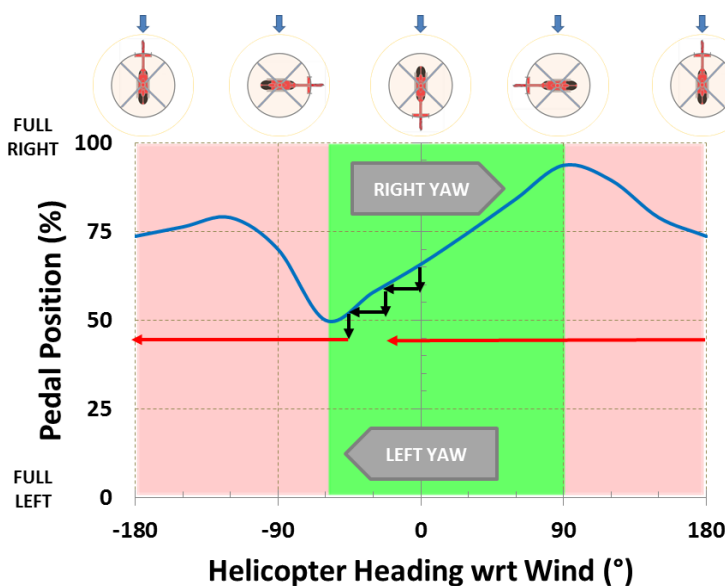
**Figure 2: Starting an Unanticipated Left Yaw**

This is illustrated in the graph in Figure 2. Starting from  $0^\circ$  wind heading, a left pedal step is made (indicated by a vertical black arrow). This brings the control position below the trim curve and the helicopter therefore rotates to the left until it crosses the trim curve, where it stops. In headwind conditions, pedal provides an attitude command: a control step mainly produces a heading step.

The gap between the current pedal position (red arrow) and the blue trim curve gives an indication of the encountered yaw rate. In the Figure 2 example, after passing the minimum of the blue curve (about  $-60^\circ$  heading), that gap increases drastically. It is not due to a pedal input, but to a trim position that is moving away. The pilot has no indication of this changing trim position and the resulting yaw acceleration is therefore wrongly perceived as being uncommanded, attributable to some external factor.

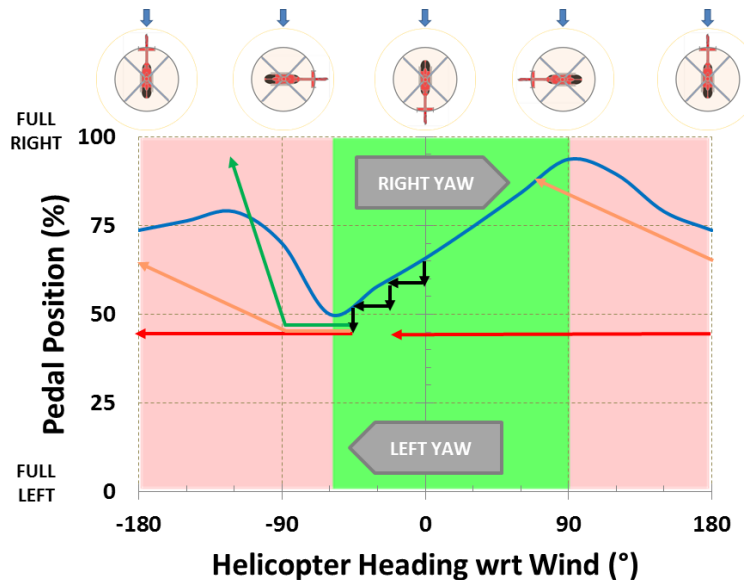
**Figure 3: Recovering from an Unanticipated Left Yaw**

The most probable reason for accidents following unanticipated yaw events is a late and too limited pedal input. The pedal curve shows that this cannot stop the yaw in the short term. During an unanticipated yaw event, the tail rotor remains fully effective and provides the best chance to recover. Yaw rate and wind conditions reduce its thrust if it is at a constant pitch. There must be counterbalance by a huge pitch increase. The only warning the pilot may get of potential loss of control is the onset of unanticipated yaw.

The apparent lack of efficiency of a limited pedal input can lead to misinterpretation of an unanticipated yaw as a full loss of tail rotor thrust (for example, as would be the case after rupture of the tail rotor drive). The symptom (unexpected intense left yaw) is similar and the short term response to a small and late pedal input is almost zero for both. Only full right pedal input will make the required difference and enable the pilot to identify whether he is experiencing unanticipated yaw or full loss of tail rotor thrust (due to malfunction) and, as a result, enable him to take the most appropriate action. If full right pedal has no effect on the yaw, it is clear that there has been a definite full loss of thrust, necessitating an immediate landing. If, however, full right pedal decelerates the yaw, it becomes clear that the issue is unanticipated yaw in character, which necessitates staying well clear of the ground and obstacles until a full recovery has been achieved.

The key feature of an unanticipated left yaw recovery is large amplitude right pedal input. Recovery may not be immediate, but will occur if the pilot persists in maintaining right pedal. In some instances, the pilot re-centered the pedal before entering again a right pedal input. This cannot help and only delays recovery from the yaw. If the yaw deceleration is not enough, more right pedal must be added, reaching the pedal end-stop if necessary.
