AIRCRAFT ACCIDENT FINAL REPORT
A 08/22P
Air Accidents Investigation Bureau (AAIB)
Ministry of Transport Malaysia

Airbus Helicopter AS355 F2 Registration 9M-SSW
in Brinchang, Perak, Malaysia
on the 26 October 2022

ACCIDENT REPORT NO.: A 08/22

OPERATOR : LAYANG LAYANG AEROSPACE SDN BHD
AIRCRAFT TYPE : AIRBUS HELICOPTERS AS355 F2
NATIONALITY OF AIRCRAFT : MALAYSIA
REGISTRATION : 9M-SSW
PLACE OF OCCURRENCE : BRINCHANG, PERAK, MALAYSIA
DATE AND TIME : 26 OCTOBER 2022 AT 1303 LT

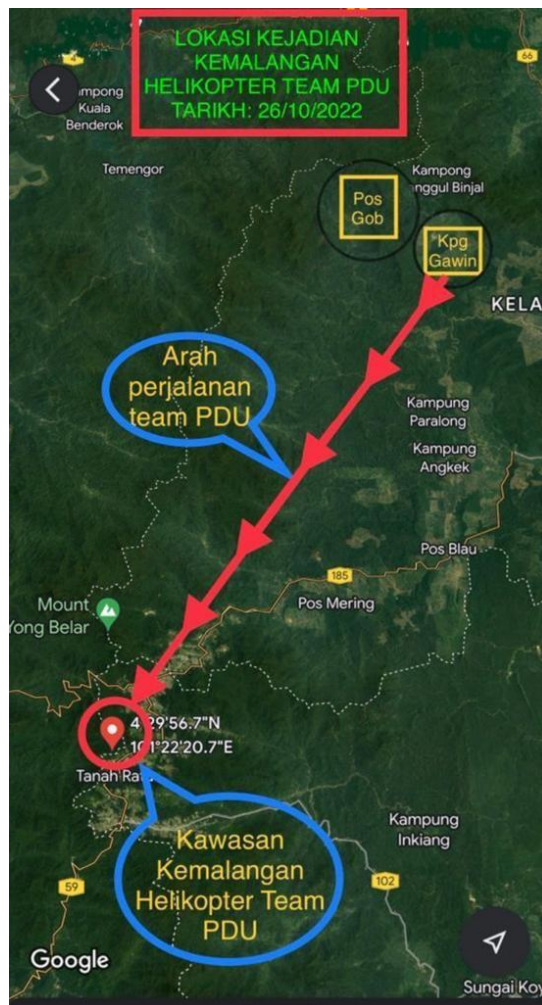
Figure 1: Flight Path (Kg Gawin to Crash Site)

On the return leg, the aircraft took-off from Kampung Gawin at 1241 LT for Hospital Tanjung Rambutan (Figure 1). Upon reaching the reporting point of Kampung Raja, the pilot observed heavy rain with embedded CB clouds and decided to deviate and track towards Brinchang where a clear opening between the cloud base and a mountain ridge was sighted.
