FINAL REPORT

A 03/22

Accident Involving Fixed Wing Aircraft

Piper Warrior II PA28-161, Registration 9M-BAA

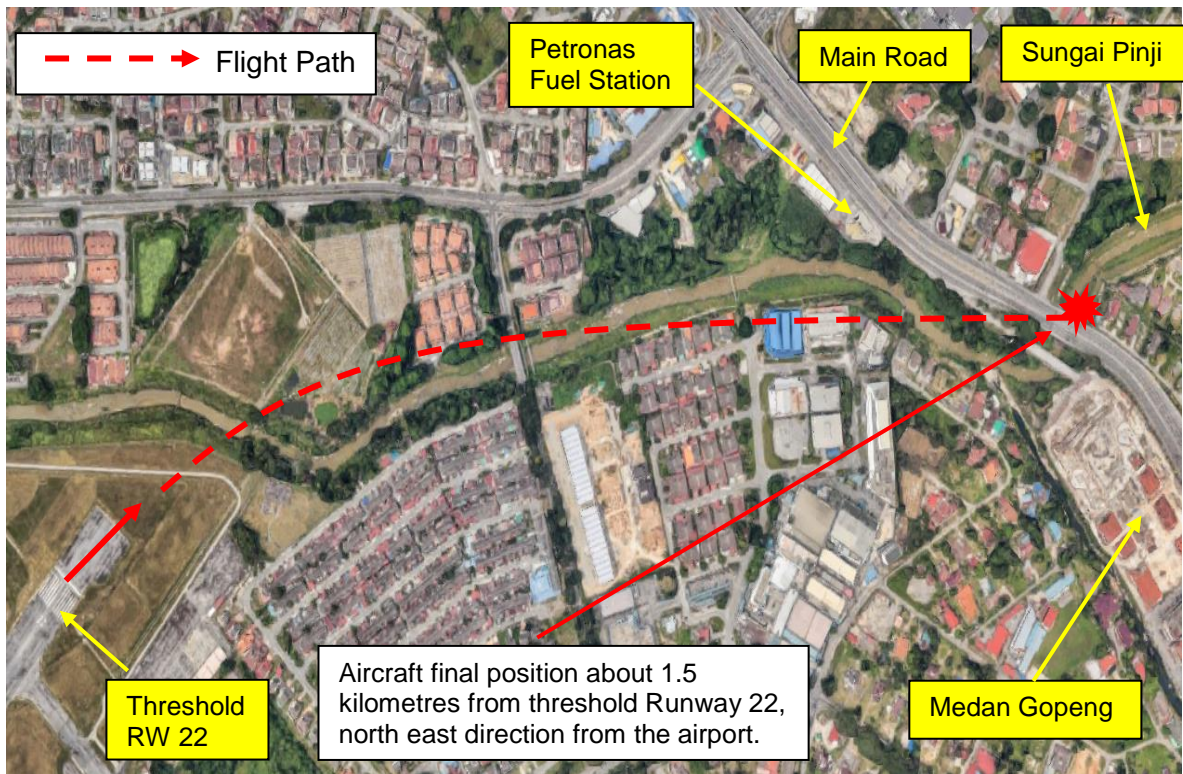
Figure 16: Flight path and final position of aircraft (Diagram not to scale)

The aircraft's right wing hit a lamp post situated on a road bridge and the wing broke into two. It then veered right and rotated 180° slamming into the side of the water diversion culvert, aircraft belly first before coming to a rest with the aircraft nose facing vertically down. The aircraft suffered major damage to the right side, undercarriage, engine nacelle lower section and rear T-tail plane.

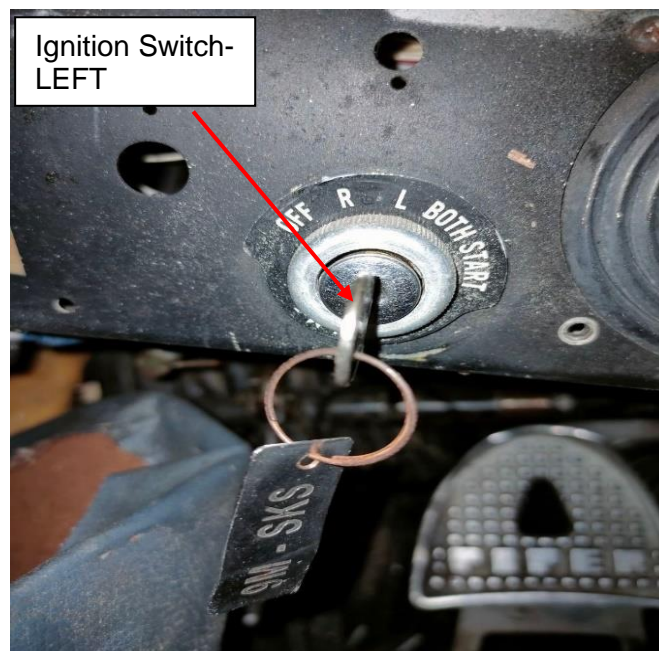
Figure 19: Ignition Switch Position on the Aircraft Wreckage

Evidence at the aircraft wreckage shows that the Magneto Switch was at 'L' (Left) position and the Carburettor Heat Lever at 'ON' position. The Fuel Selector was selected to Left Tank. The Throttle Lever was at 'CLOSED' and Mixture Lever was at 'IDLE CUT-OFF' position. One propeller had bend inwards after impacting the lamp post while the other blade was in normal condition with some scratch marks. Flaps were observed to be at UP position (Figure 18 to 23).

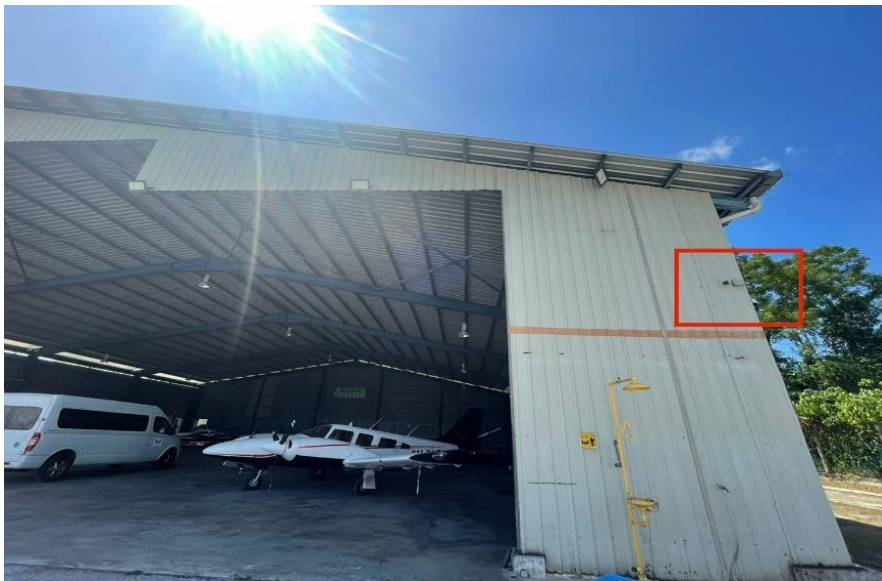
Figure 33: CCTV Camera location

There is a CCTV camera located at the left side of the FTO Hangar view towards the direction of the dispersal area and runway (Figure 33). Observation revealed that this camera is 'motion activated' type and focus mainly on the right side of the dispersal area (Figure 34). It is also observed that the recording time is not synchronised to the actual real time as it indicates about 15 minutes ahead compared to actual real time.

The location of the CCTV camera resulted in no recording of activities on the left side of the dispersal. The aircraft 9M-BAA which was park on the left side of the dispersal was not seen in the CCTV recording. There was no continuous recording which would have provided critical information on events taking place on the runway, taxiway and dispersal area. The inaccurate time of recording also does not give real time information when an event which is time critical happens.

The Aircraft Operator should consider to place at a suitable location a 180° or 360° view CCTV camera with continuous recording for safety and security reasons. There is also a need to ensure the CCTV system is operating normally. It will assist in any incident or accident investigation and provide evidence if there is a breached of safety or security.

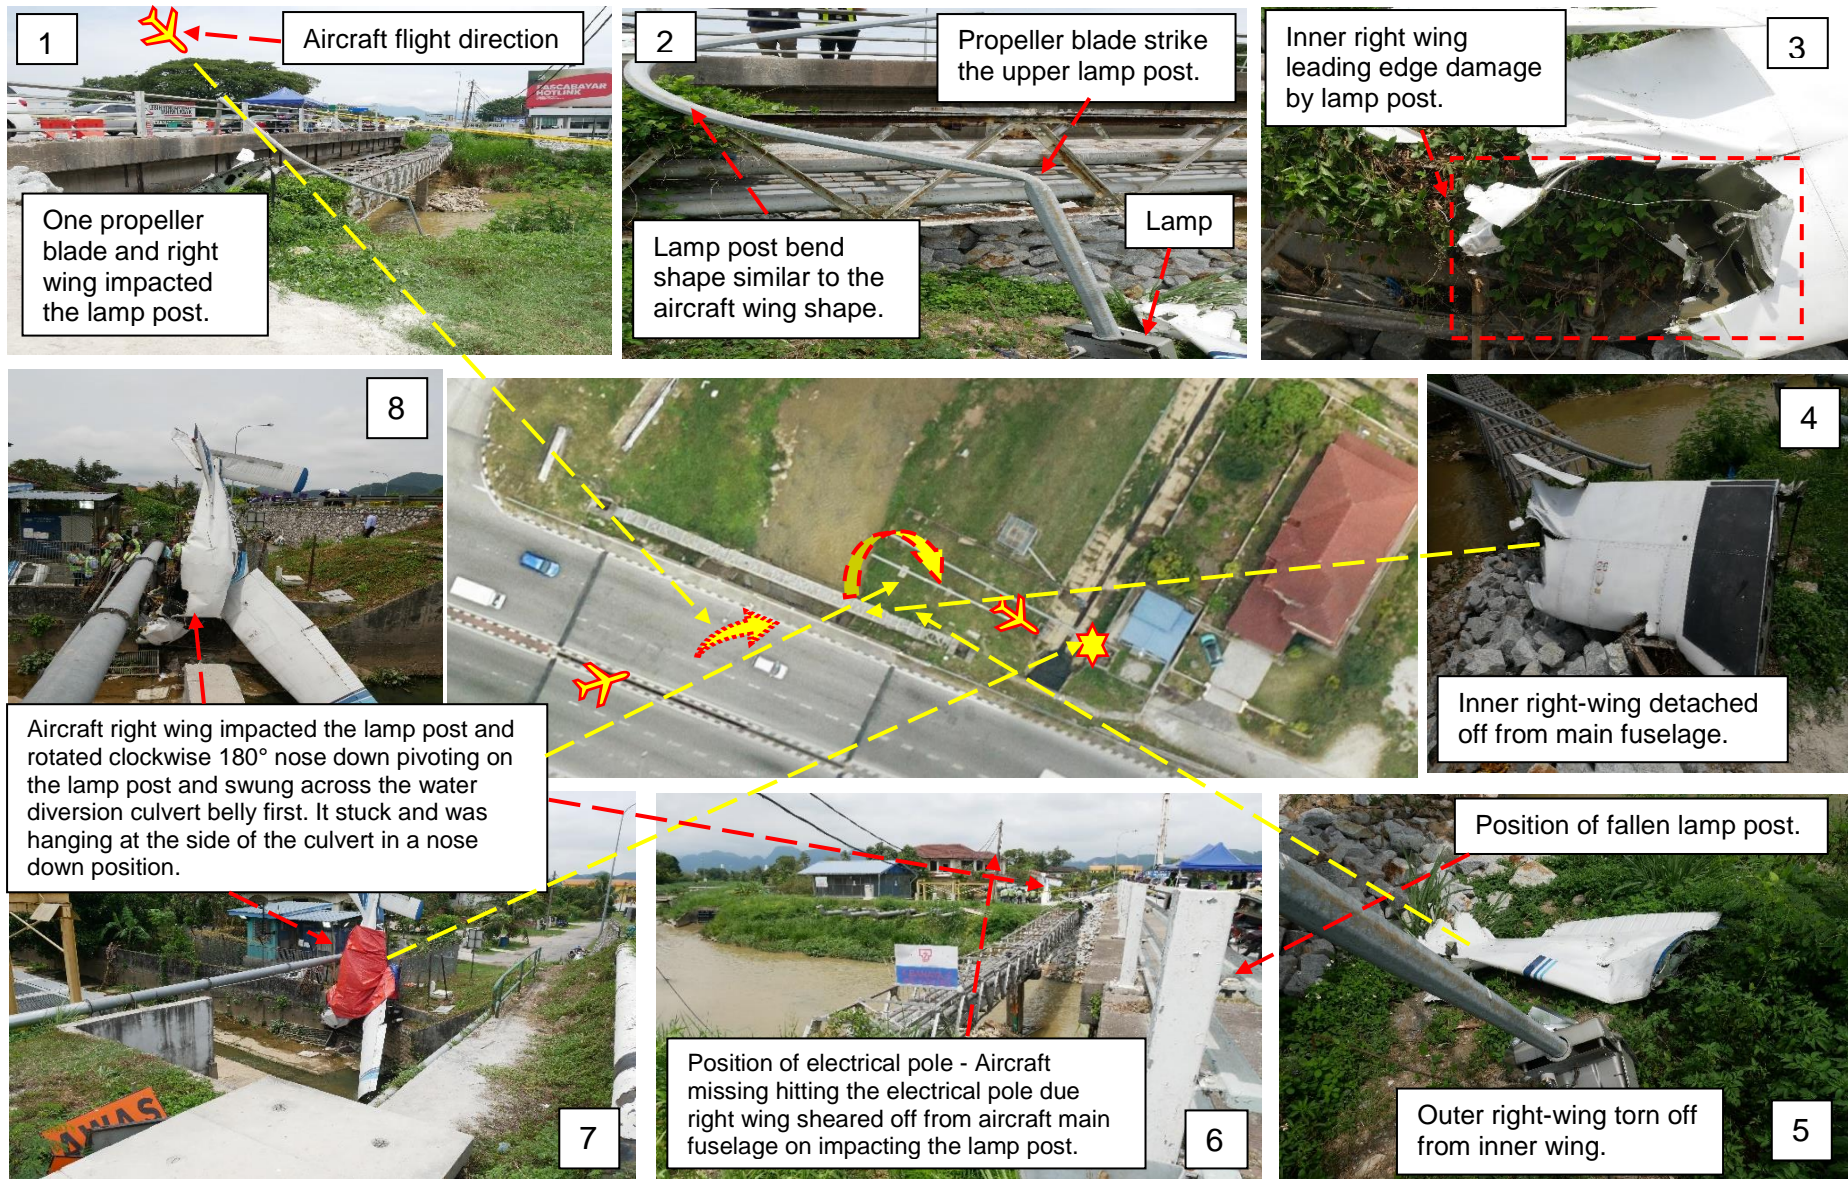
Figure 39: On-site investigation sequence of event

Photo 6 & 7 – The aircraft's right wing impacted the lamp post and rotated clockwise 180° nose down pivoting on the lamp post and swung across the water diversion culvert, belly first. When the aircraft swung across the culvert, it missed hitting an electrical pole as the right wing had sheared off from the aircraft main fuselage.

Photo 8 – The wreckage stuck and was hanging at the side of the water diversion culvert in a nose down position.

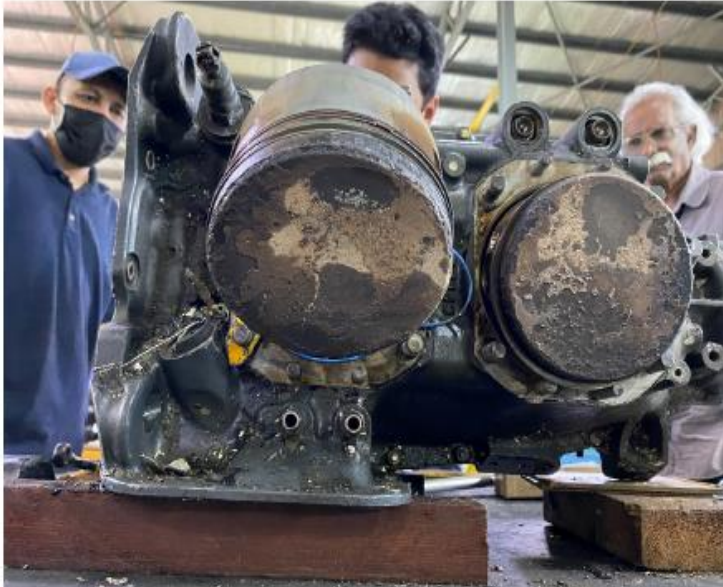
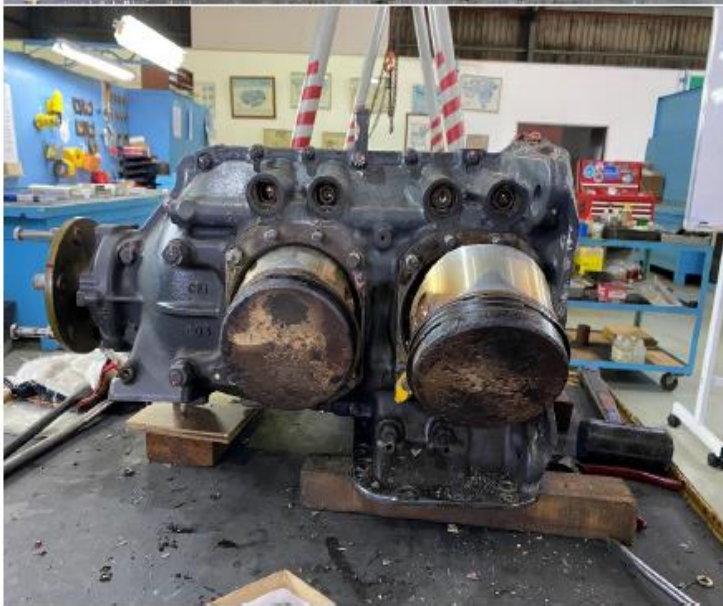
Note: Barrel removed off the engine.

- x. Removing cylinder barrel and inspected for condition. No damaged found except for cylinder No. 1 cooling fin (damage due to impact). FOUND SATISFACTORY.
